# — BACK TO THE FUTURE: —

## ROOF DECKS QUICKLY CORRODED BY INSULATION

By Chuck Marvin, RRC, and Bruce Byrne

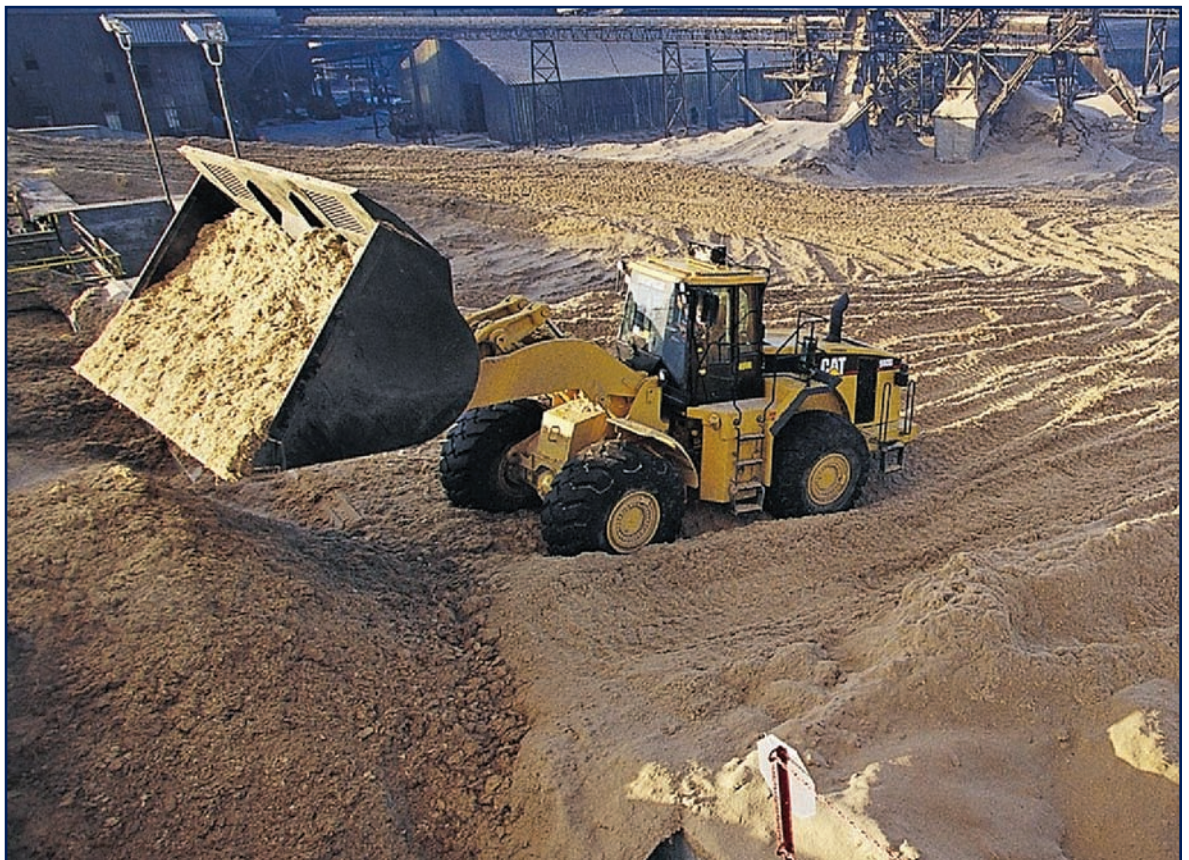
Photo 1 — Typical activities at a wood fiber manufacturing plant.

fields near a plant, and when it was needed for production purposes, it was moved onto conveyor belts to transport the raw material into the factory for subsequent production (see *Photo 1*).

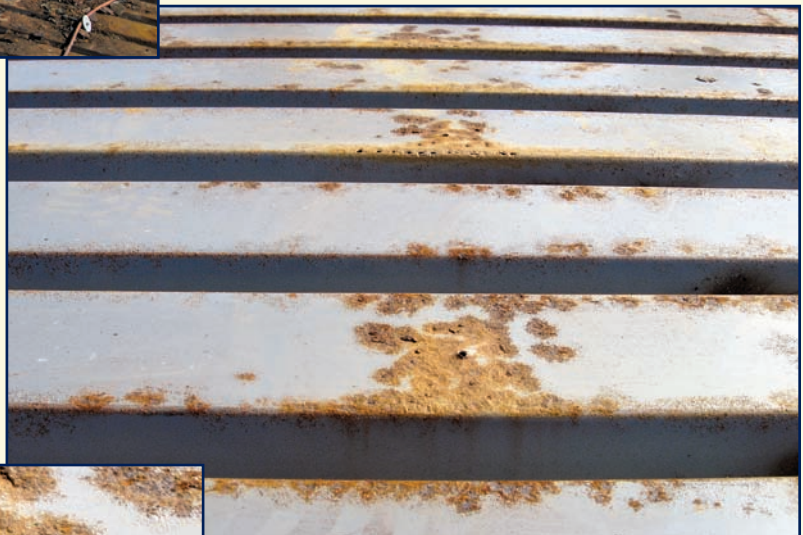
*Photo 6 — Perhaps 60% to 70% of the deck area under the roof exposed by a full tear-off was found to be in this condition and treated with a rust inhibitor.*
