— BACK TO THE FUTURE: —

ROOF DECKS QUICKLY CORRODED BY INSULATION

By Chuck Marvin, RRC, and Bruce Byrne

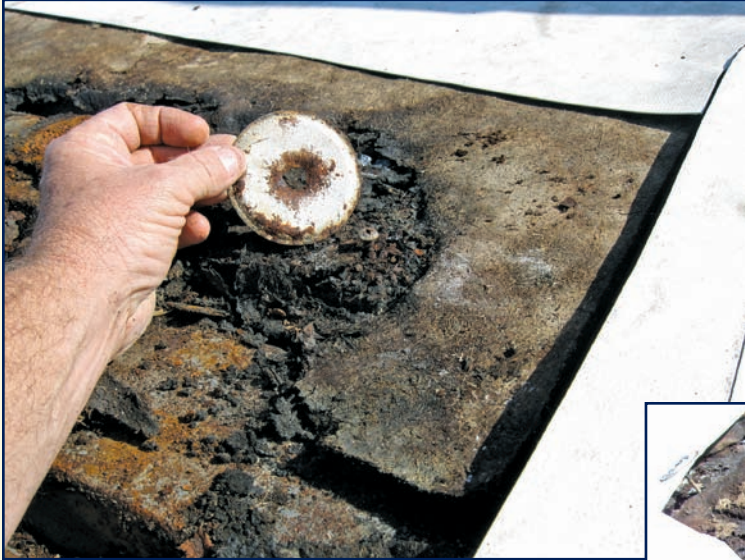
Photo 2 — Note the burned-looking insulation at this severely deteriorated location. This was common on all significantly compromised deck areas, including those replaced to address fall-through potential. This is typical of what was sent in originally for testing and showed lower levels of chlorine on all components.

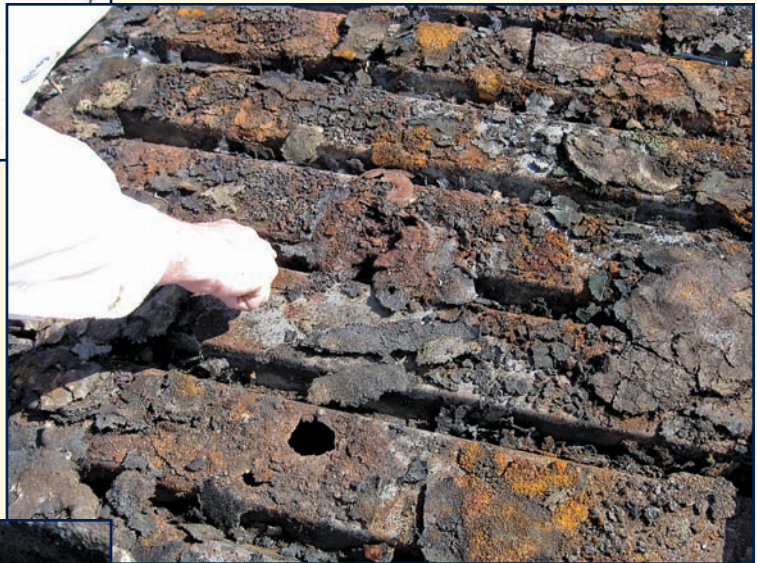
Photo 3 — The severely compromised locations are small but numerous and randomly dispersed. The roof area encompassed between 5% to no more than 10% of the deck area. The two buildings addressed were only six and eight years old. The deterioration is stunning and created a very real safety issue. We suspect deck failure will accelerate exponentially.

We encourage all firms to identify, where possible, the use of sugarcane-based wood fiber insulation in past designs or in the assets they manage. Although roof performance is an issue, the main emphasis here is safety. In one of our three buildings, a dozen areas required immediate replacement due to the potential for falling through the roof. One of the three buildings had its deck painted in recent years, making corrosion difficult to identify from below. We suggest RCI, Inc. consider acting

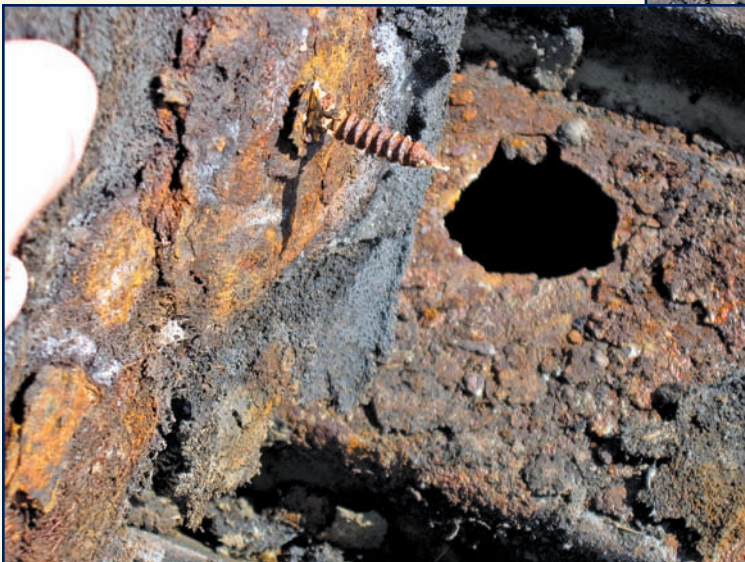
Photo 4 — The fasteners and plates were severely attacked.

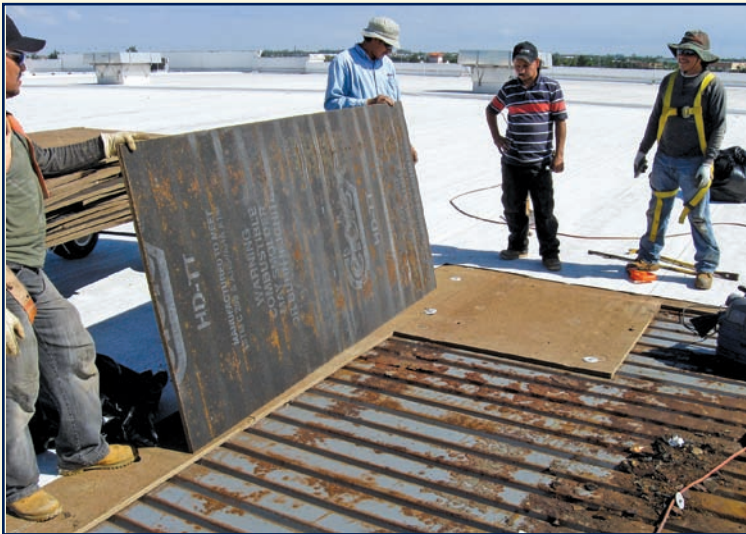
Photo 5 — This is a typical location where the insulation board is not visually deteriorated, other than minor discoloration. Rust streaks are observed on the insulation. This insulation is typical of what was sent in for a second round of testing, revealing a high level of chlorine concentrated in the insulation.

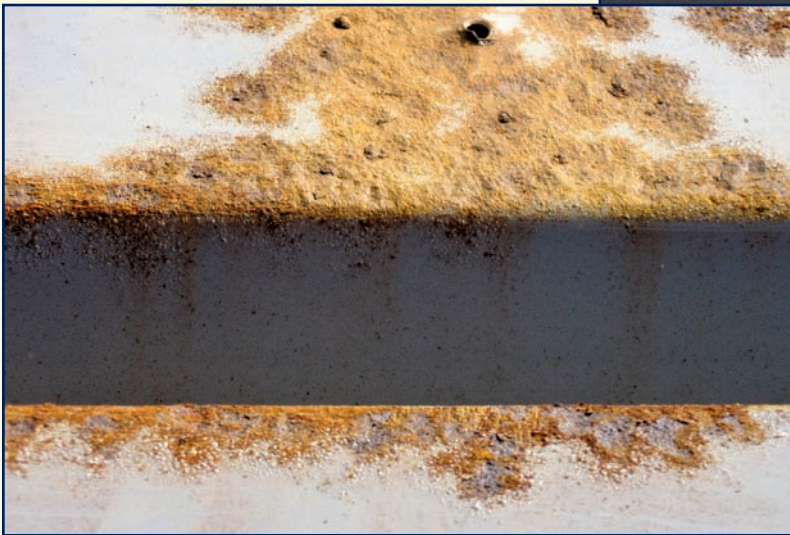
Photo 7 — A close-up of Photo 6 shows pitting and scale are developing. This was a former plate-and-screw location; the condition appears to accelerate at these locations.
