# LESSONS LEARNED FROM CURTAIN WALL FAILURE INVESTIGATIONS

By Derek B. McCowan, PE, and Joshua B. Kivela, PE

*Editor's Note: This article is reprinted from the Proceedings of the RCI 2010 Building Envelope Technology Symposium in San Antonio, TX, November 8-9, 2010.*

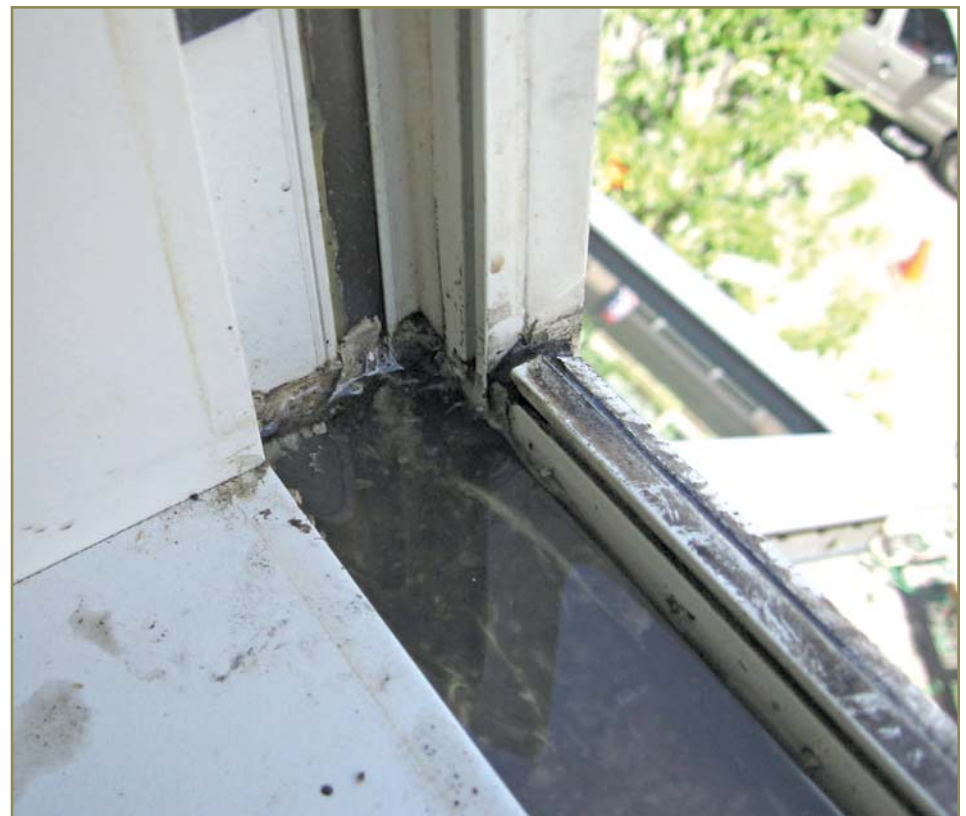
**Photo 2 - Water ponding in curtain wall.**

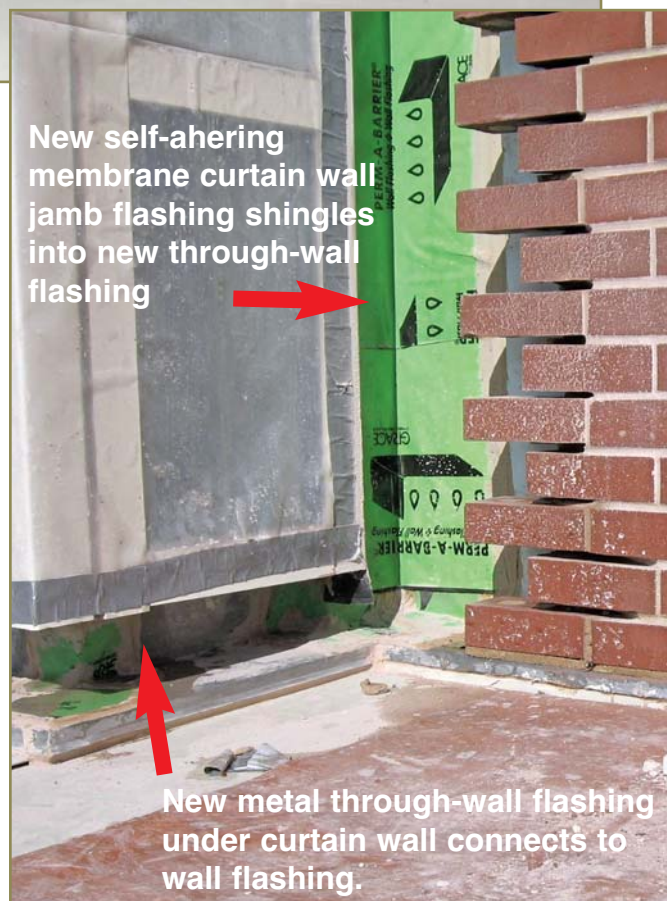
**Photo 4 - Continuous copper and membrane sill, through-wall, and jamb flashing.**

Repairs involved removing the rowlock brick below the curtain walls, “toothing out” the running bond brick at the sides of the curtain wall, and installing new continuous through-wall and jamb flashing (*Photo 4 and Figure 1*). An alternative cost-saving option was discussed that involved saw-cutting a straight vertical joint through the head joints in the brick veneer; however, this option was ultimately rejected. The repairs were complicated by the lack of working room formed by the inside corners between the brick walls and the curtain wall bays.

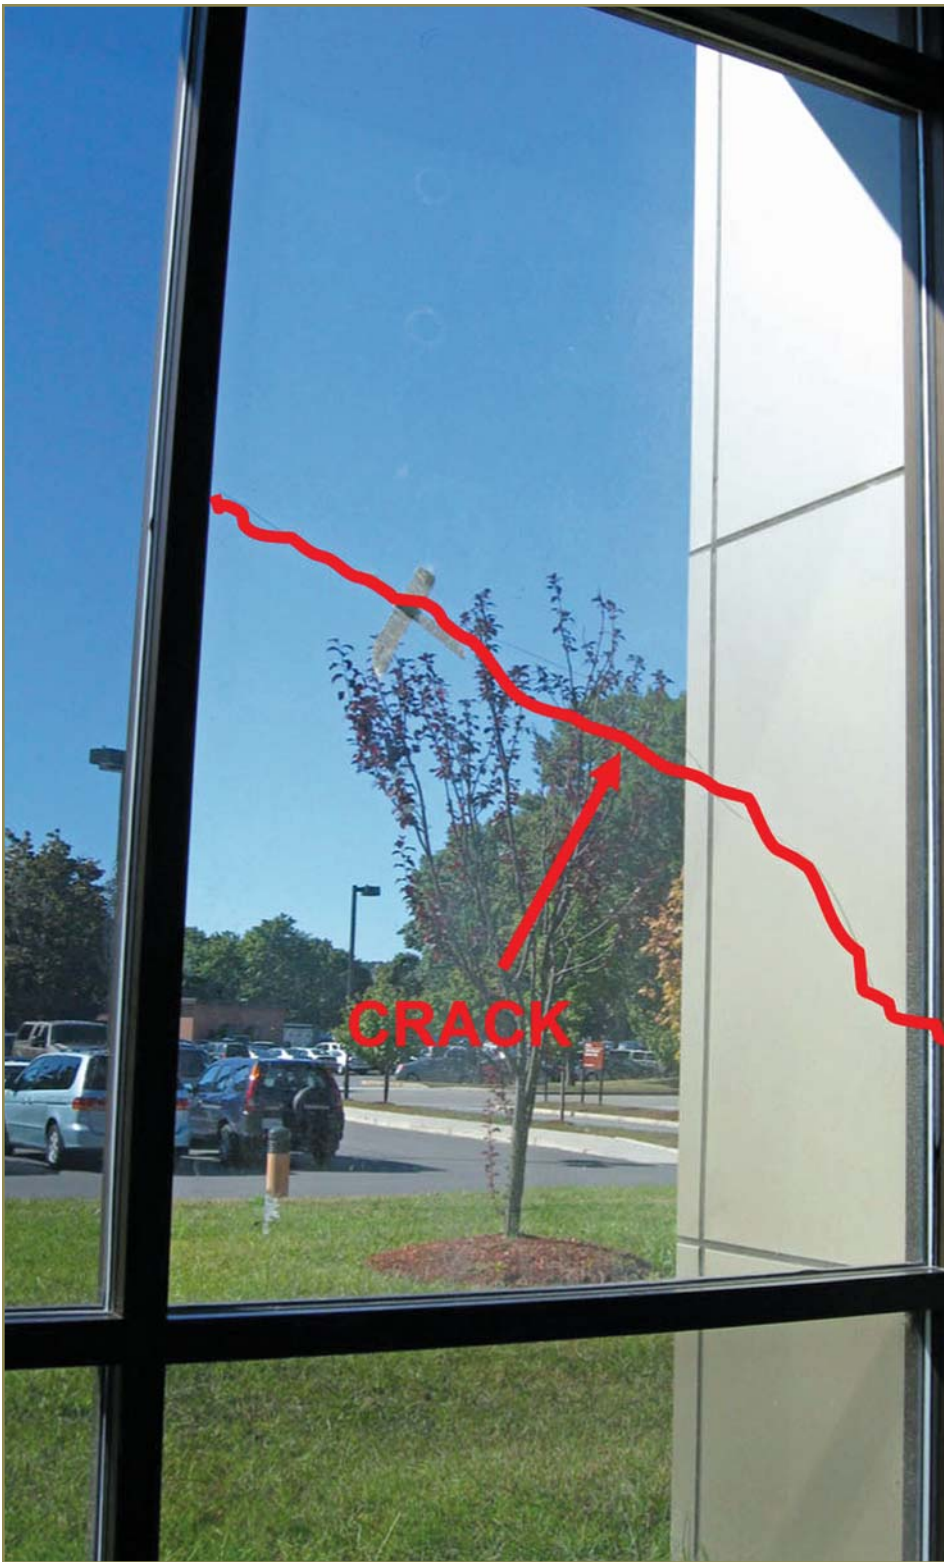
We investigated the cause of insulated glass (IG) units that were breaking at a recently renovated office building (Photo 9). The window installer removed several IG units and observed that glass-to-metal contact was the cause of some of the breaks. However, the installer could not provide an explanation for all of the cracks. We visited the site and found two crack patterns in the glass. About three quarters of the cracked IG units had cracks that ran perpendicular to the edge and surface of the glass (indicative of thermally driven breaks). The remaining one quarter of the IG units had cracks that did not run perpendicular to the edge. All of the IG units had a postapplied tint film on the interior surface (for increased occupant comfort) and vertical blinds in the offices. Cracks were occurring on the south and east elevations only and in IG units with and without postapplied film.

**Photo 9 - Crack in IG unit.**

Our analysis showed that a stronger glass, such as heat-strengthened glass, could handle the high thermal stresses. The owner replaced the cracked IG units with

heat-strengthened glass of the same thickness and size. Antiwalk blocks were installed during reglazing to prevent the glass from moving laterally and contacting metal.

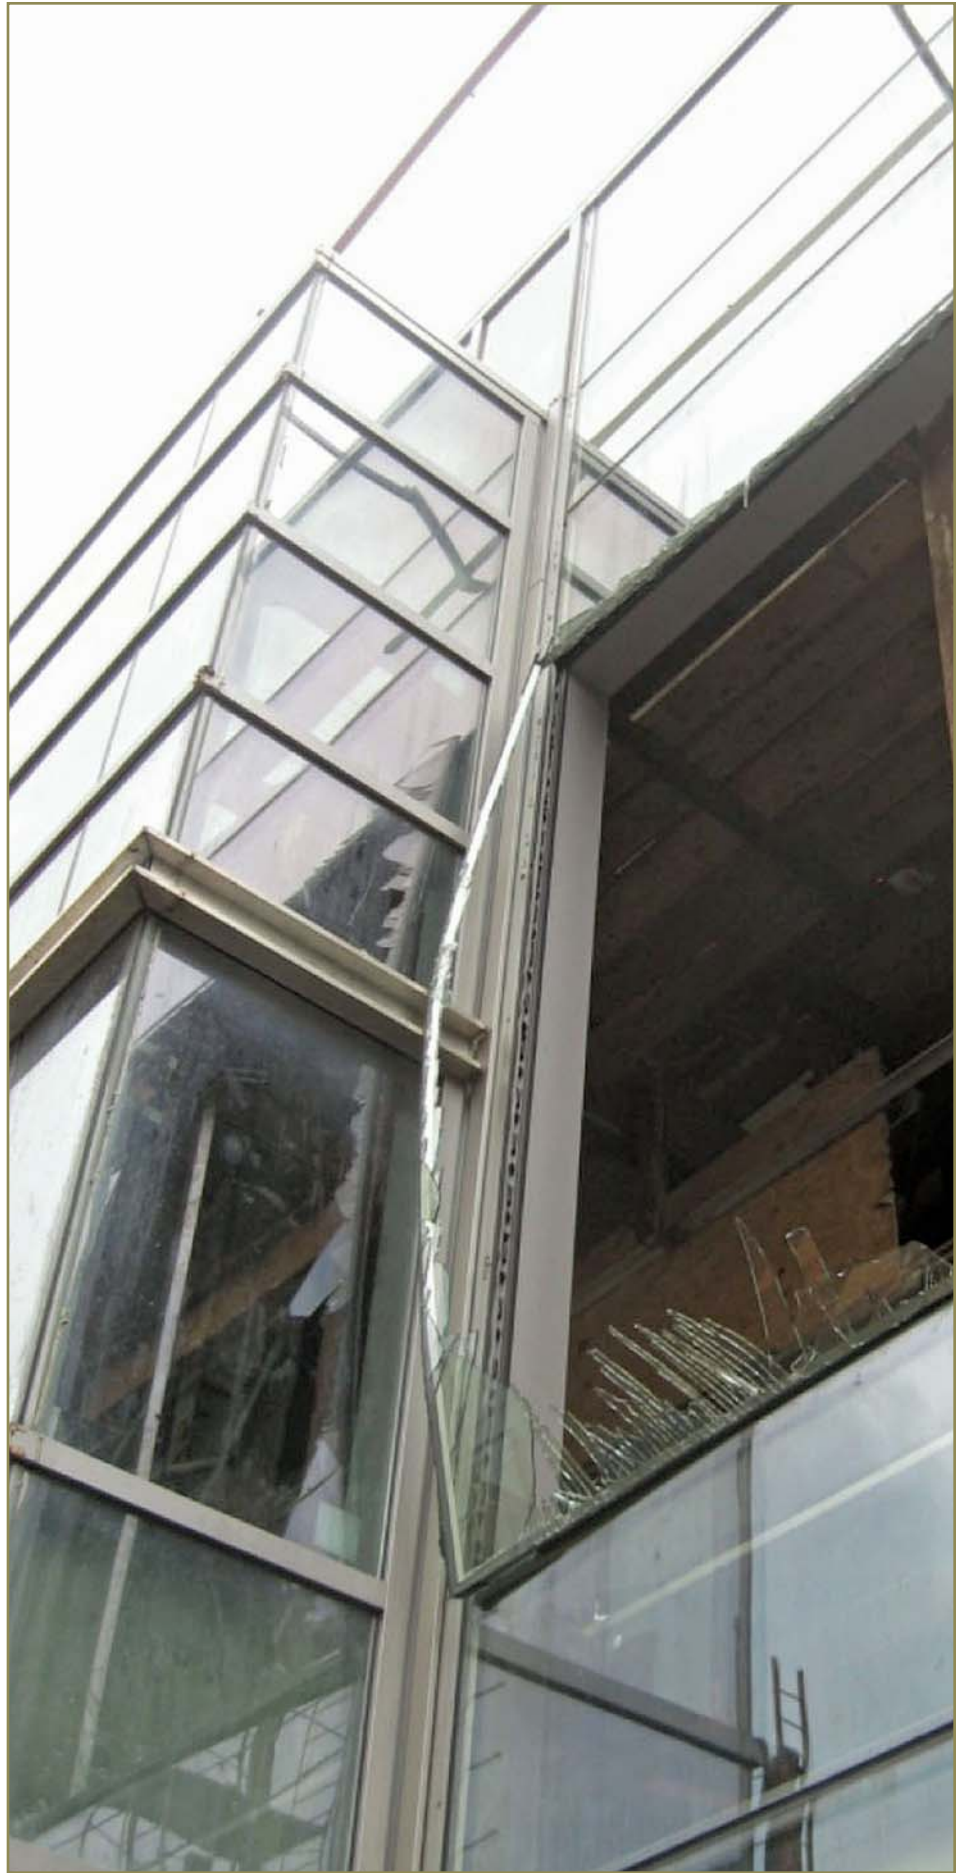
We reviewed the remnants of the glass and glazing materials at the opening of the failed unit (*Photo 11*). The spacer bar along the noncorner jamb was fully disengaged from the clips, and the spacer bar was bent at various clip locations. We noted damage to the interior pane of glass at more than one clip location, with the most severe damage located approximately 12 inches up from the sill corner. The structural silicone and low-profile aluminum tube at the corner were undamaged.

*Photo 11 - Curtain wall after 150% design load test.*

contacted the edge of one of the aluminum clips as the glass unit exited the opening, resulting in breakage.

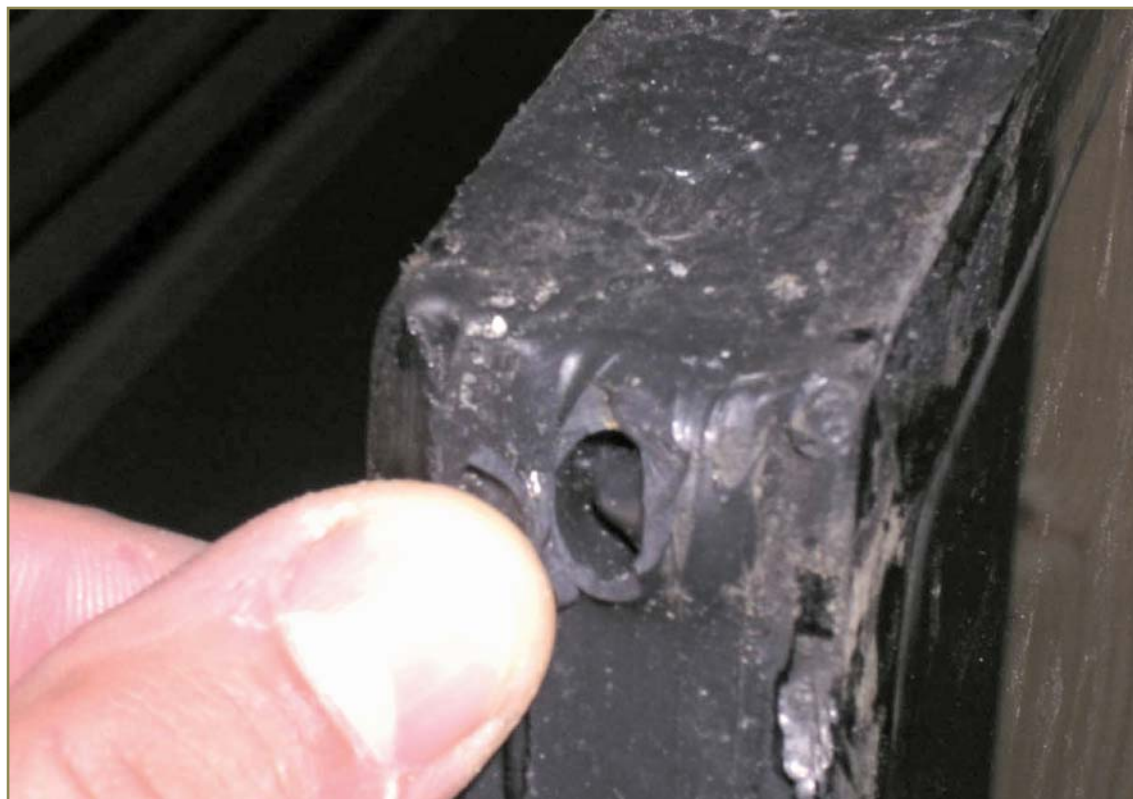
In addition to the debris issue, the insulating glass hermetic seals were faulty at failed units. We deglazed several units and inspected them up close at a curtain wall subcontractor’s shop. Upon close inspection, we noticed an open “blister” in the silicone secondary seal at one corner (*Photo*

*Photo 12 - Open blister in silicone secondary seal at the corner of an IG unit.*

12). The blister aligned with an unsealed keyed corner of the spacer bar. The blister formed prior to curing of the sealant. This blister may have resulted from pressure being applied to the IG unit before the secondary sealant cured. Another possible cause is that there may have been a mixing or manufacturing problem with the sealant material that caused the air bubble to form. Air escaped through a discontinuity in the spacer bar and primary seal at the keyed corner and exited through the uncured silicone sealant, which resulted in the blister. Inspection of other failed units revealed similar blisters.

Insulating glass units cannot readily be dried out once the hermetic seal is breached and the interstitial space is saturated; therefore, we recommended replacement of all affected units. We also suggested cleaning debris from all glazing pockets to encourage prompt drainage.
