ROOF DECKS QUICKLY CORRODED BY INSULATION

By Chuck Marvin, RRC, and Bruce Byrne

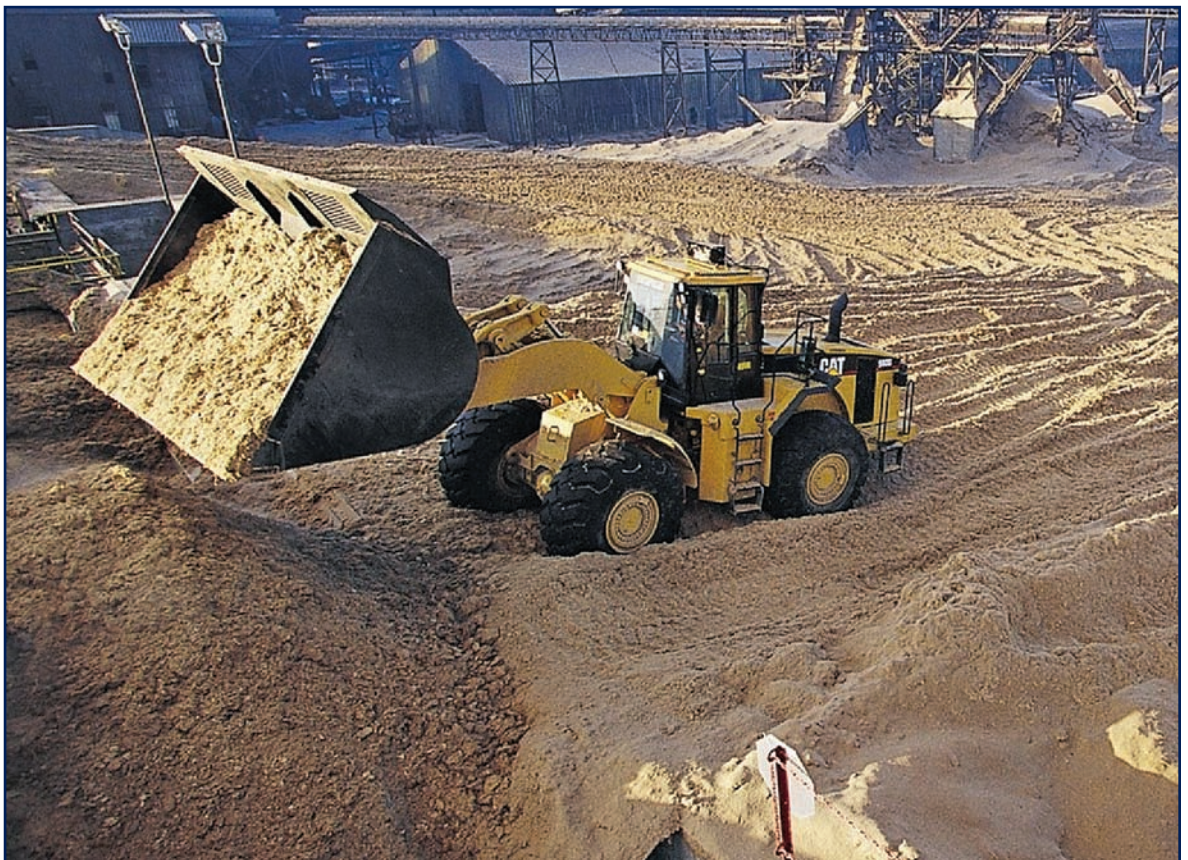
Photo 1 — Typical activities at a wood fiber manufacturing plant.

A quick synopsis of the use of bagasse follows. After the stalks of the sugarcane are crushed to extract their juice (for the production of sugar products), an organic fibrous residue, bagasse, remains. Bagasse was transported (trucked) from the various sugar cane refineries to plants for production into wood fiber insulation boards. The bagasse was stockpiled unprotected in open

fields near a plant, and when it was needed for production purposes, it was moved onto conveyor belts to transport the raw material into the factory for subsequent production (see *Photo 1*).

In RSI's subsequent investigation, we became aware that liquid chlorine was applied to the bagasse during its storage to kill the microbial growth resulting from the rapid development of mold in the sugarcane from high levels of sugar, water, and heat in the bagasse. The molding phenomenon in bagasse is rampant and can lead to an interstitial lung disease called bagassosis.

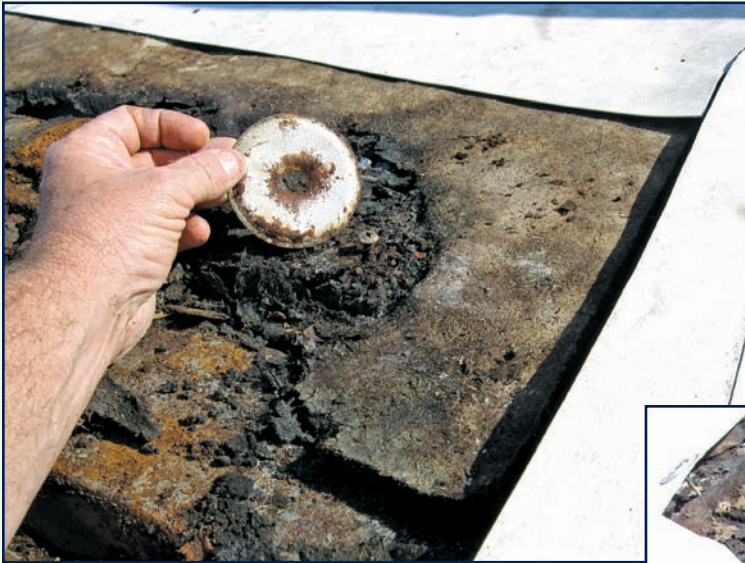
Photo 2 — Note the burned-looking insulation at this severely deteriorated location. This was common on all significantly compromised deck areas, including those replaced to address fall-through potential. This is typical of what was sent in originally for testing and showed lower levels of chlorine on all components.

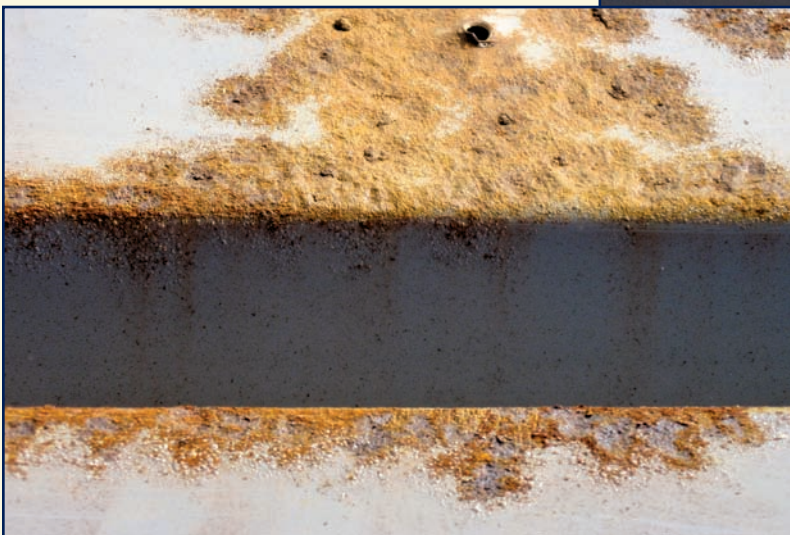
Photo 7 — A close-up of Photo 6 shows pitting and scale are developing. This was a former plate-and-screw location; the condition appears to accelerate at these locations.
