LESSONS LEARNED FROM CURTAIN WALL FAILURE INVESTIGATIONS

By Derek B. McCowan, PE, and Joshua B. Kivela, PE

Editor's Note: This article is reprinted from the Proceedings of the RCI 2010 Building Envelope Technology Symposium in San Antonio, TX, November 8-9, 2010.

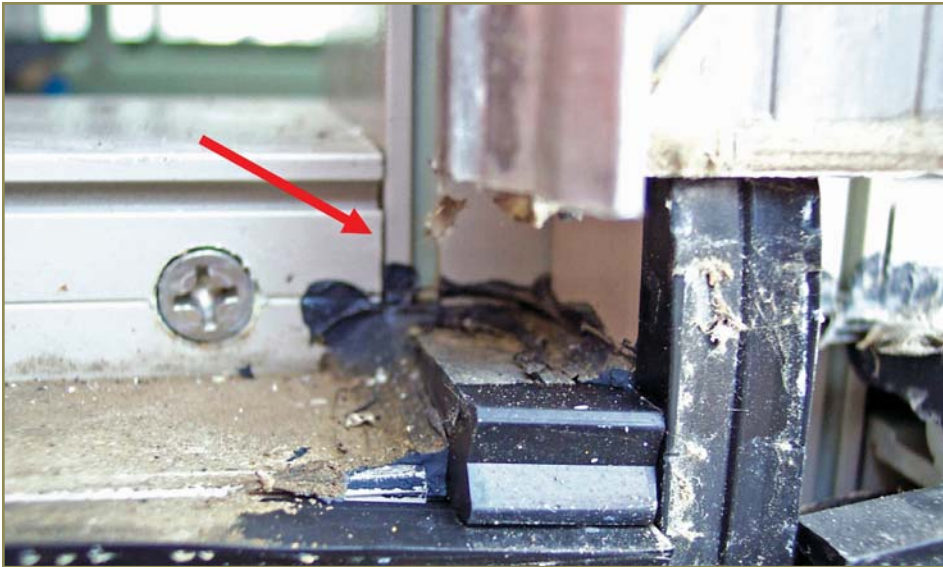
Photo 1 - Unsealed metal-to-metal joint.

wall itself existed at the frame corners (i.e., mullion intersections) and at the splices in the vertical mullions.

Frame corners required application of silicone sealant and foam rubber joint plugs (end dams) to fill and seal the joinery. The intent of these materials is to create a watertight pocket so that any water that enters the glazing pocket area exits harmlessly through the weep holes in the exterior pressure bar. We found missing and deficient end dams and missing and deficient sealant at the metal-to-metal joints where these conditions existed (*Photo 1*). Unsealed joinery located at the low point in the glazing pocket allowed water to travel inward to the building interior just as easily as it traveled outward through the weep holes. Unsealed fastener penetrations at shear blocks at these locations also served as leakage paths.

Splices were in a condition similar to that found in frame corners; negligible weatherproofing provisions were provided, with the exception of an occasional piece of department-store-grade silver duct tape. Splice joints required silicone sealant to be applied to the glazing pocket, which is a wet area. This sealant was not installed. As a result, joints acted as open funnels for any water traveling down the vertical glazing pocket. Splice joints were so poorly constructed that daylight was clearly visible from the interior at these areas when interior finishes and spandrel insulation were removed.

The corrective action included repairing 100% of the frame seals at the curtain wall. Unfortunately for all parties involved, this required removal of all of the building's 1,500-plus glass units in order to expose the frame corners that required the repairs. The entire curtain wall was reglazed. Many other repairs were also made, including replacement of perimeter membrane flashing, removal of portions of the surrounding cladding systems to allow the perimeter flashing repairs, and roof repairs.

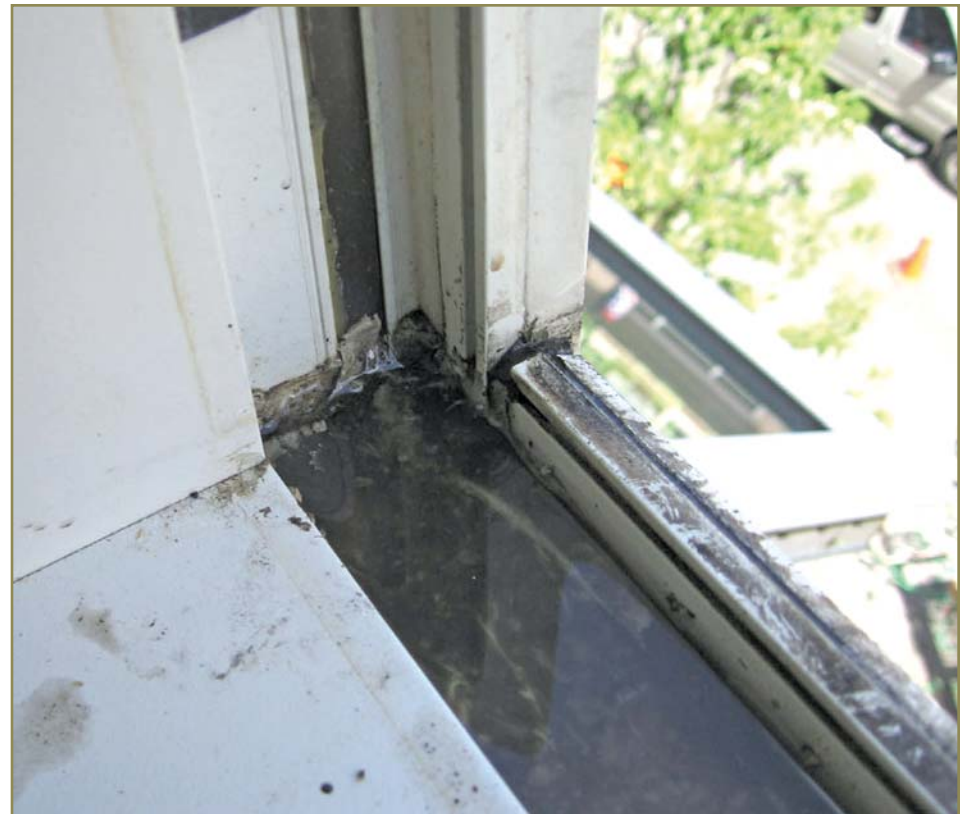
Photo 2 - Water ponding in curtain wall.

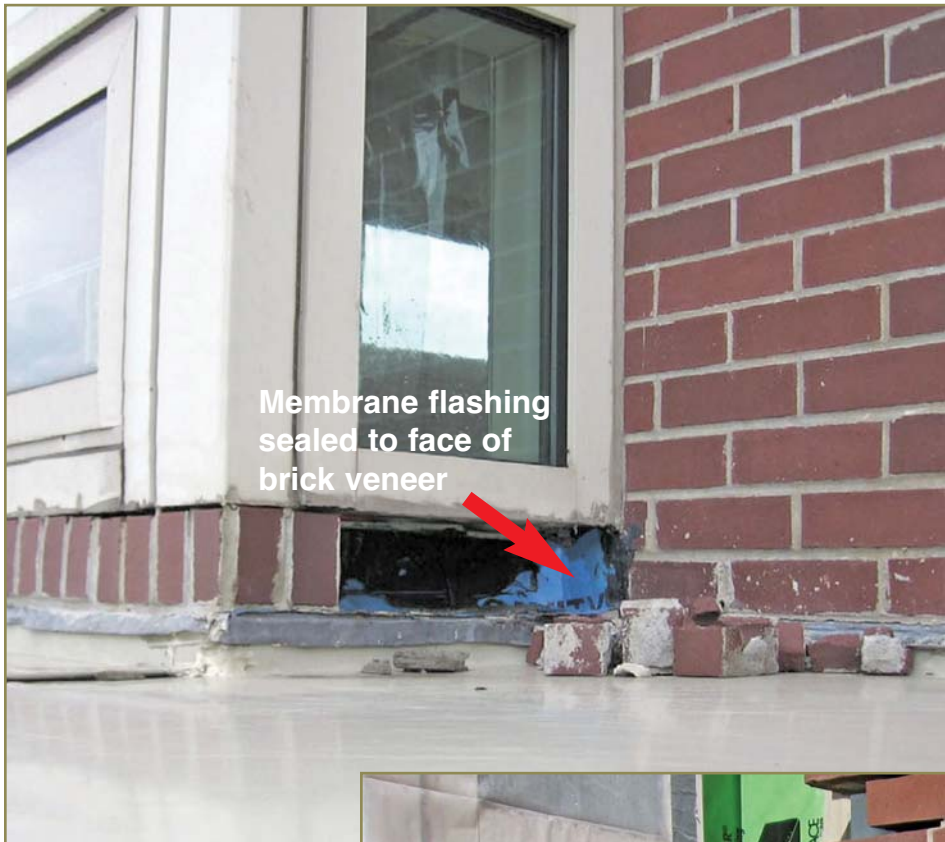
We removed the rowlock brick from the base of the curtain wall and observed that the membrane sill flashing of the curtain wall had been turned up against the brick veneer to form an end dam (Photo 3). The through-wall flashing under the curtain wall and brick wall was made from a combination of sheet metal drip edge and self-adhering membrane flashing. The upturned rear leg of the membrane flashing was supported by the backup wall at the brick veneer, but it lacked support under the curtain wall; the transverse seams in the membrane through-wall flashing were open, and the flashing sagged under its own weight.

The greater problem, however, was that the brick wall and curtain wall flashing did not connect or seal to each other (Photo 3), and the curtain wall lacked jamb flashing altogether. This discontinuity at the through-wall flashing level allowed water to leak into the building from the wall cavity.

Our review of the design drawings showed vague details, and the specifications were not explicit on flashing integration. Review of construction photographs and discussions with construction personnel showed that the brick veneer was installed before many of the curtain walls. Also, the self-adhering air barrier membrane ran long in many areas, and an 8- to 12-in “flap” was visible in the curtain wall rough openings. The construction manager stated that he told the curtain wall installer to seal the membrane to the jamb of the curtain wall during

Photo 3 - curtain wall sill flashing not sealed to through-wall flashing.

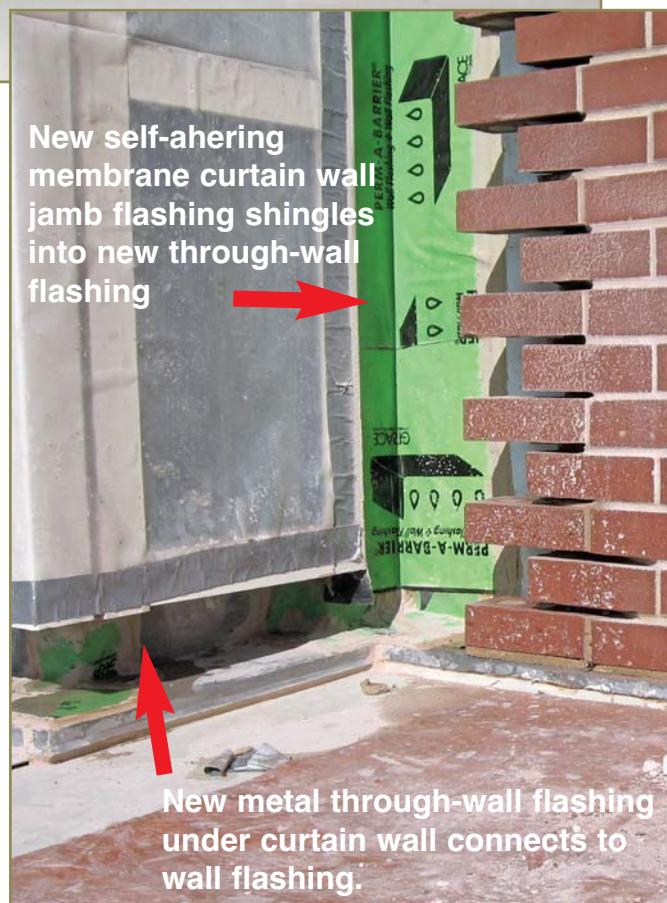
Photo 4 - Continuous copper and membrane sill, through-wall, and jamb flashing.

Repairs involved removing the rowlock brick below the curtain walls, “toothing out” the running bond brick at the sides of the curtain wall, and installing new continuous through-wall and jamb flashing (*Photo 4 and Figure 1*). An alternative cost-saving option was discussed that involved saw-cutting a straight vertical joint through the head joints in the brick veneer; however, this option was ultimately rejected. The repairs were complicated by the lack of working room formed by the inside corners between the brick walls and the curtain wall bays.

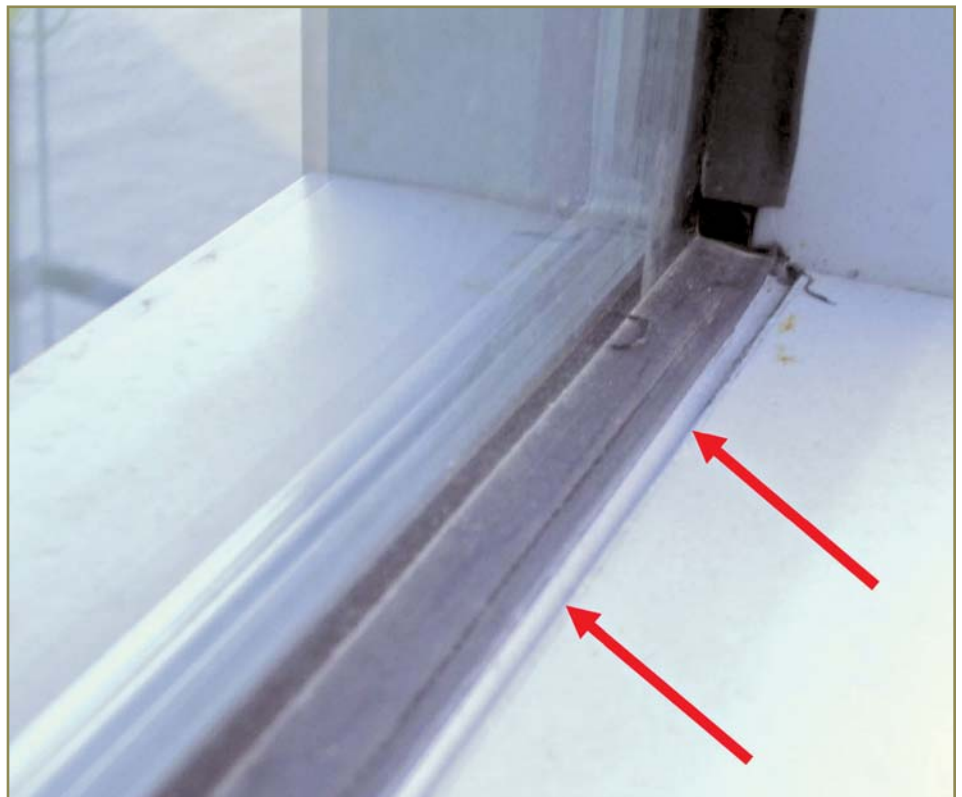
unitized curtain wall panels. We found a handful of areas where covers were missing, and we found dozens of areas where covers were slightly disengaged. The disengagement was often visible via a small (1/16-in to 1/8-in) joint between the inside edge of the snap cover and the exterior glazing gasket at the pressure bar (*Photo 5*). This open joint was not present at properly engaged covers.

Photo 5 - Space between glazing gasket and trim cover.

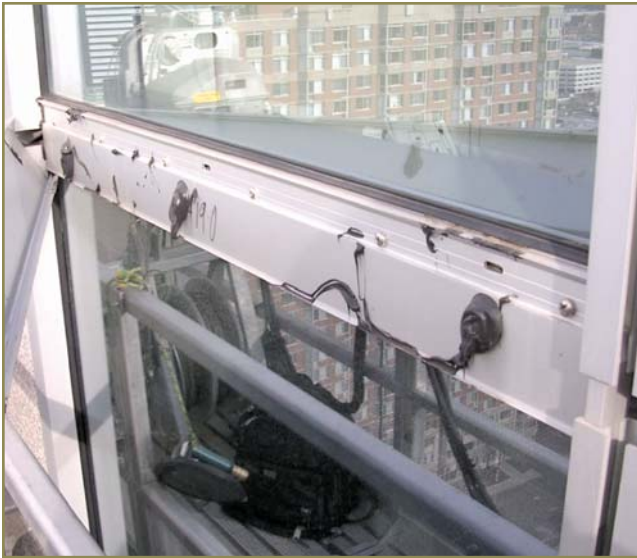
Photo 6 - Trim cover removed from curtain wall by hand with minimal effort.

We reviewed these partially engaged covers up close and performed an ad hoc “yank” test. Many covers detached from the wall with little effort (*Photo 6*). Some of the disengaging covers did not immediately release due to the presence of a few daubs of silicone sealant that temporarily held the cover in place. However, after applying light pressure, the covers readily came loose.

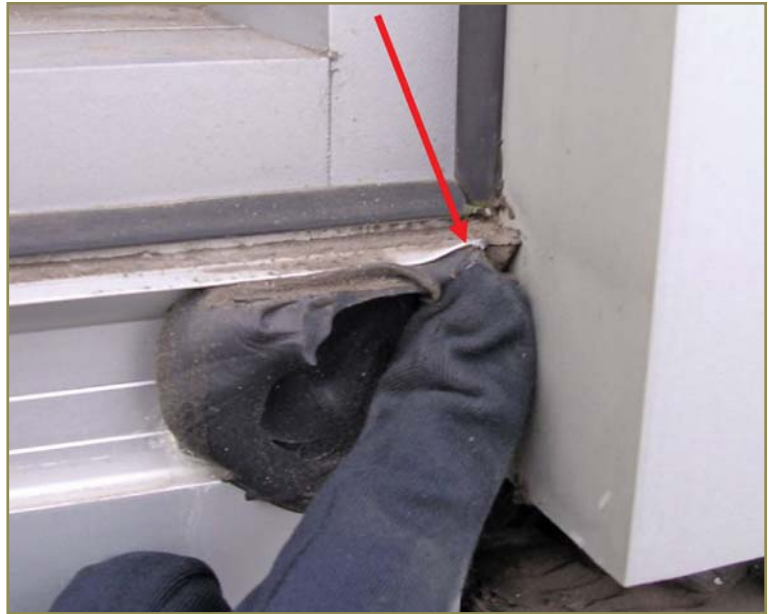
Photo 7 - Bent corner of pressure bar.

During our survey, we noted that the corners of the pressure bars below the disengaged covers were bent upward, preventing proper snap engagement of the covers (*Photo 7*). We also noted physical damage to dozens of covers, such as dents, scratches, and other evidence of abuse. The root cause of the pressure bar cover damage was not conclusively determined. We suspect that it was due to abuse during attachment onto the building. Other theories with merit include poor cutting operations in the factory and bending of covers when they were removed for other reasons, such as to allow reglazing of a failed glass unit.

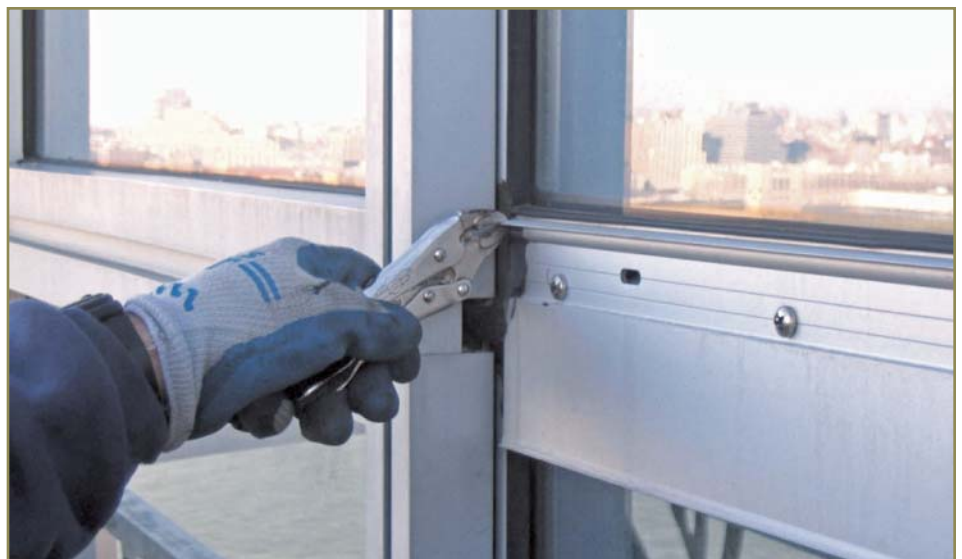
Photo 8 - Fixing pressure bar with pliers.

Perhaps the most disheartening factor for the owner was that the bent pressure bar corners could have been fixed quickly and easily during the original installation by simply bending the bent covers back into place with a pair of common pliers (*Photo 8*). Unfortunately, the original construction process included an aggressive schedule for curtain wall erection, and this quick fix was not implemented. Consequently, a 100% survey and widespread repair campaign were implemented within five years of construction of the building. We added fasteners to all snap covers as part of the repair process, just to provide an additional safety factor and more comfort for the owner.

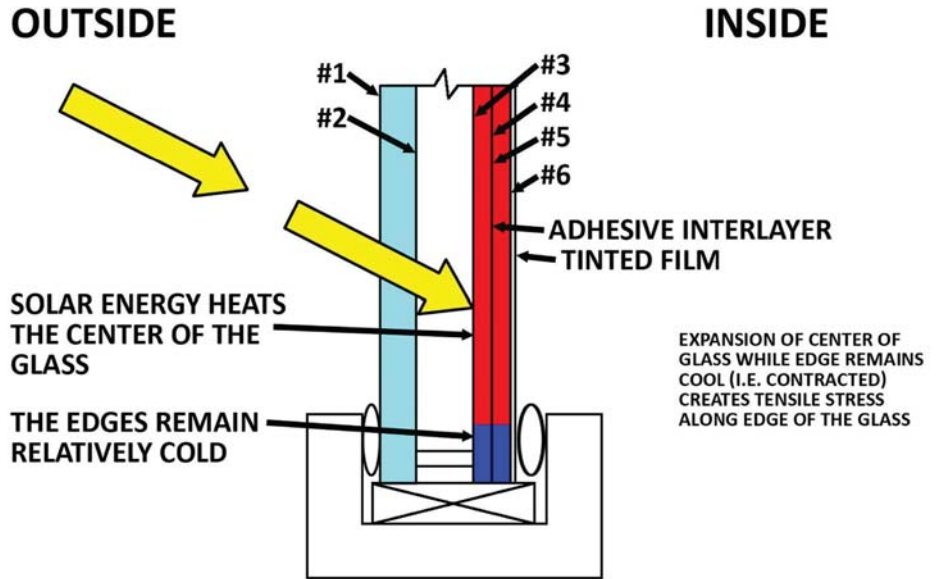
Figure 2

We performed a thermal analysis on the IG units, film included, based on ASTM E2431, *Standard Practice for Determining the Resistance of Single Glazed Annealed Architectural Flat Glass to Thermal Loadings*. This analysis assesses the probable edge stress in the glass as a result of the

temperature differential between the exposed central regions of the glass and the concealed edge (Figure 2). Current industry standards for determining thermal edge stresses in annealed glass apply only to monolithic glass. Other analyses were required to assess the more complex IG unit with applied tint. (A standard for evaluating

Next, we calculated the allowable thermal stress for various-sized IG units on the building, based on the allowable breakage rates set by the specifications. The predicted in-service thermal stresses were acceptable on the north elevation, but they were excessive on the west, east, and south ele-

vations. Our analysis showed that a south-facing unit with an angular shadow pattern would reach the highest stress. The tinted film causes excessive thermal loading in the glass.

Our analysis showed that a stronger glass, such as heat-strengthened glass, could handle the high thermal stresses. The owner replaced the cracked IG units with

heat-strengthened glass of the same thickness and size. Antiwalk blocks were installed during reglazing to prevent the glass from moving laterally and contacting metal.

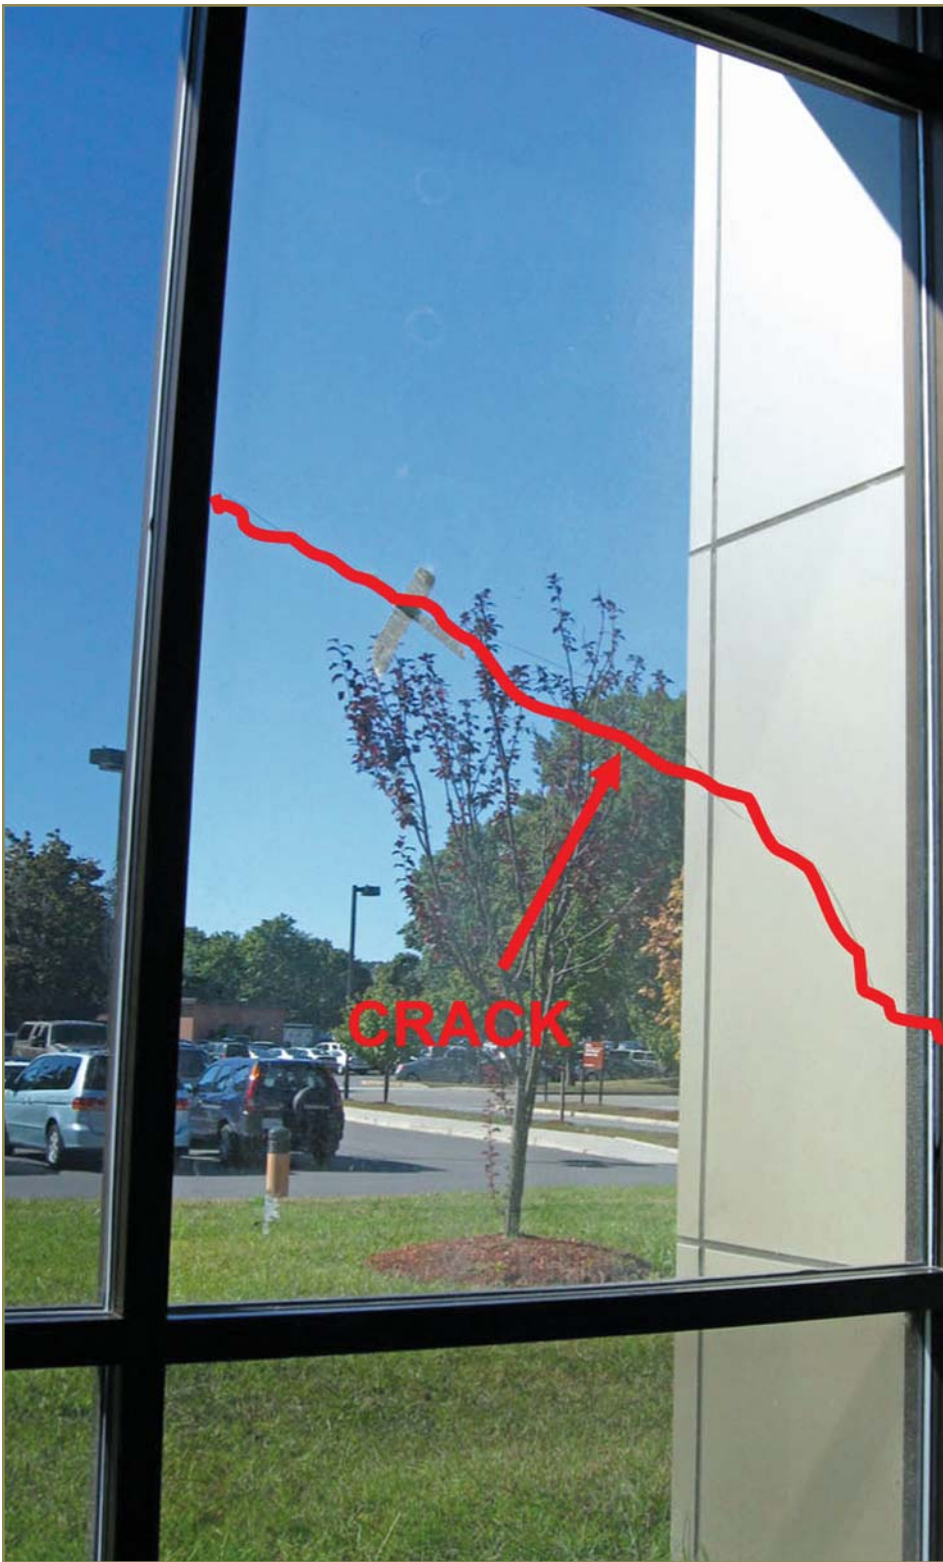
We investigated the cause of insulated glass (IG) units that were breaking at a recently renovated office building (Photo 9). The window installer removed several IG units and observed that glass-to-metal contact was the cause of some of the breaks. However, the installer could not provide an explanation for all of the cracks. We visited the site and found two crack patterns in the glass. About three quarters of the cracked IG units had cracks that ran perpendicular to the edge and surface of the glass (indicative of thermally driven breaks). The remaining one quarter of the IG units had cracks that did not run perpendicular to the edge. All of the IG units had a postapplied tint film on the interior surface (for increased occupant comfort) and vertical blinds in the offices. Cracks were occurring on the south and east elevations only and in IG units with and without postapplied film.

Photo 9 - Crack in IG unit.

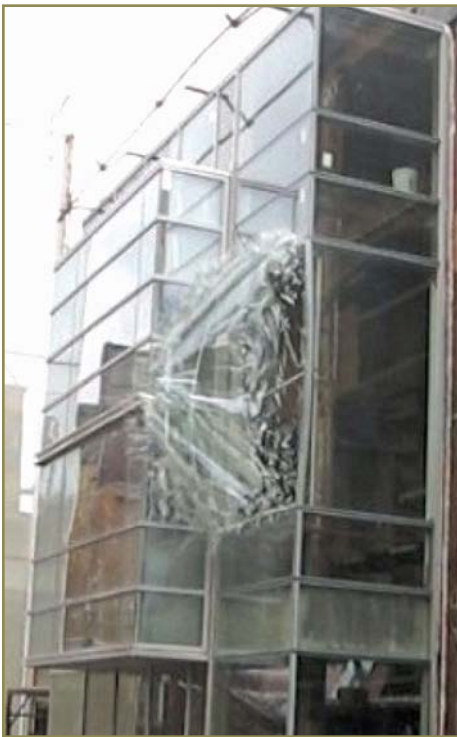
We witnessed this glass breakage firsthand during performance testing of a large mock-up assembly at a testing laboratory (*Photo 10*). The failure occurred during a 150% ASTM E330 overload test. The test applied 150% of design wind load for façades. The failure occurred during a second, unspecified overload test that the contractor elected to complete. We noted no visible damage during the first overload test.

Photo 10 - Glass break.

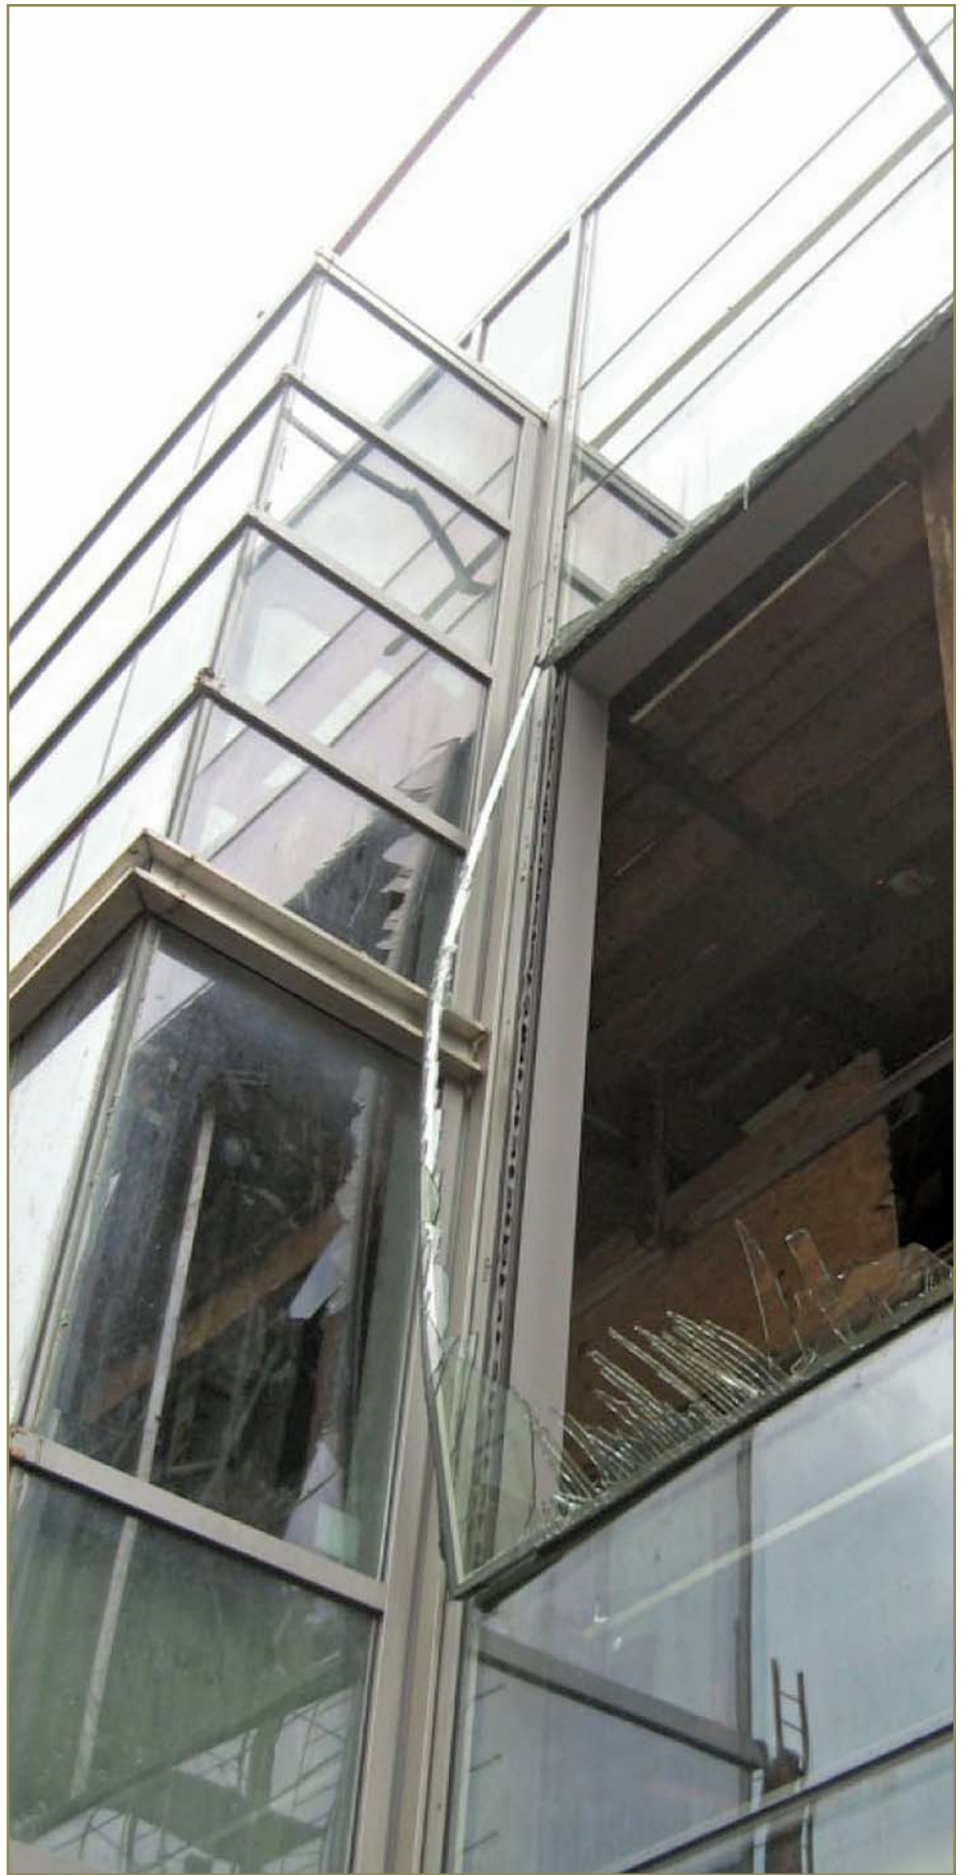
We reviewed the remnants of the glass and glazing materials at the opening of the failed unit (*Photo 11*). The spacer bar along the noncorner jamb was fully disengaged from the clips, and the spacer bar was bent at various clip locations. We noted damage to the interior pane of glass at more than one clip location, with the most severe damage located approximately 12 inches up from the sill corner. The structural silicone and low-profile aluminum tube at the corner were undamaged.

Photo 11 - Curtain wall after 150% design load test.

contacted the edge of one of the aluminum clips as the glass unit exited the opening, resulting in breakage.

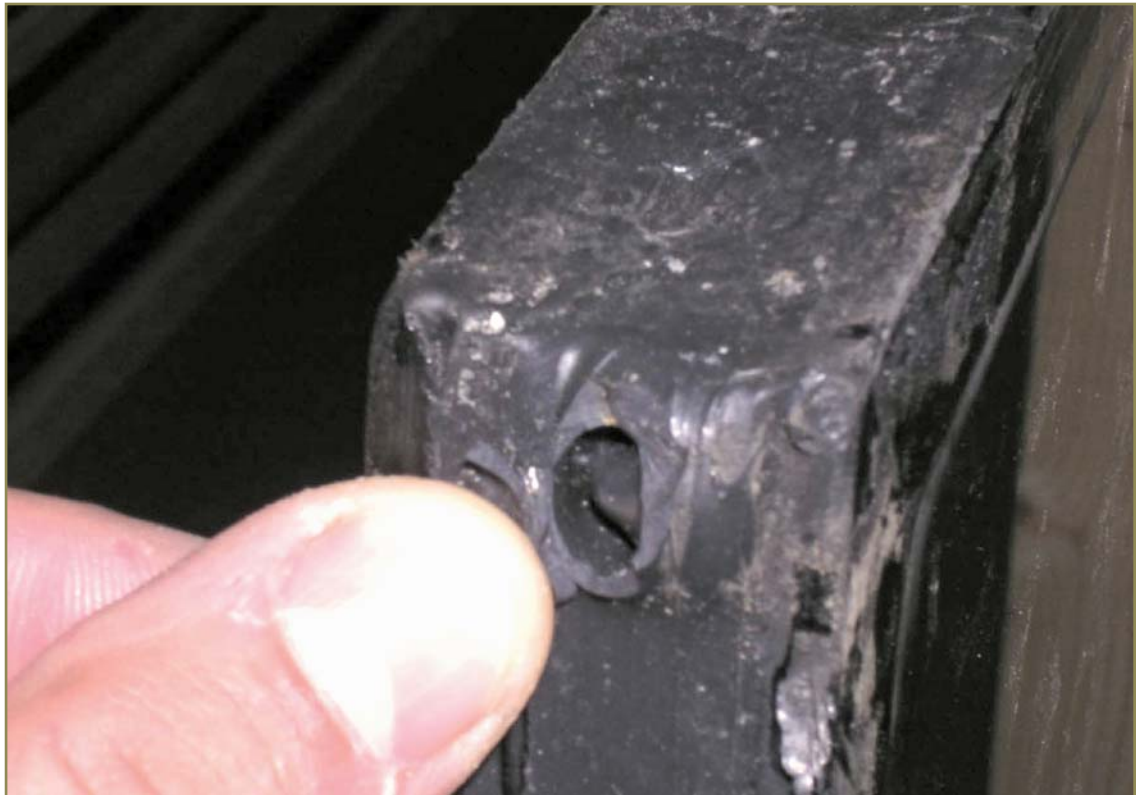
In addition to the debris issue, the insulating glass hermetic seals were faulty at failed units. We deglazed several units and inspected them up close at a curtain wall subcontractor’s shop. Upon close inspection, we noticed an open “blister” in the silicone secondary seal at one corner (*Photo*

Photo 12 - Open blister in silicone secondary seal at the corner of an IG unit.

12). The blister aligned with an unsealed keyed corner of the spacer bar. The blister formed prior to curing of the sealant. This blister may have resulted from pressure being applied to the IG unit before the secondary sealant cured. Another possible cause is that there may have been a mixing or manufacturing problem with the sealant material that caused the air bubble to form. Air escaped through a discontinuity in the spacer bar and primary seal at the keyed corner and exited through the uncured silicone sealant, which resulted in the blister. Inspection of other failed units revealed similar blisters.

Insulating glass units cannot readily be dried out once the hermetic seal is breached and the interstitial space is saturated; therefore, we recommended replacement of all affected units. We also suggested cleaning debris from all glazing pockets to encourage prompt drainage.

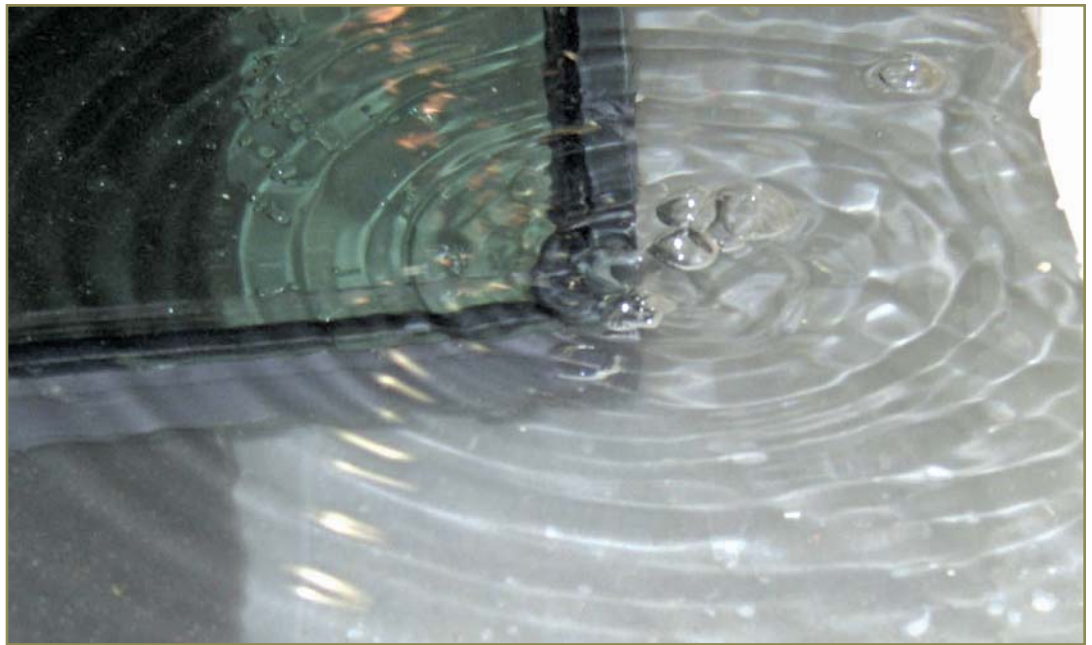
Photo 13 - Air bubbling from IG unit.

To confirm that the blistered sealant at the keyed corner was the root of the problem, we placed failed units in a water bath and applied slight pressure to the units. We witnessed air bubbles exiting the blistered corners, which confirmed that there were breaches in the continuity of the hermetic seals (*Photo 13*). Small amounts of moisture vapor reaching the sealed air space were reacting with the metallic low-e coating in the air space and causing the formation of the brown spots.
