Humidity “GETS HIGH” on Medicinal Marijuana

By Dustin T. Smoot, RRC, RRO, LEED AP

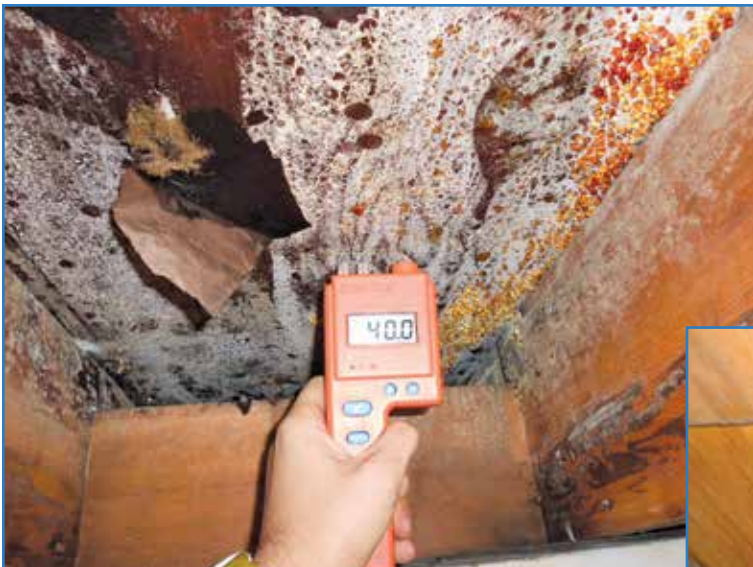
Photo 1 – Very high moisture content. The surface of the wood was wet.

There are three conditions required for biological growth: moisture, warmth, and organics.⁴ All of these conditions were present in the grow room structures that were investigated. This indicates a high likelihood of biological growth development within these buildings, much of which may be hidden from view within a wall or roof system. The interior operating conditions, building design, and materials within the ceiling/wall system dictate the amount of damage that can develop and the rate at which deterioration and biological growth begins. *Photo 1* illustrates a moisture probe reading of 40% moisture content, the highest reading this equipment model can indicate. The glue is migrating out of the plywood, which will cause delamination and loss of strength.

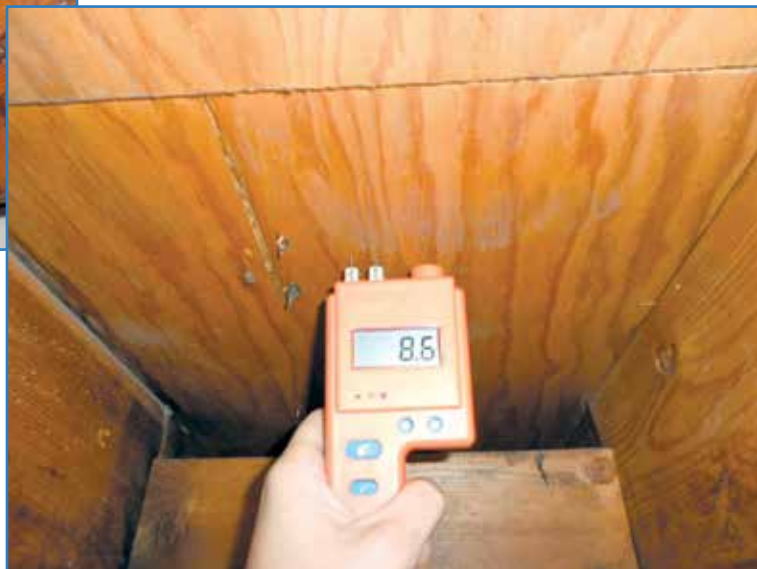
Photo 2 – Adequately ventilated space has moisture content well within acceptable range.

Photo 2 illustrates adjacent joist spaces that were adequately ventilated. These joist spaces had significantly less biological growth and recorded much lower wood moisture content.

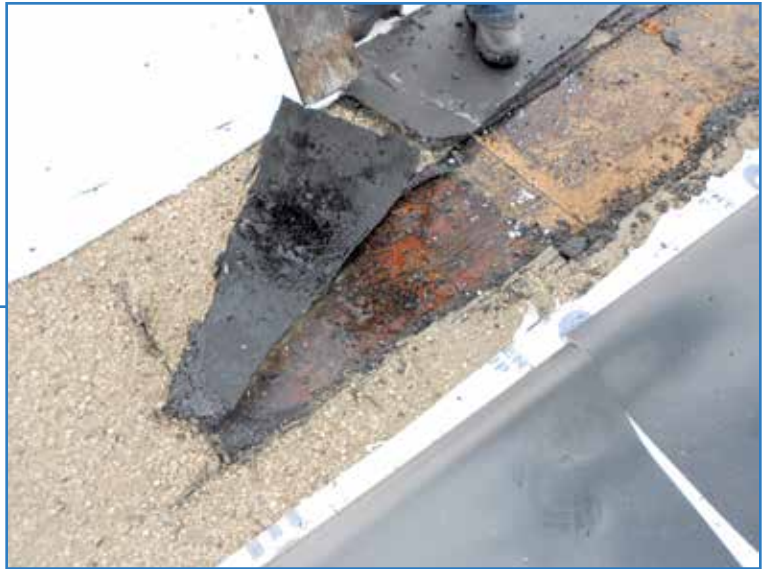
Photo 4 – Moisture was accumulating between the roof deck and the BUR.

- The roof cuts showed the moisture was present below the original BUR only (*Photo 4*). None of the cuts had evidence of moisture between the BUR and the PVC membrane. This indicates the moisture had traveled up through the interior of the structure and condensed on the bottom side of the material, which had a permeance low enough to retard the flow of moisture—in this case, the BUR. Because there was little insulation above the BUR, the temperature of its surface fell below the dew point, which allowed condensation to form.

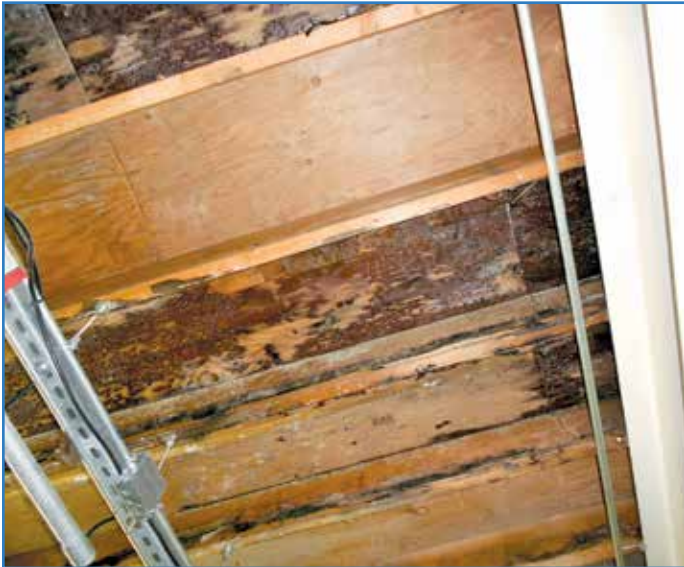
Photo 3 – Roof deck from below. Note dryness of properly ventilated joist spacing.

- The underside of the roof deck had evidence of moisture on nearly all of the surfaces of the plywood. The moisture content of the wood was elevated in all but a few of the areas. The locations that did not show evidence of moisture deterioration were between specific joist spaces that had been vented to the outside.
