# FORENSIC PROCESSES FOR WATER INTRUSION INVESTIGATIONS

## Case Study

By Lonnie Haughton, CDT

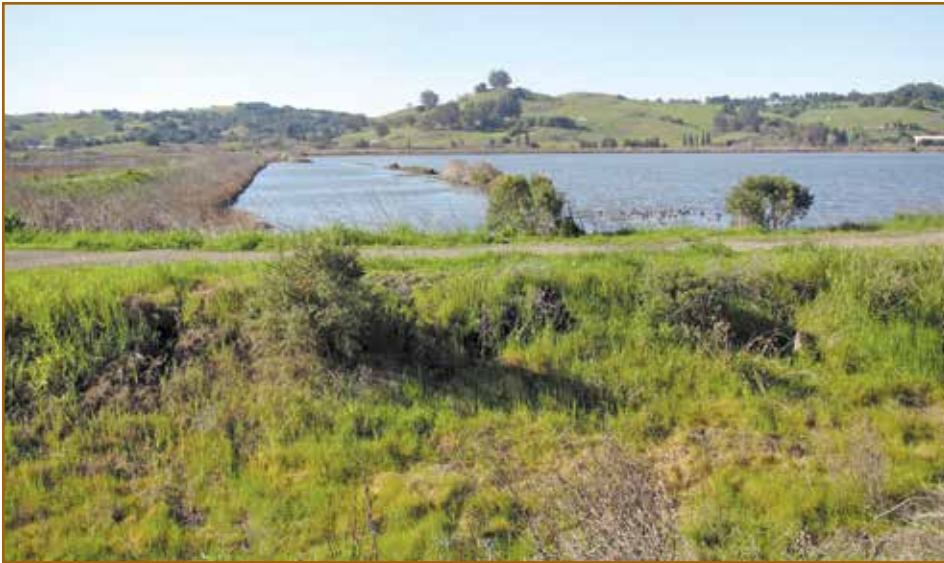
*Photo 3 – The building was constructed atop a high water table adjacent to a tidal estuary.*

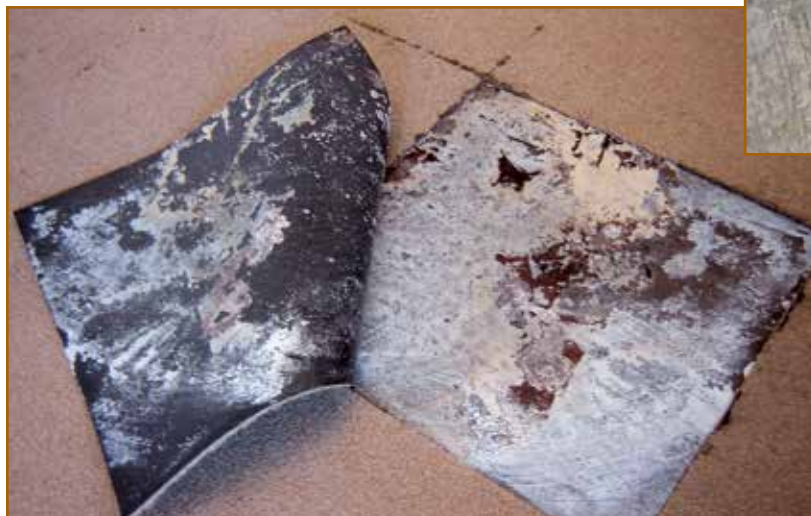
As seen in *Photo 4*, our inspection confirmed deterioration of the latex adhesive used to secure the vinyl-backed carpet tiles, which were functioning as a barrier against the dissipation of water vapor rising through the floor slab. Such adhesive failure can result when “moisture traveling upward through the concrete brings alkalis to the surface where they can attack flooring materials.”<sup>1</sup> We expedited samples of the smelly, emulsified adhesive to a laboratory for assessment of potential health risks to the building occupants and then, as directed by indoor air quality (IAQ) specialists, removed the carpet tiles and deteriorated adhesive, exposing the underlying “wet” floor slab.

*Photo 4 – Latex adhesives are emulsified and deteriorating, creating smelly IAQ problem.*

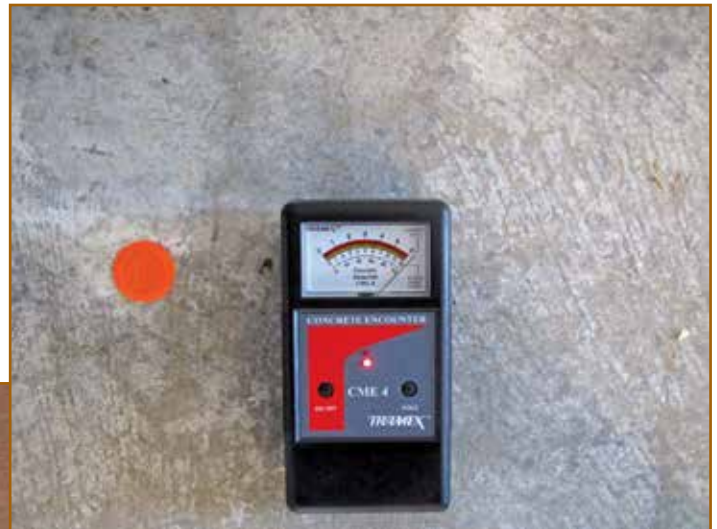
With the electrical impedance meter, we found that the near-surface moisture content of the slab ranged from about 5% to greater than 6%.<sup>8</sup> These high values clearly demonstrated some form of moisture-resistant performance failure in the design and/or construction of the on-grade concrete slab and its surroundings.

*Photo 5 – Electrical impedance confirms floor slab is saturated.*

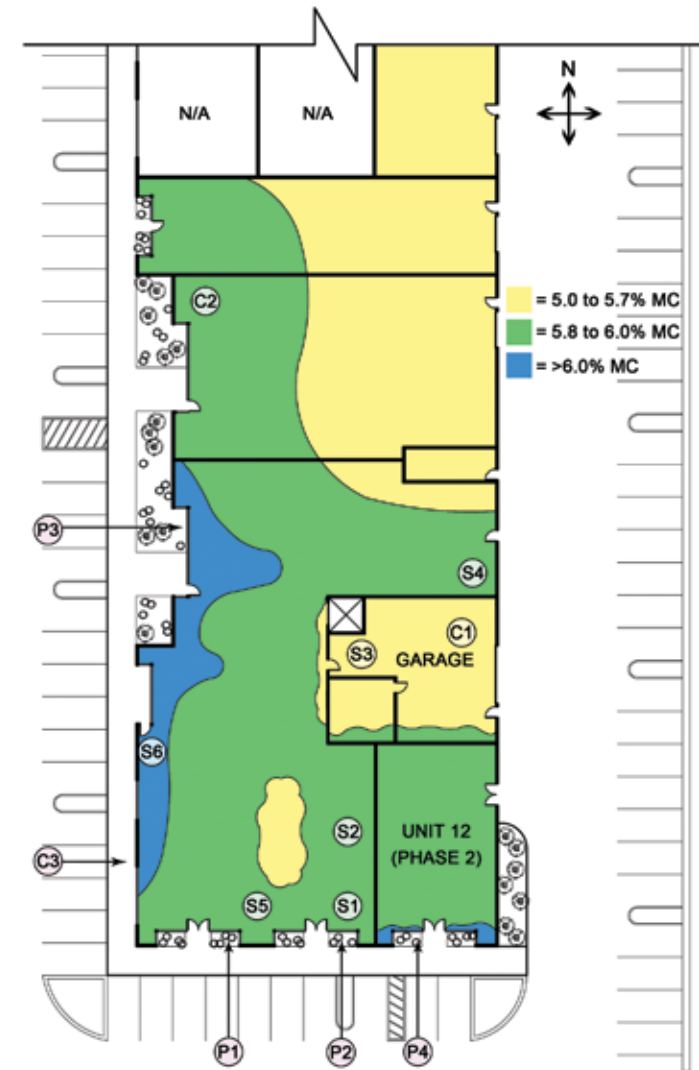
In *Figure 1*, which presents a floor plan of the building, our preliminary (Phase 1) and later (Phase 2) electrical impedance metering is summarized in three approximate zones of moisture content: “yellow” (5.0 to 5.7%), “green” (5.8 to 6.0%), and “blue” (>6.0%). The Phase 1 data suggested that primary origin(s) of the unintended moisture infiltration might be located at or near the western edge of the slab.<sup>9</sup>

Figure 1 – Partial plan view identifies the “internal RH” sensors (S), the concrete test cuts (C), four inspected planters (P), and approximate moisture content (MC) measurements at the concrete slab.

Meanwhile, we had received permission to take moisture content readings of the concrete floor slab inside south-facing Unit 12 (see Photo 14), which had become vacant. As shown in Figure 1, the entire floor in Unit 12 was found to be very wet, with the wettest readings at the southern edge adjacent to the planters.

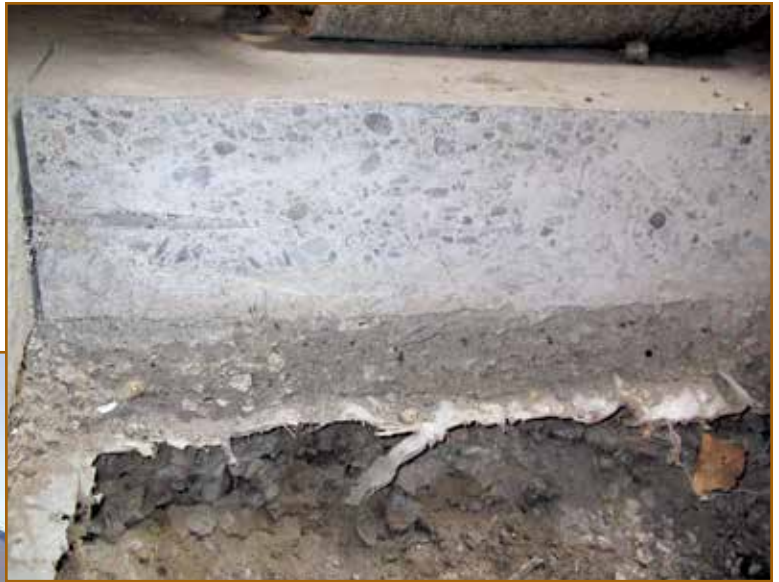
Photo 7 – Test cut C-1 exposes the overlap joint of the 10-mil polyethylene vapor retarder.

slab were investigated destructively at three locations (C-1, C-2, and C-3) identified in Figure 1. In test cut C-1 (Photo 7) near the S-3 sensor, we found multiple punctures in the 10-mil polyethylene vapor retarder<sup>12</sup> (Photo 8) installed between the compacted granular base and granular subbase. No evidence of free water was found in this hole.

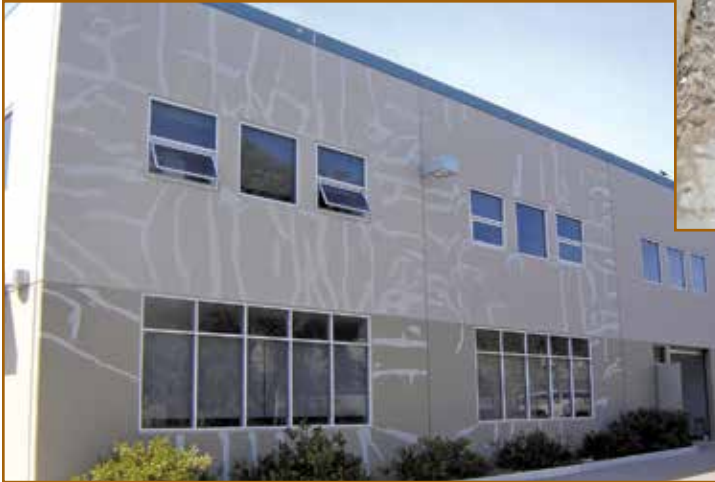
Photo 6 – Widespread cracking of concrete tilt-up panels was an exacerbating source of water infiltration.

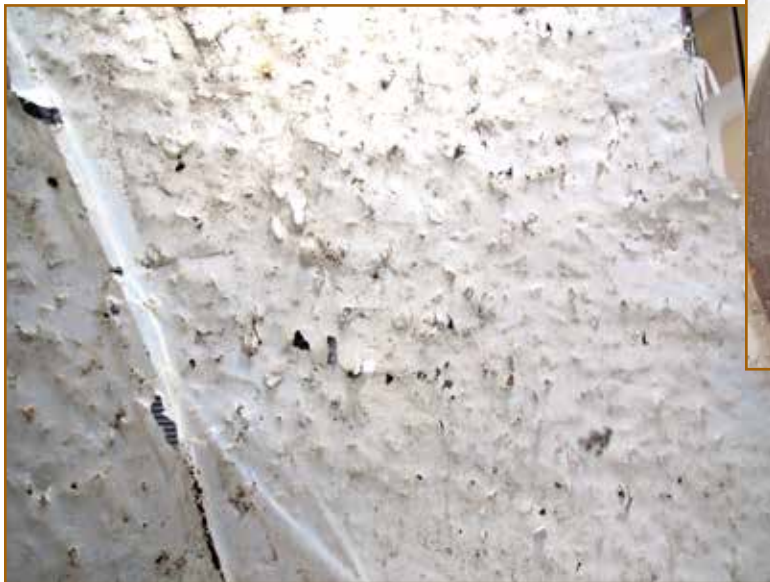
At test core C-2, near the western edge of the concrete floor slab, pooling water (Photo 9) was found directly under the floor slab. Similarly, at test cut C-3, after excavation below the sidewalk, water began seeping outward (Photo 10) from under the concrete

Photo 9 – Test core C-2: Pooling water was found directly under the floor slab.

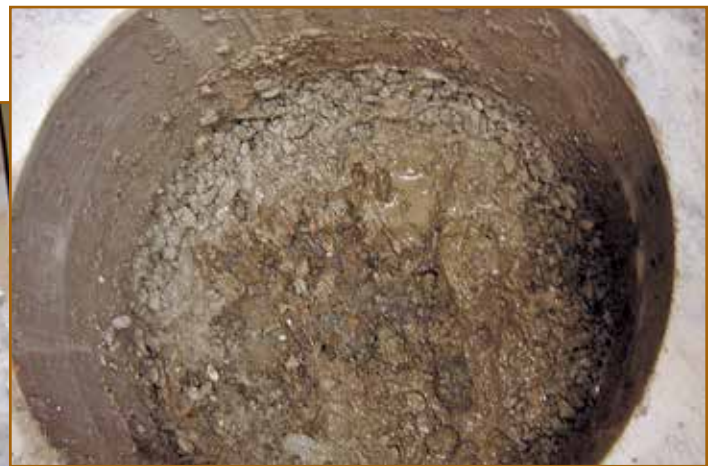
Photo 8 – The polyethylene vapor retarder was found to have numerous punctures.

At this point in the forensic analysis, it seemed reasonable to hypothesize that a primary moisture source for the wet floor slab was some form of upward “percolation” of unintended moisture (water and/or vapor) through the underlying clay soil<sup>13</sup> from the high water table<sup>14</sup> (Photo 3) traveling vertically through the punctured vapor retarder<sup>15</sup> (Photo 8) into the on-grade concrete slab.

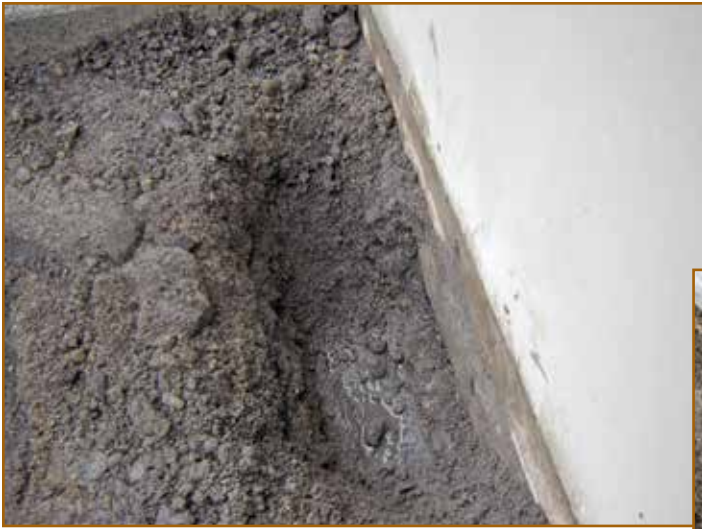
tilt-up panel, indicating the existence of a pool of water under the slab at its western perimeter.

Photo 10 – Test cut C-3 at sidewalk: Water began seeping outward from under the concrete tilt-up panel.

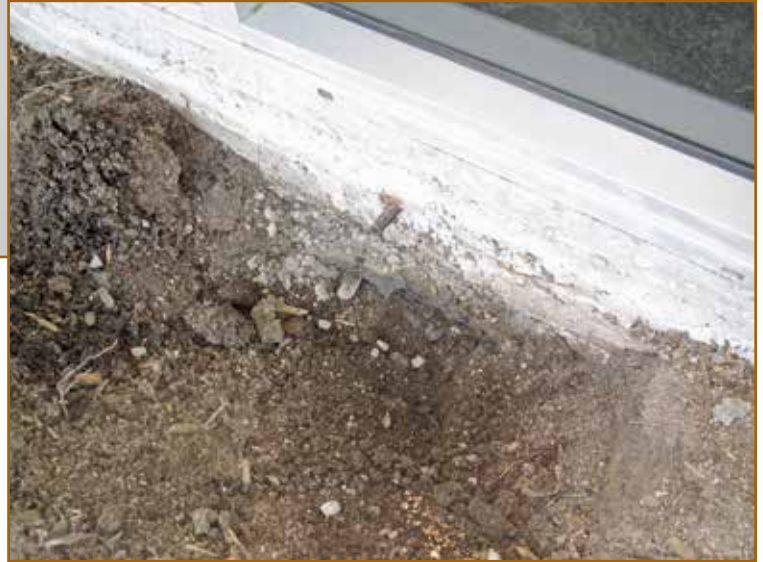
Upon digging into planters P-1 and P-2 (see Figure 1) between the front of the building and the sidewalk, we found corroded rebar and the exposed edge of a blackish 10-mil polyethylene vapor retarder (also punctured). In other words, as seen in Photo 11, the contractor had not closed off (or “turned down”) the edge of the concrete slab to provide a water migration barrier between the planter soil and the granular base and subbase under the concrete slab. However, within these two planters, we found no evidence of ponding or trapped water, and we observed that the granular fill supporting the sidewalk promoted good

Photo 11 – Soil in planter directly abuts the granular subgrade under the concrete slab. The punctured polyethylene vapor retarder is visible under the corroded rebar.

In retrospect, the early information gained from the moisture content values summarized in *Figure 1* and the subgrade conditions (see *Photo 11*) exposed at the interface between the P-1 planter and the slab easily could have been sufficient to solve this moisture-migration puzzle. However, even if our conclusions perhaps came slowly, our forensic process remained consistent with the investigative methodology prescribed in ASTM E2128,<sup>25</sup> which includes the following guidance: “The information systematically accumulated in a leakage evaluation is analyzed as it is acquired. The new information may motivate a change in approach or focus for subsequent steps in the evaluation process.”

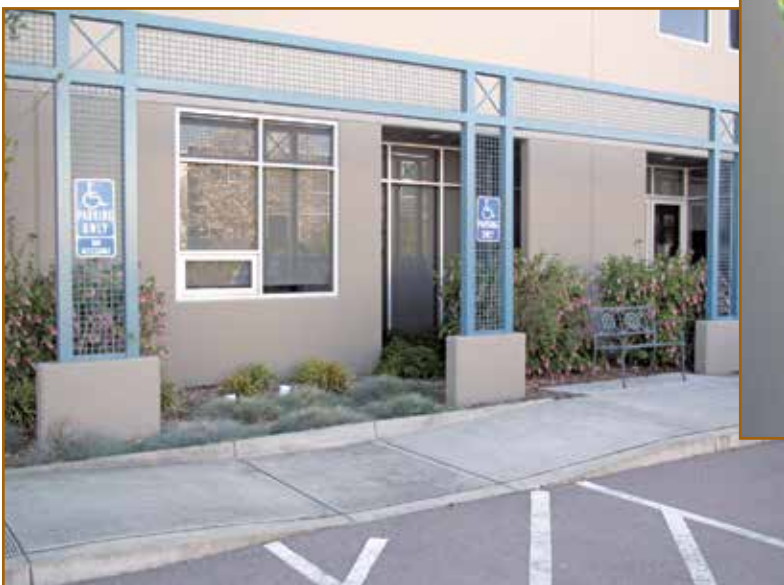
Photo 12 – Overview of P-3 planter.

ern edge. Upon excavation into the infill planter (P-3) seen in Photos 12 and 13, we found wet soil, the exposed edge of the polyethylene vapor retarder, and water trails leading under the concrete slab and granular base and subbase atop the LTS pad. And, even though some, but not all, of these planting areas were serviced by landscap-

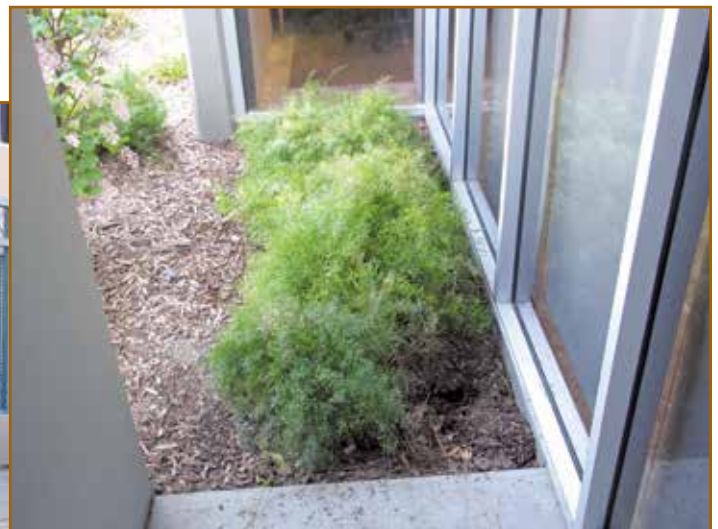
Photo 13 – Close view of P-3 planter.

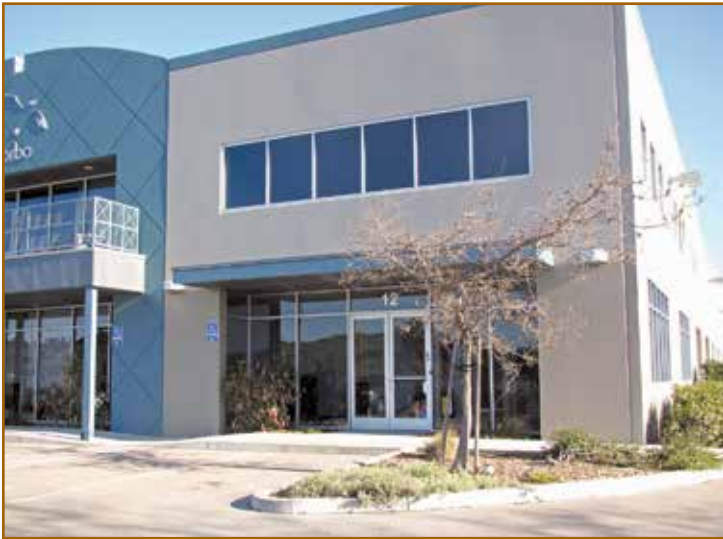
Photo 14 – Phase 2 investigation occurred at Unit 12.

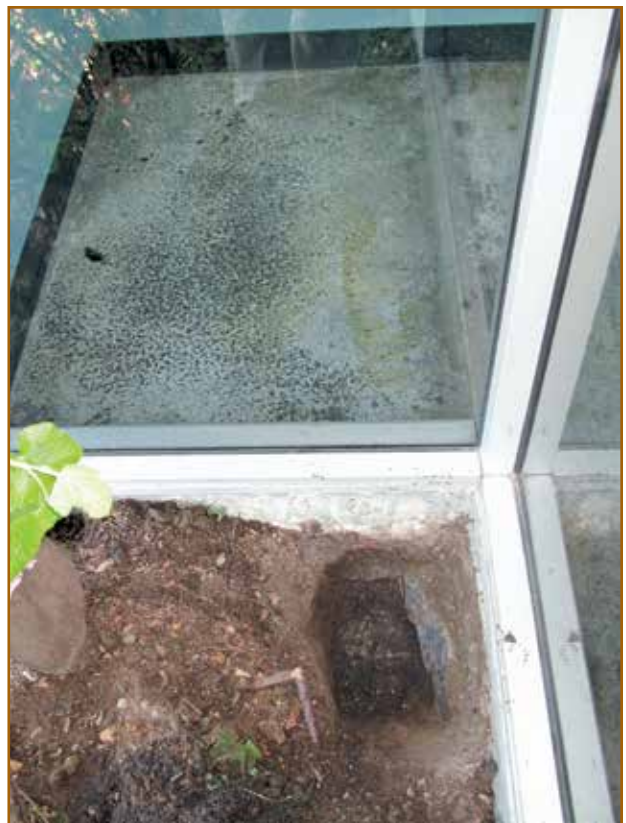
We excavated into the P-4 planter (Photo 15), again finding wet soil, the exposed edge of the polyethylene vapor retarder, and visual evidence that water migration under the concrete slab was occurring atop the LTS pad, which was found to have an undulated surface that could pond water. Then, under the P-4

sidewalk, we again found native clay soil that was highly sticky and water-saturated, providing minimal drainage, if any, from the planter. (Also note the plastic piping for the landscaping irrigation in Photo 15.)

Photo 15 – The pour strip (or pour-back strip)<sup>21</sup> within Unit 12 was saturated. The planter drains under the slab via the LTS pad.
