# What LURKS Beneath the Blue Tarp

By Aaron Nelson, RRC, RRO

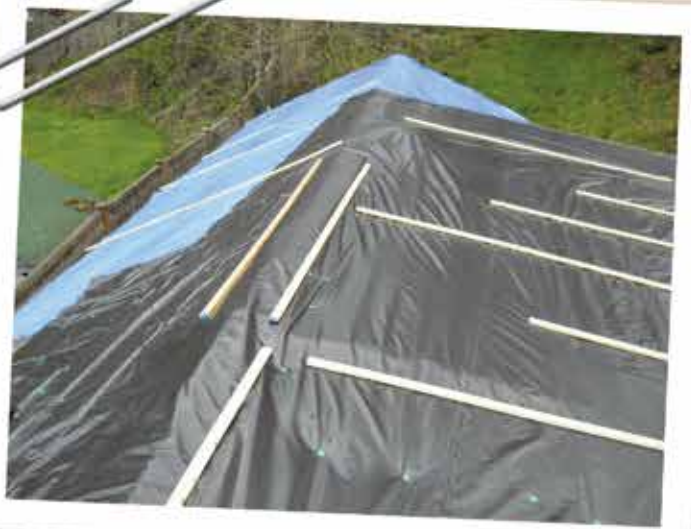
*Photo 1 - Visqueen over blue tarp.*

This brings us to the tarp. Seeing so much evidence prior to viewing the actual roof can lead to conclusions that may be unfounded. Topical observation of the roof covering is essential to provide an accurate report for the client. We cautiously climbed onto the roof and observed the Visqueen to determine the best course for removing it (a roofing contractor had been hired to re-cover the roof with new Visqueen). We elected to remove the covering from the main body of the residence atop the location of the reported damage. (The residence has T-shaped ridges with valleys in the “armpits” of the T.) Upon its removal, an interesting sight awaited us.

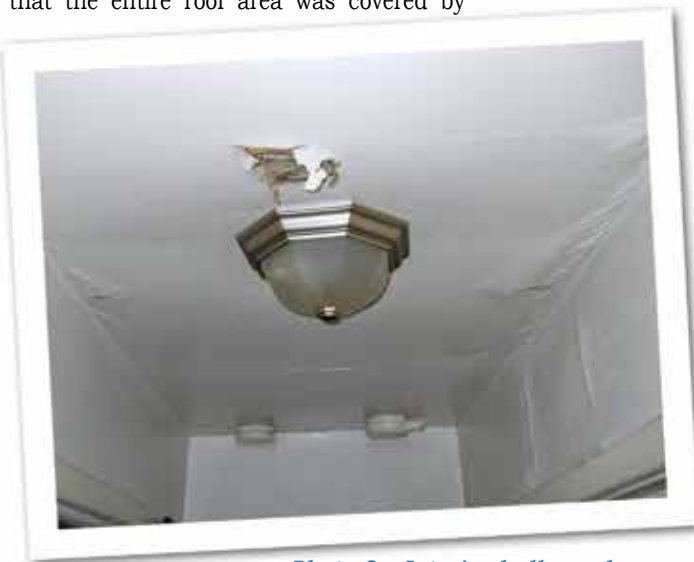
We toured the residence to visually observe where the intrusion had occurred. There were numerous locations indicating an abundance of moisture invasion. The drywall was sagging; paint blistering and stains from water were prevalent. (We noted, incidentally, that the kitchen cabinets had a tapered trim that matched the sagging of the roof.) As we walked through the residence, we were more and more convinced that this was not the result of a single wind event, but more the result of long-term intrusion.

*Photo 2 - Interior hallway damage.*

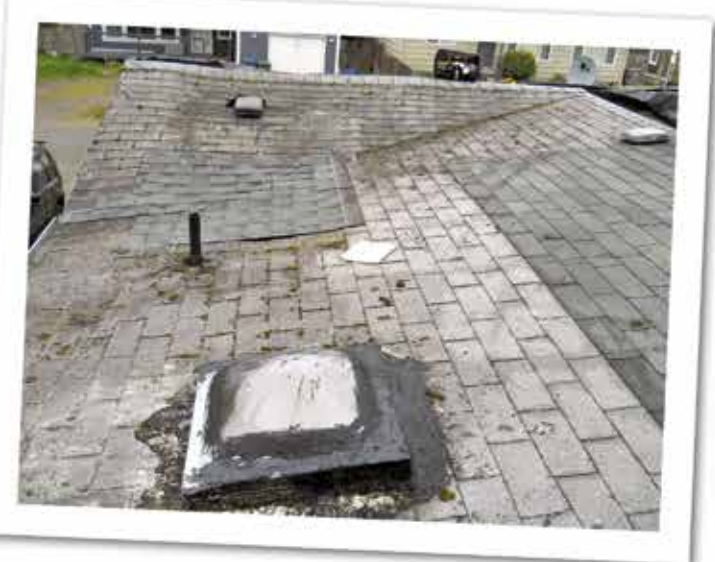
We observed a tired three-tab roof. A portion of the roof had been replaced with newer three-tab shingles near the

*Photo 3 - The exposed roof.*

ridge. Additionally, a portion of the shingles in the valley had been replaced with laminate shingles. The substrate undulated visibly in multiple locations and just flat-out looked scary. We examined each section individually in an attempt to provide accurate descriptions of each area.

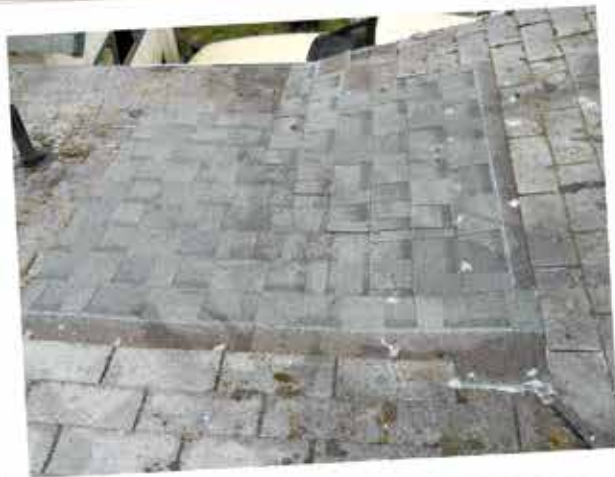
At the valley, underlying substrate was replaced and laminate shingles were integrated into the existing three-tab shingles. On the up-slope side of the repair area, the laminate shingles were tucked under the existing three-tab shingles, allowing overexposure of the laminate shingles. On one side of the valley, the laminate was placed on top of the existing three-tab and sealant was applied. For exposed fasteners, sealant was also topically applied. A woven valley had been attempted with the laminate shingles; however, it consisted of just weav-

**Photo 4 - Valley condition.**

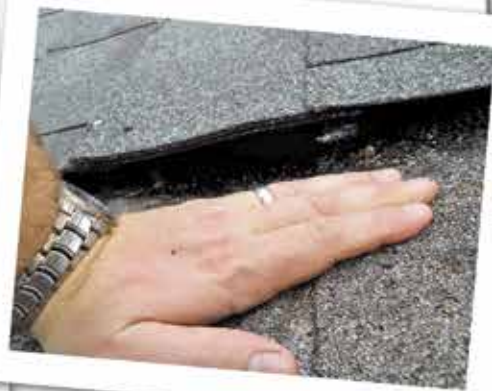
**Photo 5 - Pressing next to the laminate shingle exposed the interior of the attic to view.**

ing enough of the shingle to provide an overlap, in lieu of extending well beyond the valley line. The laminate shingles terminated in a straight line, roughly one inch beyond the new wood substrate. This provided an environment in which pressing on the three-tab shingles adjacent to the laminate shingles allowed one to actually see into the attic space.

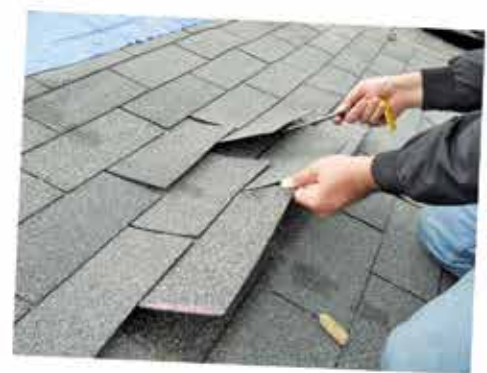
As the three-tab section near the ridge was above the area where the homeowners had indicated the bulk of the moisture damage was, we addressed it first. The substrate sloped to the perimeters at 2:12. The shingles had roughly the correct exposure; however, the offset was not in accordance with the manufacturer's requirements. Additionally, there was no underlayment on top of the new plywood substrate. There were generally two fasteners per shingle (one located near each end), and the fasteners were located at the top of the shingle (in

lieu of above the slots near the seal-down strip). The seal-down strip was not active, allowing for the shingles to be easily lifted up and the underlying substrate observed. This area was clearly identified utilizing historic satellite imagery as having a blue tarp installed, followed by a later photo showing the shingle installation in process in this area. The new shingles extended atop the existing ones and were held in place by fasteners located at the uppermost portion of the shingle. Again, the seal-down strip was not active, and no other means of sealing the new to old was implemented.

**Photo 6 - Improper nailing of new three-tab shingles.**

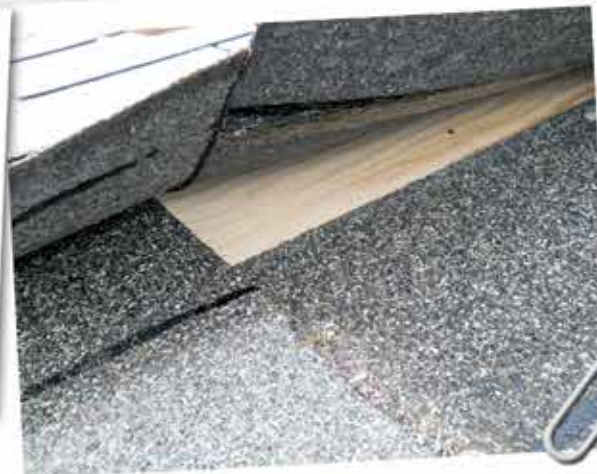
**Photo 7 - No underlayment under the new three-tab shingles.**
