# ASPHALT COMPOSITION SHINGLE DAMAGE —

## *Hail or Manufacturing Defect?*

BY DARRELL L. SMITH, RRC, PE

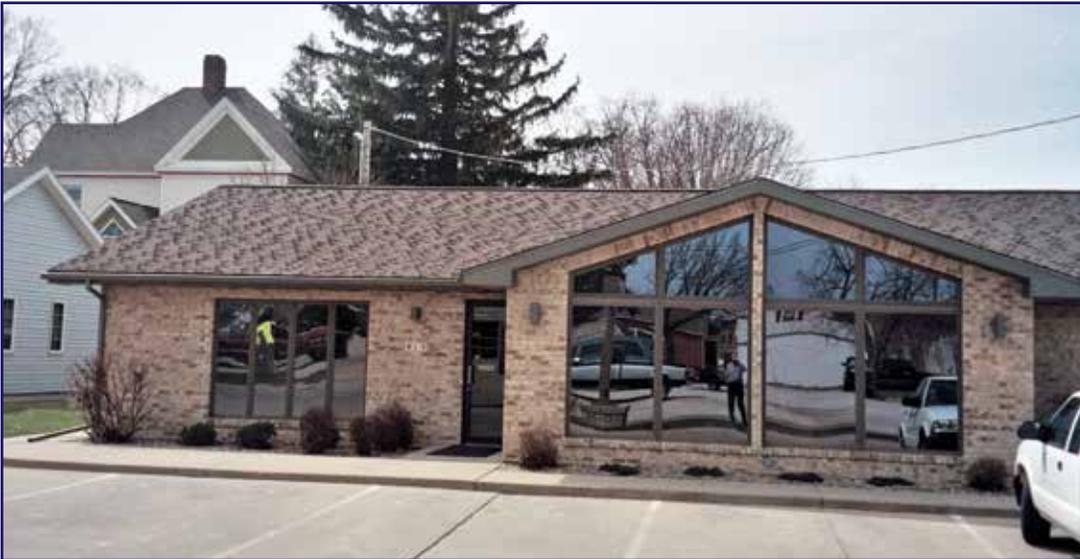
Photo 1 – East view of commercial building.

There are several hail events listed in the National Climate Database for this area. The largest hailstone size recorded in the subject community from February 2008 to April 2009 was 1 inch in diameter. The building in *Photo 1* is a one-story structure. The shingles are a laminated shingle with decorative coursing of the granules. For the purpose of this report, the main entry from the street is presumed to face east.

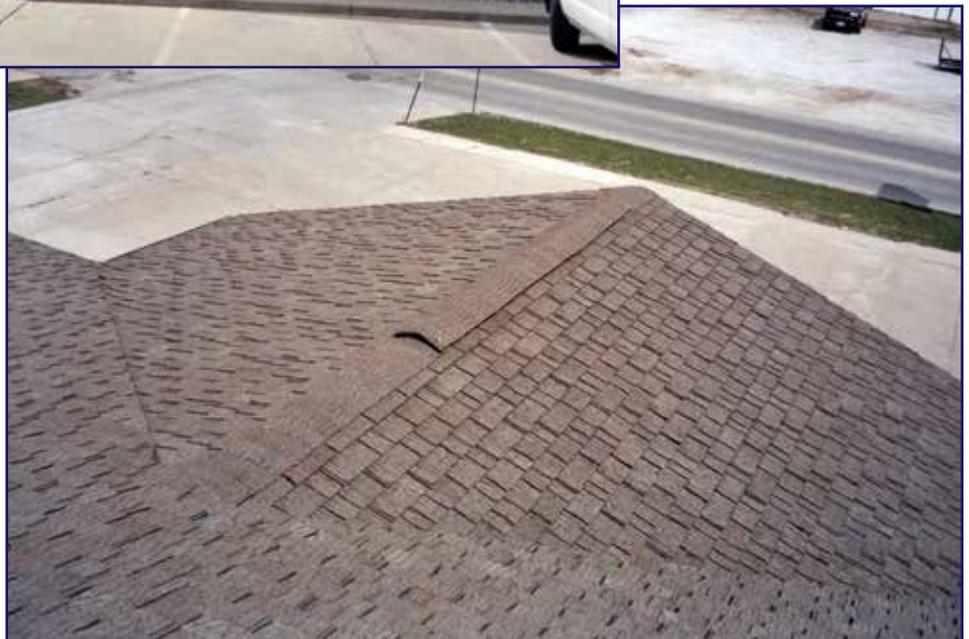
Photo 2 – View of ridge cap and shingles.

*Photos 2* through *4* show a general view of the various roof slopes and ridge caps on the building. No impact marks normally associated with hail were observed. Curling of the shingle edges appeared to be present on some of the shingles. Photos of the west

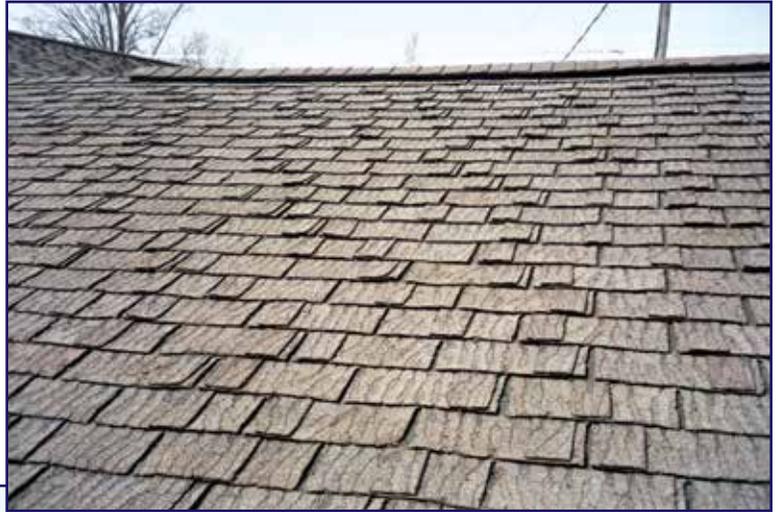
Photo 4 – View of east slope.

The shingles on the east slope also showed cracking of the granule surfacing and deterioration at the tab edges. The shingles over the entry roof area were starting to show cracks in the granule surfacing. No fractures on the underside of the

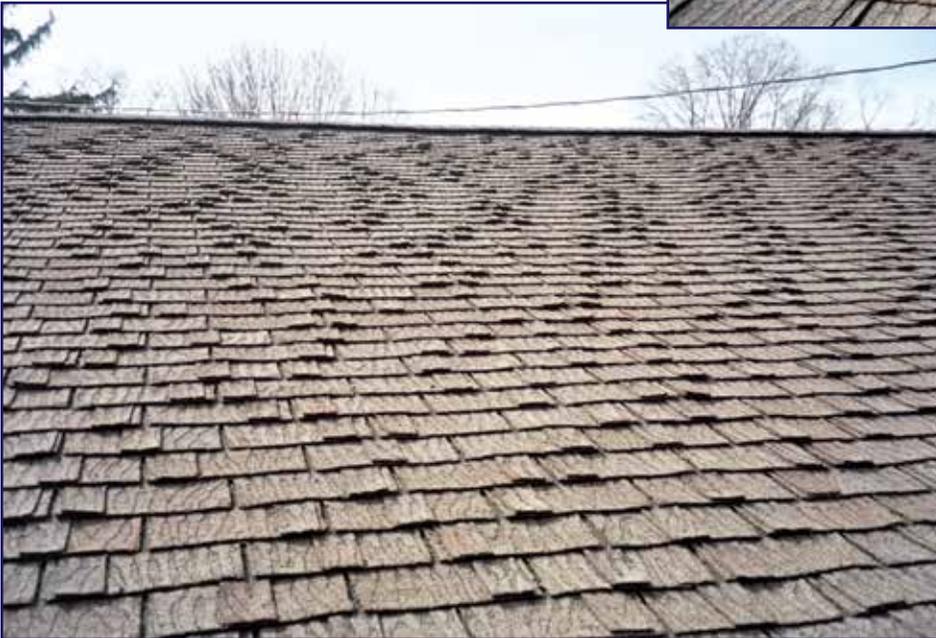
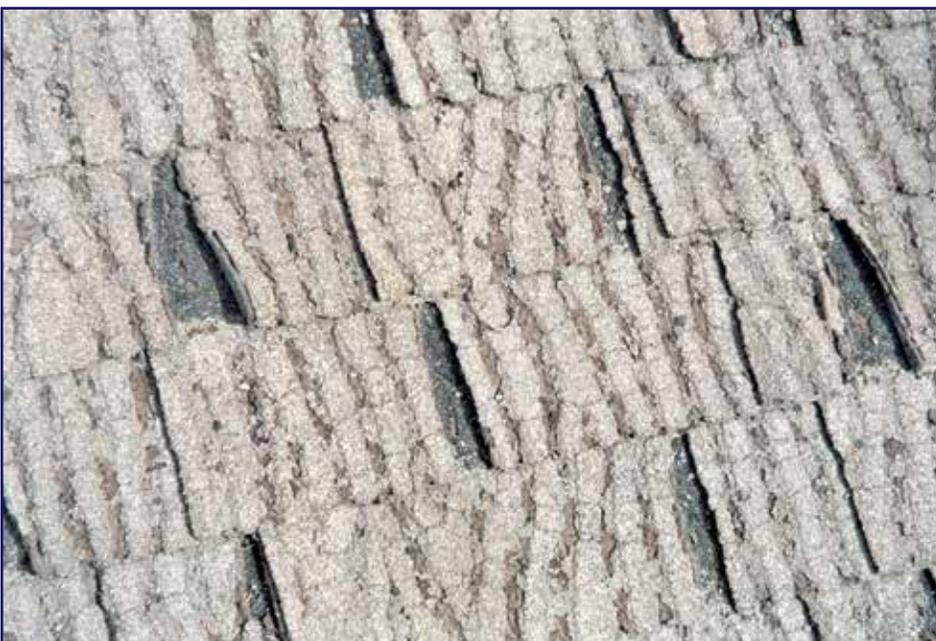
Photo 5 – West slope, close-up of cracking of granule surfacing on shingles.

slope (Photos 5 and 6) show that cracking of the granule surfacing was prevalent on the majority of the shingles. No fractures on the underside of the shingles were observed where the granule surfacing was cracked. Deterioration at the tab edges also was prevalent.

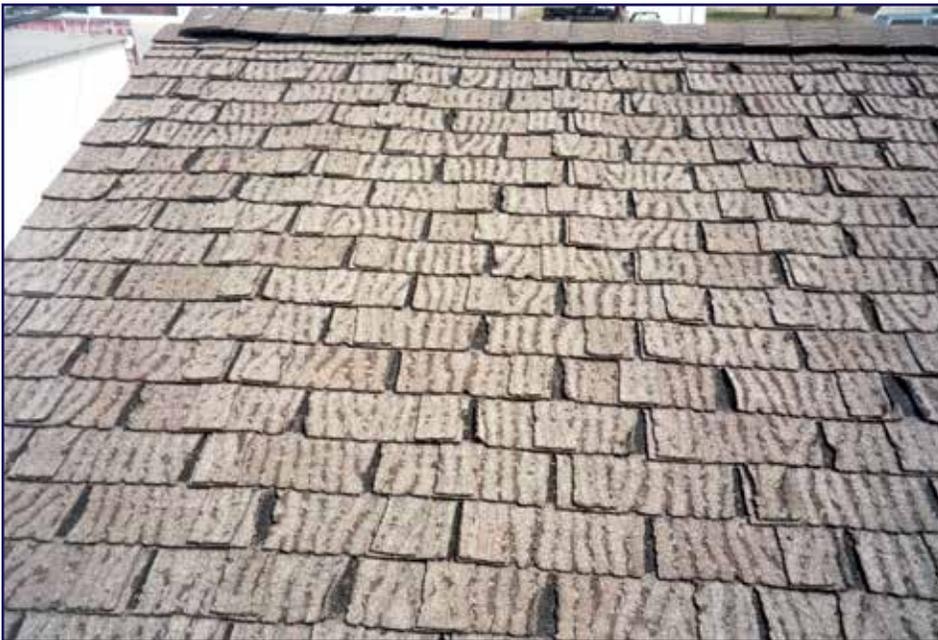
Photo 6 – West slope, cracking of granule surfacing.

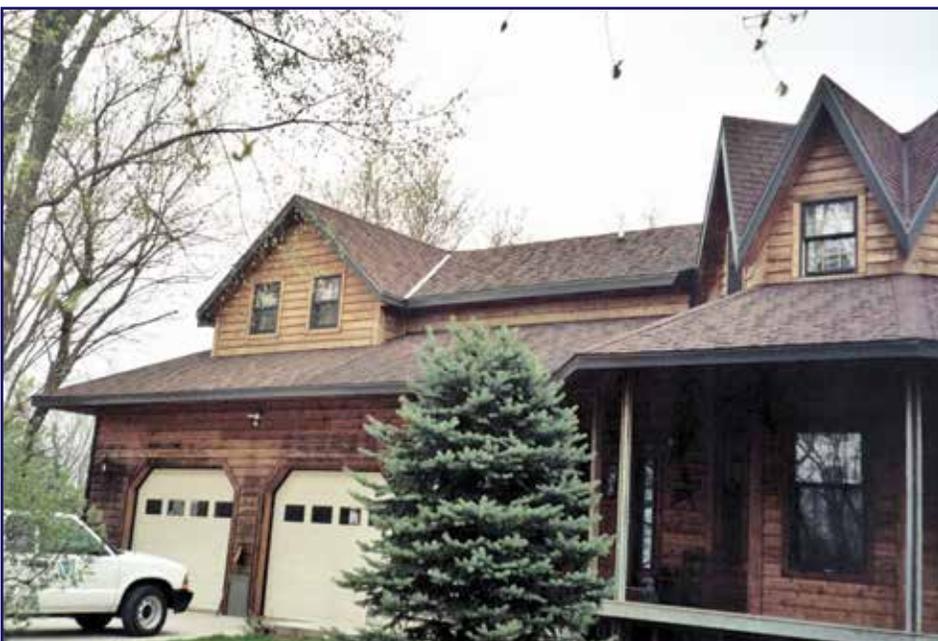
This investigation was due to a hail-storm event that occurred August 3, 2008, at the subject location. Per the local weather service reports, the closest officially recorded hail event for that day was approximately 5.5 miles distant. The recorded hail-stone size for that location was 1.5 inches in diameter. The building is a multistory structure (Photo 7) with various roof slopes.

Photo 7 – View of west side (front) and north end of house.

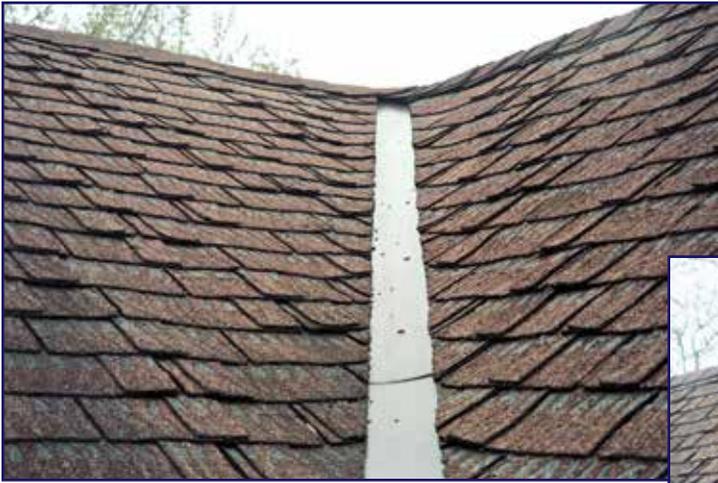
Photo 8 – View of SE valley on upper main roof. No impact marks on metal.

*Photos 8* through *11* show a general view of the various roof slopes and metal valleys on the building. No impact marks normally associated with hail were observed in the metal valleys.

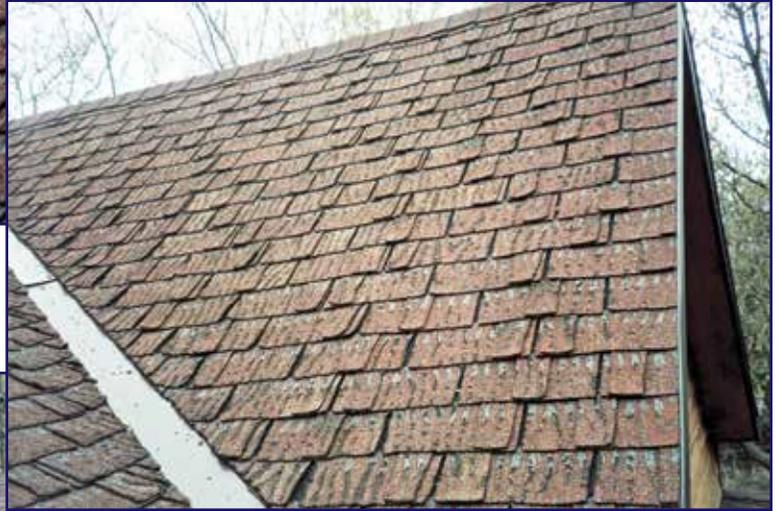
Photo 10 – View of deteriorated shingles on east lower slope.

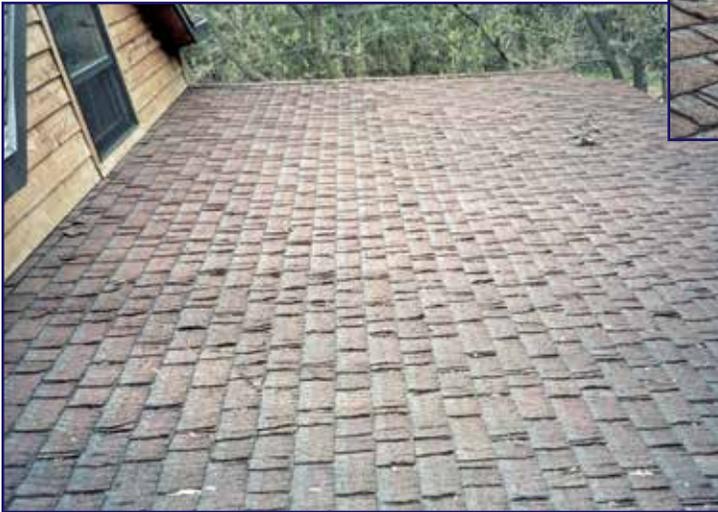
Photo 11 – View of deteriorated shingles and metal valley. No impact marks on metal on north end of upper west-side roof.

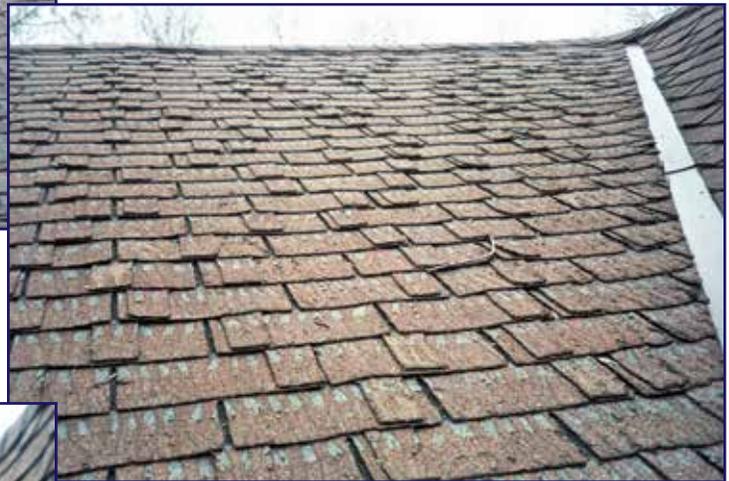
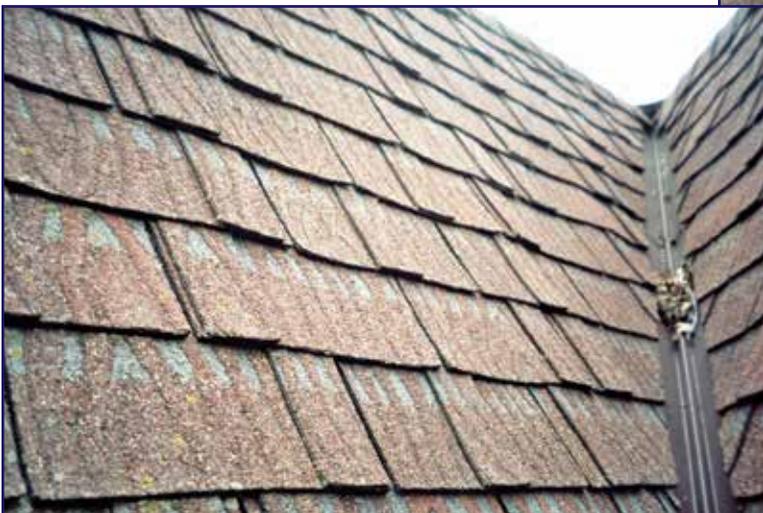
Photo 12 – Shingles on steep-slope section, south end.

*Photo 12* is a view of one of the steep slopes at the southwest corner of the house. The shingles on these steep-sloped sections appeared to be in generally good condition. The shingles on the lower and majority of the upper roof slopes con-

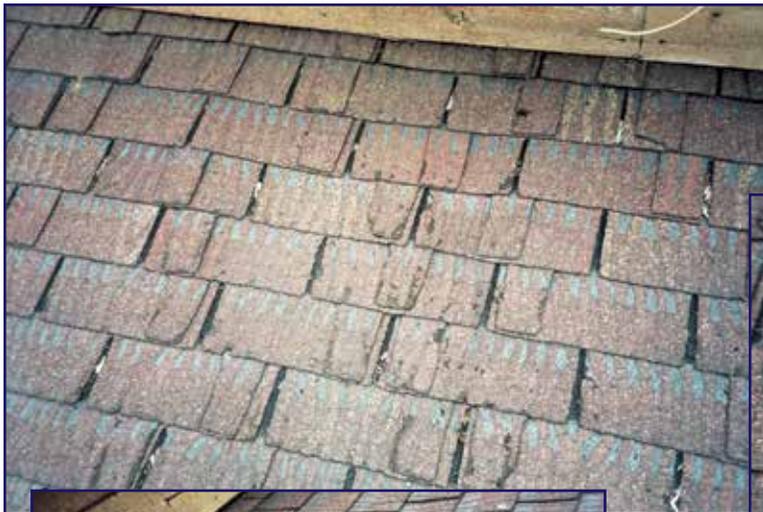
Photo 13 – Close-up of cracking granule surfacing on the east slope of the lower roof.

sistently were in a deteriorated condition (Photos 13-16) and had cracking throughout the granule surfacing on the majority of the shingles. No fractures on the underside of the shingles were observed where the granule surfacing was cracked. Deterioration at the tab edges also was prevalent.

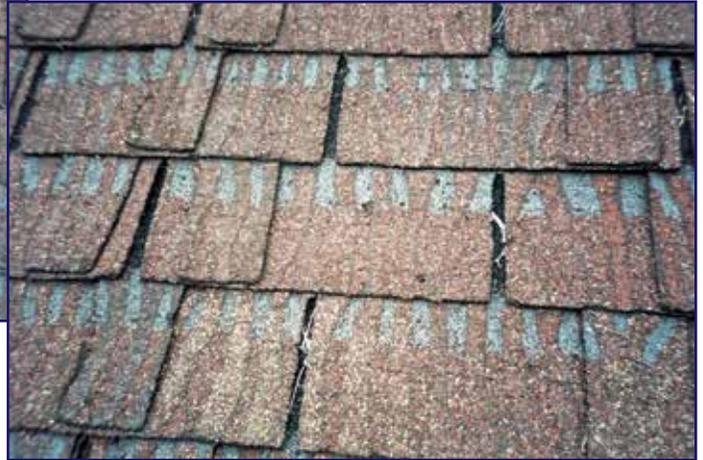
Photo 14 – Close-up of cracking granule surfacing on the north end of the upper roof.

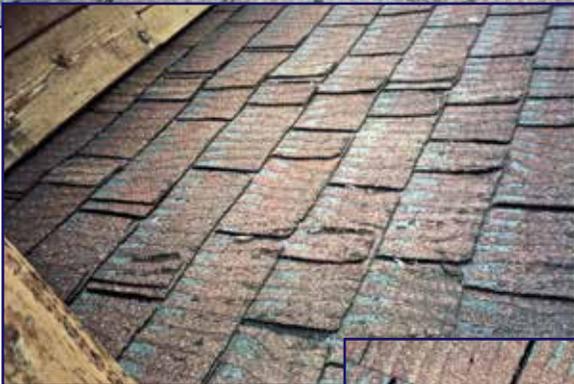
Photo 15 – Close-up of cracking granule surfacing on the west slope of the lower north end.

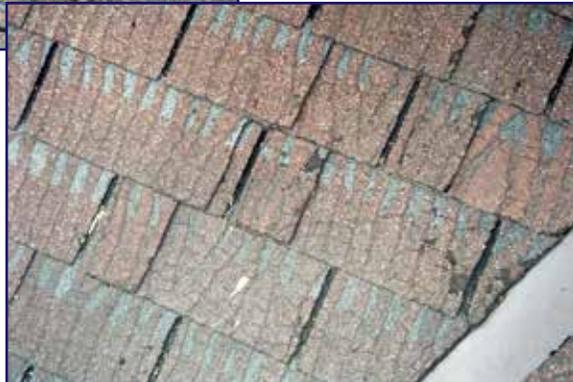
Photo 16 – Close-up of cracking granule surfacing on the south slope of the upper roof north end over the garage.
