What LURKS Beneath the Blue Tarp

By Aaron Nelson, RRC, RRO

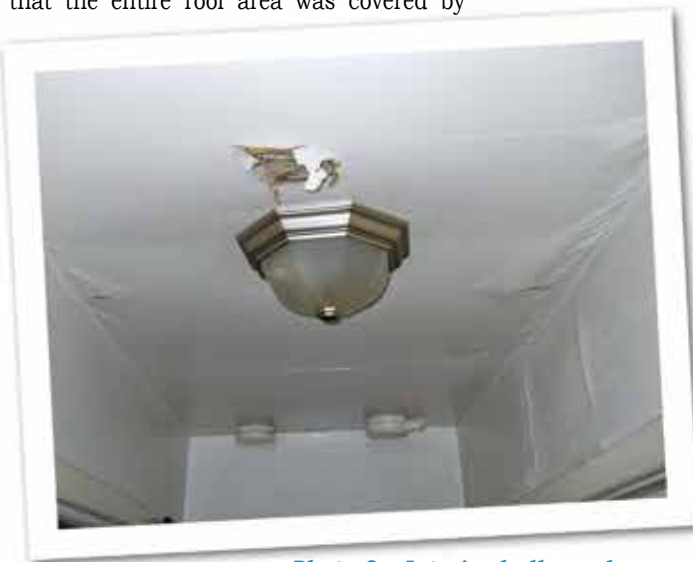
We toured the residence to visually observe where the intrusion had occurred. There were numerous locations indicating an abundance of moisture invasion. The drywall was sagging; paint blistering and stains from water were prevalent. (We noted, incidentally, that the kitchen cabinets had a tapered trim that matched the sagging of the roof.) As we walked through the residence, we were more and more convinced that this was not the result of a single wind event, but more the result of long-term intrusion.

Photo 2 - Interior hallway damage.

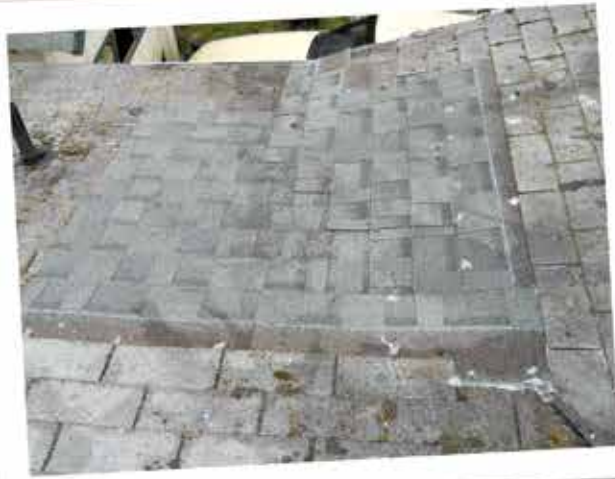
At the valley, underlying substrate was replaced and laminate shingles were integrated into the existing three-tab shingles. On the up-slope side of the repair area, the laminate shingles were tucked under the existing three-tab shingles, allowing overexposure of the laminate shingles. On one side of the valley, the laminate was placed on top of the existing three-tab and sealant was applied. For exposed fasteners, sealant was also topically applied. A woven valley had been attempted with the laminate shingles; however, it consisted of just weav-

Photo 4 - Valley condition.

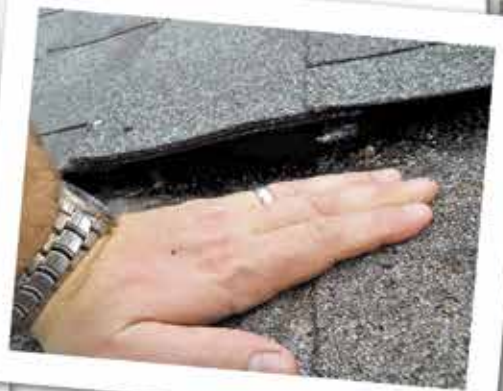
ing enough of the shingle to provide an overlap, in lieu of extending well beyond the valley line. The laminate shingles terminated in a straight line, roughly one inch beyond the new wood substrate. This provided an environment in which pressing on the three-tab shingles adjacent to the laminate shingles allowed one to actually see into the attic space.

Photo 5 - Pressing next to the laminate shingle exposed the interior of the attic to view.

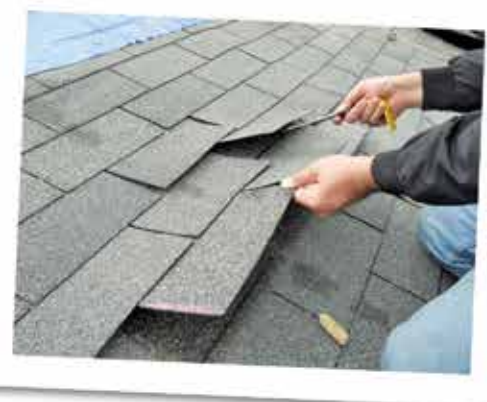
As the three-tab section near the ridge was above the area where the homeowners had indicated the bulk of the moisture damage was, we addressed it first. The substrate sloped to the perimeters at 2:12. The shingles had roughly the correct exposure; however, the offset was not in accordance with the manufacturer's requirements. Additionally, there was no underlayment on top of the new plywood substrate. There were generally two fasteners per shingle (one located near each end), and the fasteners were located at the top of the shingle (in

lieu of above the slots near the seal-down strip). The seal-down strip was not active, allowing for the shingles to be easily lifted up and the underlying substrate observed. This area was clearly identified utilizing historic satellite imagery as having a blue tarp installed, followed by a later photo showing the shingle installation in process in this area. The new shingles extended atop the existing ones and were held in place by fasteners located at the uppermost portion of the shingle. Again, the seal-down strip was not active, and no other means of sealing the new to old was implemented.

Photo 6 - Improper nailing of new three-tab shingles.

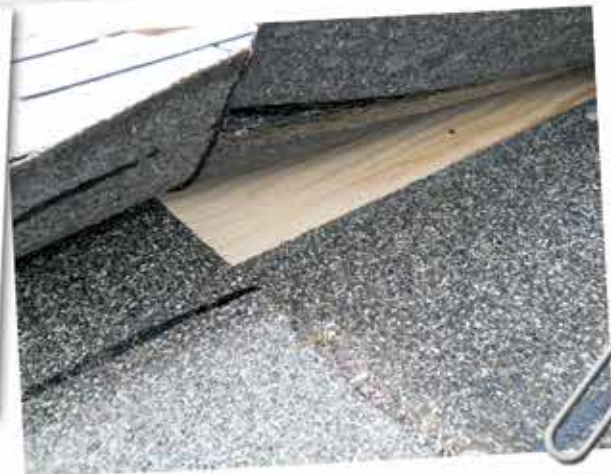
Photo 7 - No underlayment under the new three-tab shingles.
