Assessment of Hail Damage on Low-Slope Bituminous Roof Systems

By Justin Reeder, RRO, PE; and Keith Parker, RRC, RRO, CDT

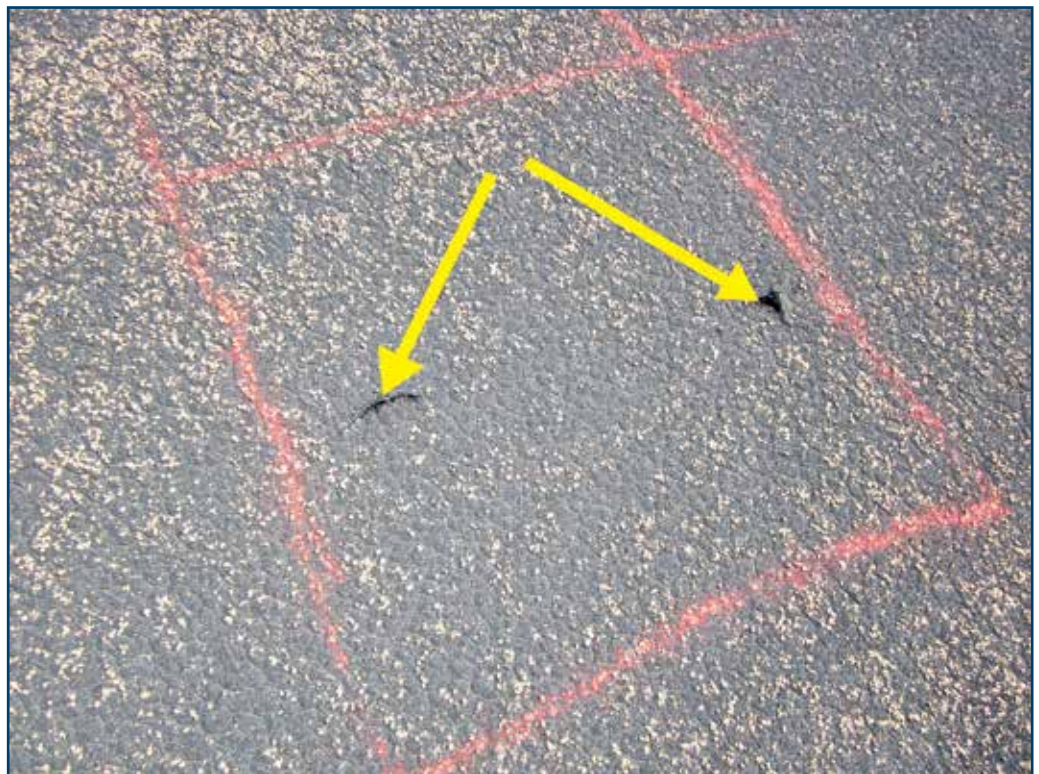
Photo 1 – Complete fracture of low-slope bituminous roof membrane from hail strikes. Membrane was installed over fiberglass board insulation, a less-dense coverboard in comparison to a gypsum substrate.

Substrate plays an important role in defense of hail strike damage on low-slope bituminous roofs. Typically, a denser cover board (such as gypsum) over the insulation system will provide a better resistance to hail. The softer the substrate, the more the membrane can be moved or displaced as a result of the hail strike. This allows for increased chances of a fracture in the reinforcement mat or scrim and even the entire membrane itself. For example, a granulated cap sheet installed over fiberglass insulation boards was completely fractured during a recent hailstorm in Texas.

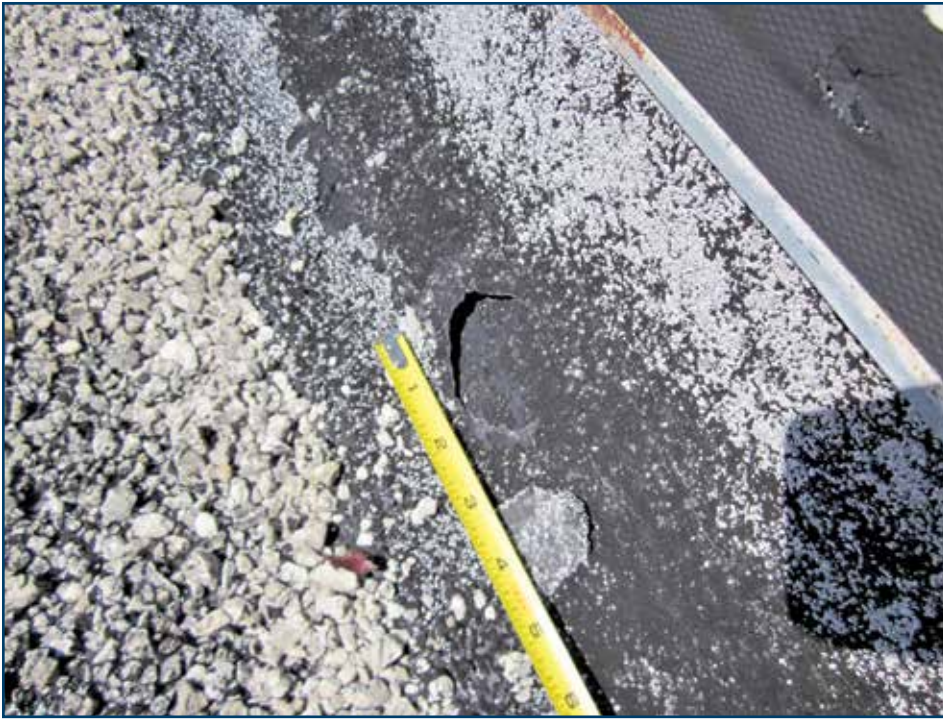
Photo 2 – Unsupported modified-bituminous flashing membrane and resulting hole from hail strike. Note: Gravel-surfaced BUR was otherwise undamaged from the hail.

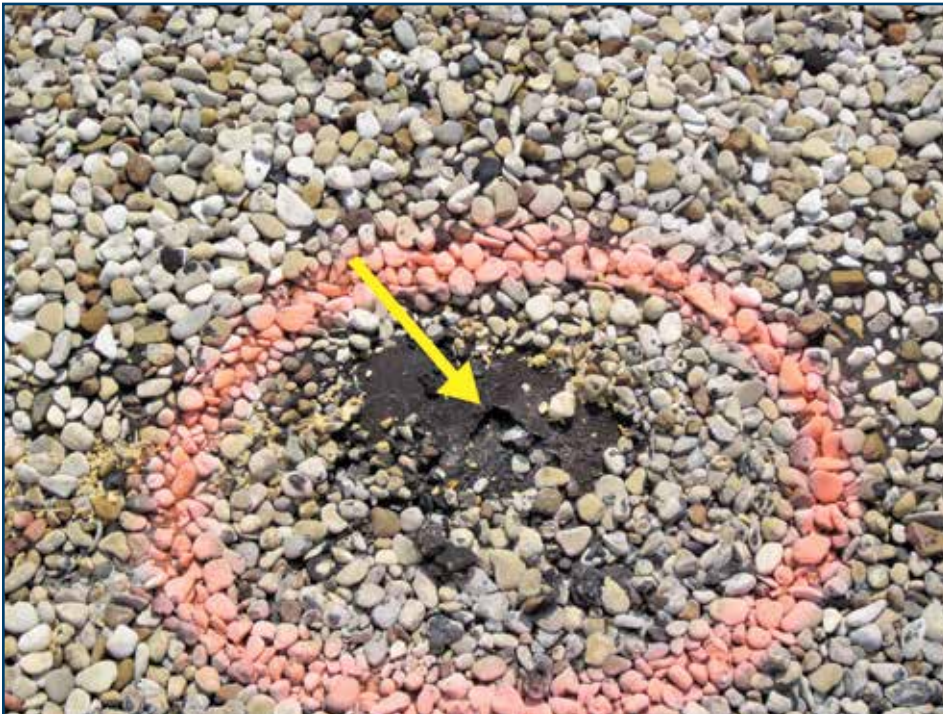
Photo 3 – Blister observed in a coal-tar pitch roof. A “lucky” hail strike right on target left this system with a reasonably sized hole.

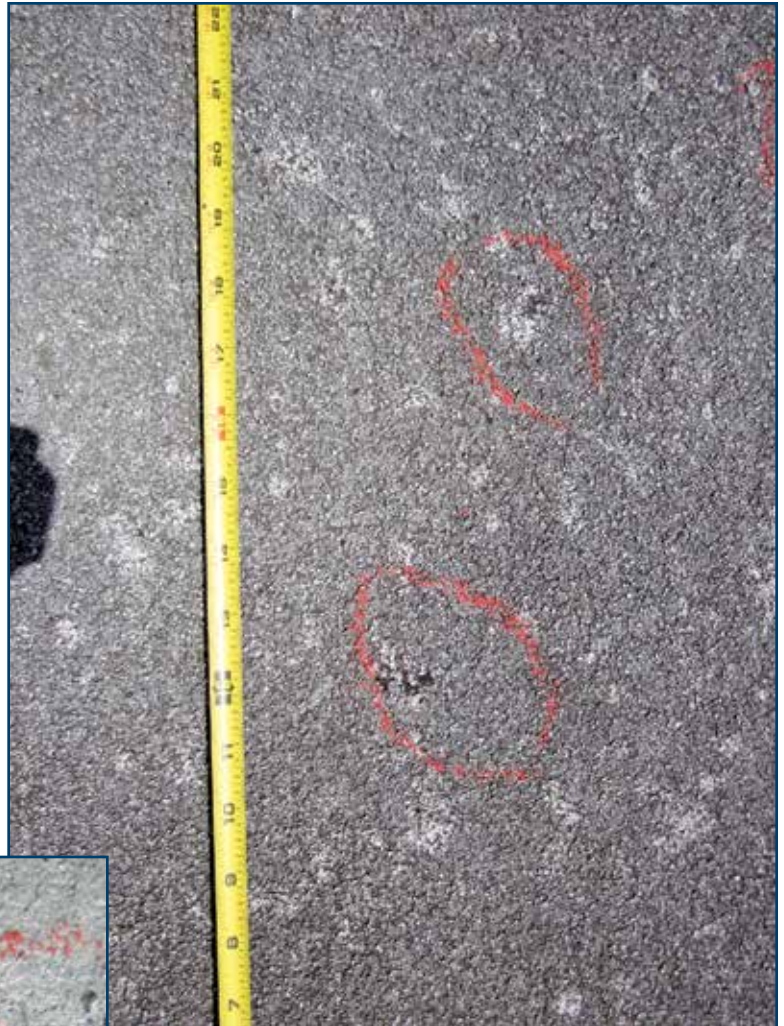
Photo 4 – Overview of hail strikes on a granule-surfaced cap sheet. The two worst hail strikes are circled. Each showed granule loss and felt soft or “bruised.” The additional white marks are also hail strikes, but not as severe. Removal of the oxides from the granules leaves a clean spot or “splash mark.”

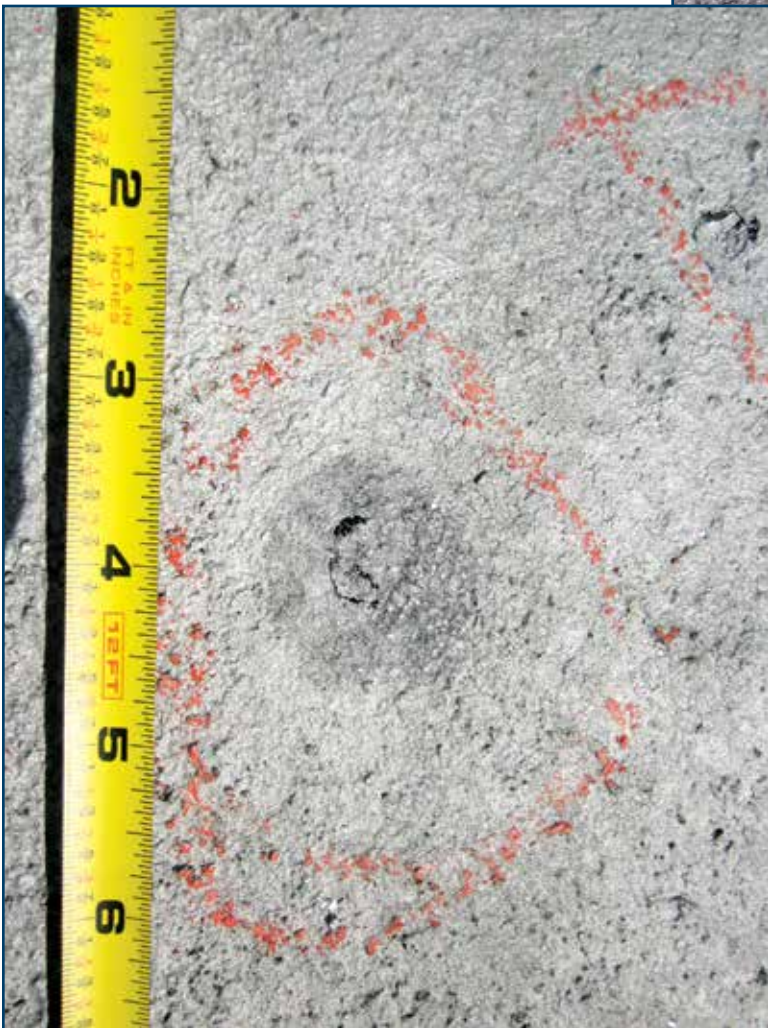
Photo 5 – Fracture in a coated, granule-surfaced cap sheet. Note wicking of moisture from within membrane plies.

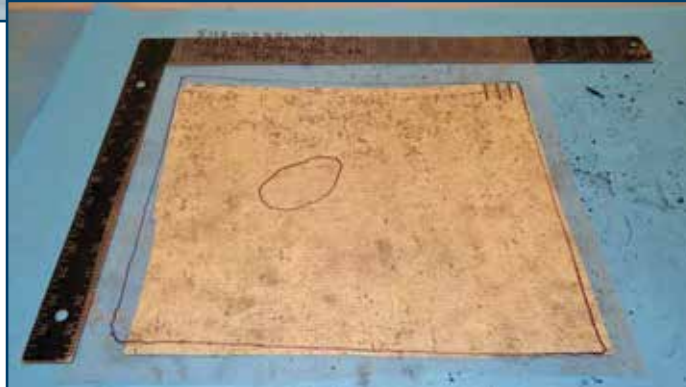
Photos 6A and 6B – A modified-bitumen roof membrane before and after desaturation.
