WAYS TO FIND THOSE MYSTERY LEAKS

By Marc Schwerzmann, PEng, CEM

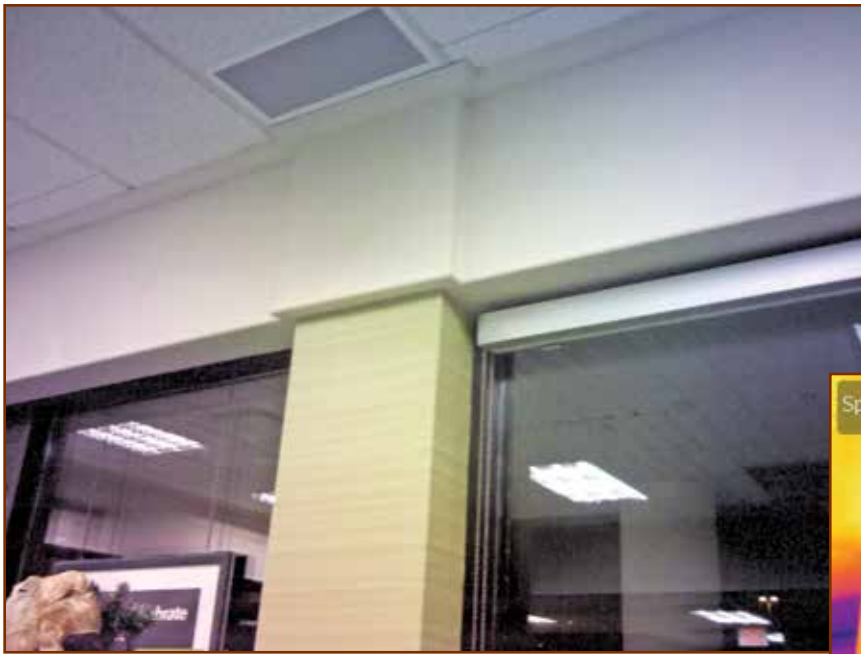
Figure 1 – Visual image of column and window interface at Site 1.

The test involved depressurizing the entire building by 50 Pa, the equivalent of a 50-km/h (30-mph) wind hitting the building’s exterior walls and roof. Thermographic images of the wall were taken with an infrared camera while the building was pressurized to identify conditions behind the gypsum finishes. Figure 1 shows the location in question; no evidence of interior damage or deficiencies is visible. Figure 2 is the thermographic image of the same column under depressurized conditions. The darker-colored streaks outline the path of air infiltration concentrated around the

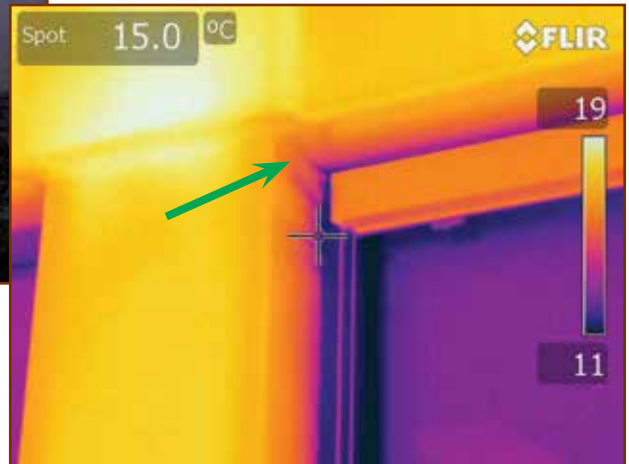
window frame; the bright yellow area is directly below a forced-air heating diffuser. Figure 3 shows a typical exterior wall-to-floor junction in a corner of the building.

Figure 2 – Infrared (IR) image of Figure 1. Note the streaks of dark color by the arrow showing air leakage.

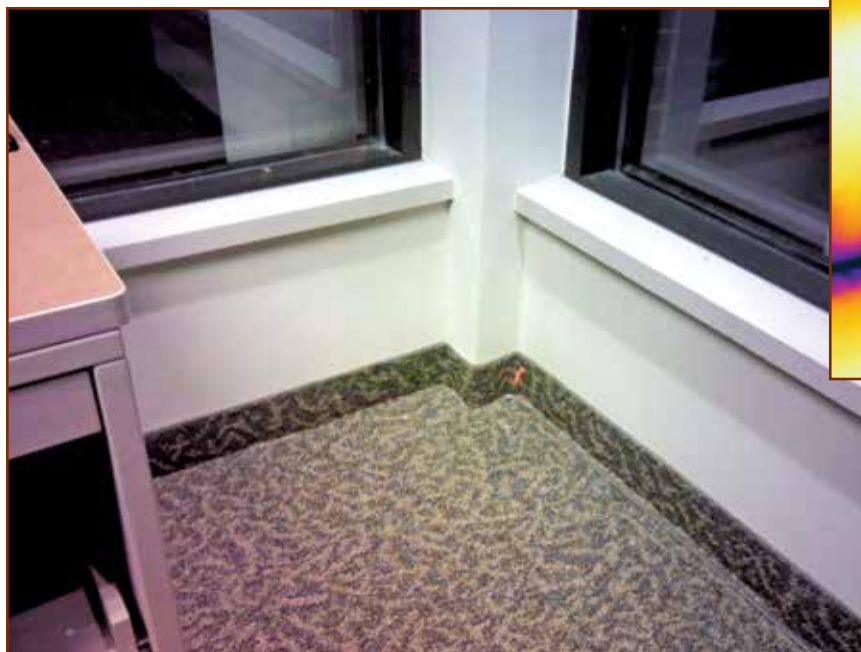
Figure 3 – Visual image of wall with floor interface in corner office at Site 1.

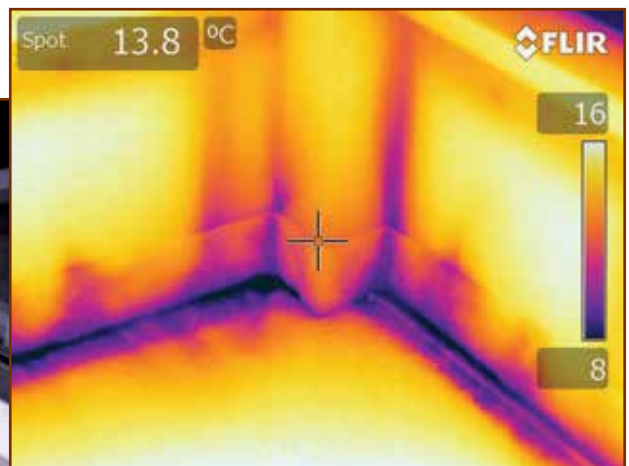
Figure 4 identifies the same corner under pressure, displaying significant amounts of heat transfer due to air infiltration and thermal bridging at the base of the walls and surrounding the exterior steel column.

Figure 4 – IR image of Figure 3. Dark streaks on walls and floor indicate air leakage into building.

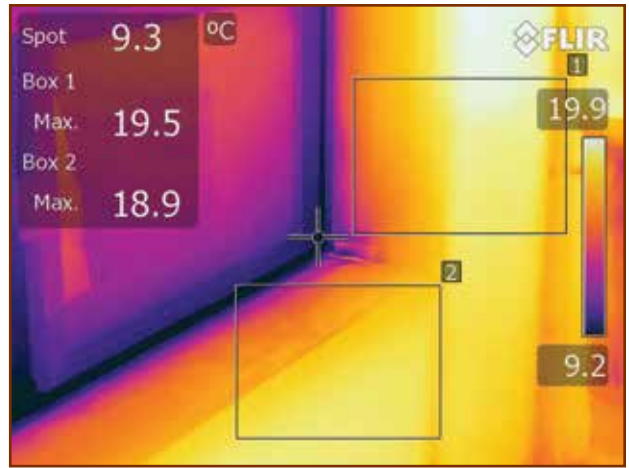
Figure 5 shows an infrared image of the inside face of the exterior fenestration-to-wall interface prior to pressurization, showing thermal transfer from the window frame to the gypsum finish, but no air infiltration. Figures 6 and 7 are images taken during pressurization; each image demonstrates significant air infiltration occurring around the windows.

Figure 5 – IR image of fenestration. Wall interface prior to depressurization.

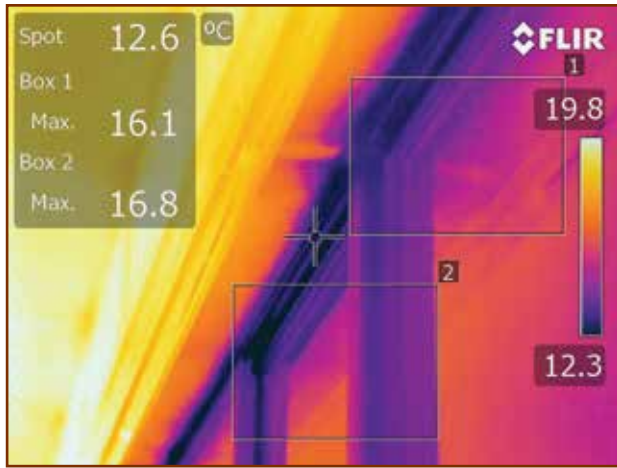
After these images were taken, a destructive test of the window detail revealed deficiencies in the original construction. Termination of the air barrier up to the window frame was allowing significant amounts of air to enter the building, bringing with it the moisture experienced through driving rain.

Figure 6 – IR image of fenestration system under depressurization. Note streaks indicating air leakage.

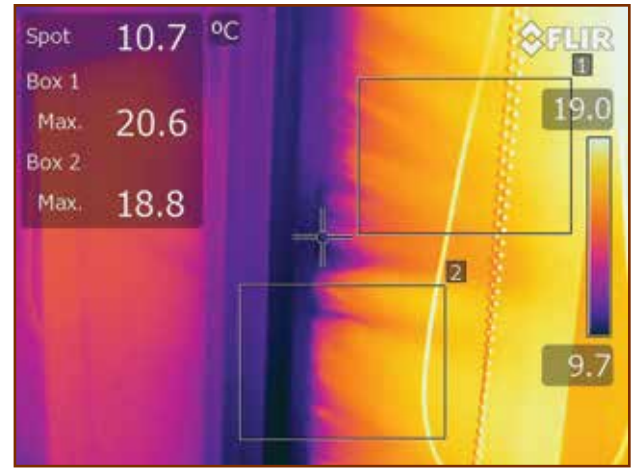
Figure 7 – IR image showing significant air leakage (streaking) between fenestration and wall system.
