Identifying Deliberate “Hail” and “Wind” Damage to Shingle Roofs

By Lyle D. Hogan, RRC, FRCI, PE

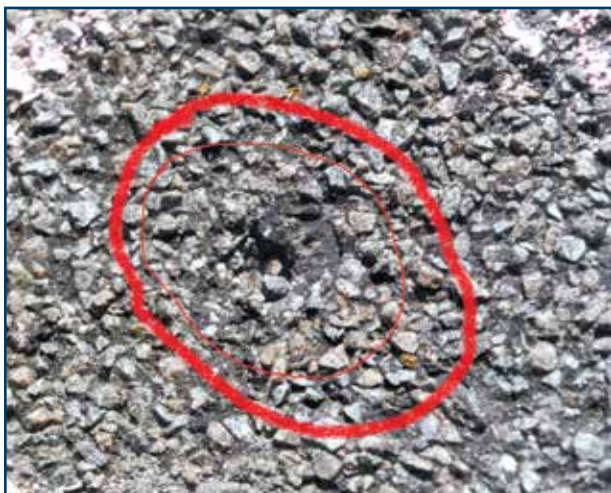
Figure 1 – Deliberate puncture from round mandrel of some type.

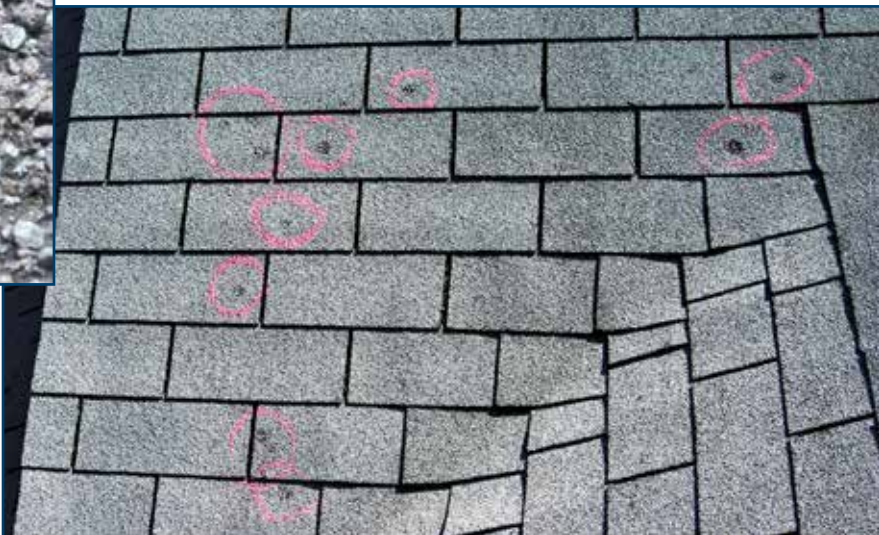
Figure 2 – Unnatural radial pattern from deliberate impacts. This type of pattern can be inflicted by anything from a rake handle to a golf ball in a sock.

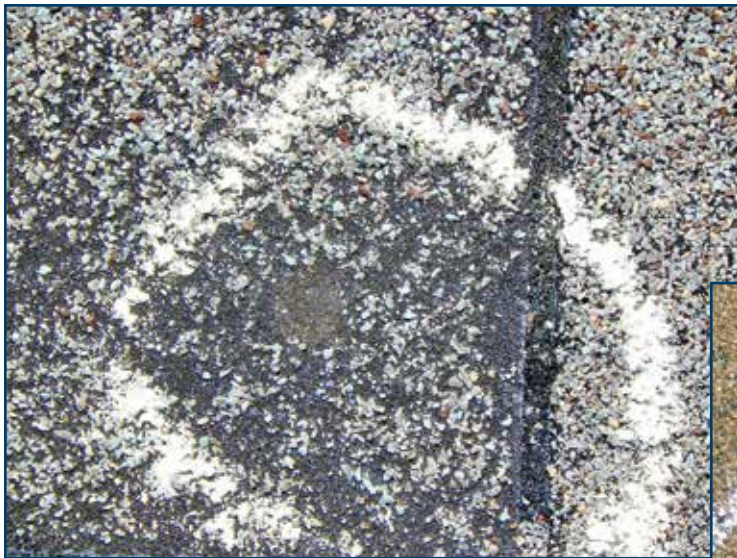
ulate natural hail impacts (Figures 1-4). Ice particles, regardless of size, will not pulverize mineral granules (Figure 3). Where surfacing material has been reduced to powder, there is something else at work.

Figure 3 – Another technique to simulate hail pockmarks is known as “dime-spinning,” although other denominations work just as well. Peripheral observations will support or negate the intensity of whatever hail was actually sustained.

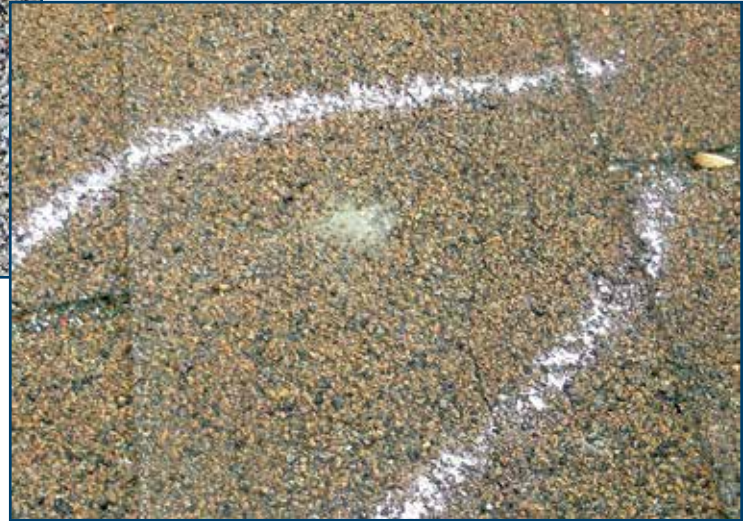
Figure 4 – Crushing of mineral granules from deliberate blunt-force impact. Hail particles, regardless of size, will not pulverize granules, reducing them to powder.

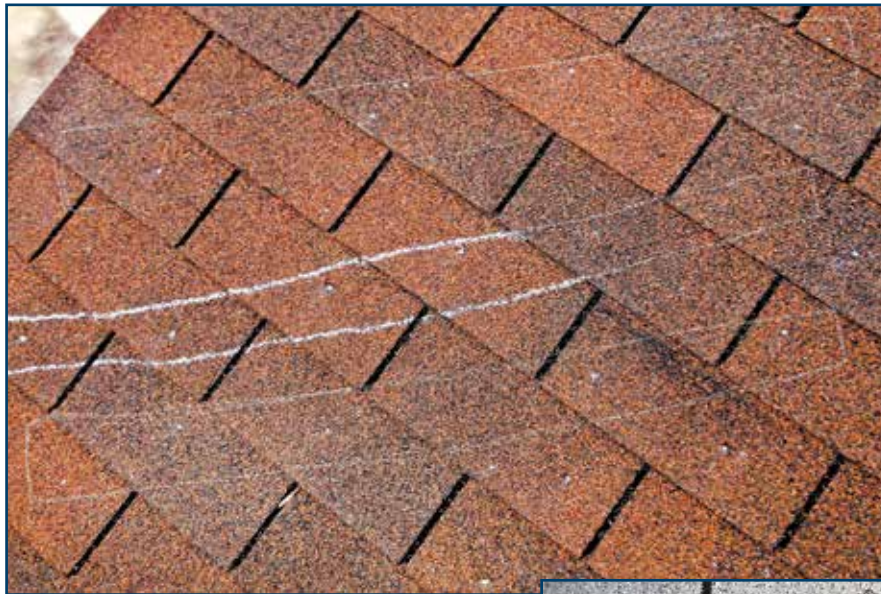
Figure 5 depicts a case in which the owner spent considerable effort simulating a fairly random pattern of impacts. The problem in this instance was the tool used—the small (angular) end of a ball-peen hammer. These strikes (although uniformly created) were small, yet they pulverized the surfacing granules, punctured two plies of shin-

gles and felt, and extended even into the wood decking.

Figure 5 – The small end of a ball-peen hammer was used on this one. Impacts extended through two plies of shingles, underlayment, and into decking. Hail particles of this small size would have no such kinetic energy. Again, the granule surfacing was powdered; also note the linear pattern of swing lines. Large Caladiums and Colocasia plants (elephant ears) directly below this roof were completely unaffected.

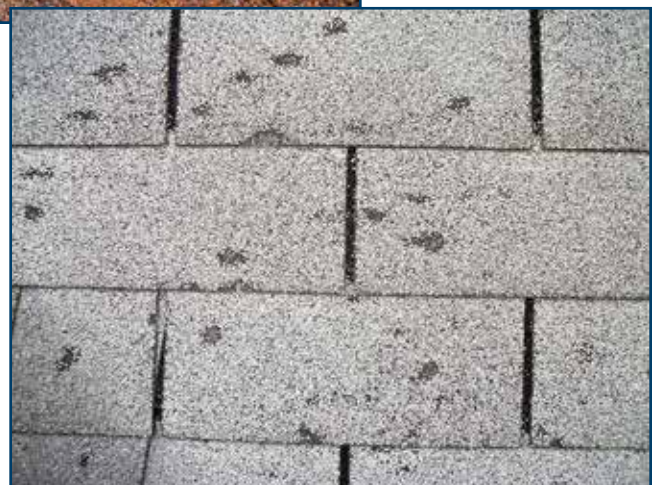
Figure 6 – Innocent, natural, random pattern of legitimate hailstone pockmarks. These are greying-out from UV exposure in contrast with more recent hits that would be darker.

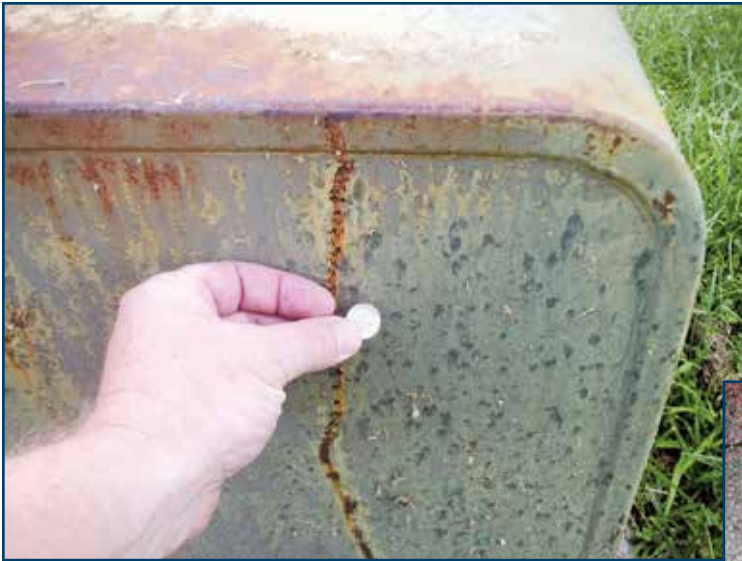
Figure 7 – A little detective work will prove worthwhile. Here, the oxidized paint of a roadside utility box provides good evidence regarding particle size (all smaller than a penny). Markings on a roof that deviate appreciably from this should be regarded with suspicion.

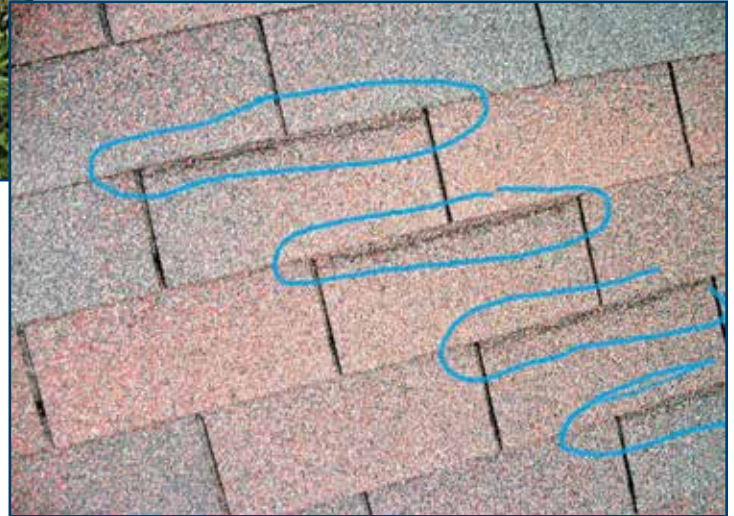
Figure 8 – The author witnessed this pattern made by a well-meaning contractor who was determining the nailing pattern; nonetheless, this is not a natural pattern of creasing due to high winds. Tabs were very well bonded here. When some damage is encountered but remaining shingles are very well bonded, the basis for concern is present.

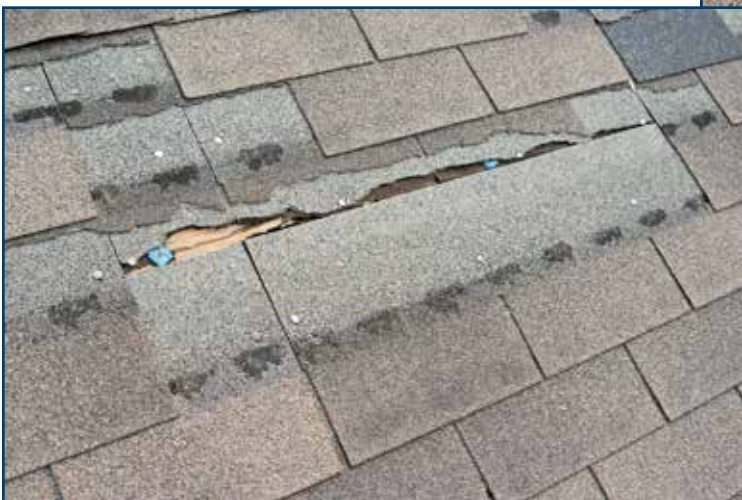
Figure 9 – Unnatural tear pattern from deliberate destruction.

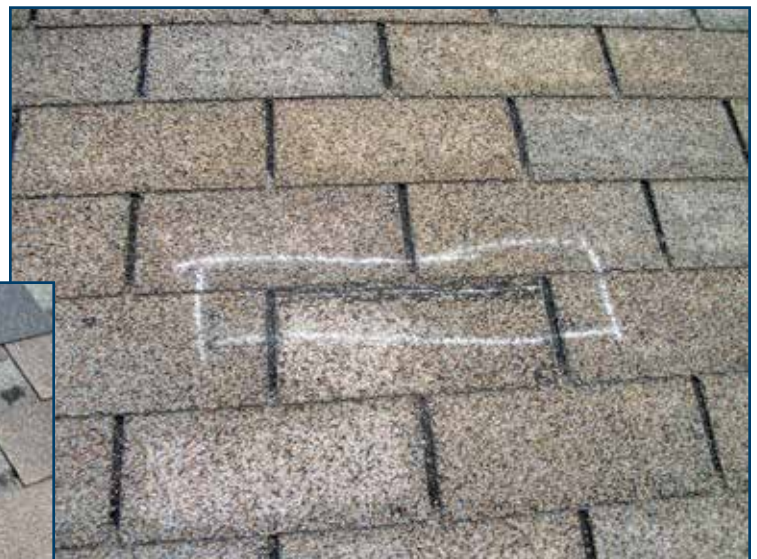
(Figure 10) represents legitimate compromise to a shingle roof; folding and creasing elsewhere on the tab exposure is a dubious occurrence. A casual Internet search will reveal the common manner of wind influence on shingles.

Figure 10 – Natural linear folding/creasing that constitutes legitimate roof damage. Note also the “graying-out” of the crease, suggesting this tab has been flexing in the wind for some time.

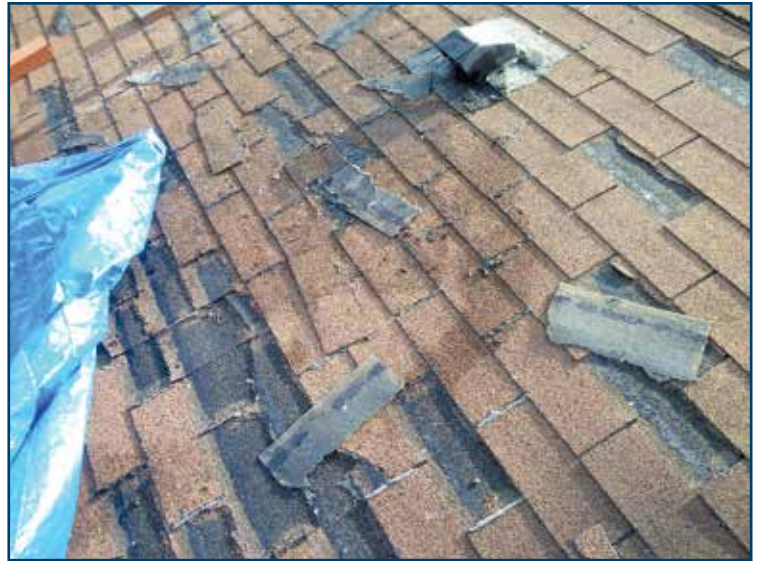
a leeward side may collapse under the weight of rational analysis; moreover, shingles torn away in irregular lines—especially with the torn fractions still nearby—are inconsistent with windstorm activity (Figure 11). The person of dubious character who carries out his own wind damage should always throw the torn fractions to the ground [Memo to the crook: If you are going to rip off the tabs, don’t leave them on the roof].

Figure 11 – Highly irregular tear lines are inconsistent with ordinary wind influence. More importantly, winds sufficient to inflict this extent of damage would not have left the loose fractions still scattered about the roof surface; this “practitioner” needs a course in remedial reasoning.
