# Risks of Roofing Over Concrete Decks

By Joe Schwetz

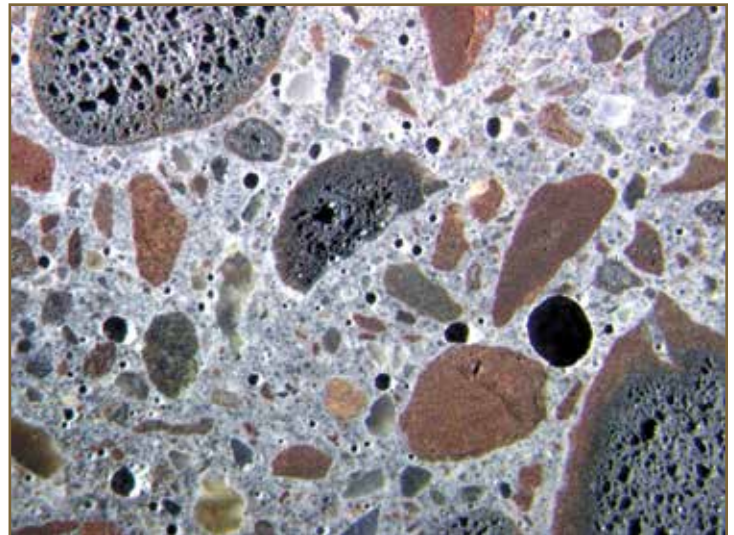
Photo 1 – Micrograph of lightweight concrete with expanded shale aggregate (compliments of SGH).

The LWSC can achieve the low “in-place” densities by using a lightweight porous aggregate containing air voids. The most common aggregates used in LWSC are expanded shale slate, slag, or clay. The materials are processed at very high temperature (2000°F) in a rotary kiln. These aggregates have a textured surface, a network of internal pores, and absorb relatively large amounts of water (*Photo 1*).

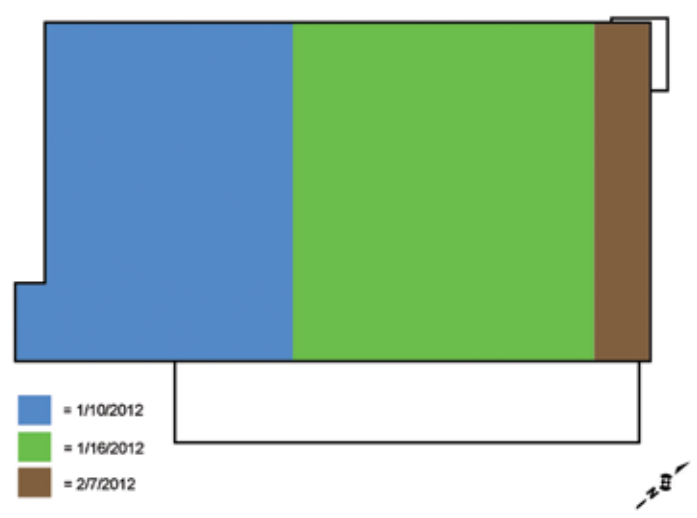
Figure 2 – Dates for the installation of the self-adhered vapor barrier, Case Study 1.

The air temperature on the days of the pours ranged from 3° to 33°F. With interior finish work already in progress, the general contractor (GC) pushed the roofing contractor to dry-in the building as quickly as possible. The vapor barrier was installed over three days (January 10 and 16, and February 7, 2012), when the temperature ranged between 7° and 43°F (within the

acceptable temperature installation range for the vapor barrier). (See *Figure 2*.) The roofing project reports state that the concrete was visibly dry and the GC, roofing contractor, and FM Global representative witnessed and accepted the adhesion testing of the vapor barrier to the concrete deck. According to the project records, on the south section of the roof, the initial concrete pour was exposed for 25 days, and the north sections were open for 12 to 18 days.

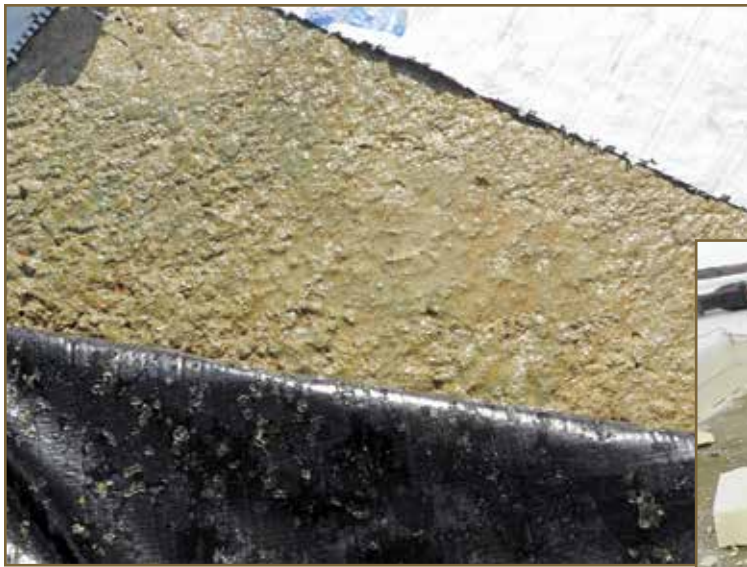
Photo 2 – Moisture between the concrete and self-adhered vapor barrier.

On February 15, blisters were seen under the adhered vapor barrier. Test cuts showed moisture and standing water on the deck (*Photos 2, 3, 4, and 5*). An additional 12 test cuts were done on February 23, with nine test cuts showing moisture and standing water between the vapor barrier and the concrete deck (*Figure 3*). At this point, the project was shut down, and accusations and blame for the presence of the water started, followed by claims that the products and/or the workmanship were at fault. The GC refused to share the construction documents, specifically for the concrete floor and roof deck applications. He did state that the concrete was a “normal-weight structural concrete.”

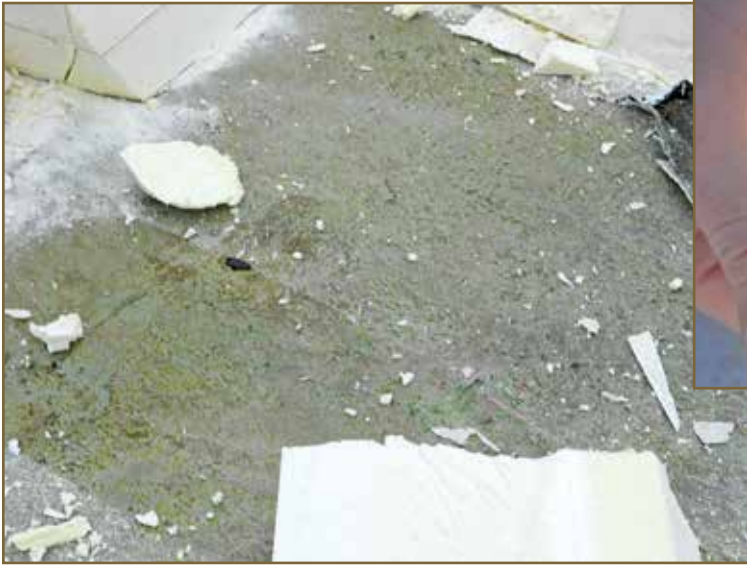
Photo 5 – Primer coming off the concrete deck.

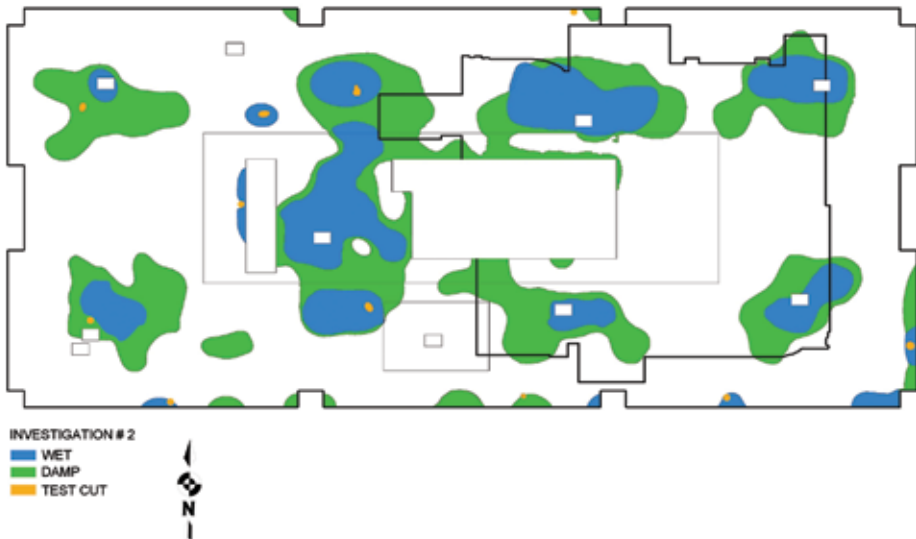
Figure 5 – Test cuts indicating all areas of the roof to appear to be dry (Case Study 2).

The construction team identified areas of the roof to be replaced (approximately one-third of the total area), which was done during the late summer and early fall of 2008 (*Figure 4*). It appears that most of the areas identified as wet/damp from the nuclear scan were replaced (heavy black lines on Roof Plan 4). Project records indicate not all of the identified damp/wet areas were replaced, primarily at the west end of the building. At the completion of the rework, 11 test cuts were done by a third party to determine the condition of the roof assembly; the cuts are designated by the orange dots on Roof Plan 5. Based on the report, all test cuts indicated the roof system layers and concrete deck to be dry, including the west end of the building where there was no product replacement (*Figure 5*).

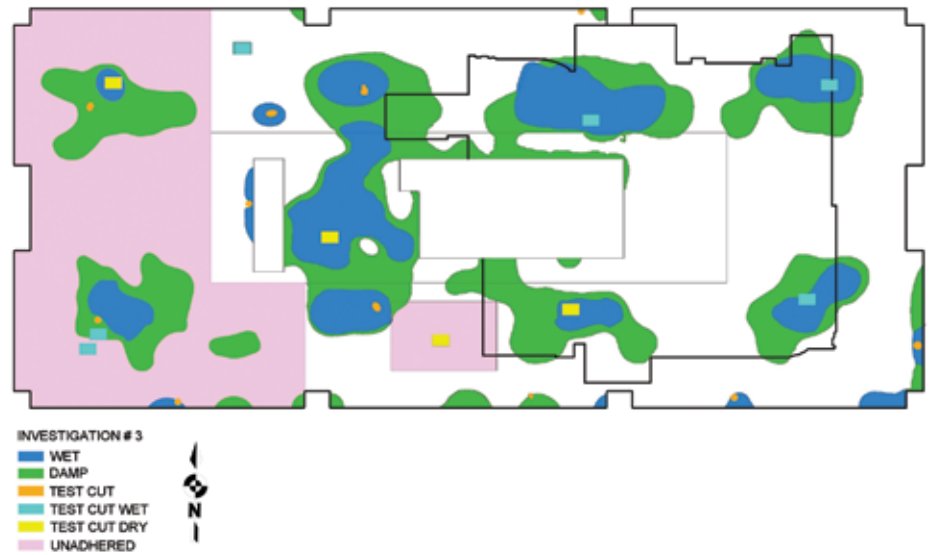
*Figure 6 – Field evaluation with test cuts indicating the movement of the moisture within the system at Case Study 2.*

replaced with new insulation and membrane had three areas that showed wet conditions (Samples 6, 7, and 9). The roof system was thoroughly checked to see if there were any breaches or possible entry points for the water, and none was found

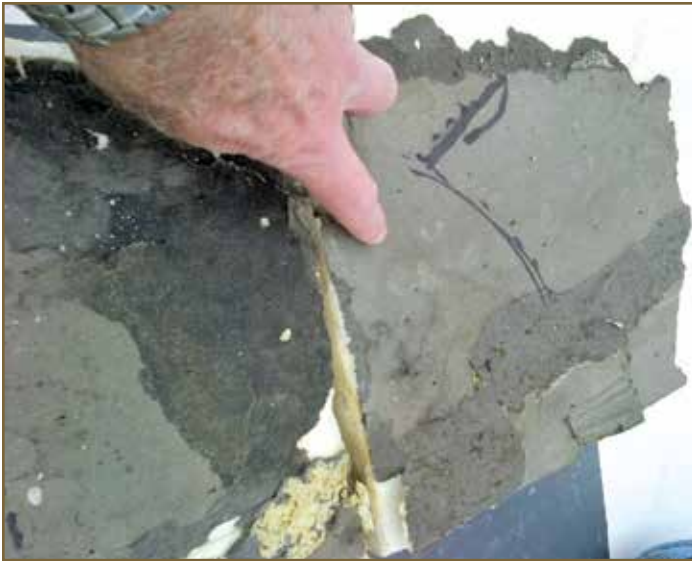
Photo 7 – Moisture underneath the bottom layer of iso.

the roof system was able to move between the roofing components and along the concrete deck, aided by hydrostatic pressure (Photos 7, 8, 9, and 10). After the water test, the water in the system has to travel around the insulation boards as well as the ribbons of urethane adhesive. The adhesive ribbons that were on the concrete deck most likely trapped some of the water in the U-shaped application pattern. The records indicate there were areas where the insulation was not removed and replaced for up to three months. It is also unknown if all of the wet or damp insulation was replaced. Comparing the nuclear scan results with the 2012 test cuts that were taken in the designated replacement zone (Samples 6, 7, and 9), these test cuts should have been dry. An unanswered question: Is the original insulation still in place (which can explain the results), or was it replaced and moisture migrated toward these areas? With the wet insulation and water in contact with the concrete deck for up to three months, a portion of this excess water soaked into the concrete deck.

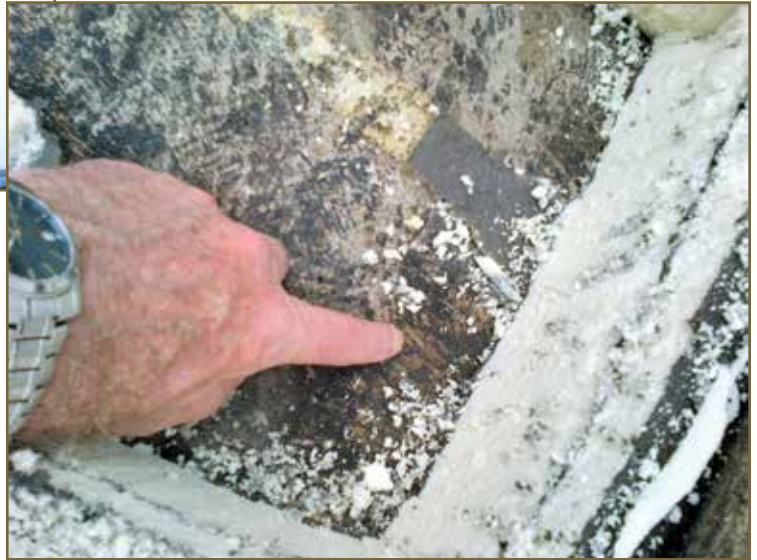
Photo 8 – Moisture on concrete deck.

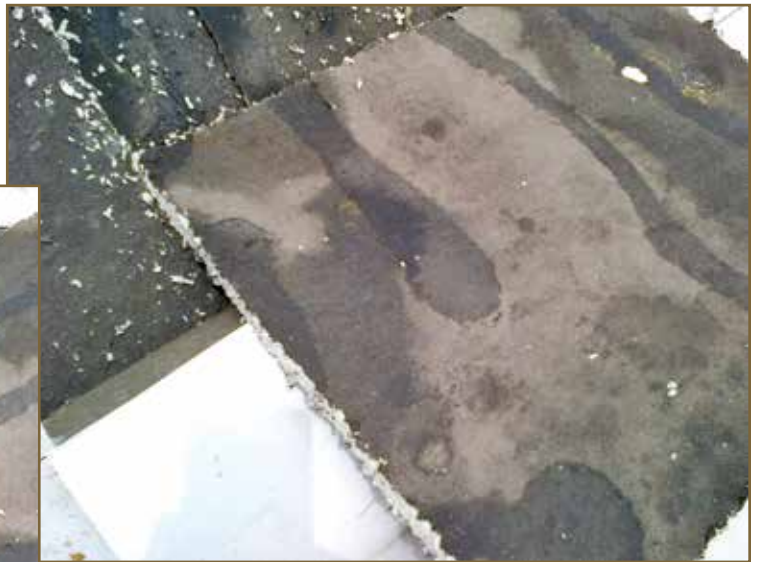
Photo 9 – Moisture between the layers of boards.

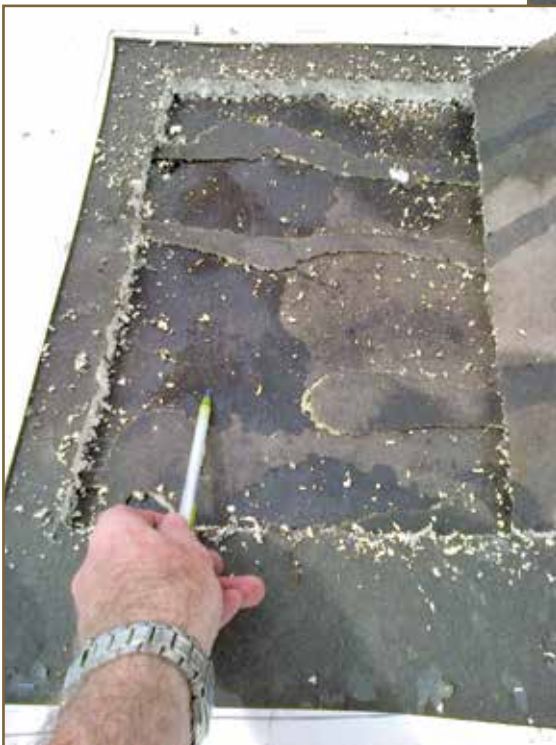
Photo 10 – Moisture between the layers of iso.
