# DESIGNED TO FAIL:

## Three Case Studies Illustrating Common Exterior Wall Practices Guaranteed to Leak

By Lurita McIntosh Blank

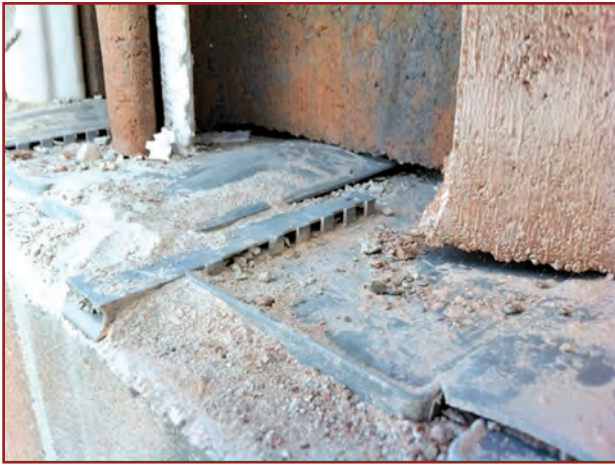
susceptibility of these systems to water infiltration. At the elementary school, the embedded flashing system was a modular polyethylene pan flashing (Figure 1). The interlocking flashing pans are centered over the block cells and positioned so that the molded

Figure 1 – Plastic pan flashing exposed in an investigation opening.

weeps are flush with the exterior face of the block. To maintain mortar bond between the block units—critical in a single-wythe wall system—the pan flashing is recessed approximately 1 in. from the faces of the block. The intention of the pan flashing is to allow rapid drainage of liquid water from inside the block cells.

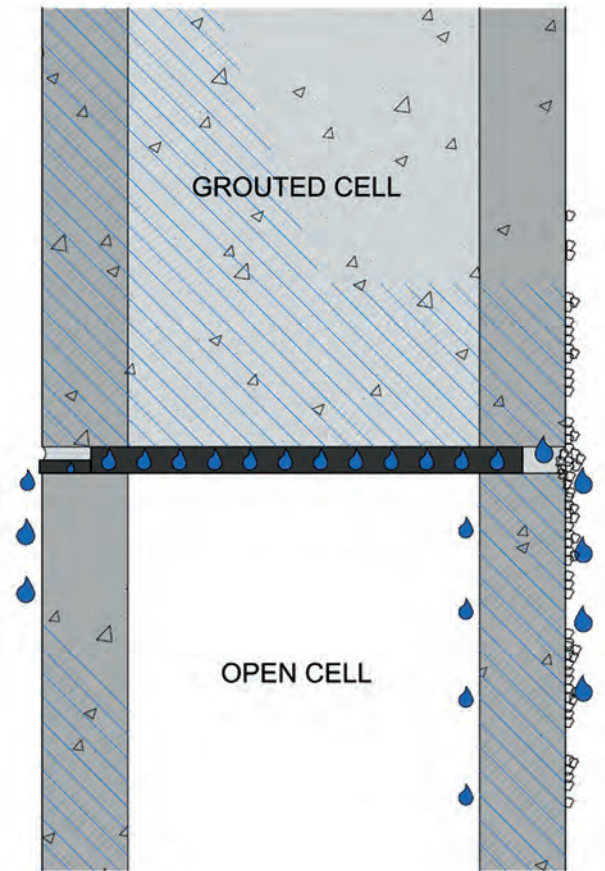
Although the pan flashing was typically installed at industry-recommended locations within the exterior walls, the discontinuity of the flashing system allowed water to bypass the plastic pans at mortar joints, penetrations, mortar droppings, and, particularly, grouted cells (Figure 2). According to the design specifications and manufacturer product data, the architectural block was required to have been manufactured with an integral water repellent. Subsequent laboratory material testing failed to identify any integral repellents; additionally, the architectural block was found to have excessive pinholing. These two factors (which allowed rapid saturation of the architectural block) in combination with discontinuous flashing and a wall system inherently susceptible to leakage created an exterior wall that was unlikely *not* to leak.

Figure 2 – Plastic pan flashing allowing water to bypass flashing at saturated block, leading to efflorescence and leakage at interior.

Correction of the known deficiencies at the elementary school will not be possible without excessive reconstruction of the exterior walls. Remedial solutions, including coatings, have been discussed. At this time, the options are still under consideration by the project team.

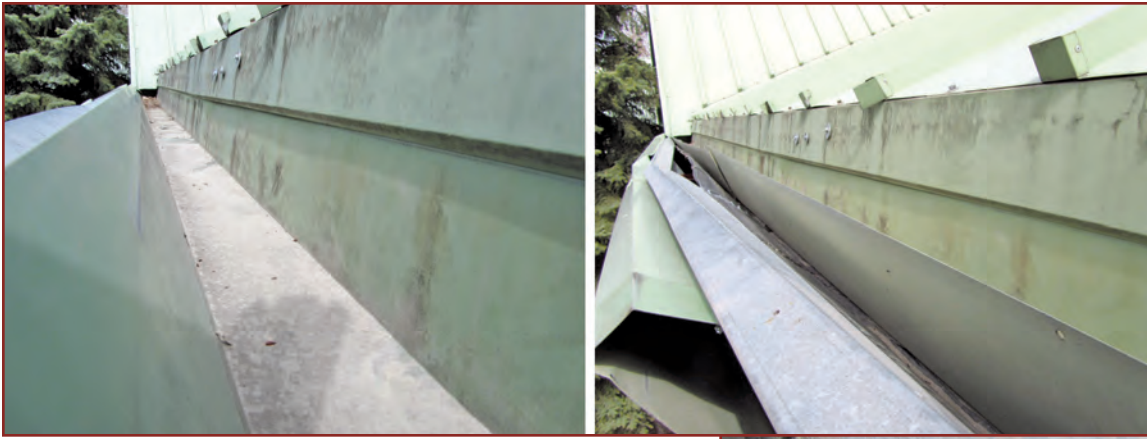
While integral gutters usually rely on a seamless or soldered-seam liner to create a watertight assembly, investigation into the as-built construction at the care facility showed that the integral gutters were break-formed (Figure 3). A prefinished steel sheet liner was set into a galvanized steel trough with a loose-laid membrane flashing sandwiched between the two. Corners and seams were left unsealed, and the mem-

Figure 3 – Integral gutter in place (left) and at beginning of exploratory demolition (right).

brane flashing was not integrated into the downspouts nor formed into end dams. Water that entered the integral gutter had free range to migrate through open seams or out the ends of the gutter and flow past the membrane flashing. Because the gutters were positioned inboard of the cladding, water saturated the gypsum sheathing and fiberglass insulation. Unfortunately, the long-term leakage had also created the perfect microclimate for uninhibited mold growth, an intolerable condition at a medical facility (Figure 4). In addition to the hard costs of the repairs, the facility is also challenged with hazardous-material abatement, infection-control requirements, negative publicity in the local community, and a significant impact on the daily lives of the residential patients.

Permanent repairs to the existing gutter construction were not feasible. Solutions involving modification of the design and reconstruction of the integral gutter were explored but ultimately rejected by the project team. The preference was to remove

the integral gutter system entirely. As part of the roofing and cladding replacement project currently under construction, the integral gutters will be removed, the eave structure extended, and commercial-grade hung gutters installed at the roof edge, outside of the plane of the exterior wall.

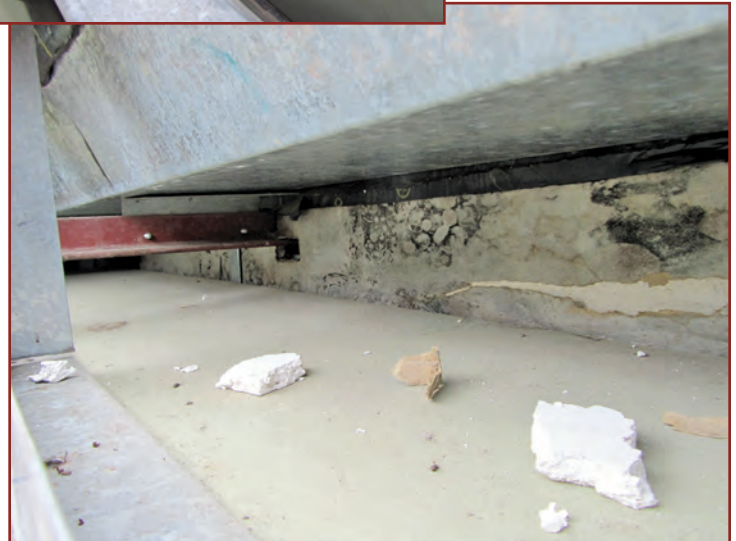
Figure 4 – Mold growth and damage to wall components under and behind integral gutter.

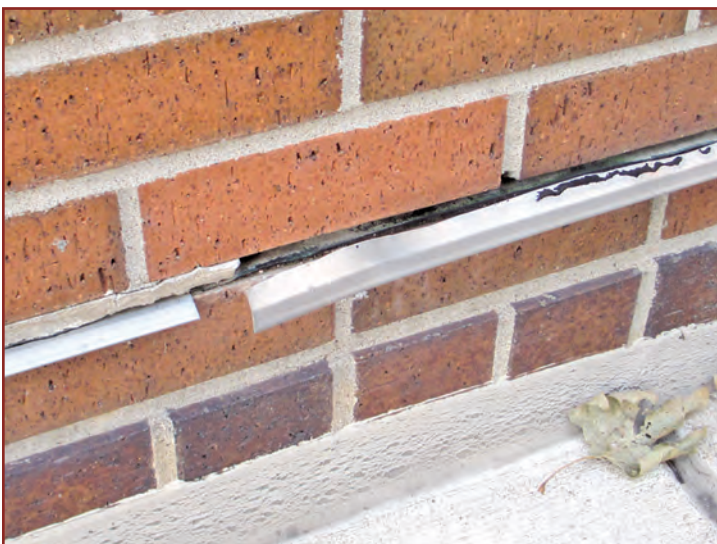
Figure 5 – Fake drip edge inserted into the joint. The contractor must have forgotten to install the stainless steel drip.

sure. Any professional working in diagnostics or renovation can readily call to mind a dozen recent projects where improper or inadequate flashing was unequivocally associated with water infiltration, and through-wall flashing is a notorious offender. In our practice, we regularly provide third-party quality assurance review—sometimes called building enclosure commissioning—for new construction during the design phases. Comments that can consistently be applied to these projects invariably involve through-wall flashing, with particular reference to the necessity of an exposed drip edge (Figure 5).

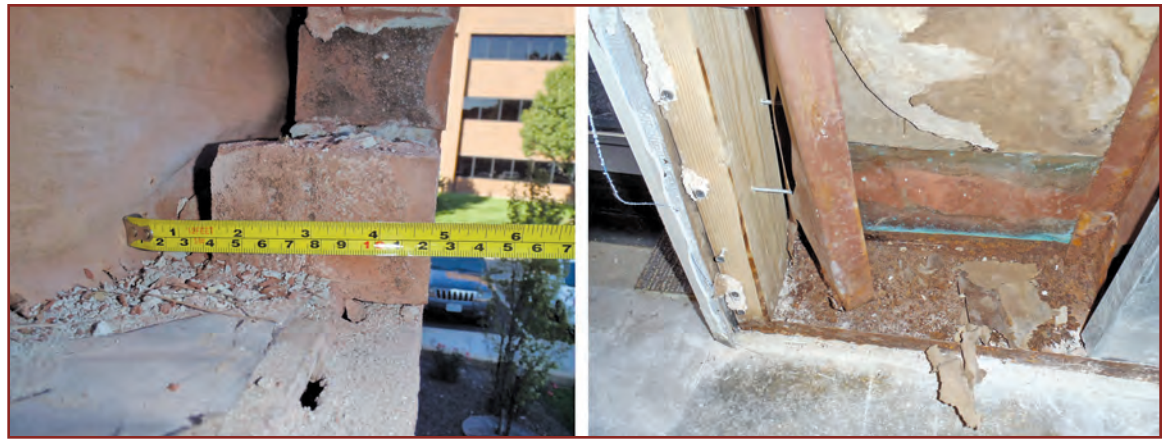
Figure 6 – No drip edge at existing flashing (left) allowed water to saturate the exterior walls (right).

incurring unbudgeted remediation costs. As interior finishes were removed to assess the extent of the mold, the project team came to the realization that the moisture infiltration that facilitated the mold growth was a global issue. Destructive evaluation at numerous places across the interior and exterior revealed a number of deficiencies in the existing flashing at shelf angles and the foundation—most notably, the short horizontal leg of the flashing and the lack of a drip edge to direct water out of the cavity.

Long-term water leakage had also severely deteriorated the gypsum sheathing and metal wall studs at grade (Figure 6).

The project team was in complete agreement that installation of a new flashing system at all façade locations was a necessary action. Repairs of this nature are exceedingly expensive and very disruptive, requiring removal of at least four courses of brickwork to access flashing locations. Noise and dust are always troublesome, and sourcing replacement brick units that

to be successful. Although the project team had settled on the scope of remedial work, one component of the proposed flashing repairs was only hesitantly adopted: our recommendation that the new flashing have an exterior drip edge.

For flashing repairs, our typical approach involves a multi-ply membrane flashing with a stainless steel drip edge that extends beyond the face of the masonry. Resistance to a daylighted drip edge is a common response from architects and clients, the concern being that the exposed drip edge will be a visual disturbance. Various workarounds to daylighting the drip edge have been proposed: terminating the flashing at the face of the masonry, turning the flashing edge back into the joint, and even concealing the edge of the flashing behind mortar or sealant with the false assumption that the weeps will provide sufficient drainage (Figure 7). None of these alternate drip designs fully address the fundamental need for flashing to physically isolate liquid water within the wall system and force that water to exit the wall.

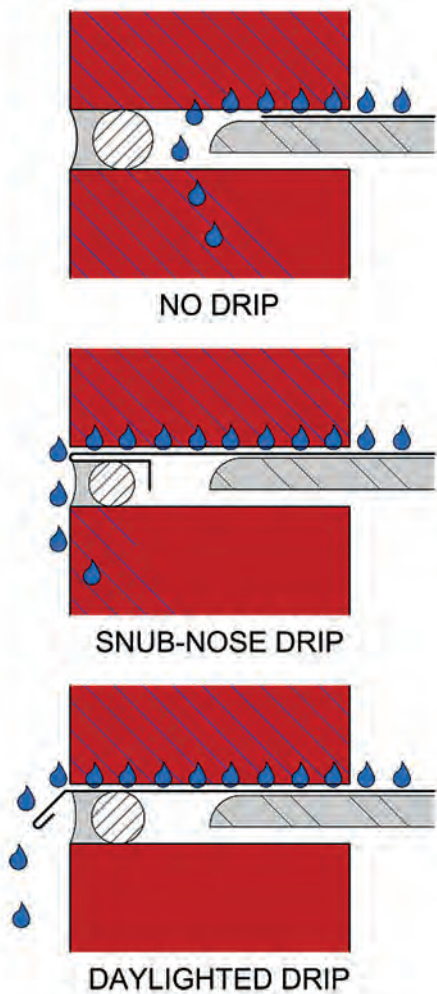
Figure 7 – How the design of the drip edge impacts the shedding of water from the wall system.
