REROOFING PROJECTS FOR HERITAGE BUILDINGS AND DAMAGED MASONRY:

Is There a Connection?

BY PAUL JEFFS

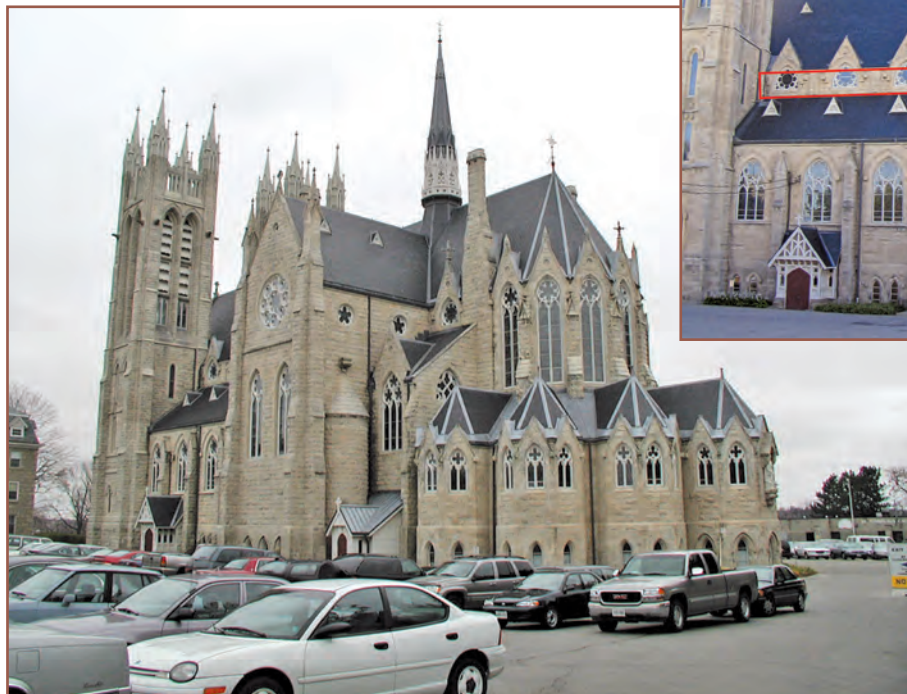
Figure 1 – Bowing of upper portions of the clerestory walls was first observed about ten years ago.

The first example is a 19th-century church in Ontario (Figure 1). About ten years ago, cracks were first observed within the interior of the church at the ends of the upper (clerestory) nave walls. Later investigations using 3-D laser scanning techniques from both the interior and the exterior revealed that the center upper portion of the clerestory walls bowed outward some two or three inches (Figure 2).

The possibility that the bowing of the walls could have been an ongoing progressive phenomenon naturally raised major concerns, particularly since—following an engineering review—it was recommended that consideration be given to reinforcing

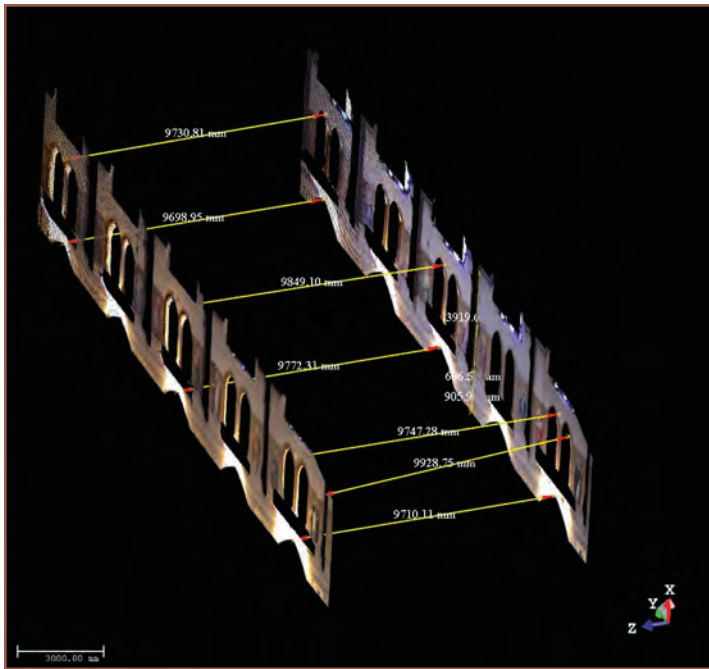
Figure 2 – Computerized illustration of 3-D laser scanning confirming outward bowing.

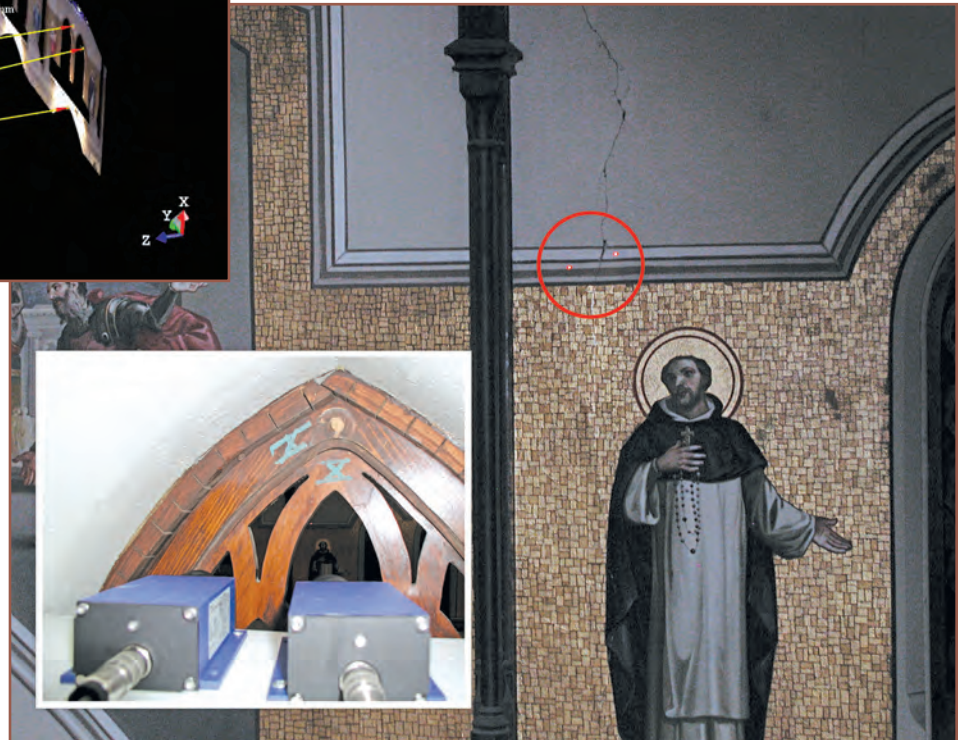
Figure 3 – The red circle highlights laser dots from two of four lasers (inset).

Displacement-measuring lasers were therefore installed at either end of one of the clerestory walls, directed across the nave at the opposite wall, and set to record measurements every four hours to a data-logger (Figure 3). A temperature sensor was also installed on the exterior of the church. The data gathering continued over almost one year, after which the results were analyzed (Figure 4). These confirmed that, although

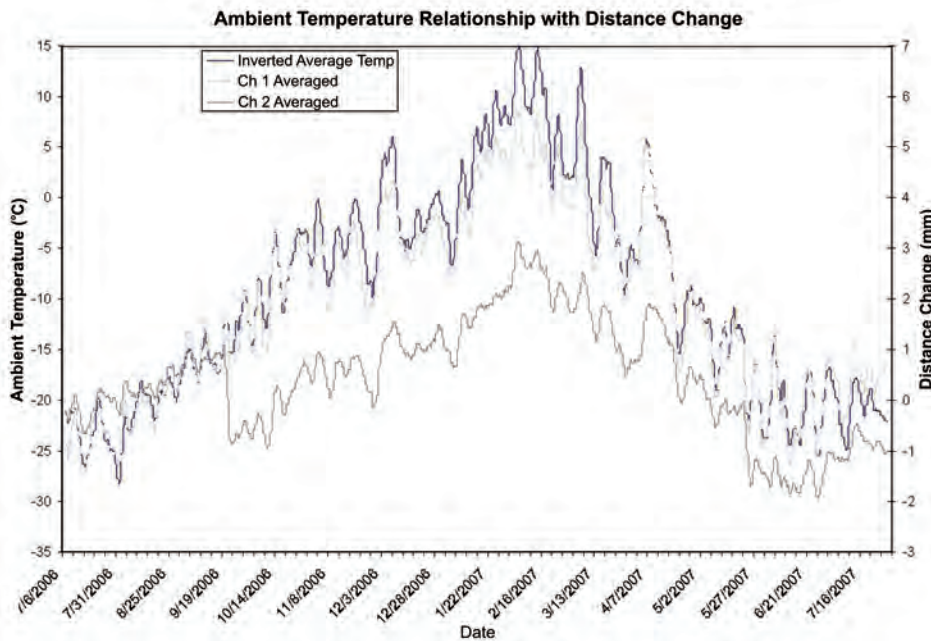
the walls moved outward at the center a maximum of just over a quarter of an inch between the warmest and coldest times of the year, this movement was fully recovered at similar temperatures.

two years ago, the walls moved outward about another quarter of an inch—but only after the slate was installed, and this displacement was not recovered. It is also interesting to note that the new slate had a more uniform nominal thickness than the slate used in the 1990s, thereby somewhat increasing the load on the walls.

Figure 4 – The data gained over one year confirmed that the bowing of the walls was not progressive.

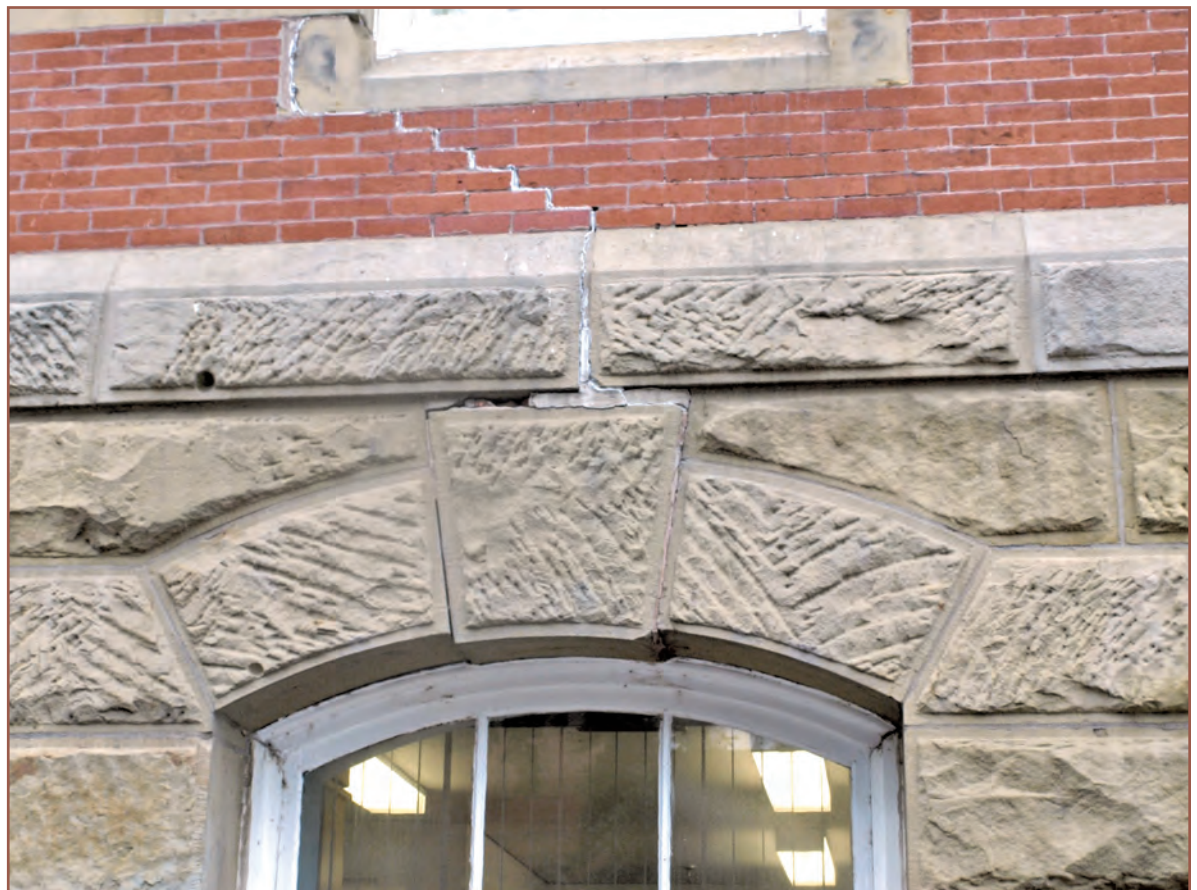
The second example is an 1870s municipal building situated in Eastern Canada that had suffered extensive cracking of its masonry. Over the years, attempts had been made to repair the cracks, but each time they reopened or more cracks had occurred (Figure 5). Finally, a comprehensive investigation was carried out to identify the factors likely to have contributed to the damage; a restoration strategy was appropriately developed; and, during 2010 and 2011, phased restoration work was begun.

The earlier investigation included the use of ground-penetrating radar—a nondestructive testing technique that confirmed a considerable number of voids had occurred within the inner core rubble of the traditional mass masonry foundation walls. The voids were considered most likely to have been the result of water infiltration through deteriorated joints—particularly since it was known that flooding of the nearby major river had occurred over the years. In addition, a study of the building's basic design confirmed that the lintels across windows did not extend beyond their jambs, thereby concentrating gravity loads immediately within the masonry on either side of the openings. These two factors most likely

Figure 5 – Example of just one area of cracked masonry, together with a dislodged keystone. Note the failure of the previous repairs.

contributed to the development of overload conditions within the exterior-wythe portion of the masonry, resulting in the cracks.

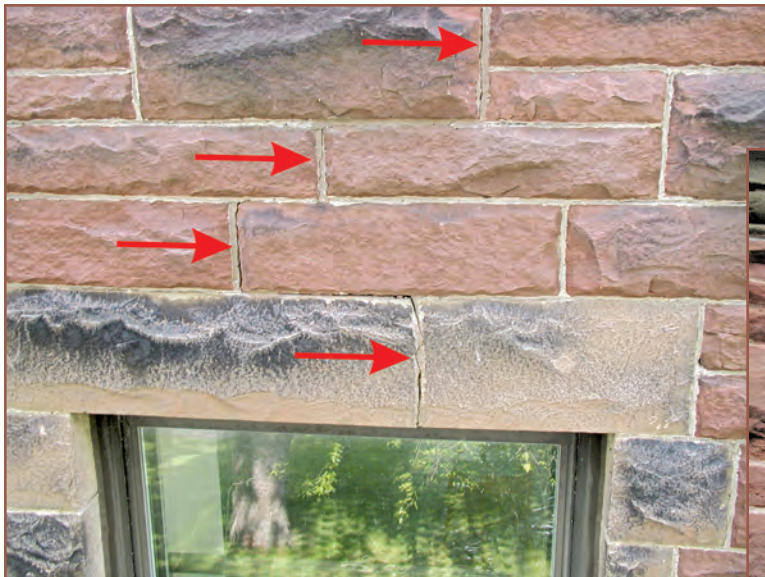
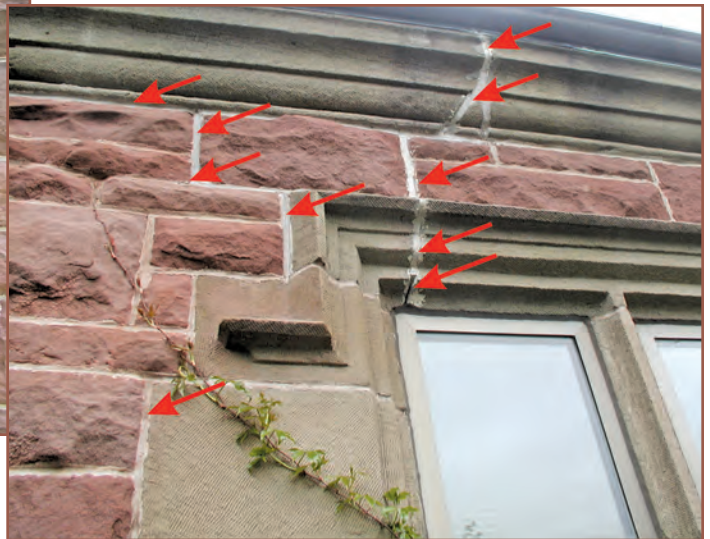
Figures 6 (left) and 7 (below) – Both of these buildings experienced extensive cracking following reroofing projects. Note the lintels rest only on the jambs. The building in Figure 6 also had hidden voids within its foundation walls.

determined to have occurred after reroofing had taken place to replace aging slate with asphalt shingles (Figures 6 and 7). Although both buildings had lintels that did not extend beyond their window-opening jambs, following ground-penetrating radar investigations,

only one was determined to have hidden voids within its foundation walls.

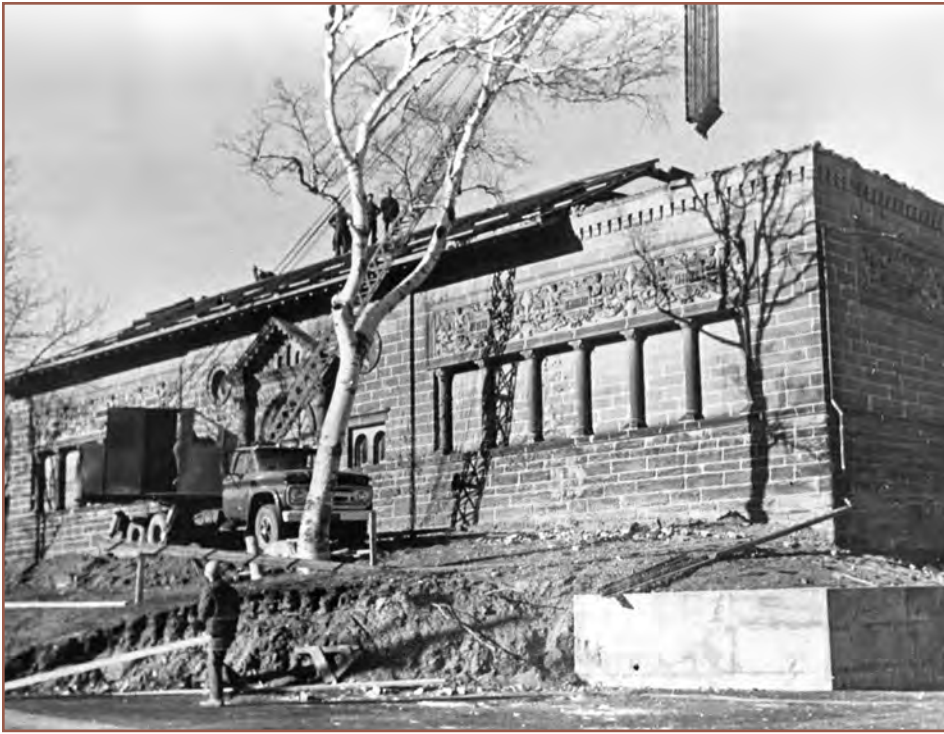
Figure 8 – In 1971, the roof of this building was removed and replaced with a redesigned structural steel superstructure.

The final example—also in Eastern Canada—is an early 1900s art gallery and museum that underwent total roof reconstruction work during 1971, when its use was changed from a university fine-arts faculty building (*Figure 8*). Later, extensive

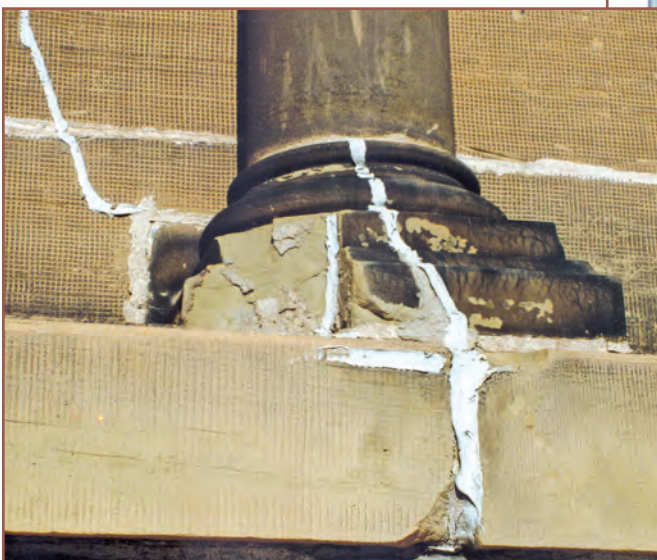
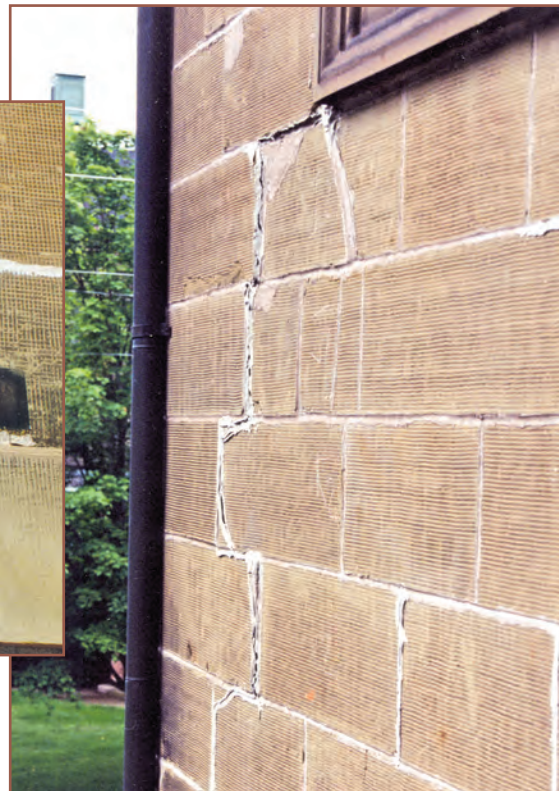
cracking of columns and masonry units became evident (*Figures 9 and 10*). The damage was unsuccessfully repaired on several occasions over the years, but it was only during recent investigations that the primary cause of the damage was discovered: The steel stub columns connecting

Figures 9 and 10 – Extensive cracking occurred after roof reconstruction work and many attempts at repair were carried out.

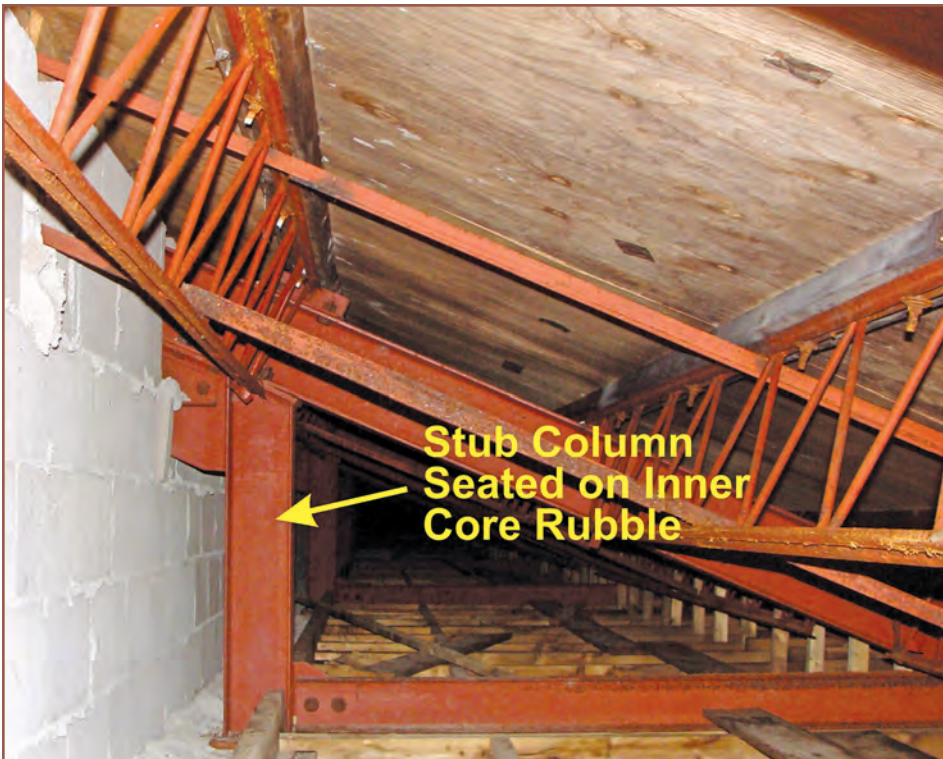
the roof structure to the masonry had been located directly over the inner-core portion of the walls (*Figure 11*). As a result of this inappropriate hidden detail, excessive gravity loads had been transferred to the exterior wythe of masonry rather than being uniformly distributed across the full masonry assembly.

Figure 11 – The hidden-from-view culprit was found to be the location of the steel stub columns.
