Entrapped Moisture...

But This Is a LEED® Gold Building!

By Remo Capolino, RRC, PE

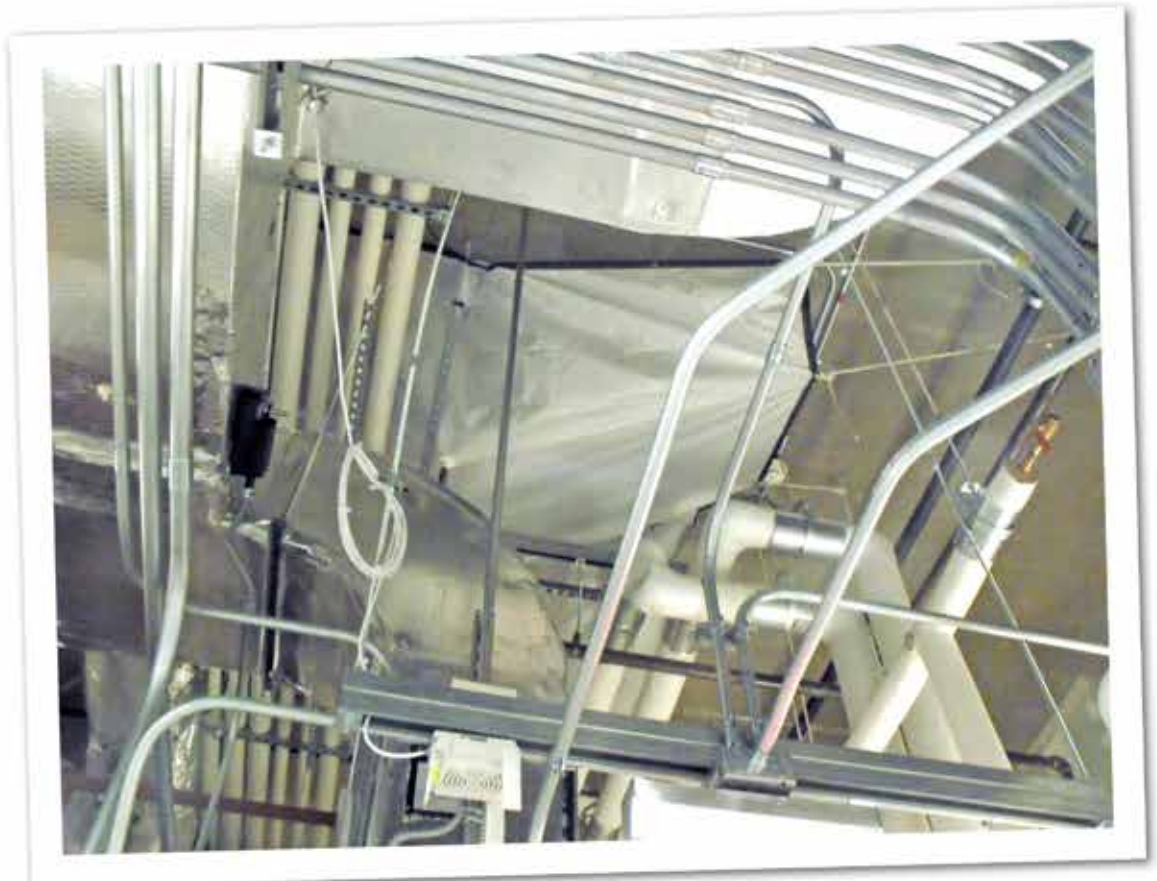
The building in question is a multistory LEED® Gold educational building on a university campus in the Northeastern United States. The structure was completed circa 2006, and the top floor is a very congested, warm, mechanical floor (Figure 1). The roof deck is a 14-in.-thick concrete slab covered with iso insulation that tapered from 1.5 to 9 inches, with all layers set in foam adhesive with a fully adhered, fleece-backed, reflective, white, single-ply roof membrane that, of course, utilized a water-based, low-VOC, LEED®-friendly bonding adhesive. The roof was relatively free from penetrations, with the exception of a few roof curbs, vent

Figure 1 – Overview of congested mechanical room space directly below the roof deck.

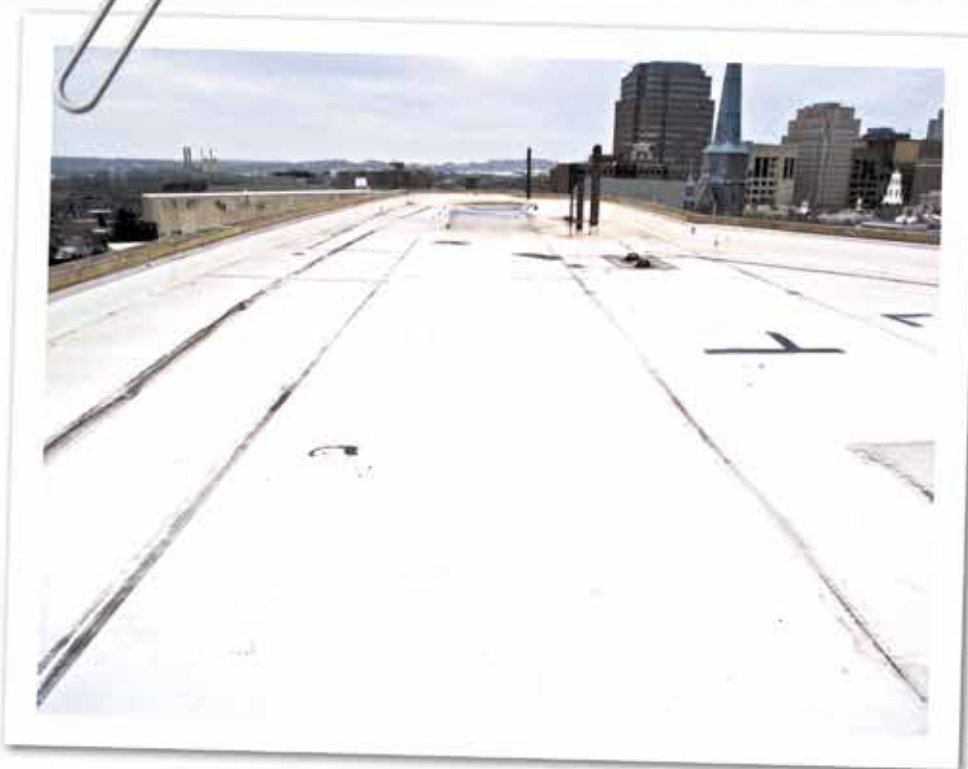
pipes, and, of course, roof drains (Figure 2).

Figure 2 – Overview of roof.

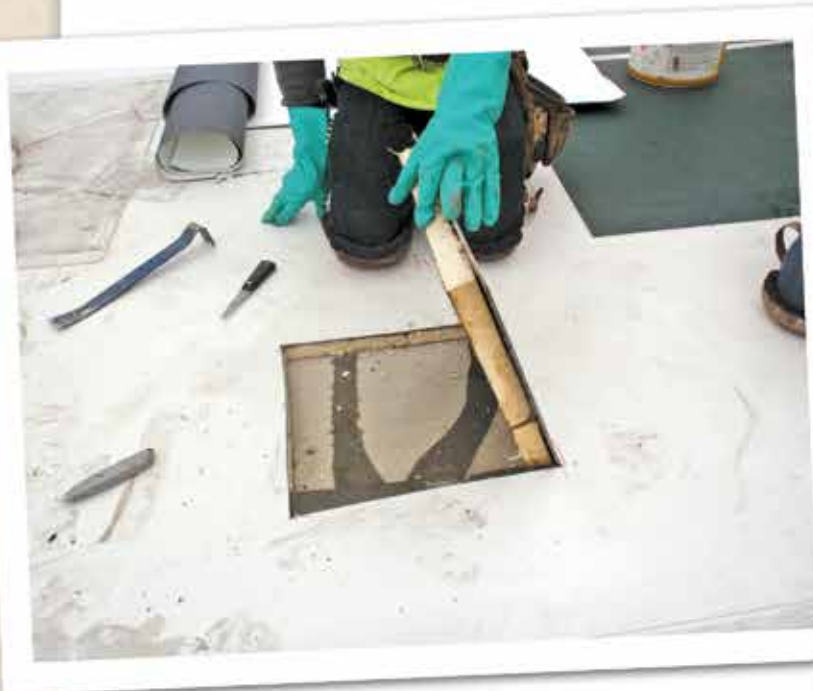
At areas where the insulation was thin, the conditions of the insulation and membrane were similar: The single layer of insulation was debonded from both the concrete deck and the single-ply membrane. The mode of failure at both sides of the insulation board was a cohesive failure of the iso board fiberglass-reinforced paper facers (*Figures 3 and 4*). At locations where the insulation was a single layer, organic growth was observed at varying degrees (from moderate to complete) on the paper facer of the insulation board (*Figure 5*).

Figure 3 – Cohesive facer failure. Note facer material on adhesive ribbons on deck but no foam core visible.

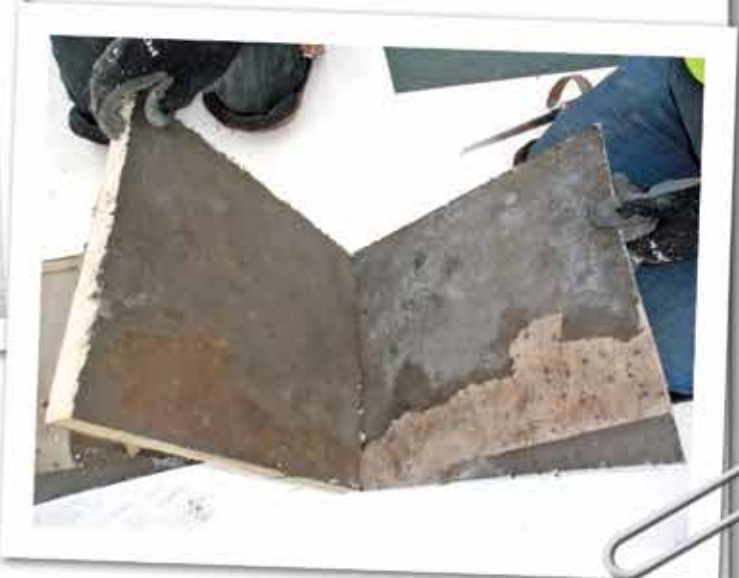
Figure 4 – Mostly (80%+) cohesive failure of facer with remnants of facer on iso board and bottom side of fleece-backed membrane.

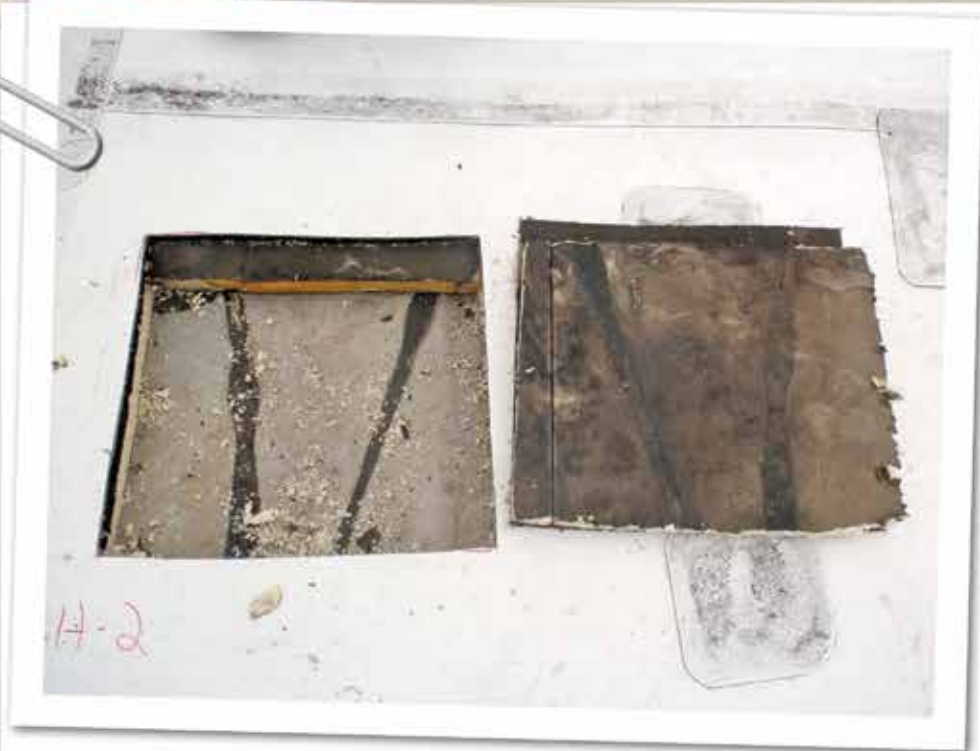
Figure 5 – Organic growth on bottom facer

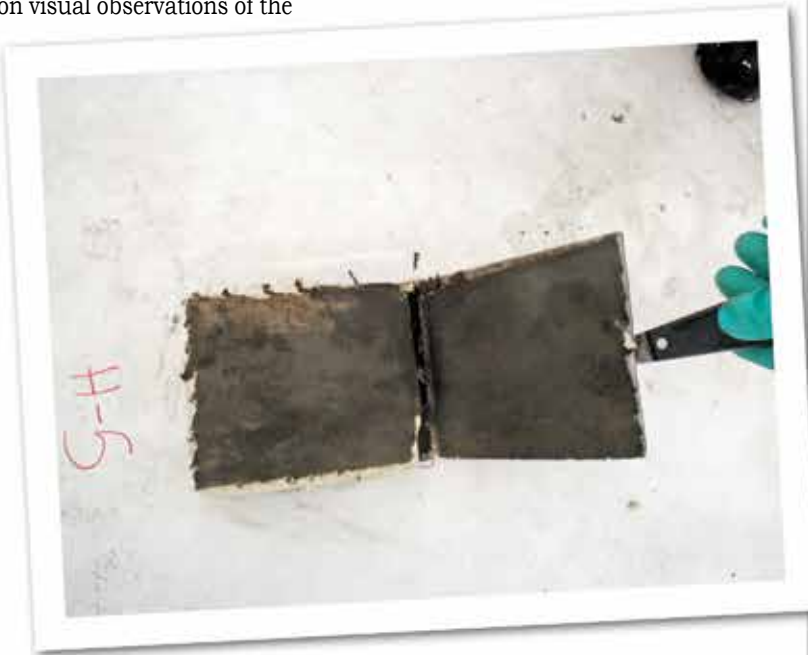
boards were well bonded to the concrete deck. The bond, however, between the single-ply membrane and insulation had failed, with the mechanism of failure being cohesive failure of the insulation paper facer (*Figure*

6). The interface between the top layer and underlying layer of insulation was inspected, and no adhesive was found; however, signif-

Figure 6 – Cohesive failure of iso board top facer, leaving facer remnants on iso board and fleece-backed membrane.

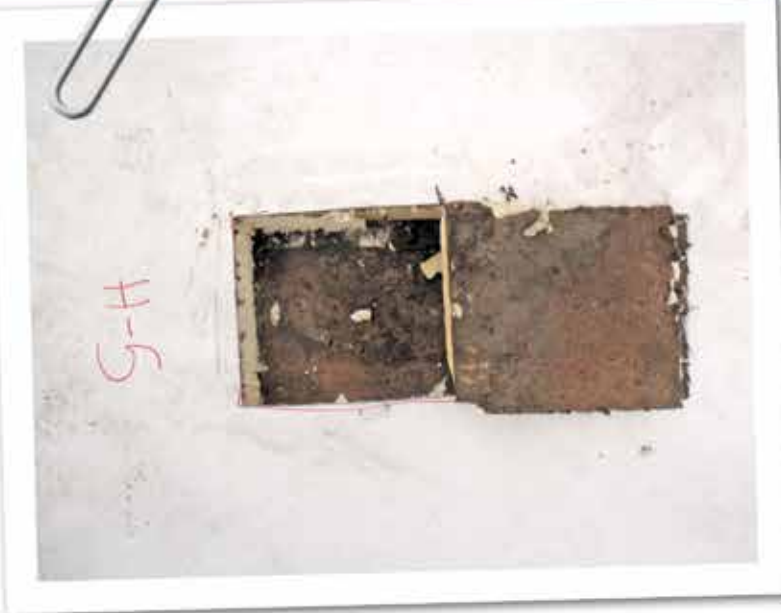
icant organic growth was noted on both paper facers at this level (*Figure 7*). To summarize, the failures observed at the areas with three layers of insulation were similar to the areas with one layer of insulation, in that cohesive insulation facer failures were noted in the top insulation layer and significant organic growth on the paper facers was also observed.

Figure 7 – Organic growth on iso facers.

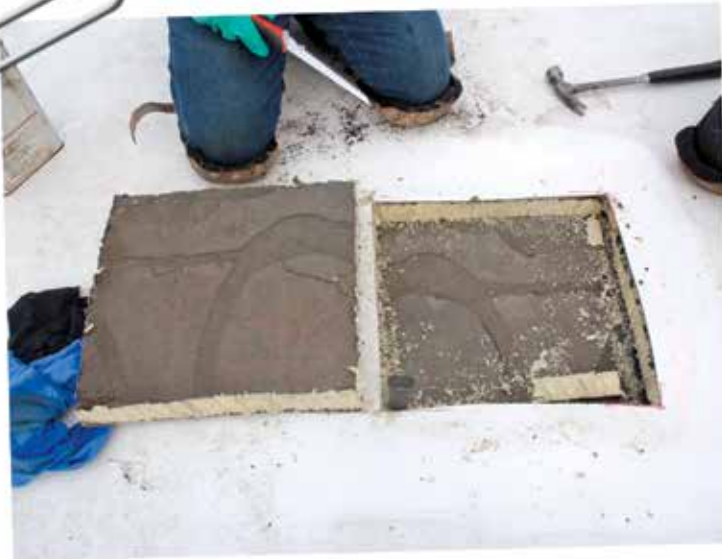
A condition of interest after laboratory testing was the mode of failure of the insulation boards during removal from the roof. The boards were adhered; however, forced removal resulted in cohesive failure of the iso facers and did not cause the facer to peel off of the foam core (Figure 8).

Figure 8 – Removal of insulation at area with several layers. This appeared dry when compared to areas with a single layer. Note removal of top insulation board resulted in cohesive failure of facers.
