Risks of Roofing Over Concrete Decks

By Joe Schwetz

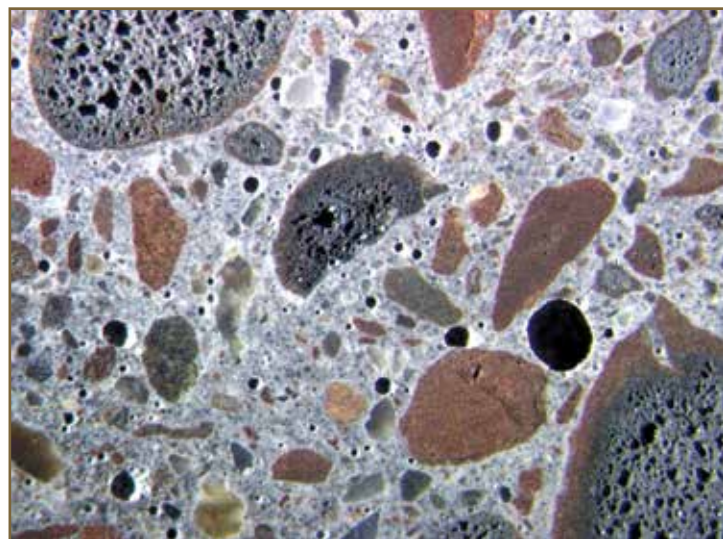
Photo 1 – Micrograph of lightweight concrete with expanded shale aggregate (compliments of SGH).

The LWSC can achieve the low “in-place” densities by using a lightweight porous aggregate containing air voids. The most common aggregates used in LWSC are expanded shale slate, slag, or clay. The materials are processed at very high temperature (2000°F) in a rotary kiln. These aggregates have a textured surface, a network of internal pores, and absorb relatively large amounts of water (*Photo 1*).

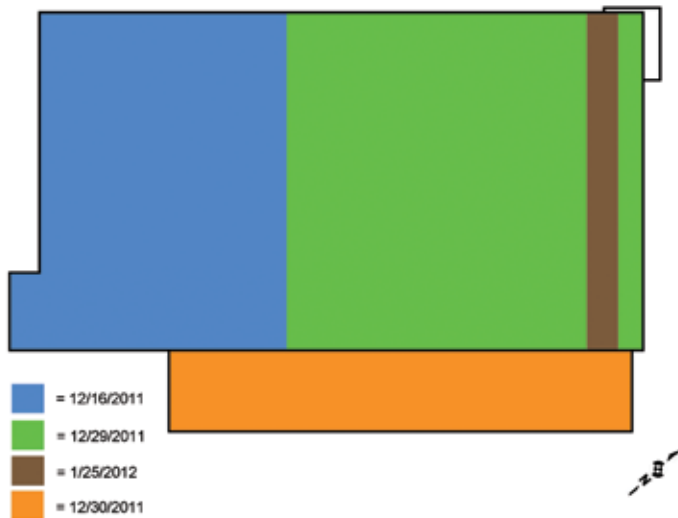
Figure 1 – Dates for the new concrete roof deck pours for Case Study 1.

The roof deck was poured in four sections on December 16, 29, and 30, 2011; and January 25, 2012 (*Figure 1*).

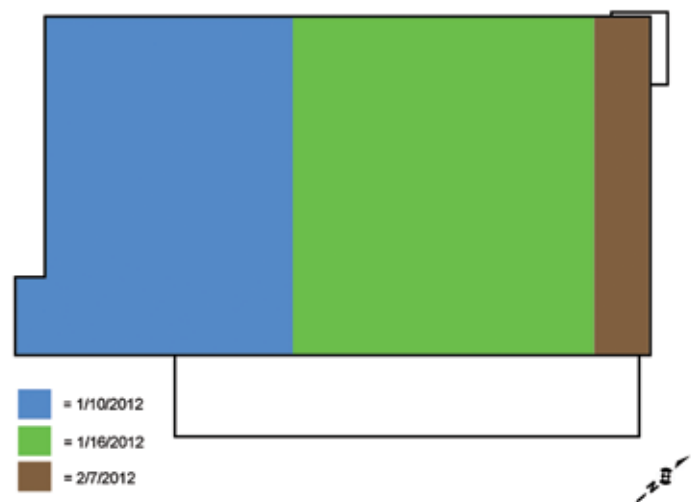
Figure 2 – Dates for the installation of the self-adhered vapor barrier, Case Study 1.

acceptable temperature installation range for the vapor barrier). (See *Figure 2*.) The roofing project reports state that the concrete was visibly dry and the GC, roofing contractor, and FM Global representative witnessed and accepted the adhesion testing of the vapor barrier to the concrete deck. According to the project records, on the south section of the roof, the initial concrete pour was exposed for 25 days, and the north sections were open for 12 to 18 days.

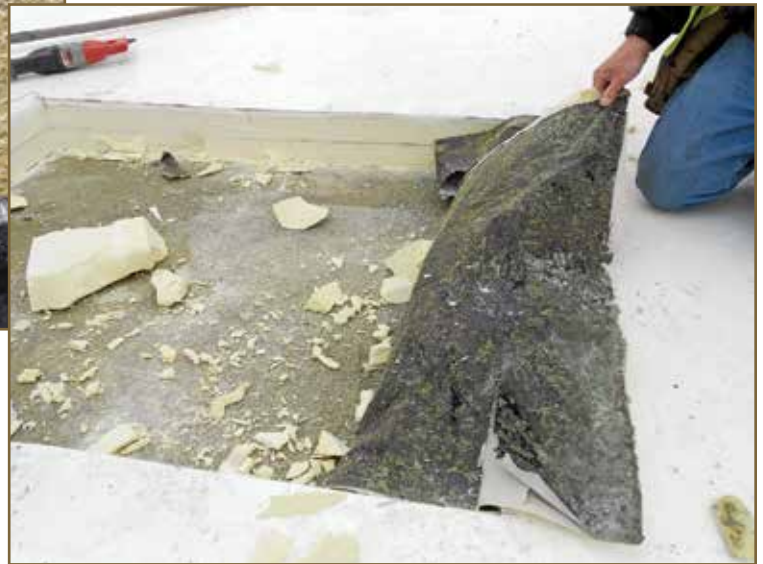
Photo 3 – Removal of adhered vapor barrier from primed concrete deck.

On February 15, blisters were seen under the adhered vapor barrier. Test cuts showed moisture and standing water on the deck (*Photos 2, 3, 4, and 5*). An additional 12 test cuts were done on February 23, with nine test cuts showing moisture and standing water between the vapor barrier and the concrete deck (*Figure 3*). At this point, the project was shut down, and accusations and blame for the presence of the water started, followed by claims that the products and/or the workmanship were at fault. The GC refused to share the construction documents, specifically for the concrete floor and roof deck applications. He did state that the concrete was a “normal-weight structural concrete.”

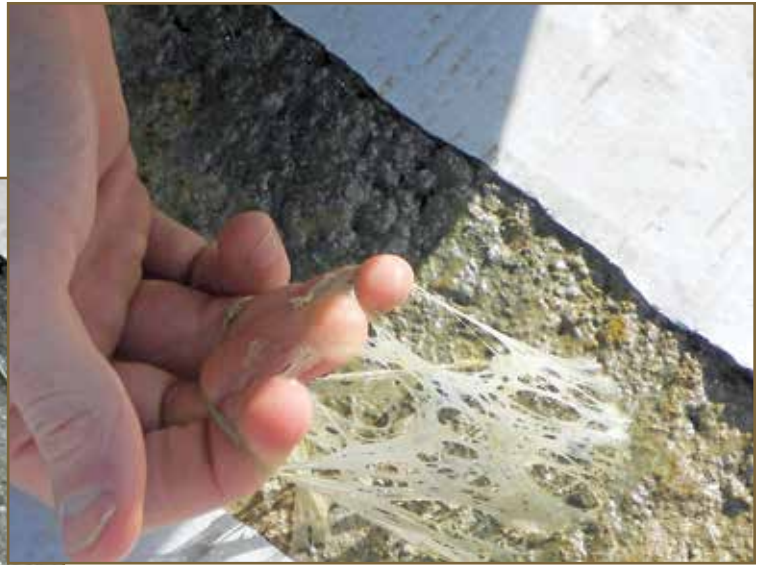
Photo 4 – Moisture on the deck; minimal primer.

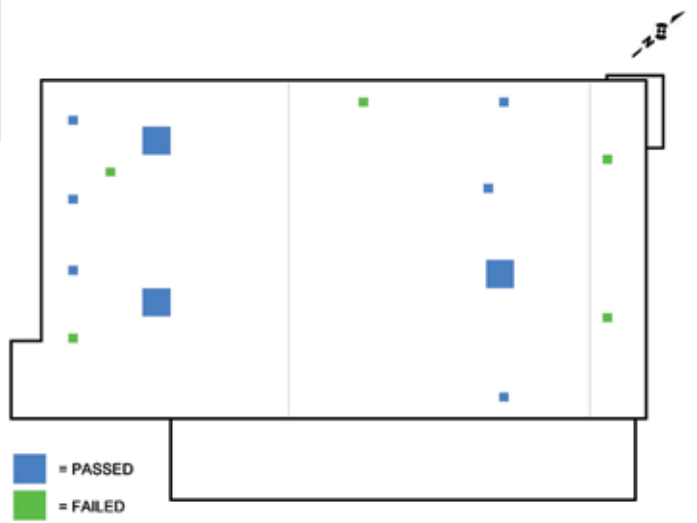
Figure 3 – Field-testing of the self-adhered vapor barrier, Case Study 1.

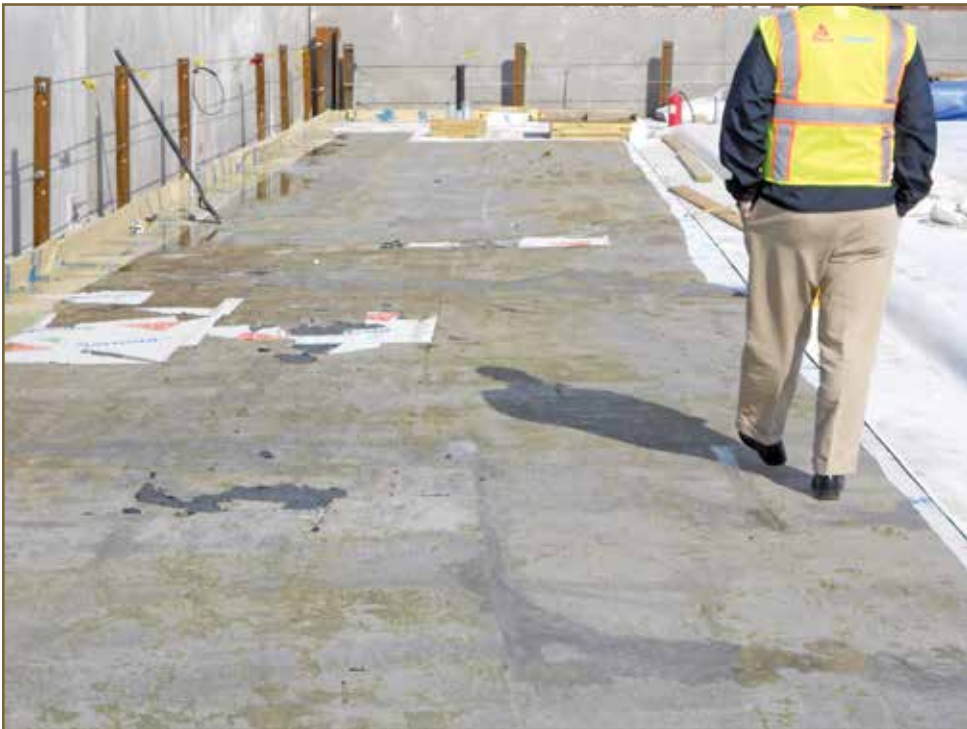
Photo 6 – Roofing removed from the perimeter.

The self-adhered vapor barrier sheeting was removed from the entire 20-ft.-wide perimeter on February 23. The exposed deck was left to surface-dry (Photo 6). On March 5, pull testing was done on new self-adhered vapor barrier to the primed deck. The first test failed within the urethane adhesive foam due to inadequate cure time. The other five assemblies all showed very good pulls, with the readings between 645 and 1,185 pound force—well above the calculated design uplift load of 28 psf for the wind uplift pressure. During this site visit, the GC did acknowledge that the interior of the building was heated to a constant 70° to 75°F temperature to allow the intumescent paint to dry.

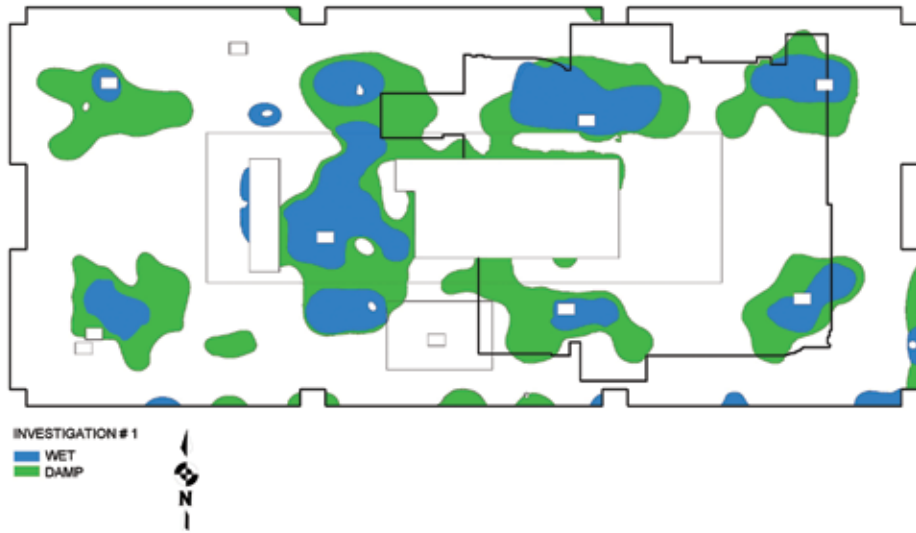
Figure 4 – Initial area of moisture in the roof system and replacement (Case Study 2).

The construction team identified areas of the roof to be replaced (approximately one-third of the total area), which was done during the late summer and early fall of 2008 (Figure 4). It appears that most of the areas identified as wet/damp from the nuclear scan were replaced (heavy black lines on Roof Plan 4). Project records indicate not all of the identified damp/wet areas were replaced, primarily at the west end of the building. At the completion of the rework, 11 test cuts were done by a third party to determine the condition of the roof assembly; the cuts are designated by the orange dots on Roof Plan 5. Based on the report, all test cuts indicated the roof system layers and concrete deck to be dry, including the west end of the building where there was no product replacement (Figure 5).

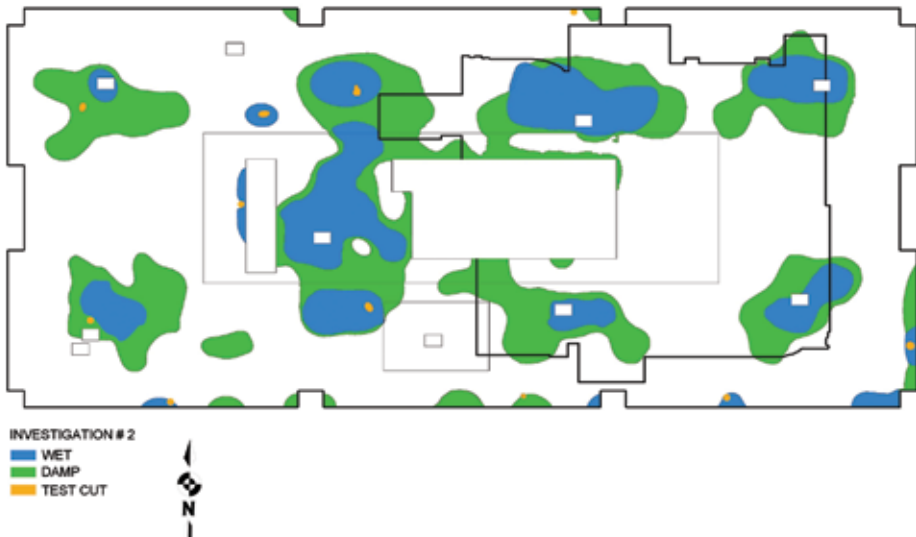
Figure 5 – Test cuts indicating all areas of the roof to appear to be dry (Case Study 2).

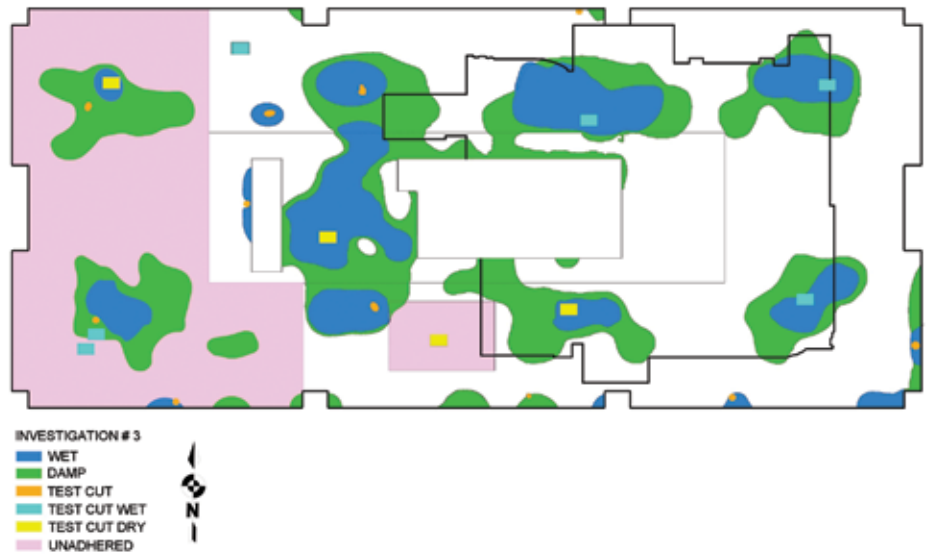
Figure 6 – Field evaluation with test cuts indicating the movement of the moisture within the system at Case Study 2.

replaced with new insulation and membrane had three areas that showed wet conditions (Samples 6, 7, and 9). The roof system was thoroughly checked to see if there were any breaches or possible entry points for the water, and none was found

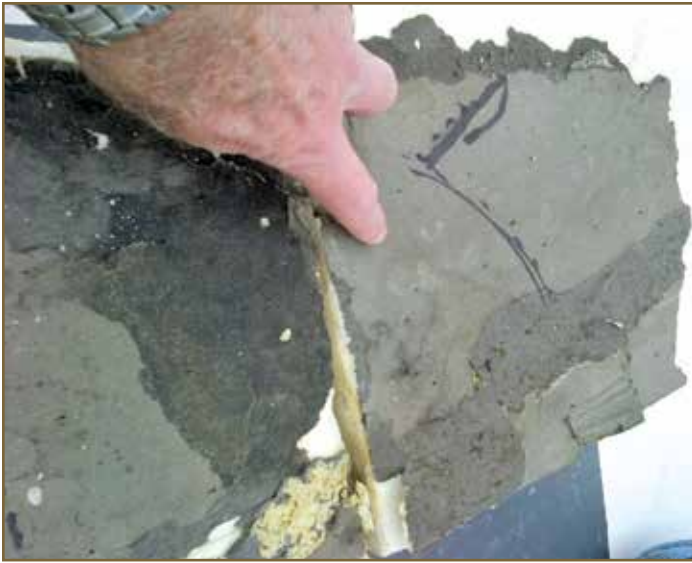
Photo 7 – Moisture underneath the bottom layer of iso.

the roof system was able to move between the roofing components and along the concrete deck, aided by hydrostatic pressure (Photos 7, 8, 9, and 10). After the water test, the water in the system has to travel around the insulation boards as well as the ribbons of urethane adhesive. The adhesive ribbons that were on the concrete deck most likely trapped some of the water in the U-shaped application pattern. The records indicate there were areas where the insulation was not removed and replaced for up to three months. It is also unknown if all of the wet or damp insulation was replaced. Comparing the nuclear scan results with the 2012 test cuts that were taken in the designated replacement zone (Samples 6, 7, and 9), these test cuts should have been dry. An unanswered question: Is the original insulation still in place (which can explain the results), or was it replaced and moisture migrated toward these areas? With the wet insulation and water in contact with the concrete deck for up to three months, a portion of this excess water soaked into the concrete deck.

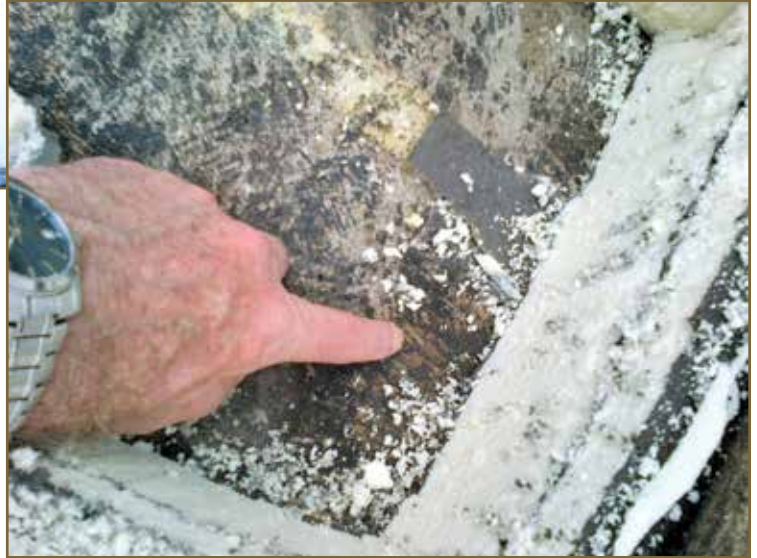
Photo 8 – Moisture on concrete deck.

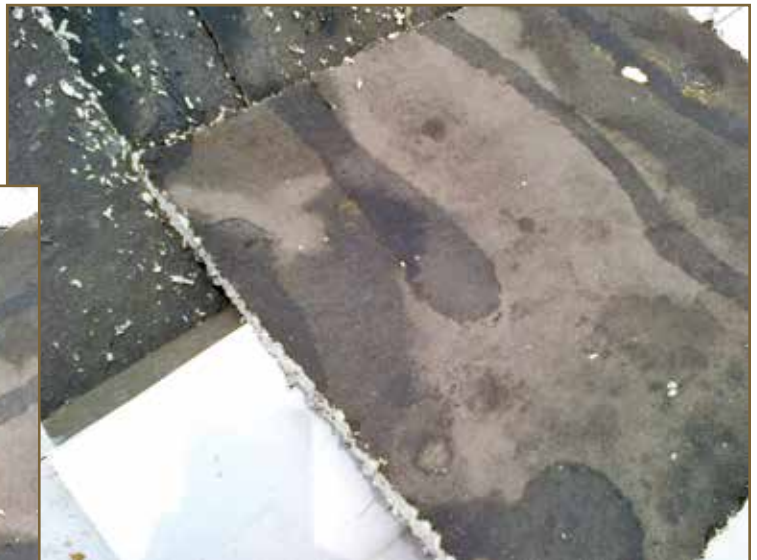
Photo 9 – Moisture between the layers of boards.

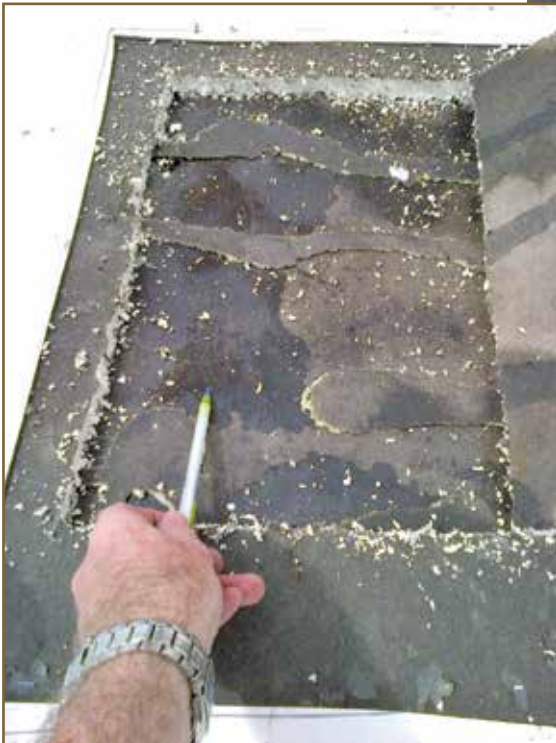
Photo 10 – Moisture between the layers of iso.
