Doing It Right the *Second* Time –

Designing Minimally Invasive, Cost-Effective Solutions for Window Repair vs. Replacement

By David Boyer, Ron Tatley, and Paul Grahovac

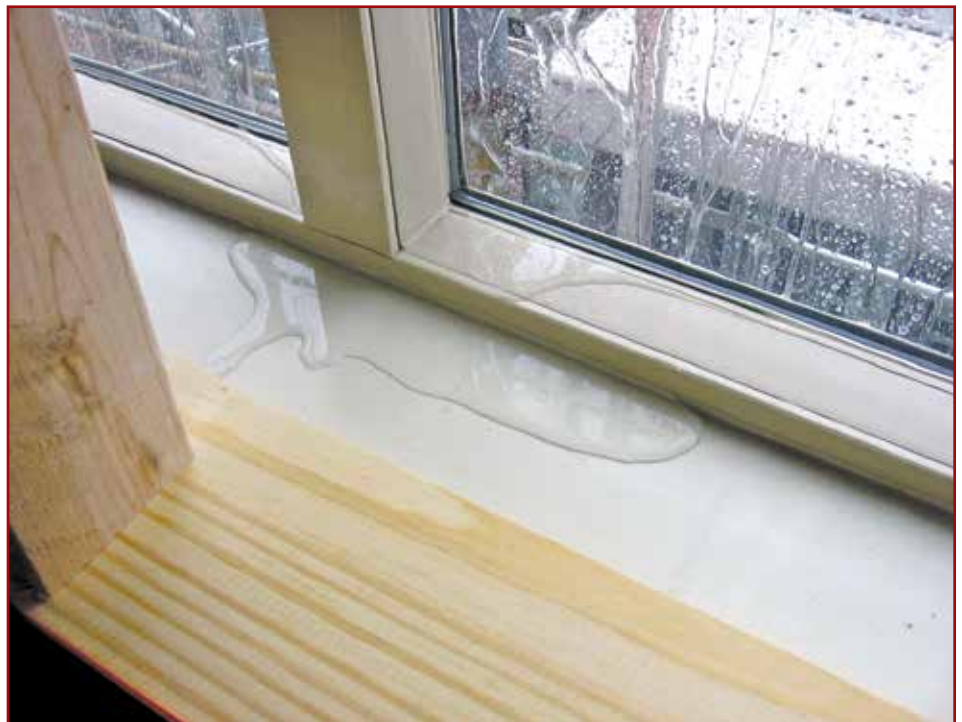
Figure 1 – A puddle beneath the window causes most property owners to suspect windows are leaking. When simple efforts to stop the leakage fail, many surrender to the costly cycle of window replacement.

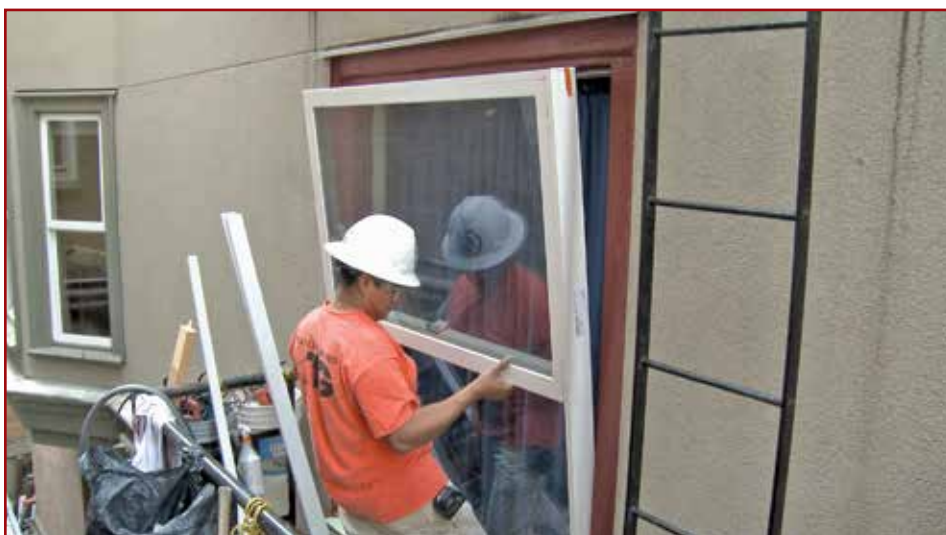
conditions, executing those details under less-than-ideal weather conditions can be challenging. Factor in contractors pressed to stay on tight construction schedules using inexperienced labor and outmoded materials, and it’s easy to understand why a higher number of windows—even better-performing windows—increases the likelihood of water penetration in modern buildings (*Figure 3*).

Figure 3 – Want to know why a window leaks? Install windows.

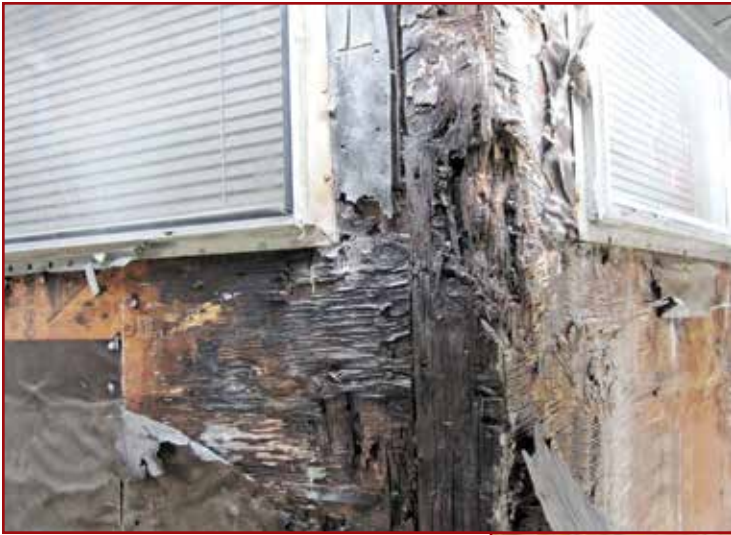
Figure 4 – The leak that got away.

Minor leaks or condensation that may have gone unnoticed just a generation ago now accumulate within rough openings and the adjacent, air-sealed wall assembly. That water causes progressive decay of interior finishes or the structure itself. Once initiated, such water-related decay can quickly snowball out of control and cause mold growth (Figure 4).

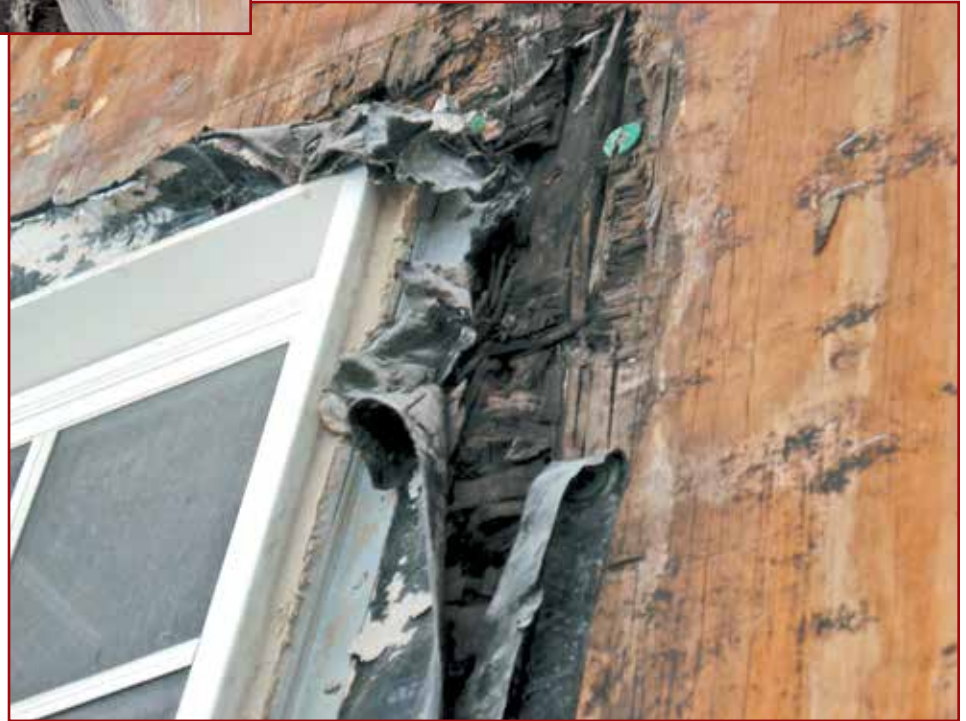
Figure 5 – Perimeter window flashing that performs as an air and vapor barrier prevents drying of water that is trapped or accumulates between the window and the rough opening.

air or rainwater than for their capacity to accommodate drying of water that may be present or accumulate within the walls (Figure 5).

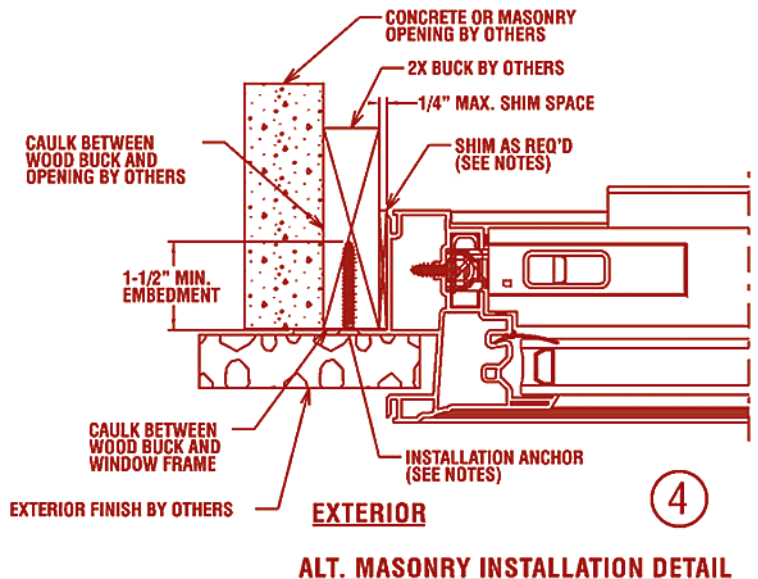
Figure 6 – Popular window installation detail.

On projects in which Tatley-Grund is involved, the rate and severity of window failures caused by a poorly designed marriage between the window assembly and the structural wall are increasing. Either the connections are not continuous, or the materials used to execute those connections are incompatible with one another or incompatible with conditions under which most construction is carried out (Figure 6).

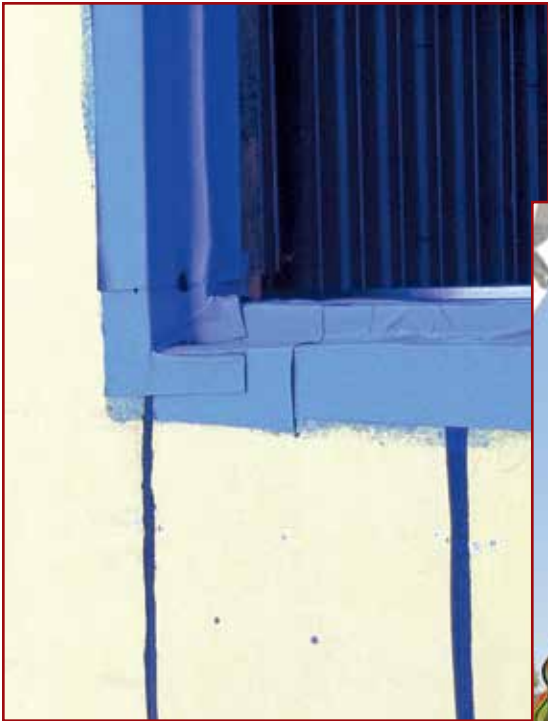
Figure 7 – When using a shingled series of straight and flexible flashing or both to waterproof the rough opening, it is easy to underestimate the impact several layers of thick membranes have on the distance between corners of the rough opening.

While such details seem logical on paper, many are impractical to execute and fail to consider the impact that several layers of thick self-adhering membranes have on the distance between corners of the rough opening (Figure 7).

There is an answer to this problem. Durable, fluid-applied flashing membranes eliminate the need to sequence, measure, cut, prime, crease, and stick layer upon layer of self-adhering flashing tapes to the perimeter and inside corners of rough openings. Formulations exist that tolerate wet conditions, fill cracks, adhere to most building materials without a primer, are immediately waterproof, and allow moisture that may have collected in the wall assembly to dry out due to their vapor permeability (Figure 8).

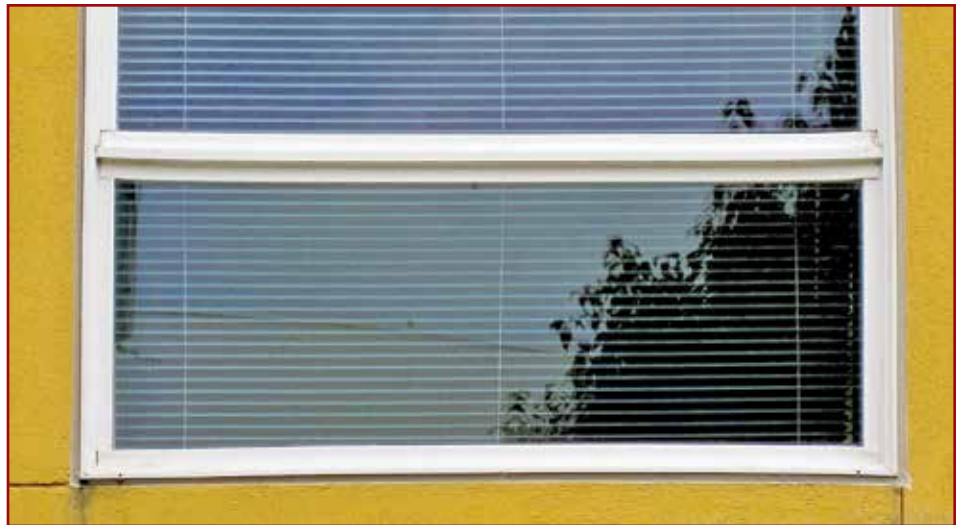
- Deformities in the horizontal mullions caused the glazing beads to exert uneven pressure on the underlying glazing tape. For some windows, glazing beads were cupped sufficiently to channel water into the window assembly, creating another complex pathway for water entry (Figure 14).

Figure 14 – Deformities in the horizontal mullions caused the glazing beads to exert uneven pressure on the underlying glazing tape. For some windows, glazing beads were cupped sufficiently to channel water into the window assembly, creating another complex pathway for water entry.

- Existing glazing beads and glazing tape were removed.

- Individual IGUs were temporarily removed.
- The horizontal mullions were heated to correct deformation.
- The aluminum strongback was bonded and mechanically fixed to

- New glazing beads were installed.
- The interior face of the aluminum strongback was painted to match interior trim.
- Minor damage done to interior finishes was repaired and repainted.

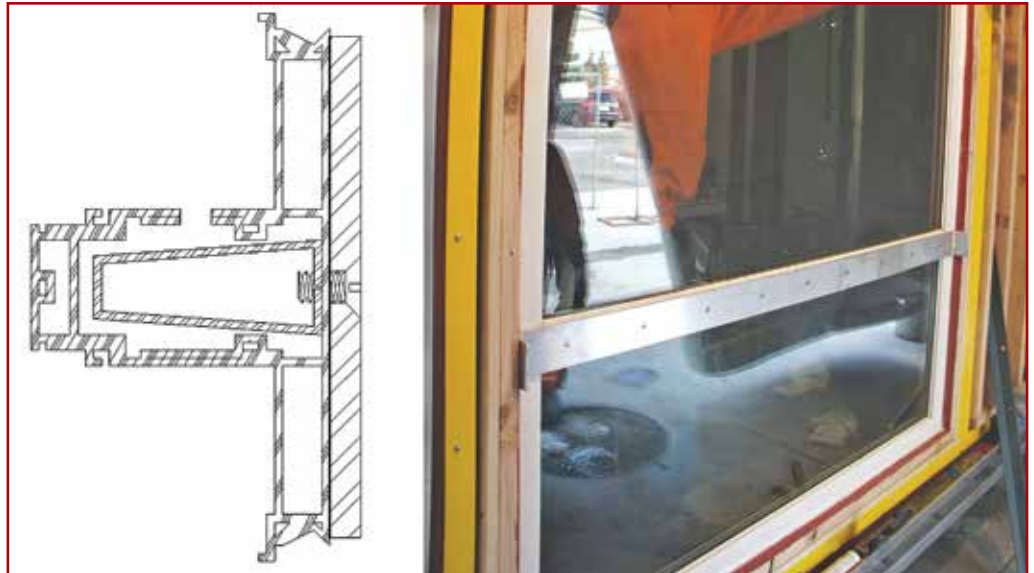
Figure 15 – Once installed on the repaired window, the aluminum strongback was tested and passed at 11.53 in. of water column (2,872 Pascals, 155-mph wind, or 60 lbf/ft²).

The higher test-pressure capabilities of the DVT chamber also made possible the design of an aluminum “strongback” to reinforce the critical horizontal mullions. Once installed, the strongback (*Figure 15*) allowed the repaired window to withstand pressure differentials that exceed the building’s structural design load and all of the window manufacturer’s original performance data... for the first time.

After reinstalling the repaired window prototype in its original rough opening, the baseline field testing described above was repeated. The system then passed.
