Missing Paint and Escargot

By Mitchell Wright, RWC, IACT,
and Robert J. Bitterli, AIA, NCARB, LEED GA

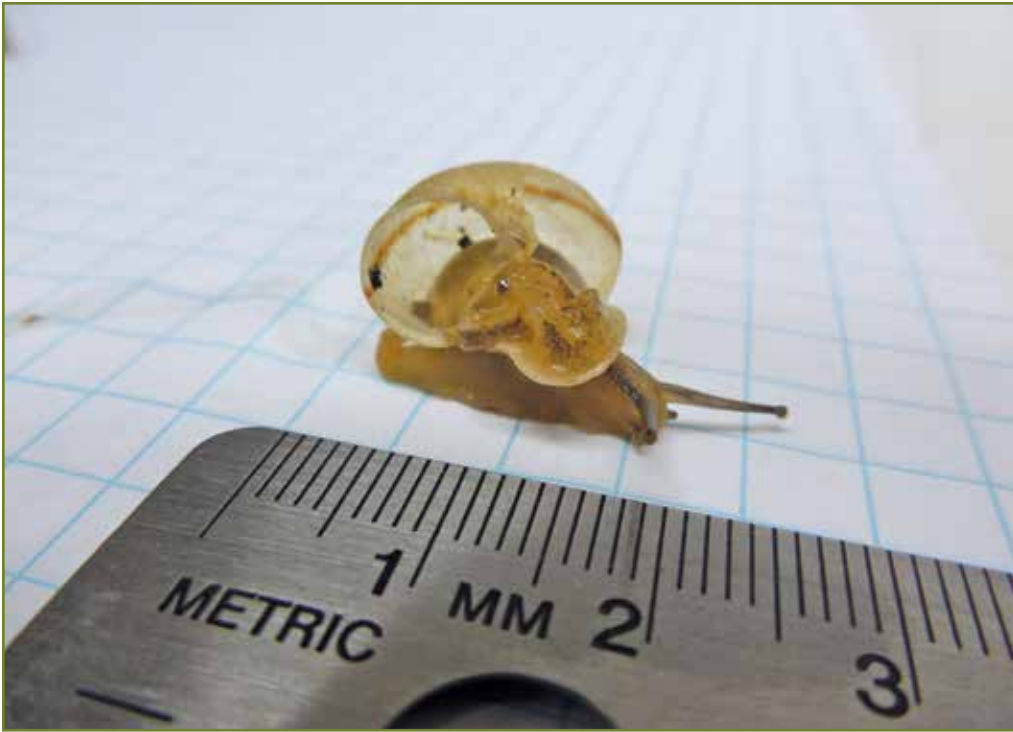
Figure 2 – The Asian Tramp Snail, a.k.a. *Bradybaena similaris*, terrorizing backyard gardens in America since 1939.

With the help of two talented biologists and snail experts in North Florida,² we now know our paint-eating friends as the Asian tramp snail, a.k.a. *Bradybaena similaris*. Terrorizing backyard gardens in America since 1939, this invasive species comes all the way from Asia and has since traveled into Florida. Now, these guys typically feed on soil and foliage—not paint. Something was a-foul here. It wasn't time to break out the garlic and butter just yet. What did these guys like so much about the paint? A little more research would soon answer the question.

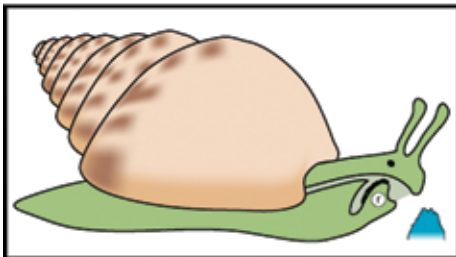
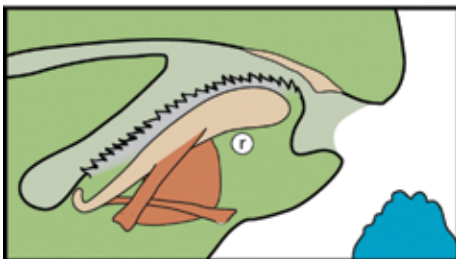
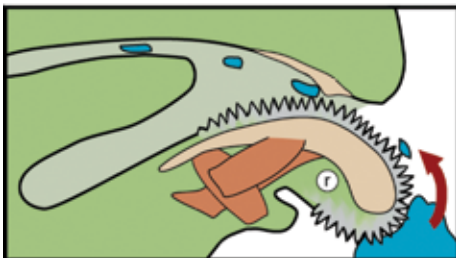
Figure 3 – A horrifying conveyor belt of thousands of tiny teeth. The paint had no chance.

We continued to hunt for some actual living snails, as the shells alone could not have done the damage. Then we spotted the first snail on the lower portion of a column. He was a small snail, observed in his not-so-natural habitat, actually during his feeding time. We caught him red-handed,¹ munching away on that nice new elastomeric paint, soon joined by a few more of the culprits. These guys really seemed to like the paint. It became clear that the hungry snails were causing all of this mischief. At this point we didn't know what kind of snail they were or why they were methodically devouring the paint on these buildings.

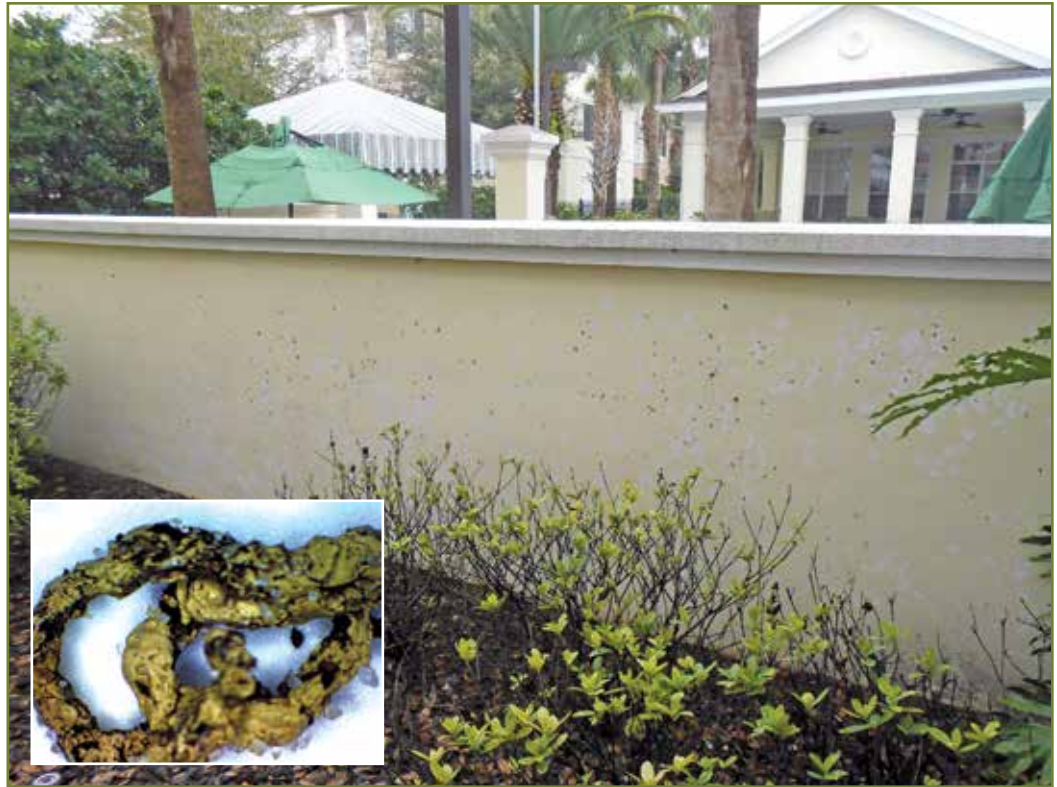
riorated or missing, we always noticed something extra. Small, dark, tube-shaped objects stuck to the surface of the wall—at times, as many as 10 to 15 of these objects within a square-foot area. They were stuck to the painted wall over perfectly painted surfaces. Many were curiously pigmented the same color as the paint. They were very small, so we pulled out our pocket microscopes and loops to get a closer look. Now, hold your breath.

What were we looking at? It turns out that the objects were the excrement of some small animals, colored with paint pigment. But how could this be? Could the painting contractor actually have painted over this much debris? Not according to the consultant's records. These walls were thoroughly cleaned prior to any painting work being started. This residue problem had to have come after the painting was complete. There

Could snails be depositing pigment-laden waste on the walls adjacent to the damaged areas? This stuff was full of undigested paint pigment. It was completely embedded within the excrement of snails that had traveled across these walls, stopping only for a meal and to relieve themselves along the way. The hunt continues.

Something about this paint was attracting the snails, so we began to research the composition to see what secrets it held. What was the delicious ingredient that this paint contained? It turned out to be calcium carbonate (CaCO_3). The paint from the bucket contained 33% CaCO_3 by wet weight measurement; and upon drying, up to 54% CaCO_3 by dry weight measurement. This simple compound, CaCO_3 , an essential ingredient in so many things on our planet (from pearls to eggshells and agricultural lime to antacid) is also the building block for these guys' shells—their homes. Snails typically eat soil and vegetation to get the calcium carbonate they need, but in this case, the paint was much more tasty!

Figures 4 and 5 – The calling card our friends left us with. Inset: Snail excrement at 60x magnification. There is only one way we know of to get paint pigment inside the stomach of an animal.

The snails had clearly overstayed their welcome. So what was the solution? Simple enough: Iron phosphate, a nontoxic snail bait recommended by the local Extension Office to "evict" the unwanted guests. This material would be applied around the perimeters of the buildings as often as needed, essentially acting as both a barrier and a poison to the creatures. That was the first

Only the lower portions of the buildings needed repainting. (The horizontal accent band was heroically acting to deter the snails from climbing any higher up the wall.) And maybe we should try a not-so-delicious paint this time. With the known track record, we selected something that contained none of the goodies responsible for this mess—no calcium compounds to tempt any stubborn snails that might remain after our iron phosphate attack.³
