# THE ROOF REPLACEMENT OF THE JAMES C. COLGATE STUDENT UNION AT COLGATE UNIVERSITY — A Case Study

By Douglas Arena, AIA

## INTRODUCTION

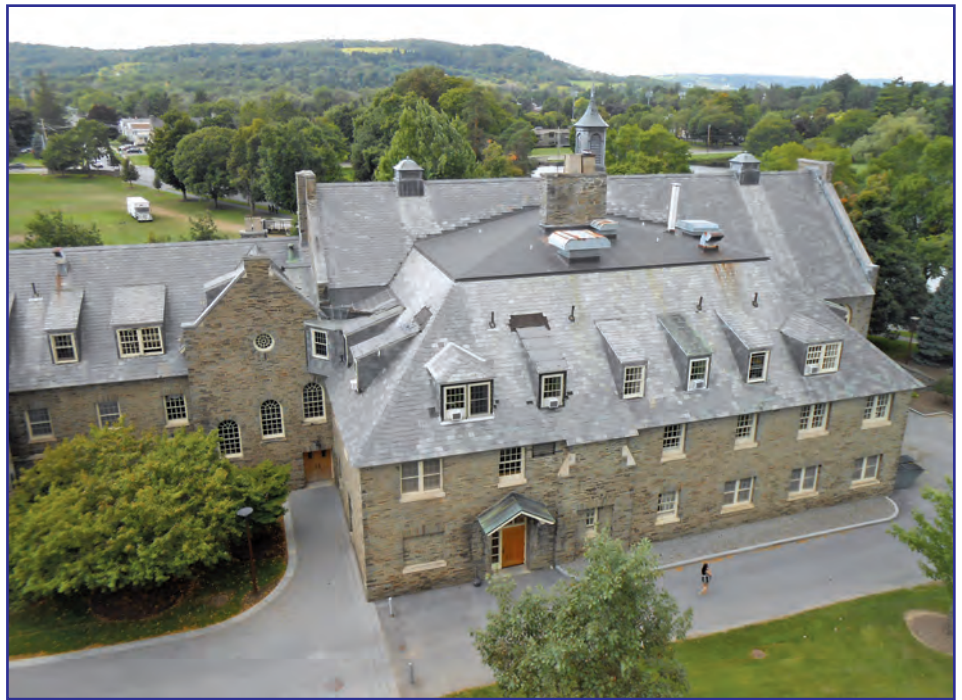
The initial 2014 project was conceived of as repairs to localized areas of the roof dormers (*Figure 4*). For many years, the university had been chasing leaks around the dormers, slates, flashings, and the original wood windows. The windows and their original wood frames and sashes were in terrible condition—both leaky and drafty. The interior plaster was severely damaged by the roof leaks and in need of replacement. The university requested recommendations from the architect on a repair scope of work that would address the source of the roof

*Figure 4 – Prior to 2014 roof replacement project.*

The building also had a history of systemic icing and ice damming problems. The prominently featured dormers on the front and back of the building are a unique architectural component and provide light and air to the attic spaces. They are also problematic because they obstruct snow and ice in places that are difficult to flash properly, are difficult to repair, and have a tendency to leak. In one particular area, a corbelled corner dormer created a very awkward roof drainage condition (*Figure 4* – inside corner on the left side).

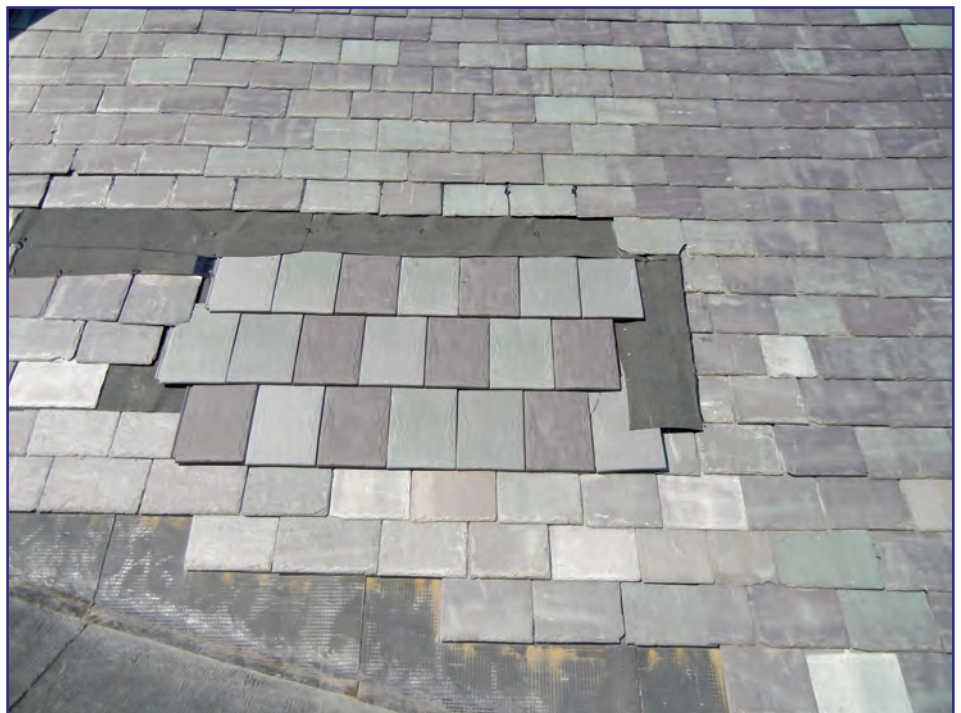
Figure 7 – Clay tile mock-up.

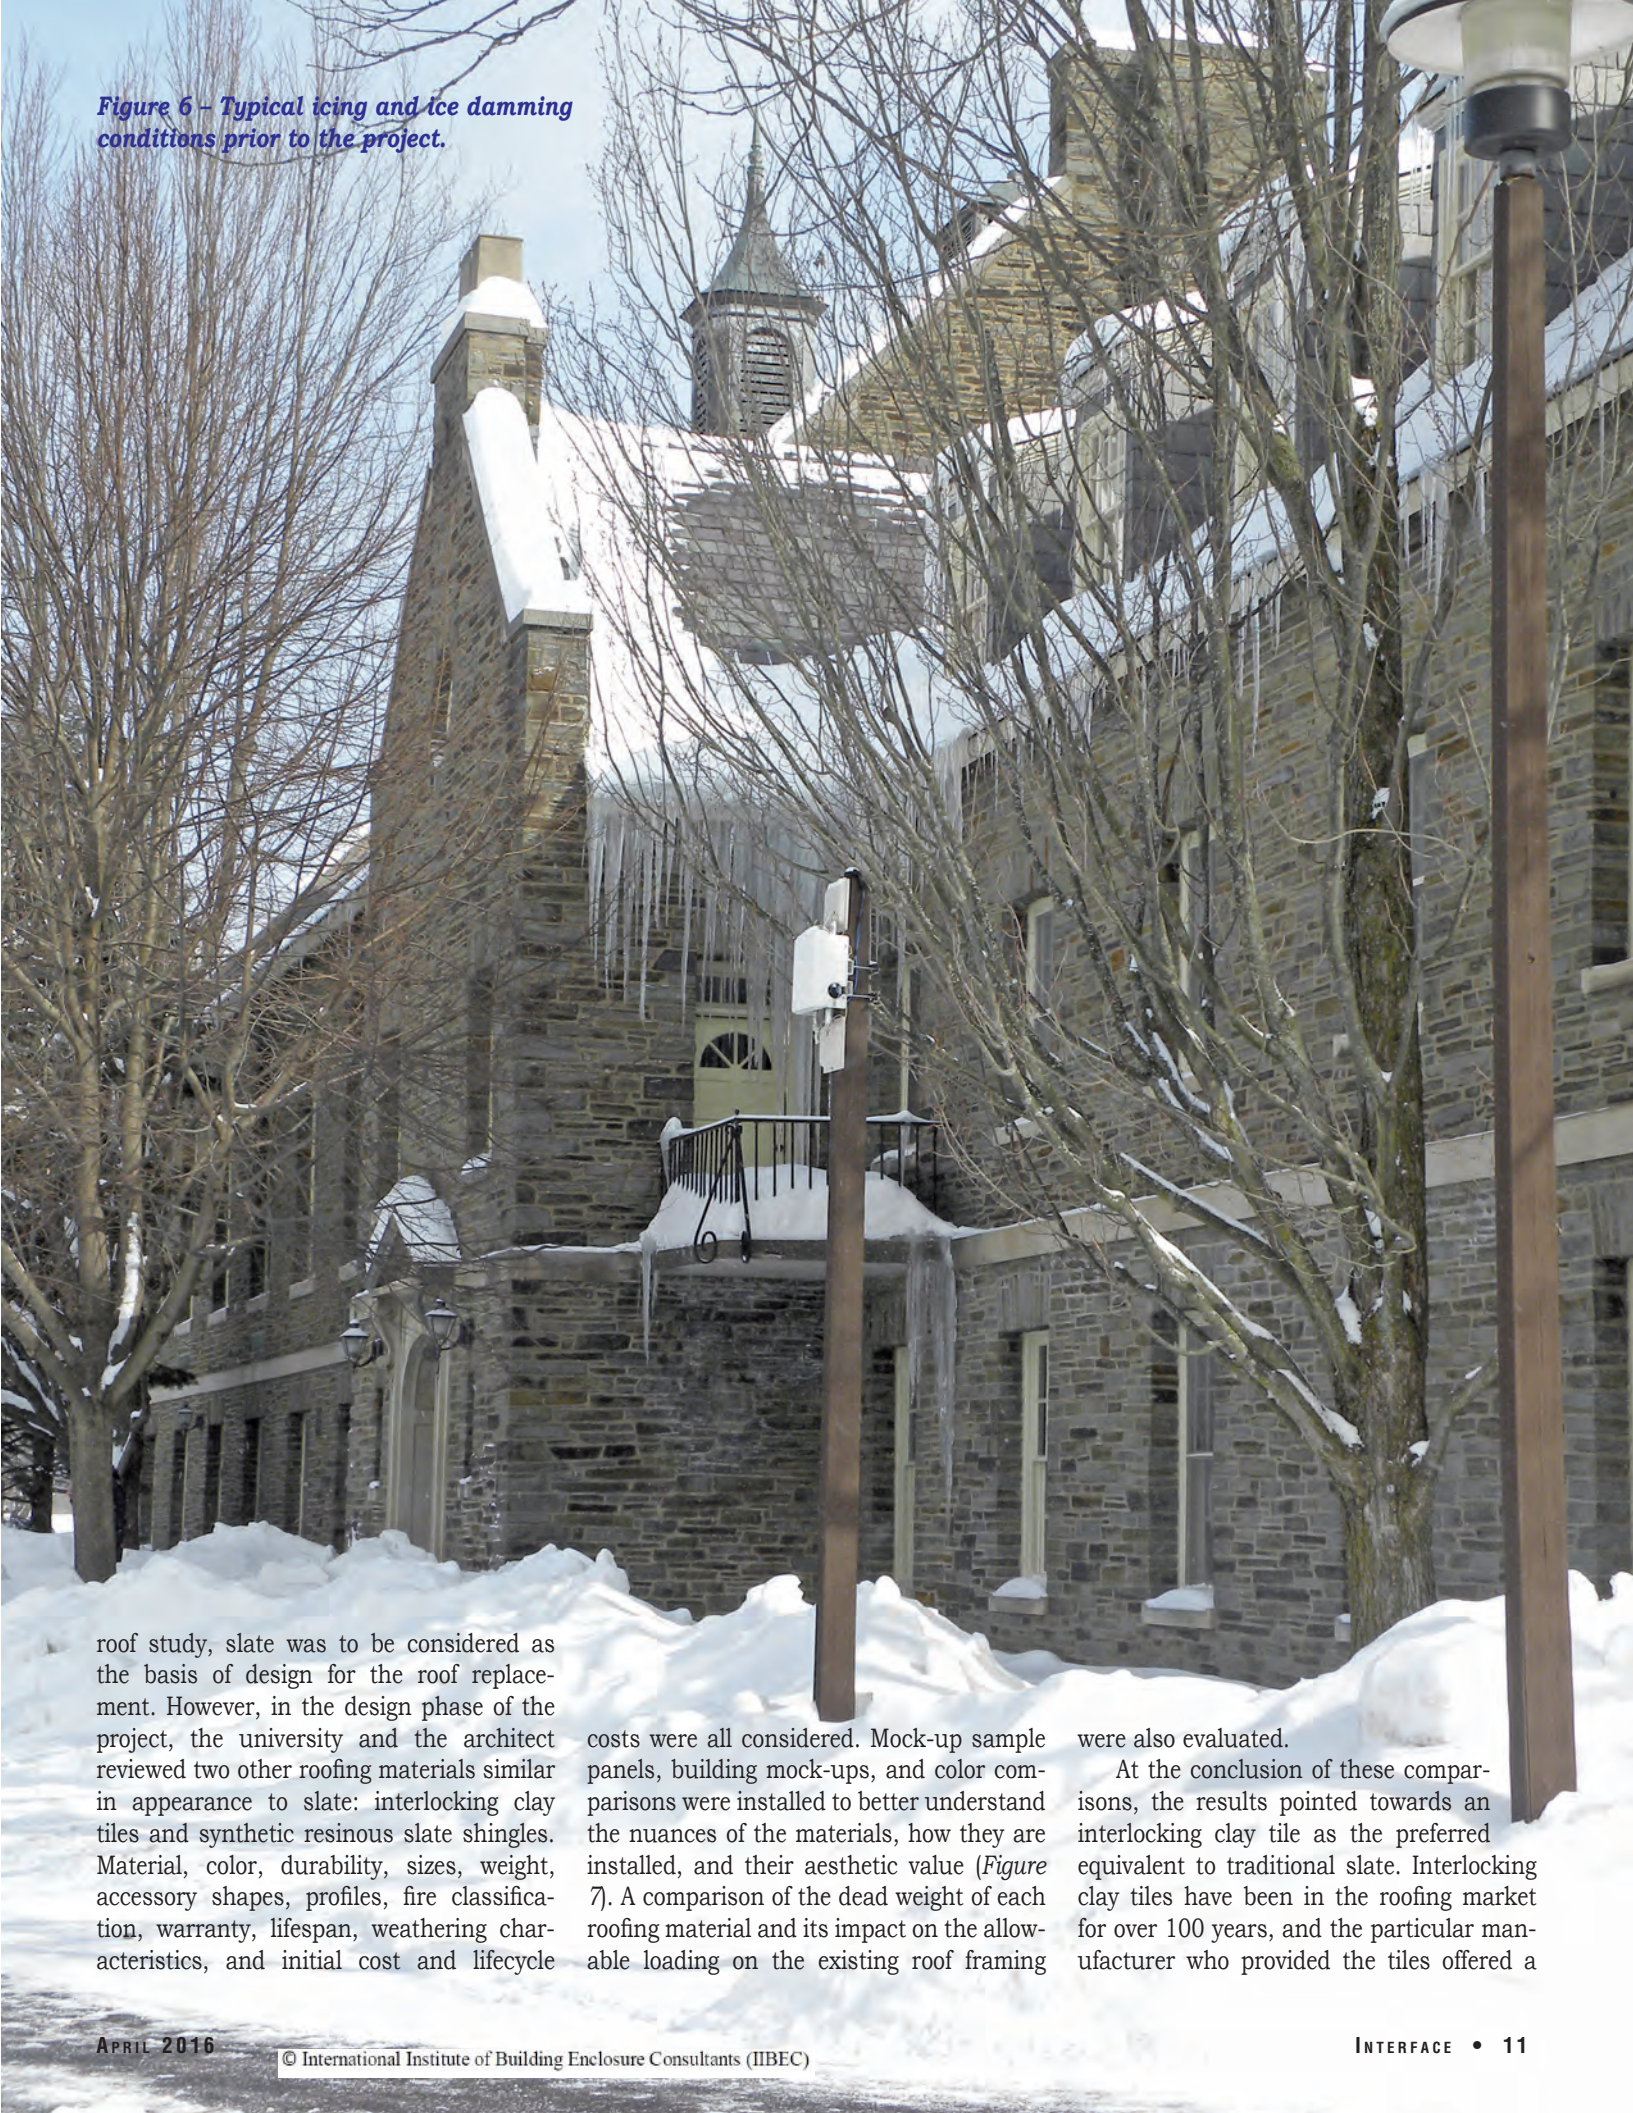
In 1936, when the student union was built, it was unlikely there was much, if any, insulation in the open wood-framed attic spaces. Over the main dining hall, called the Hall of Presidents, the vaulted scissor truss ceilings originally would have offered very little insulation value. A close look at early photos shows the roof of the student union generally clear of snow, presumably having either melted away or slid off. There is no evidence that a snow retention system (e.g., snow pads or rails) was ever installed. For the most part, the building envelope appears to have functioned reasonably well, because the snow melted away before causing problems. At some point, however, the attic spaces were outfitted with forced-air mechanical heating and cooling systems and loose-laid fiberglass batt insulation, which created problems. It was clear that the roof was suffering from inadequate thermal insulation, air losses, and damaging accumulations of snow and ice (Figure 6).

*Figure 6 – Typical icing and ice damming conditions prior to the project.*

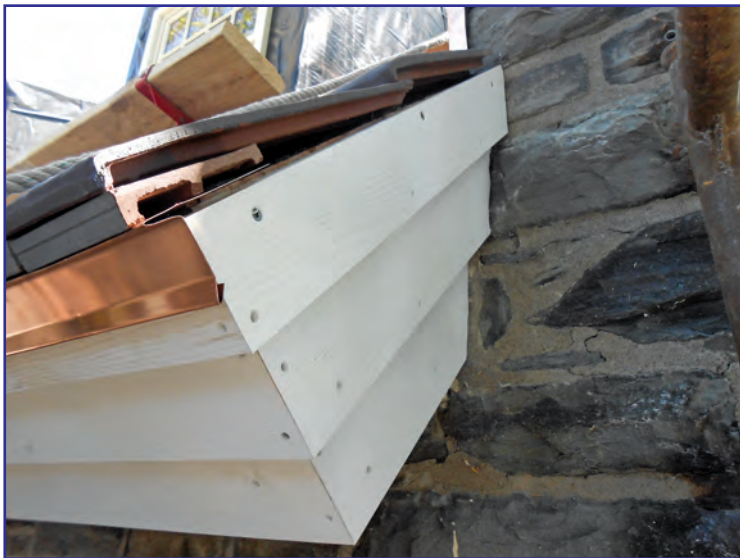
Figure 8 – The rake-end condition of the interlocking clay tile assembly, prior to completion.

have a fixed exposure (the face of the tile exposed to view) of about 11 in. (28 cm), which is approximately 3 in. (7.6 cm) larger than the existing slate exposure. And similar to synthetic shingles, interlocking clay tiles are molded products with stiffening ribs on their undersides. Once the tiles are cut, the ribs can become visible in an undesirable way when they are placed around penetrations or along valleys (Figure 8).

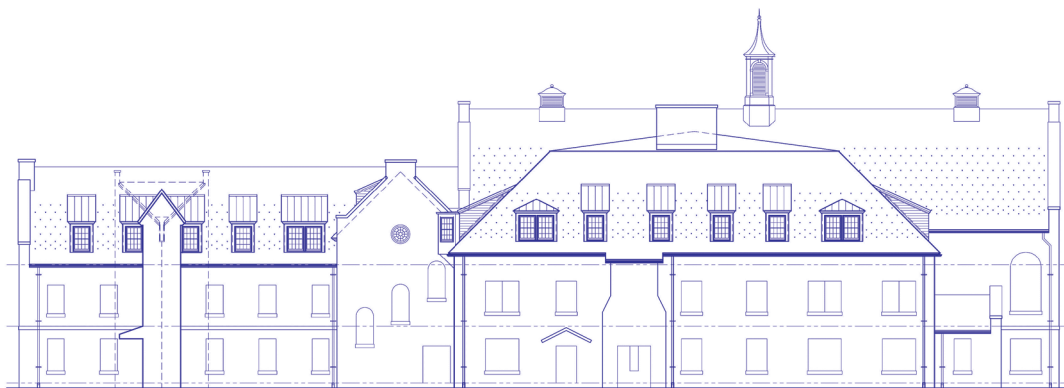
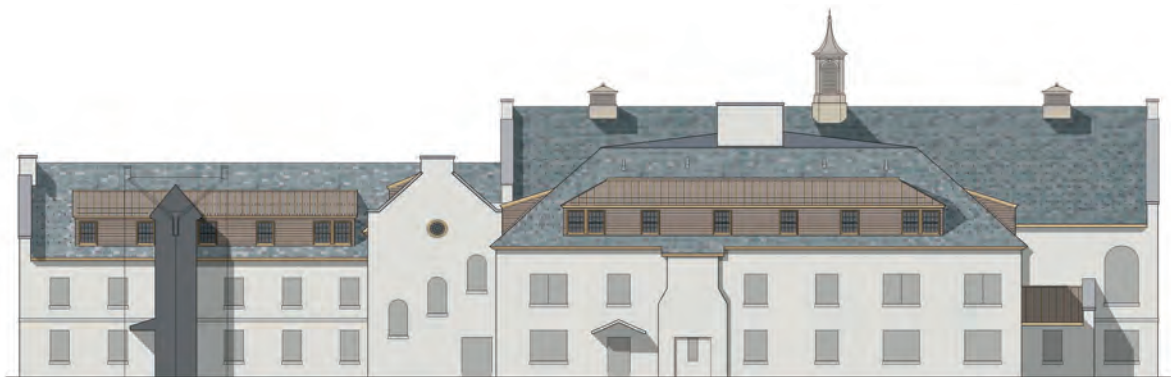
Figures 9A (above) and 9B (right) – Architectural renderings of the existing and proposed dormer reconfiguration.

mers (Figures 9A and 9B). The final designs balanced the need to preserve the historical appearance of the student union with the maintenance and costs by consolidating almost all the dormers on the back side of the building into one dormer but leaving the dormers on the front of the building unchanged.

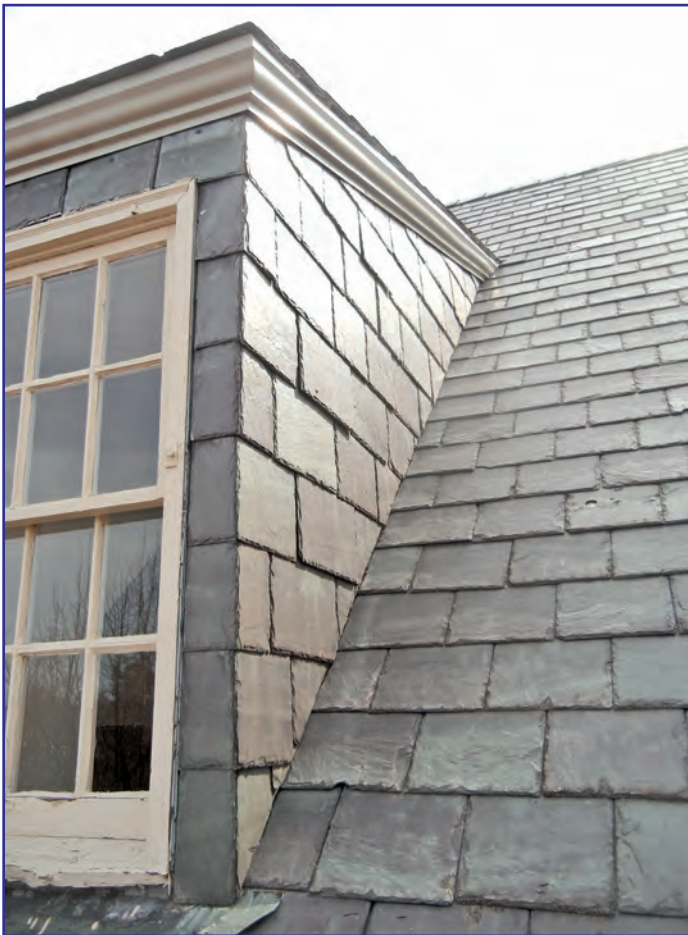
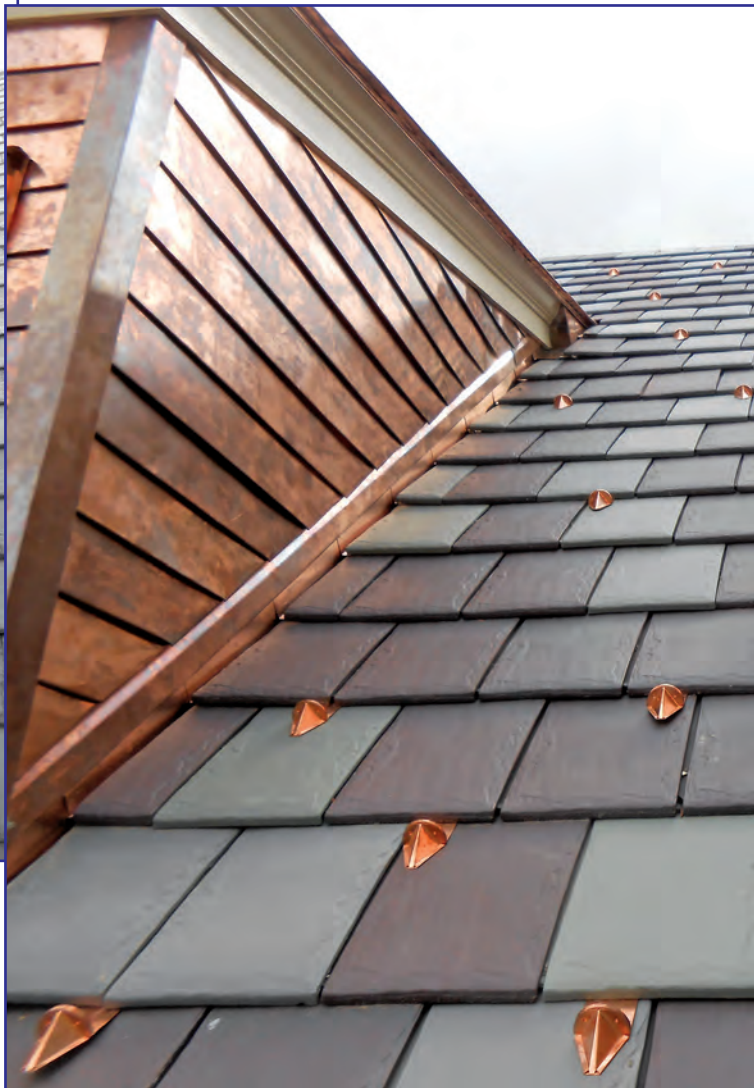
Figures 10A and 10B – Typical dormer before (left) and after (below) the project.

Due to the small size of the dormers, the architect proposed cladding them in an interlocking copper-siding panel instead of slates. The slates had proven to be difficult to maintain and were easily damaged by sliding snow. The size and scale of the copper-siding panels mimics the coursing of the slate, and the weathering of the copper was consistent with the materials used elsewhere on the building and the campus (Figures 10A and 10B).

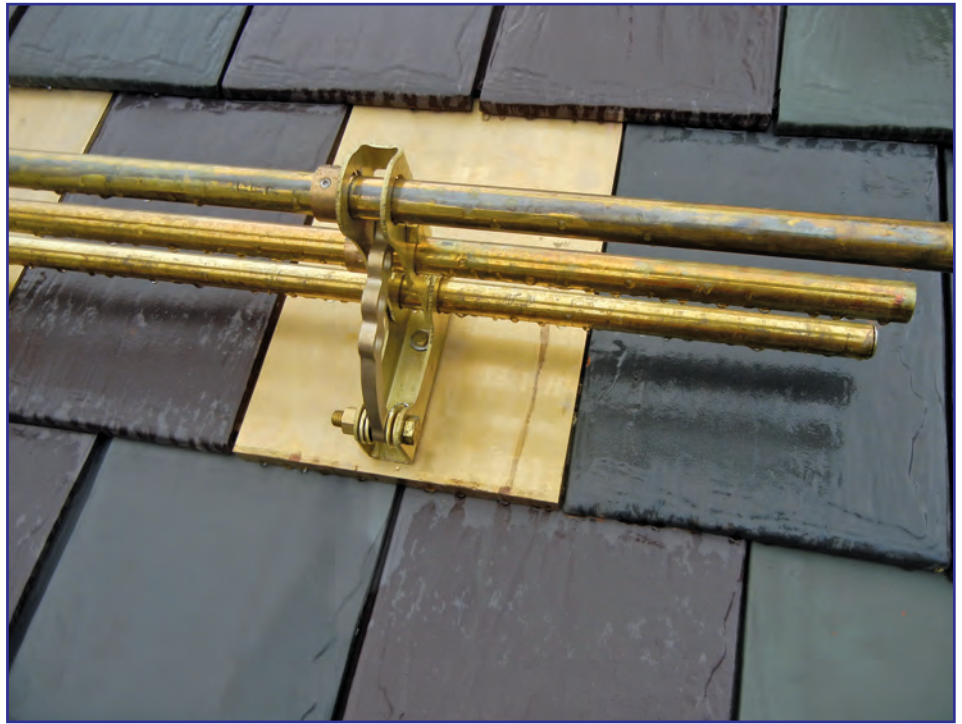
Figure 11 – Typical snow rail and bracket incorporated into the interlocking clay tile system.

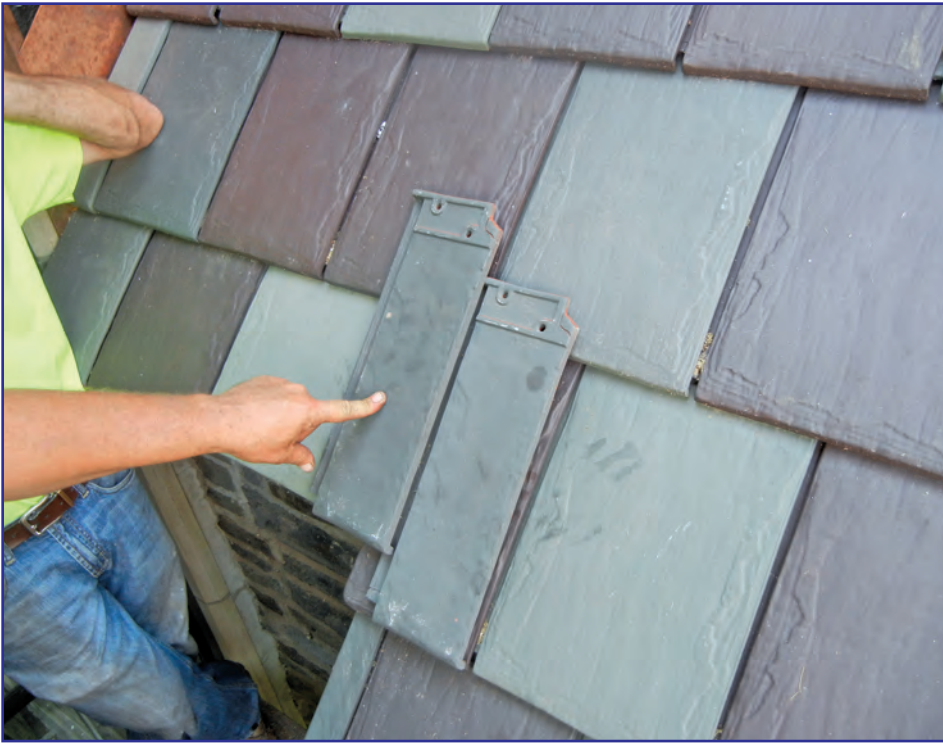
Figure 12 – Tile accessory shapes under consideration for an eave condition.

dish color of the fired clay tile itself. There were locations where this could be visible and therefore undesirable. For this project, it was neither practical nor could the schedule accommodate the time for custom pieces to be fabricated. In hindsight, it may have been desirable to have standard solid tiles made with homogenous color for locations where the tiles needed to be cut. But through some creative Tetris-type arrangements, the contractor was able to take a combination of cut tiles, eave tiles, rake tiles, and copper flashings and lay out a pattern to resolve these problem areas (Figure 12).

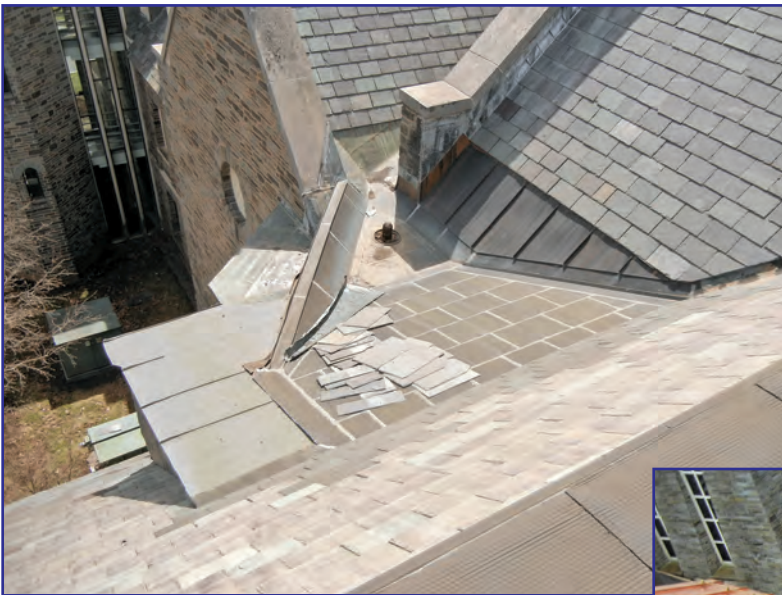
Figure 13 – Drainage basin around the corbelled dormer prior to the project.

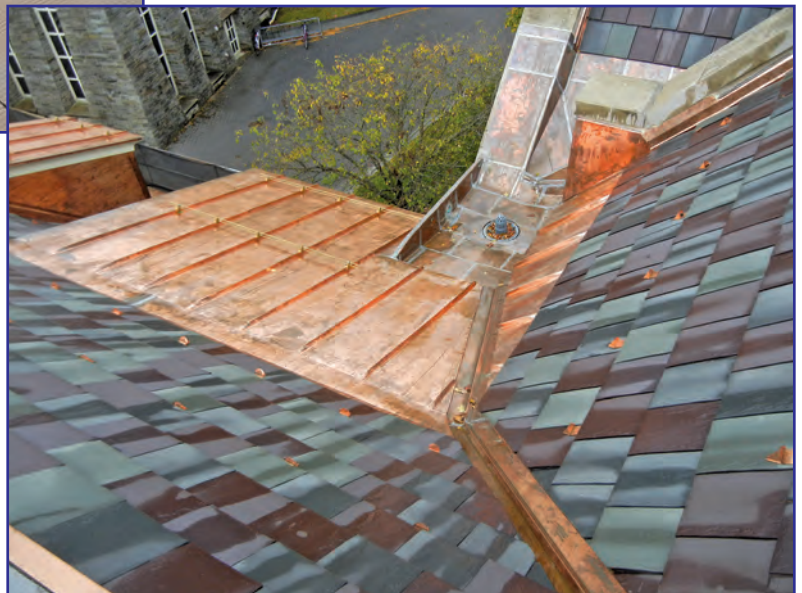
Figure 14 – Drainage basin after completion of the project.

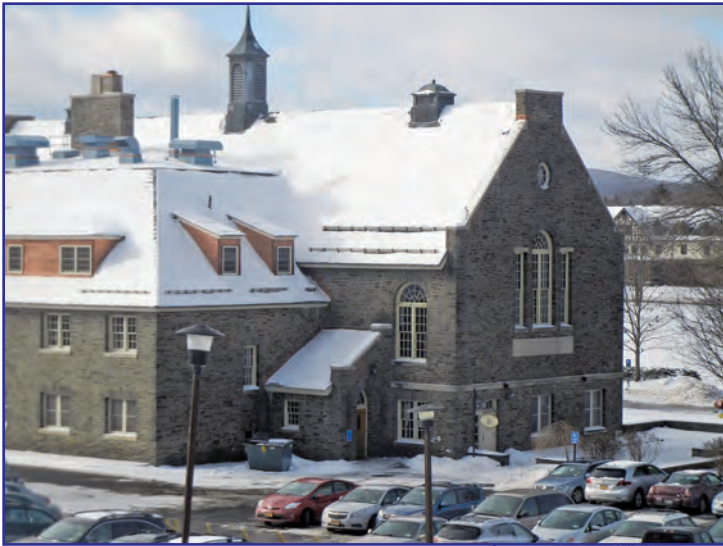
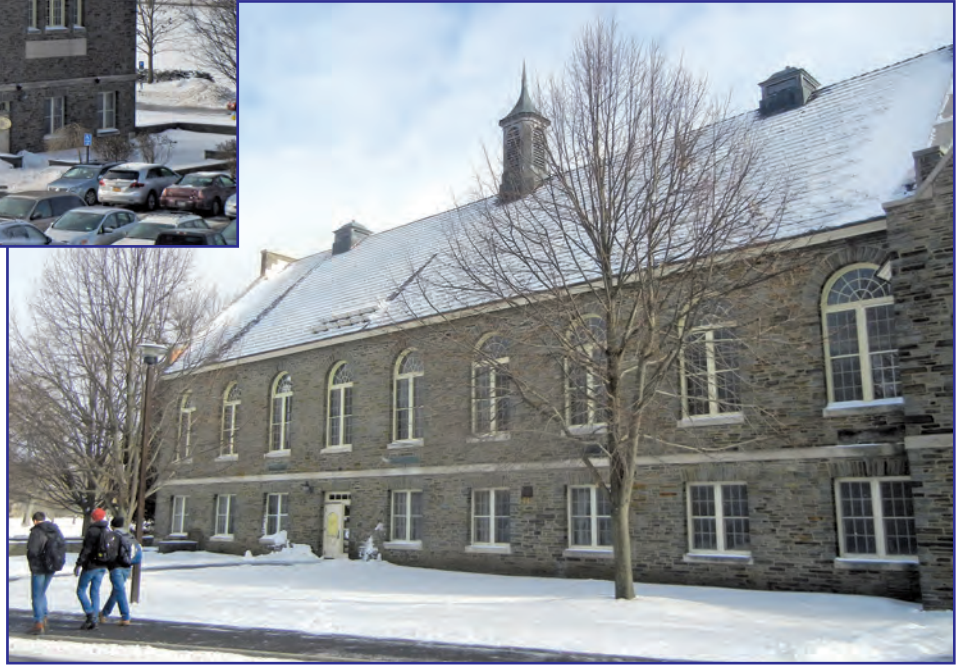
Figure 16 – Snow on the roof after completion of the project.

Figure 15 – Snow on the roof after completion of the project.

Many on campus have remarked that the restoration and overall visual improvements to the building have exceeded their expectations. In its first winter of service, it is clear that the roof design is behaving as predicted, thermal losses have been significantly reduced, and the snow retention systems are effectively holding snow in place
