LESSONS FROM WIND DAMAGE REPORTS

BY KEITH ROBERTS, CENG, MICE, MSTRUCTE, MAE

Several case studies of investigations of wind-damaged roofs in the UK and Ireland are presented here, exploring alternative causation theories and developing options for strengthening and repair.

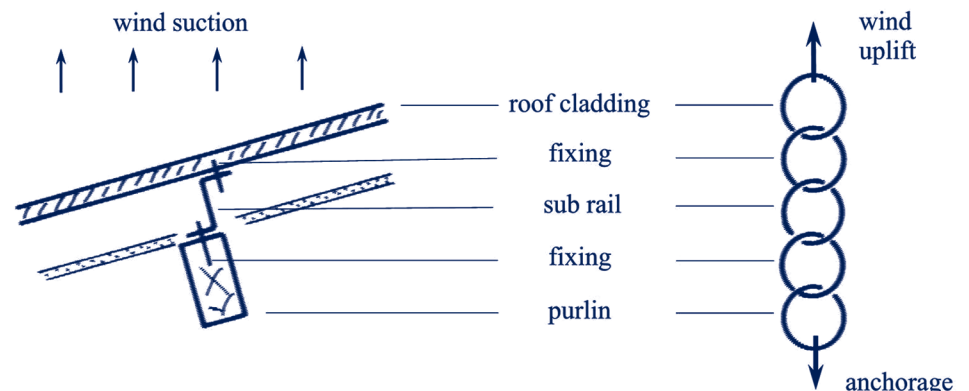
Wind suction forces acting on the upper weathering skin of a roof are transferred from layer to layer down through the roof construction into the structural framework. Each fastener transfers the upward load to the next layer down. A useful analogy is that of a chain anchoring the upper weathering skin down to the support structure. If one link in the chain were to break, then

potentially the outer sheets could become detached from the roof (Figure 1).

Figure 1 – The chain analogy for the attachment strength of a multi-layer roof system.

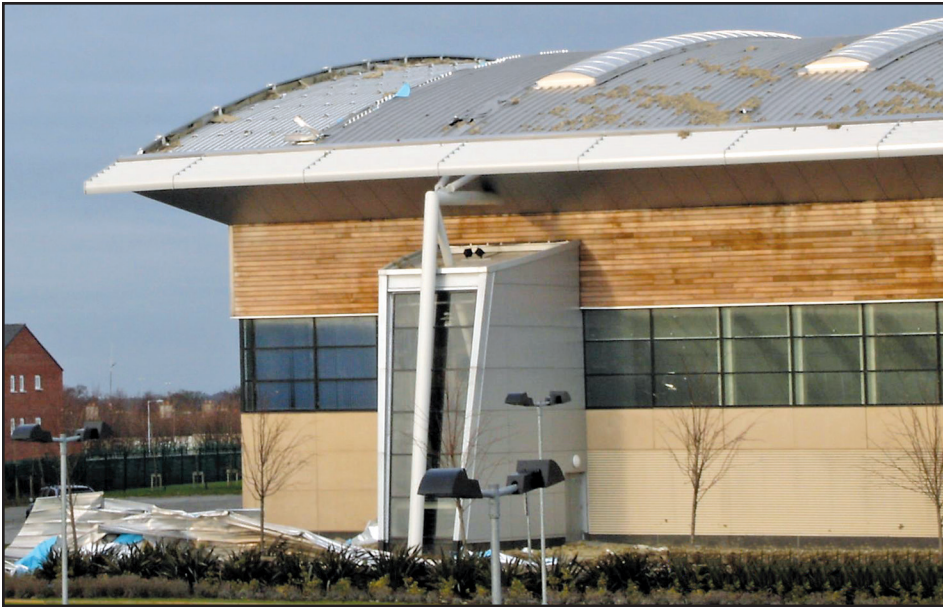
Figure 2 – Detachment of aluminum standing seam roofing from windward verge of the Competition Pool.

On New Year's Day, 2005, a strong gale blew across southern Ireland from a southwesterly direction, resulting in an extensive area of lightweight aluminum standing-seam roofing becoming detached from the windward verge of an aquatic center and adjacent gym (Figure 2) and causing consequential impact damage to roof cladding and skylights downwind. The structures were evacuated safely without injury to members of the public or staff.

The original roofing contractor undertook to replace the area of detached roofing, both to make good the downwind isolated impact damage, and to strengthen the top hat rail to saddle and purlin connection by installing additional long screw fixings through the top hat rail directly into the steel purlin below. This repair scheme had a number of disadvantages, including puncturing the vapor control layer. Those advising the building owners considered the future condensation risks to be acceptable.

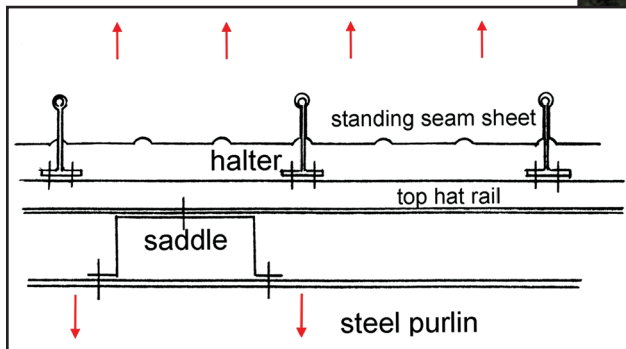
Figure 4 – Competition Pool roof assembly.

The wind damage photographs showed that there had been a detachment between the steel top hat rail and the aluminum saddle at 900-mm (3-ft.) centers (Figures 3

and 4). In addition, there was upward distortion in the wide top plate of the saddle. Calculations were prepared to check the strength at each of the connections, and the conclusions are summarized in *Table 2*.

The calculations found that the local bending stress in the crown of the aluminum saddle was excessive, and that the factor of safety against the top hat rail to saddle fixing pulling out was 1.1, significantly less than the recommended minimum of 2.0. This is the same weakest link as observed in the photos of wind damage.

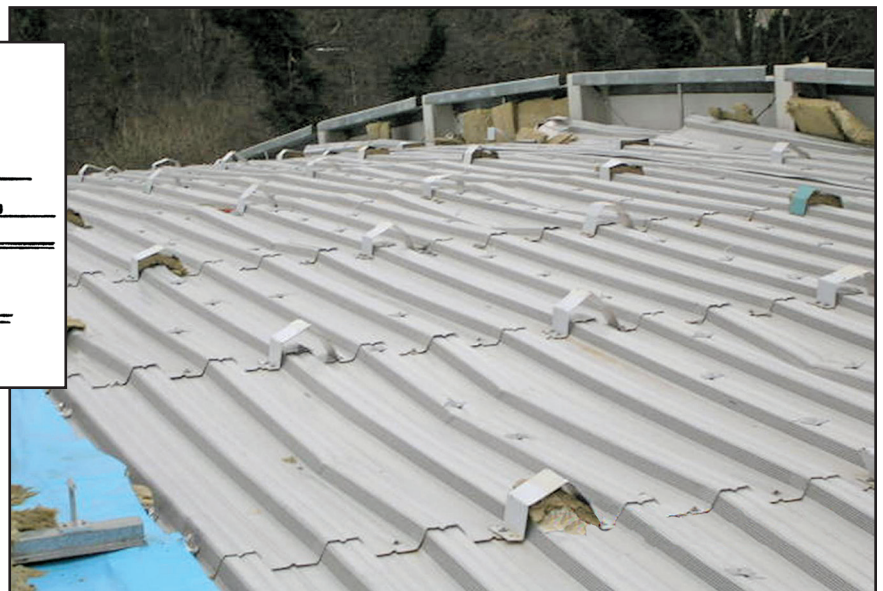
Figure 3 – Close-up of wind damage zone showing detached top hat rails and distorted saddles.

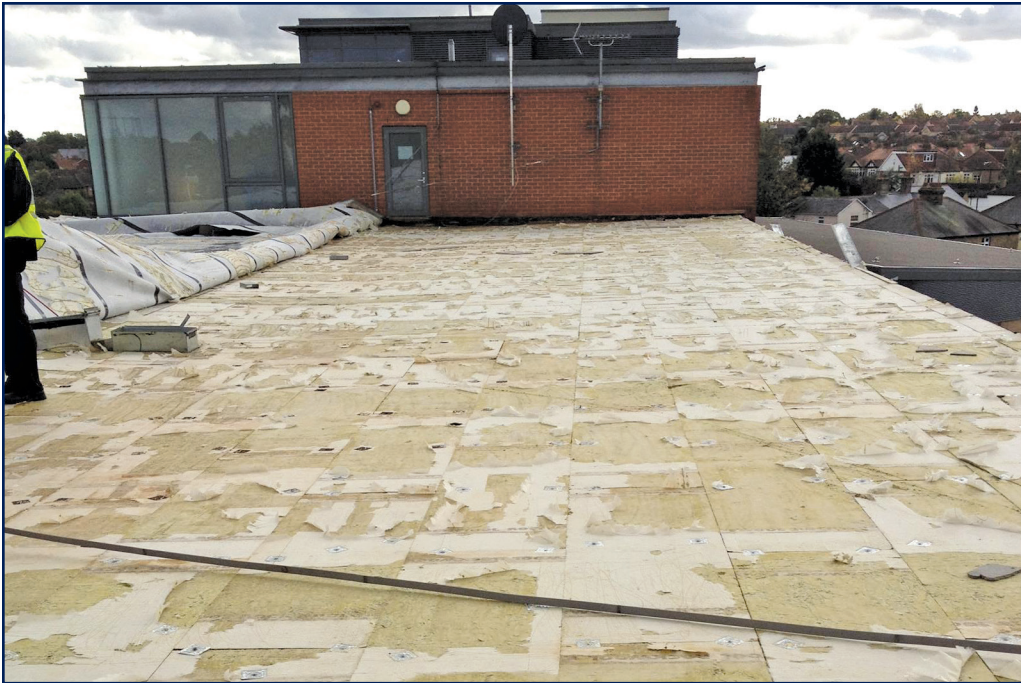
Figure 5 – Second-floor roof membrane rolled back from western edge.

On St. Jude's Day—September 28, 2013—a fast-moving, vigorous Atlantic depression brought very strong winds and heavy rain to southeast England, with winds gusting up to 36 m/s (80 mph). One modern building that suffered wind damage was a hotel in Chelmsford, to the northeast of London. Lengths of roof edging and single-ply membrane roofing became detached from the western side of the second floor

roof and peeled back, resulting in debris falling to ground level (Figure 5). This led to the closure of the public highway immediately to the east of the building for a period of several days (Table 3).

kept for examination in his local yard. The samples were closely examined to reveal an inadequate thickness and spacing of the adhesive bonding. Samples of the mineral wool insulation showed that the top tissue facing readily detached from the fibrous core and was not the specified insulation board with a “single-ply adhered facing.” The wrong product had been supplied, which had not been identified by the roofing contractor, the supplier, or the other surveyors initially inspecting the wind damage.

Within a month of the initial inspection, the second-floor roof was fully replaced with a new mechanically attached PVC single-ply membrane system. The third- and fourth-floor roofs were investigated and found to be of a similar construction, with areas of debonded single-ply membrane adjacent to the western edge. It was recommended that a new mechanically fixed PVC single-ply membrane should be overlaid over the existing membrane, with a new secure perimeter detail developed.

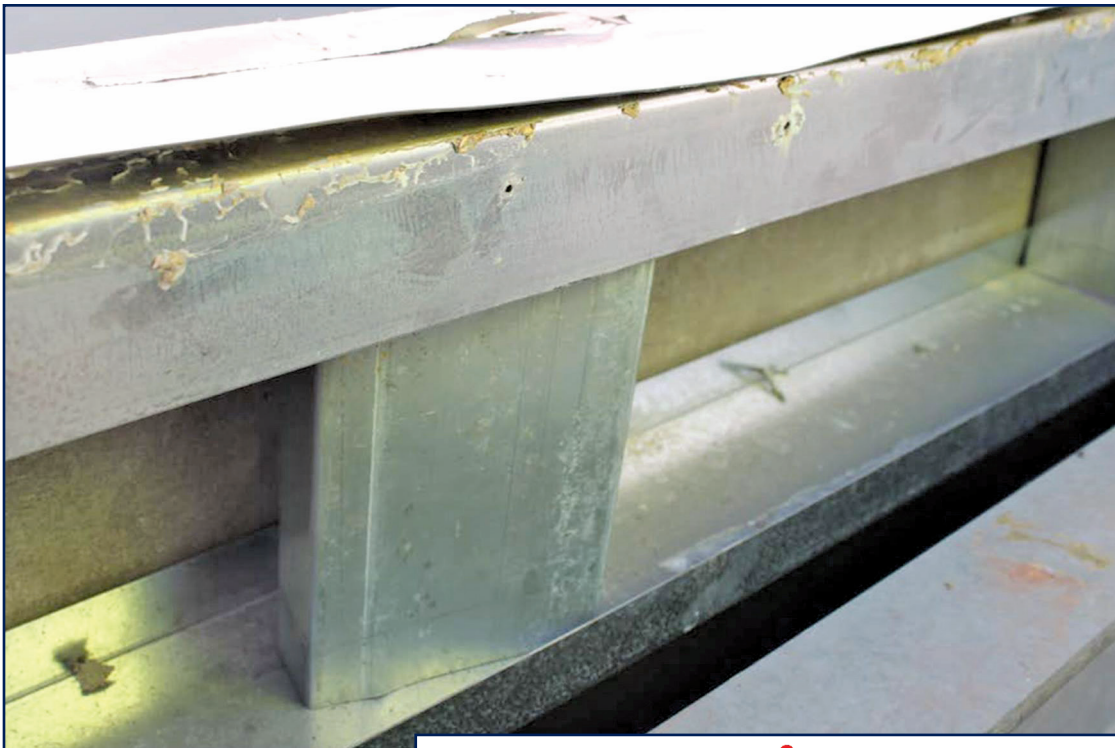
The wind damage photos also showed that the roof edge had become detached. There were no record drawings of the initial construction, and so the as-built assembly was drawn up based on site measurements, the opening-up examination, and inspection of the debris in the contractor's yard. A short parapet had been constructed using two channel sections with an internal stud and no fixings joining the channels together. Under wind uplift pressure, the capping and support could lift upwards. From this, it was possible to determine the probable sequence of detachment along the western edge of the central roof in which a Z-section flashing rotated upwards, increasing the wind uplift pressure acting on the underside of the flashing and entering the upstand detail (Figures 6 and 7). This, in turn, caused the perimeter channel and studs to lift upwards, causing the single-ply membrane to peel back readily with the lack of adhesive restraint.

Figure 6 – Examination of upstand discovered top channel not fixed to internal stud.

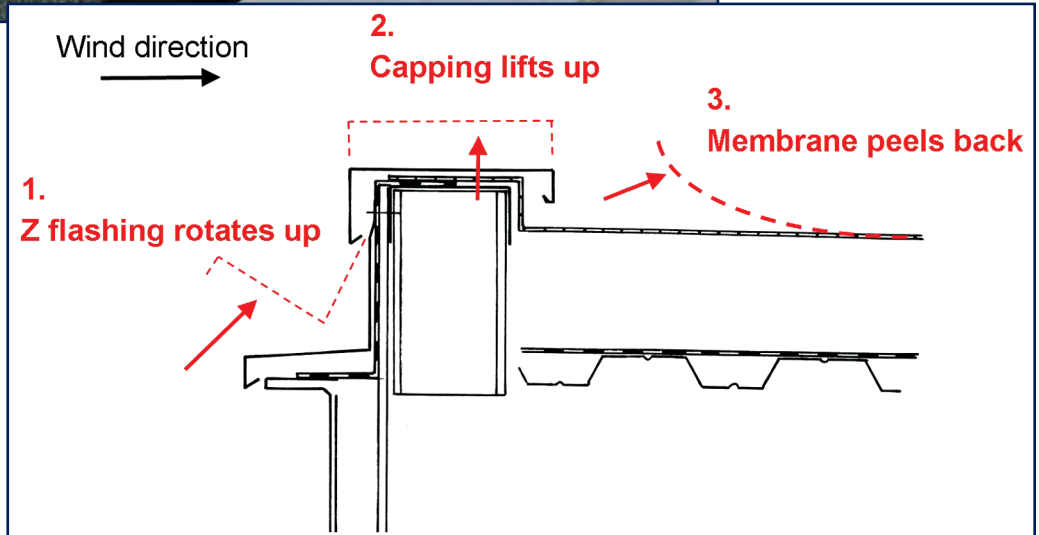
Figure 7 – Probable sequence of detachment of western half of second-floor roof.
