Composite Metal Panels as a Rehabilitation Cladding

By Marcus Dell, PEng

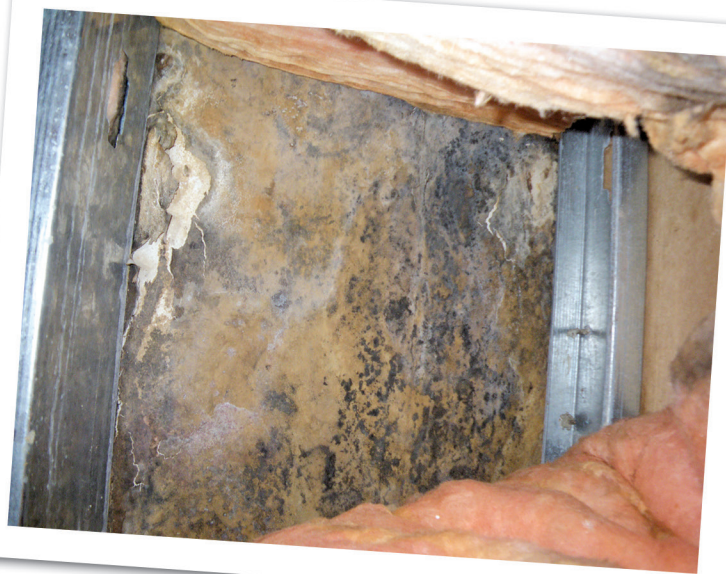
Figure 2 – Typical deterioration of gypsum sheathing to which the EIFS was adhered and corrosion on the steel studs.

cladding was adhered (Figure 2). The water ingress had also resulted in corrosion of the steel studs, and consequently, loss of structural integrity of some wall areas. The deterioration of the walls was also the result of leakage at the tie-in of the wall cladding to the balcony edge, which allowed water to drain off of the balcony directly onto the cladding (Figure 3). Figure 4 illustrates the typical problematic wall-to-window interface.

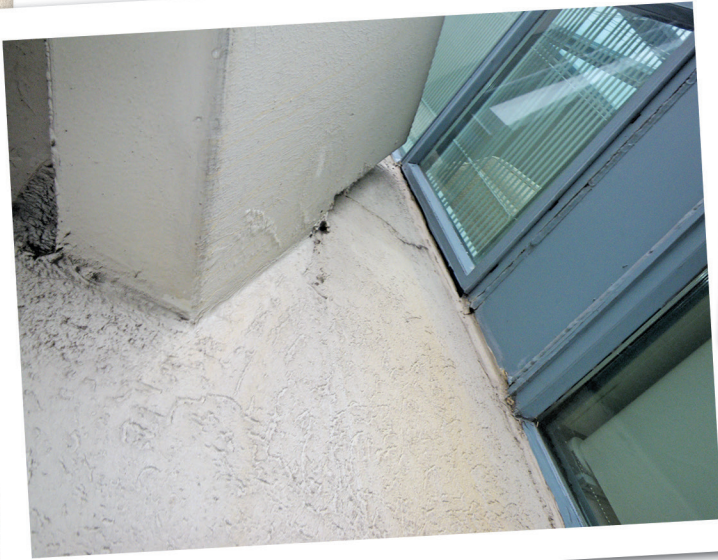
Figure 3 – Balcony-to-wall interface.

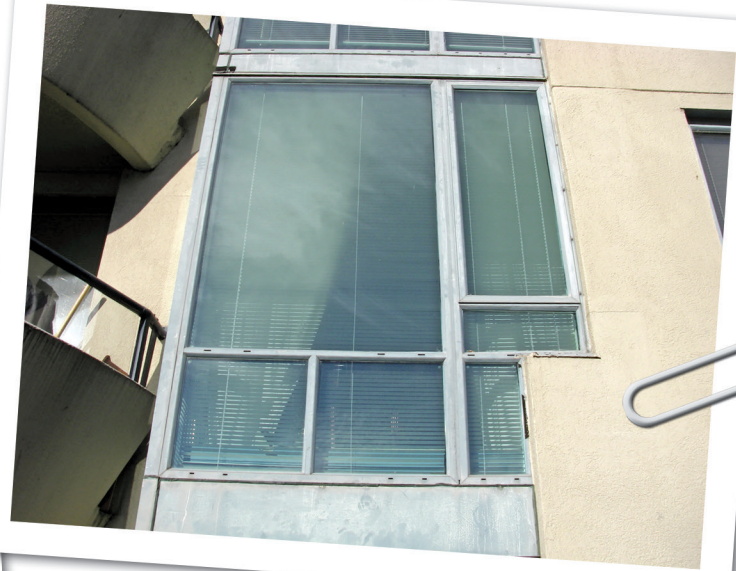
Figure 4 – Typical window assembly set into EIFS cladding; as built, there was no drainage from behind the spandrel panels.

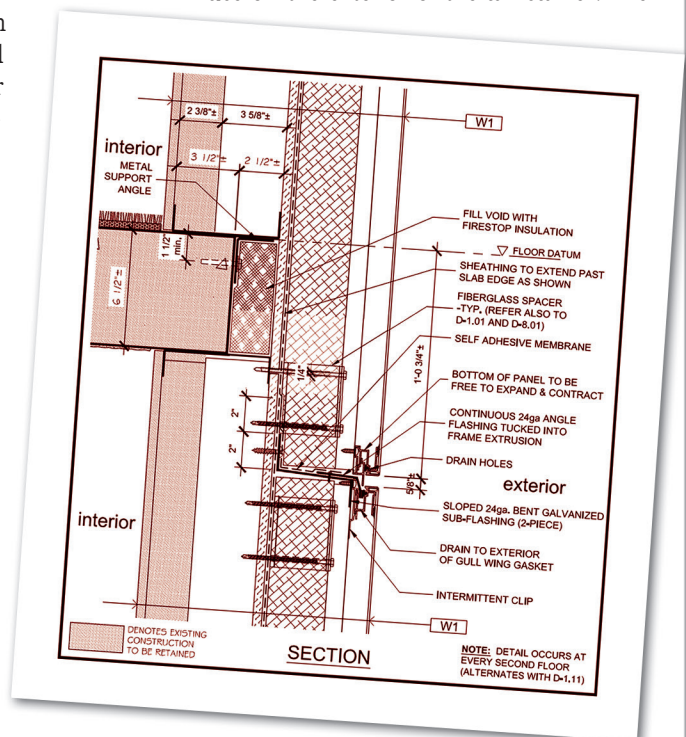
Figure 5 – Floor slab.

had resulted in gaps between the insulation and the membrane drainage plane, allowing exterior air to flow behind the insulation and reducing its effectiveness. Figure 5 is a typical cross-section detail through the slab edge, while Figure 6 illustrates the wall assembly under construction.

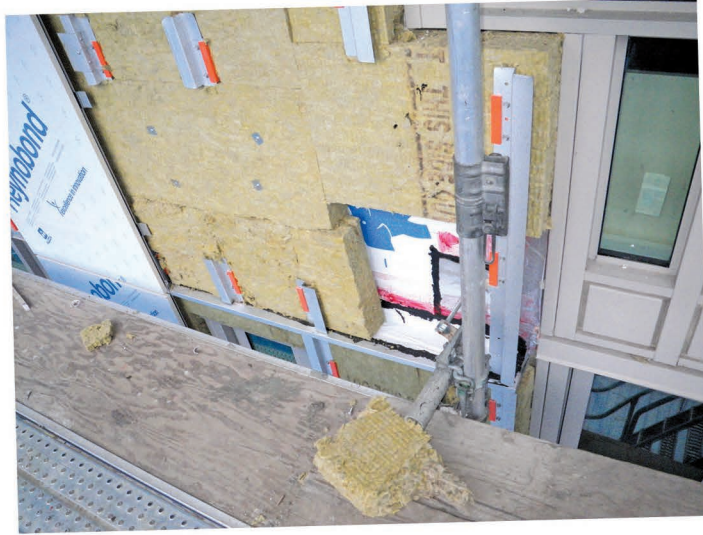
Figure 6 – Wall assembly under construction.

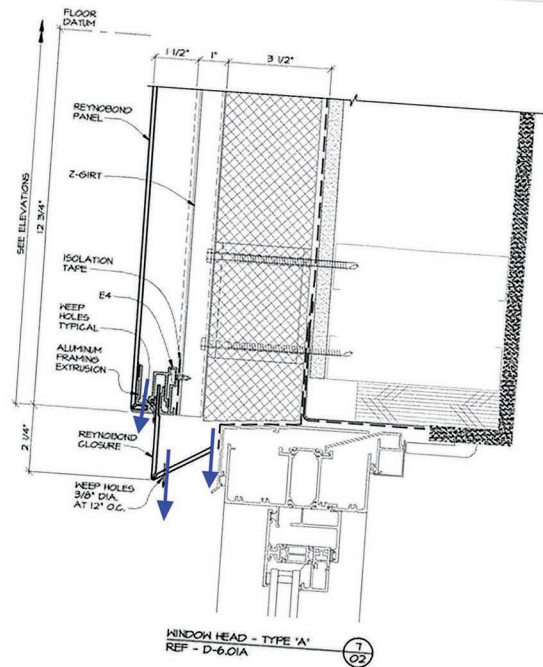
Figure 7 – Example of detail from metal panel shop drawings; blue arrows have been added to highlight the drainage paths.

Shop drawings are a key component of any successful project utilizing metal panels. Figure 7 is an example of a window head detail from the shop drawings produced for this project. Note that the window head detail incorporated drainage at three locations to ensure that water is not trapped in the assembly.

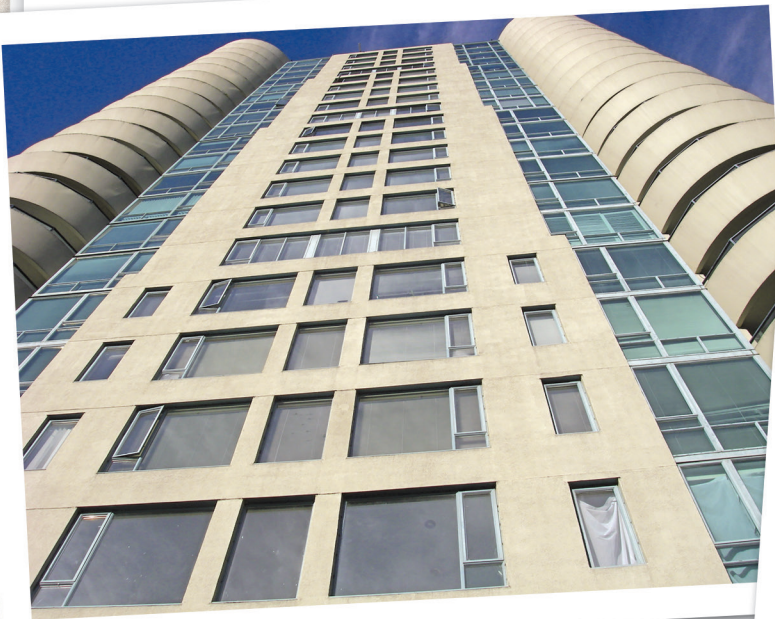
Figure 9 – Original cladding assembly.

the completed project, while *Figures 9 and 10* offer a comparison between the original cladding and the rehabilitated cladding. *Figure 11* illustrates the new building entry canopy. Importantly for the owners, the panels have remained clean and unstained since the rehabilitation was completed in 2013.

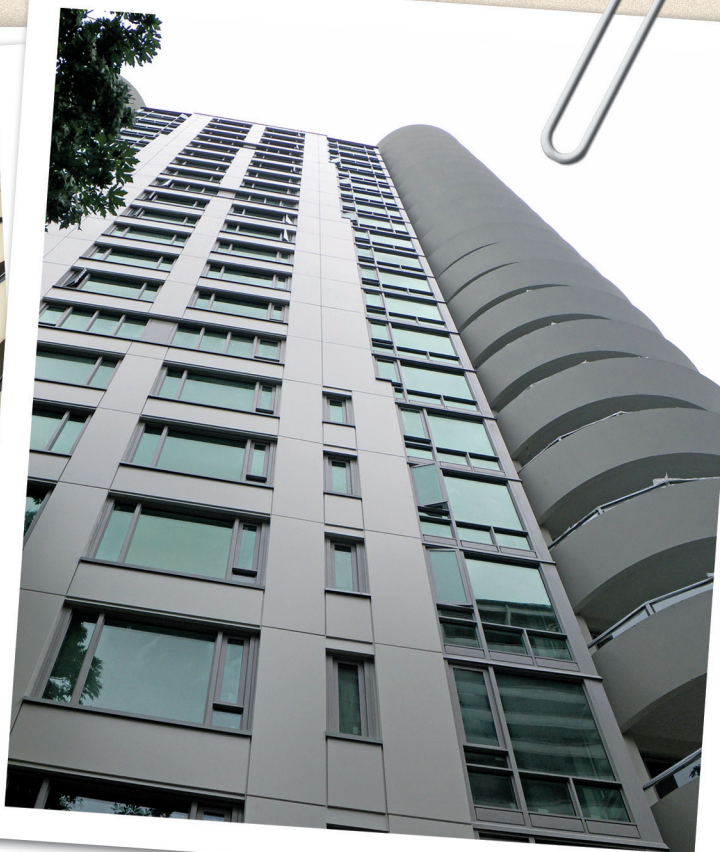
Figure 10 – New composite metal panels.
