WATERPROOFING UNDER GREEN (GARDEN) ROOFS

Part 2 of 2

By Justin Henshell, FAIA, CSI, FASTM

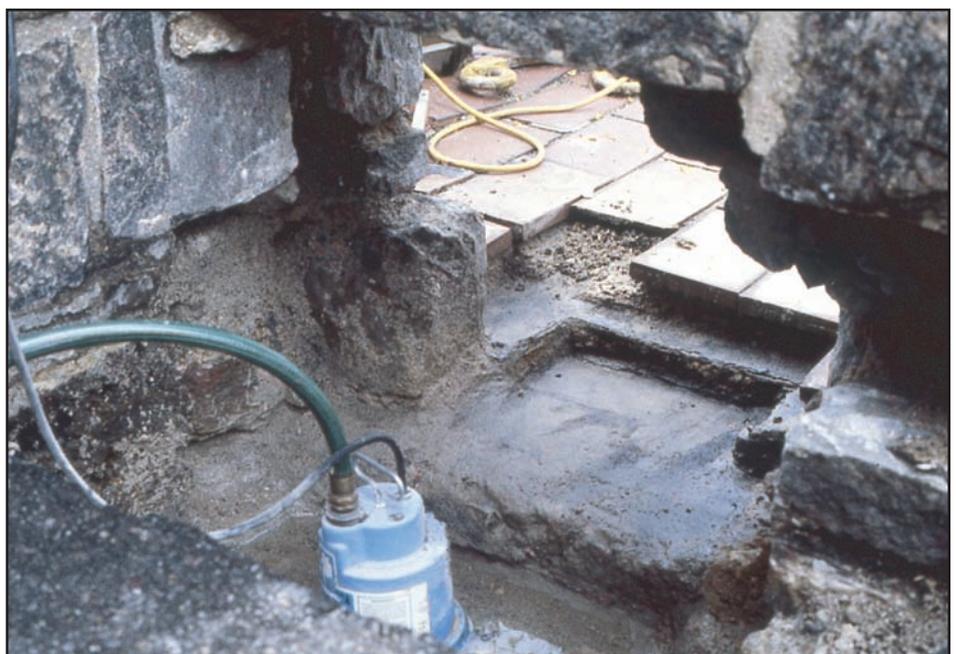
Figure 1: Exposing membrane for repair.

In selecting a waterproofing membrane under a GRS, the designer should exercise the same prudence as he or she would use when selecting a membrane under a wearing course that is to be installed in a mortar setting bed – the maintenance and repair are difficult and costly (Figure 1).

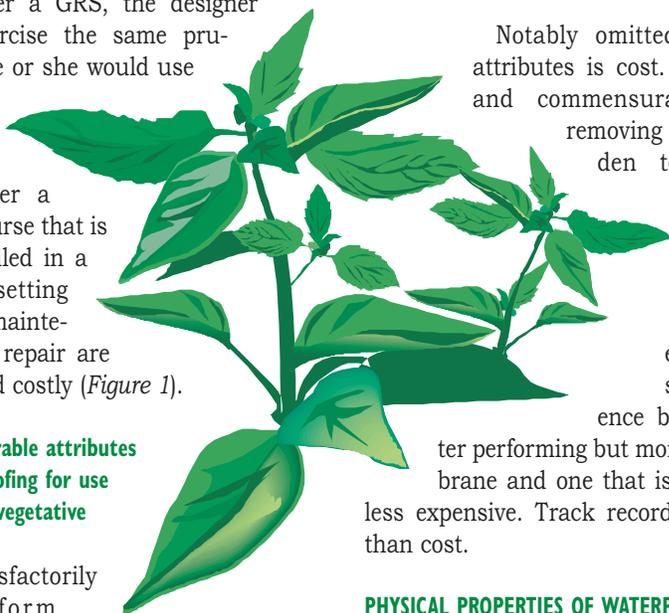
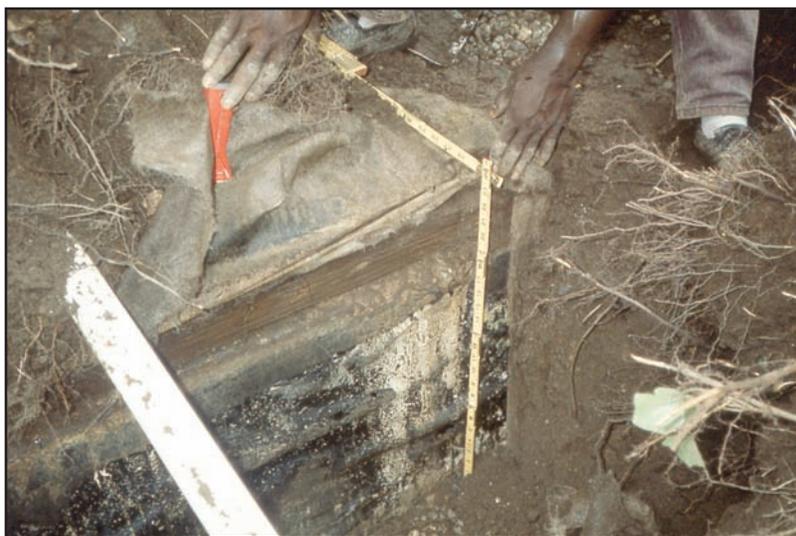
Figure 2: Root intrusion.

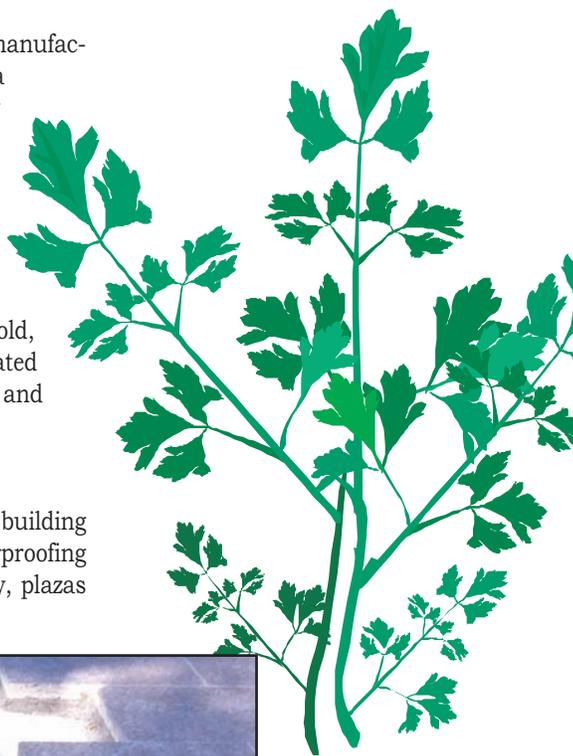
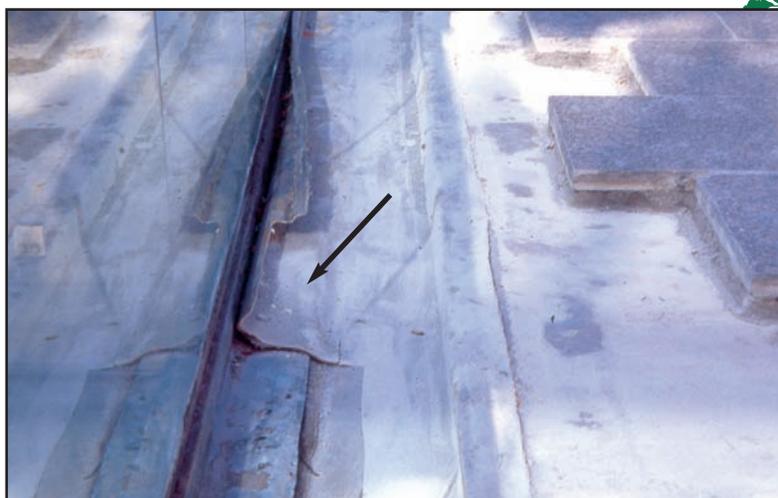
Figure 3: Flashing failure at glass railing.

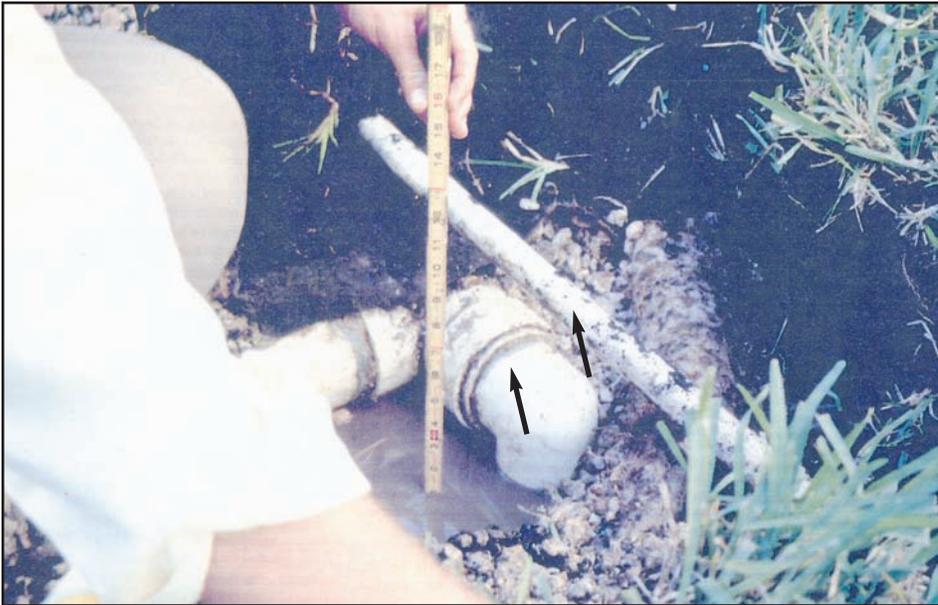
Figure 4: Elevated drainage pipes.

conceived drainage system. The planted areas were drained by perforated pipes extending from leaders through the slab. There were no conventional drains. Because the hubs on the pipe fittings and the radius of the elbow connecting the lateral pipes to the leaders raised the pipes above the slab, there was a reservoir of standing water more than an inch deep (*Figure 4*). Sheet rubber expansion joint covers had been installed flush with the waterproofed slab. The rubber was bonded to the liquid-applied membrane, creating a plane of weakness that was exploited by the hydrostatic head. The inadequate drainage and failure to elevate the expansion joint cover caused the joint to leak.
