EIFS Come and EIFS Go; A Case Study on EIFS Cladding Rehabilitation

By Christopher R. Kottra, PE, CCA, and Joshua J. Summers, REWC, SE, PE

Project Title: Exterior Facade Rehabilitation, Fisher Corporate Center

Location: 1707 North Randall Road, Elgin, Illinois

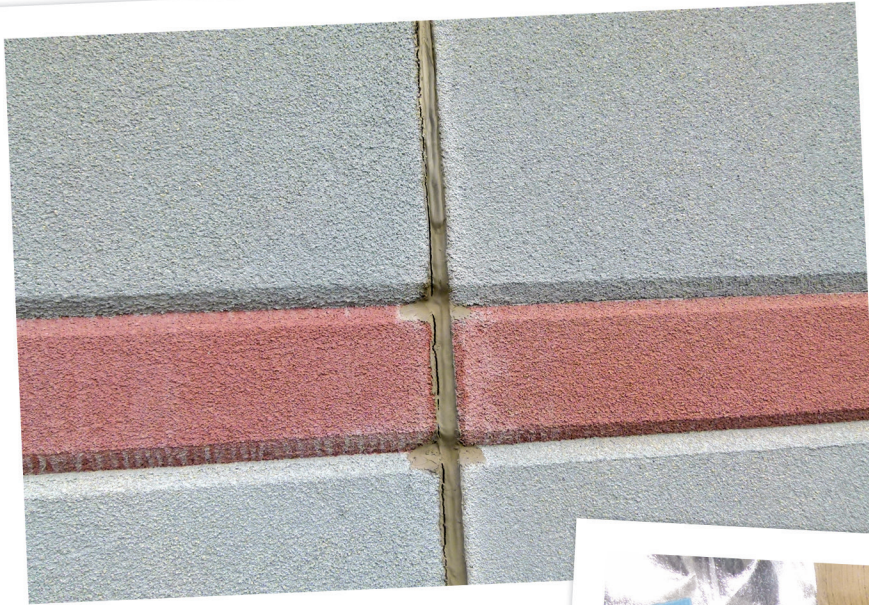
Figure 2 – Failed sealant between EIFS panels.

1. Failed primary and/or secondary sealant at joints between EIFS panels (Figure 2)
2. Failed bond between EIFS finish coat and base coat
3. Extension of EIFS base and finish coats onto supporting steel stud and completely through the thickness of the wall panels, providing a direct path for water to reach the interior of the building (Figure 3)
4. Lack of back-wrapping of the base coat behind the EIFS panels

1. A barrier wall system is defined as any exterior wall system or assembly that relies principally upon the watertight integrity of the outermost exterior wall surfaces and construction joints to resist bulk rainwater penetration and/or moisture ingress.
2. The EIFS finish coat extended into joints between panels, which meant sealant at those joints was only

adhered to the finish coat. The bond between the finish coat and base coat is not strong enough to accommodate tensile stresses from thermal contraction of the EIFS panels. As such, joint sealants were effectively pulling the finish coat off the base

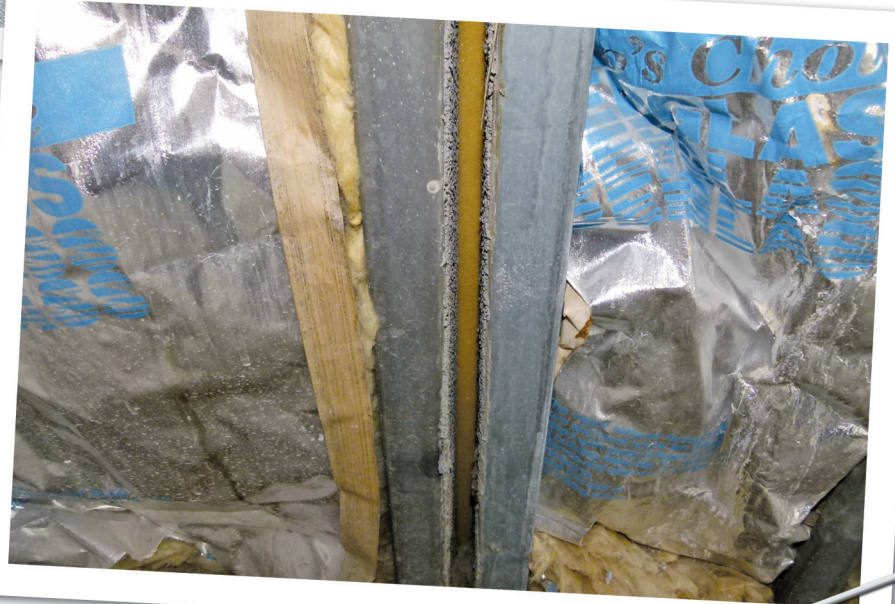
Figure 3 – EIFS base and finish coats extended onto studs.

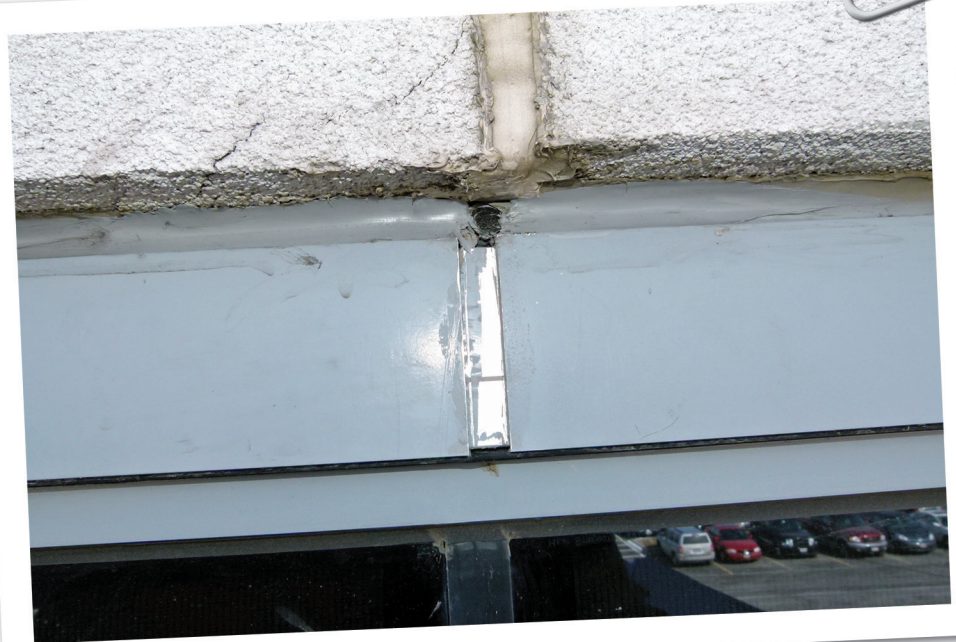
1. Lack of cover plates over splice joints between frame sections at window heads and sills (Figure 4)
2. Failure of retrofitted sealant at splices due to thermal expansion and contraction of the window frame sections (Figure 5)
3. Failure of sealant at window perimeters
4. Failure of sealant within glazing pocket

Figure 4 – Splice joint with no cover plate.

Strip window repairs included repairing internal seals and thermal breaks and adding splice cover plates at head receptor joints (Figures 15 and 16). Repairs to the internal seals and thermal breaks required temporary removal and reinstallation of glass panels at frame splice locations where leaks had been reported. The strip window repairs were uniquely designed to be performed independently. This gave the contractor flexibility to complete the strip window repairs before, during, or after installation of the stucco system. Frame splices were only repaired at known leak loca-

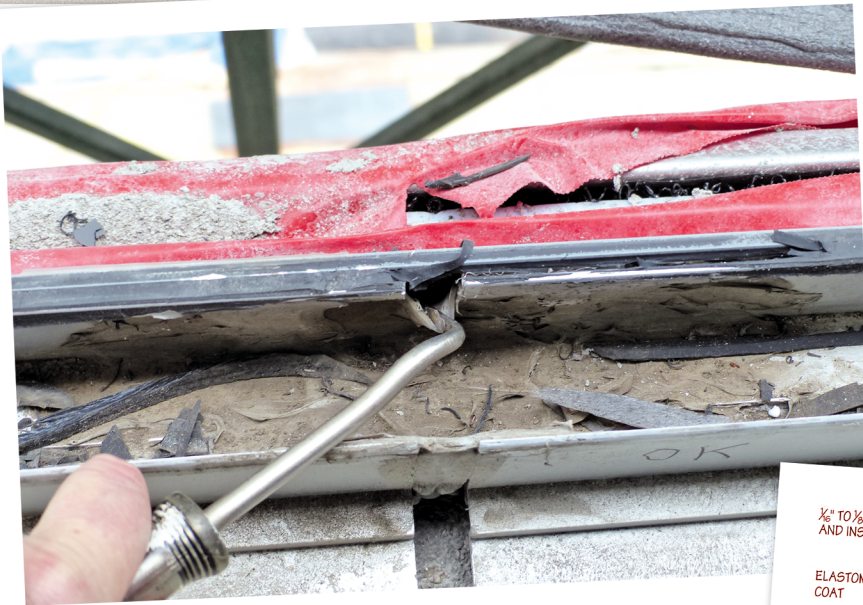
Figure 5 – Failure of retrofitted sealant at splices.

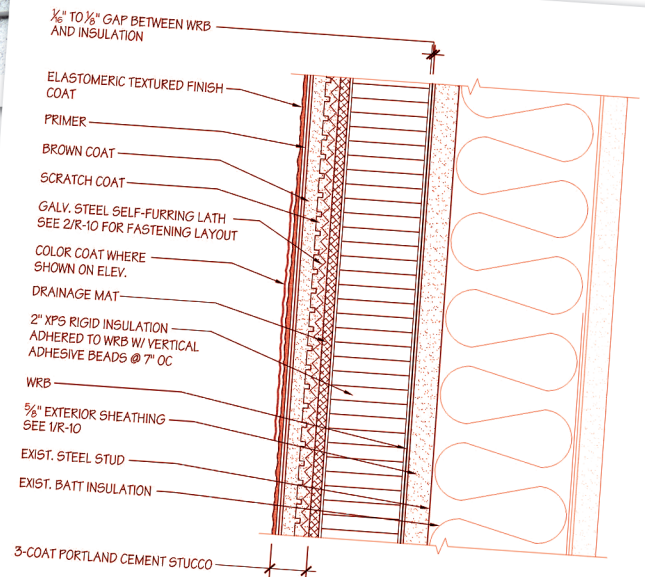
1 TYPICAL EXTERIOR ASSEMBLY
6" = 1'-0"

Figure 6 – Stucco system detail.

The three-coat stucco system was designed to appear nearly identical to the existing EIFS system, but to incorporate redundant resistance to water penetration (Figure 6). The scope of work included complete removal of the existing EIFS cladding system and installation of new sheathing, fully integrated water-resistive barrier, secondary drainage cavity, insulation, drainage composite, and three coats of Portland

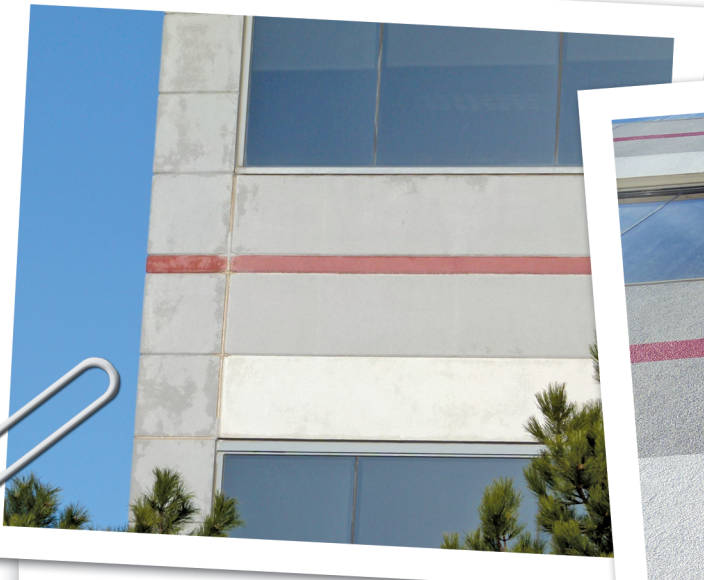
Figure 7 – Original EIFS cladding.

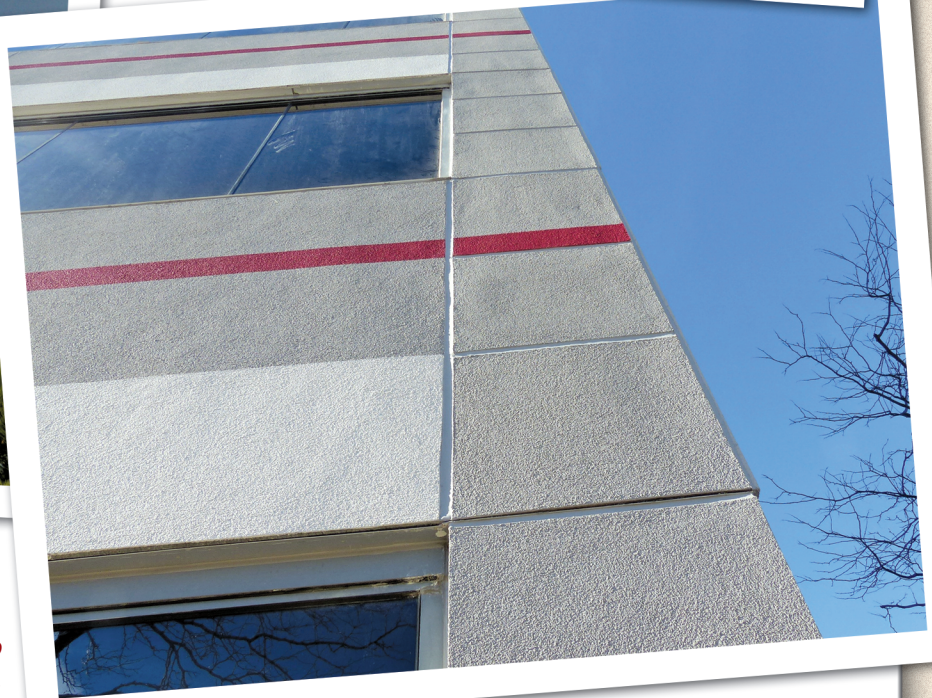
Figure 8 – Stucco system designed to replicate original appearance.

was tinted to replicate the light and dark gray colors of the original EIFS panels. An acrylic-based finish coating was then used to replicate the red stripe accent bands (Figures 7 and 8).

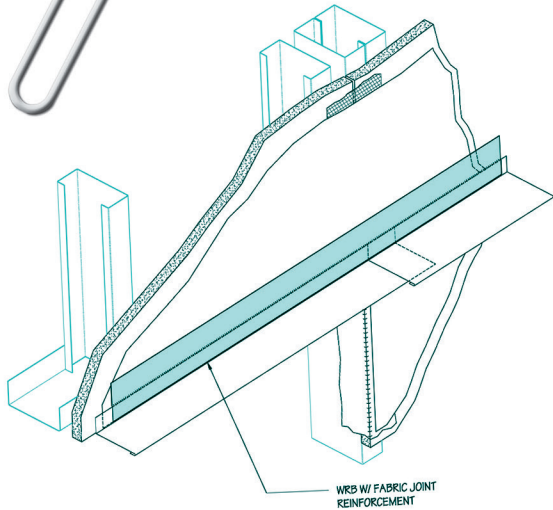
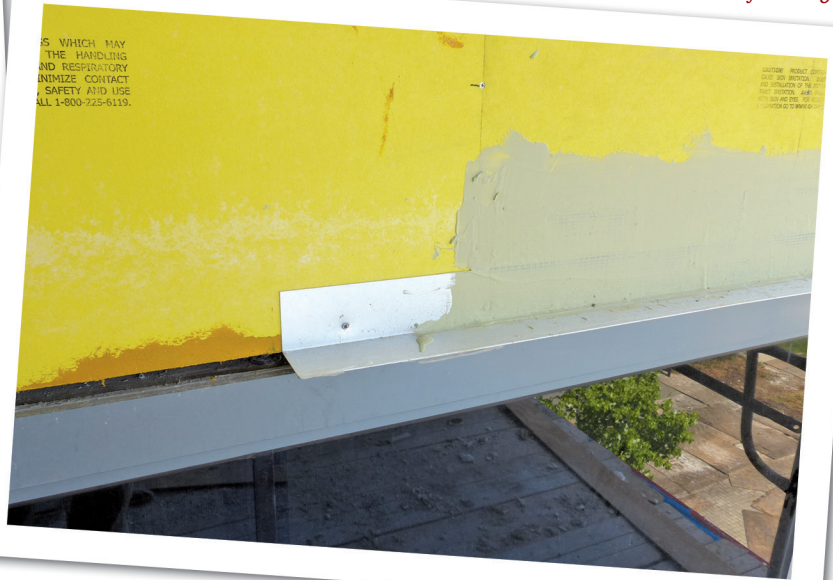
Figure 9 – Window head flashing detail.

Figure 10 – Window head flashing.

Intricate flashing details were developed to redirect water that penetrates the stucco system back to the exterior (Figures 9 and 10). The integration of the new cladding system components made material selection a critical design consideration. The stucco system manufacturer was selected because of its capability to provide appropriate water-resistive barrier (WRB) and fluid-applied flashing materials, allowing the entire cladding system to be captured under a single warranty. Using a single manufacturer also helped minimize potential for compatibility issues among various materials.

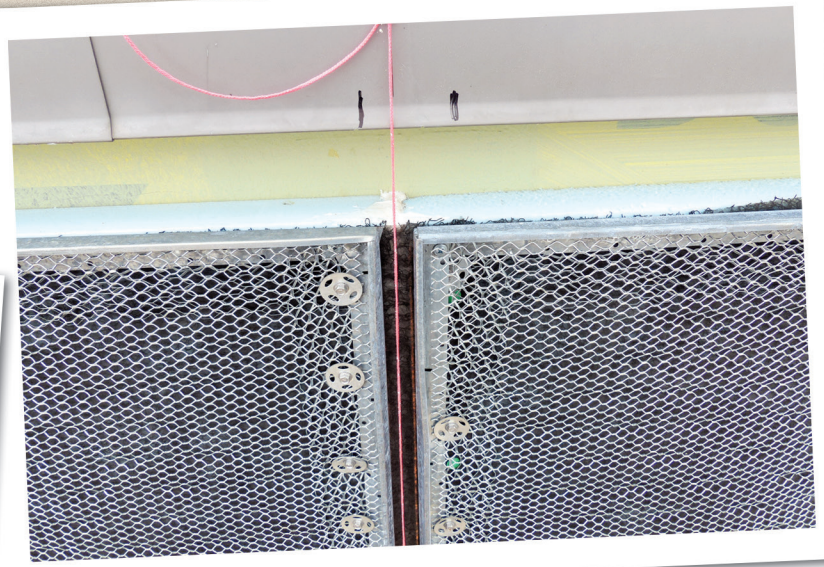
Figure 12 – Metal lath fasteners spanning across insulation and sheathing.

Figure 11 – Joint detail for metal lath fasteners spanning across insulation and sheathing.

Prescriptive requirements for fastening metal lath to light-gauge framing were based on the most common stud spacing used in the industry (i.e., 12, 16, or 19.2 inches). However, the light-gauge steel studs at the building were spaced at 24 inches. As such, detailed calculations and fastener patterns were necessary to ensure adequate resistance to wind loads, given the atypical stud spacing. Additionally, the metal lath fasteners had to span across 2 inches of insulation and the exterior sheathing to anchor into the existing studs (Figures 11

and 12). As such, the anchors had to be designed to withstand bending stresses in addition to shear and pullout strength considerations.

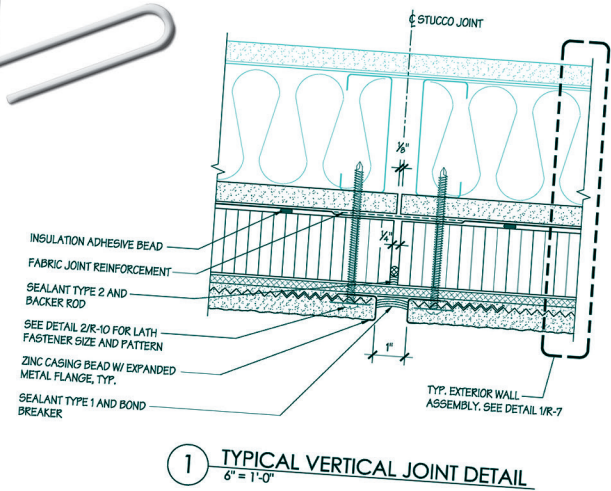
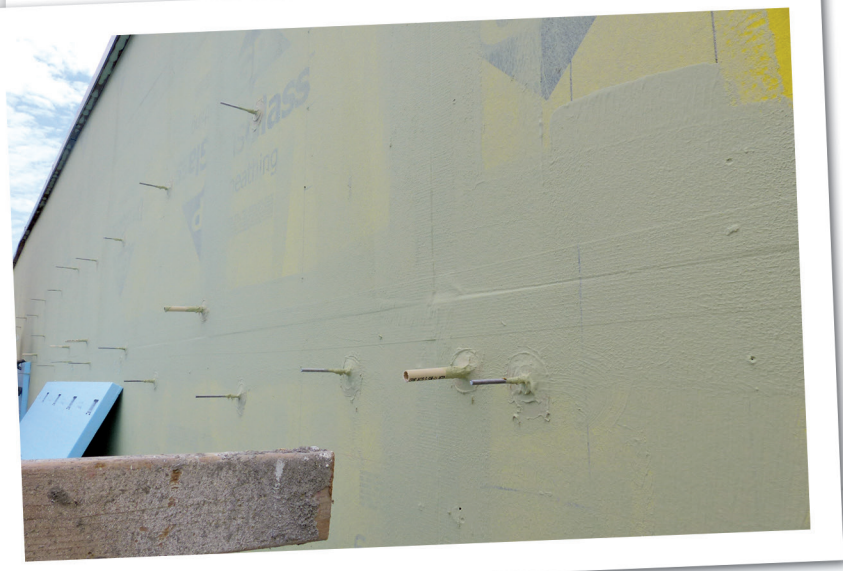
Figure 13 – WRB application around signage support anchors.

Figure 14 – Reinstallation of signage over finished stucco cladding.

longer anchors and conduits to span across the thicker stucco system. Location of the anchors needed to be closely coordinated by the various trades prior to installation of the stucco system components so they could be properly flashed with the fluid-applied WRB (Figures 13 and 14).

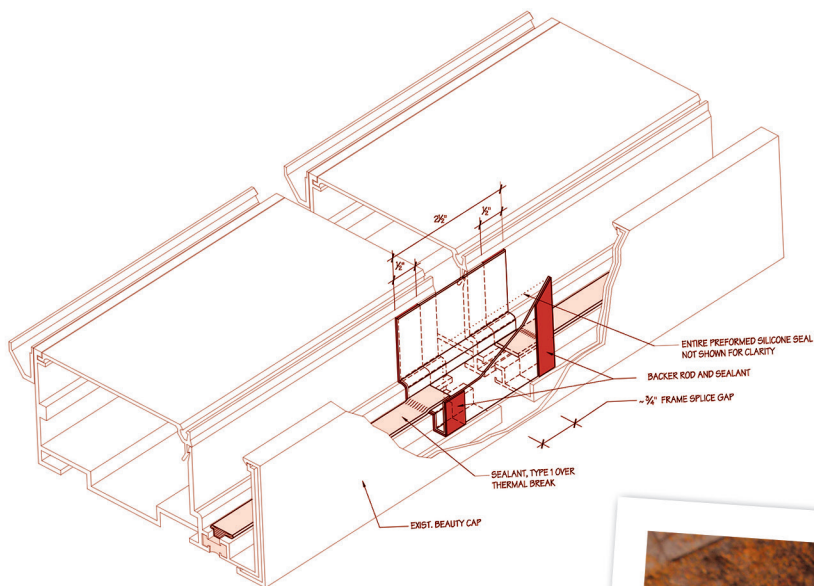
Figure 16 – Strip window repairs.

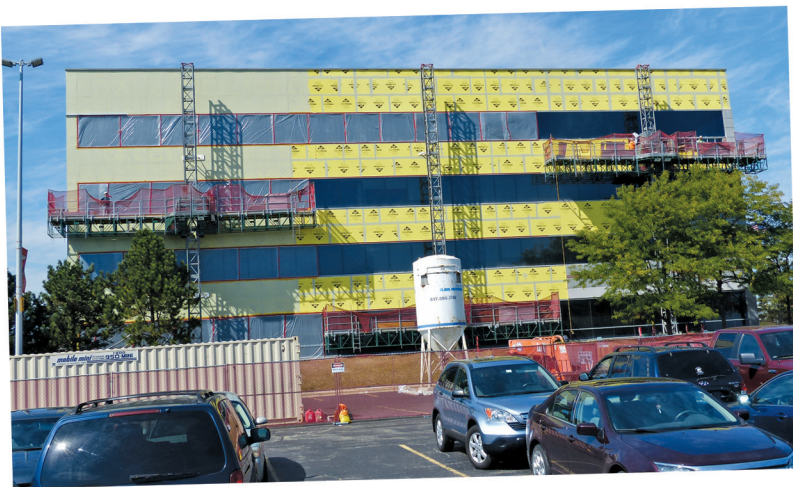
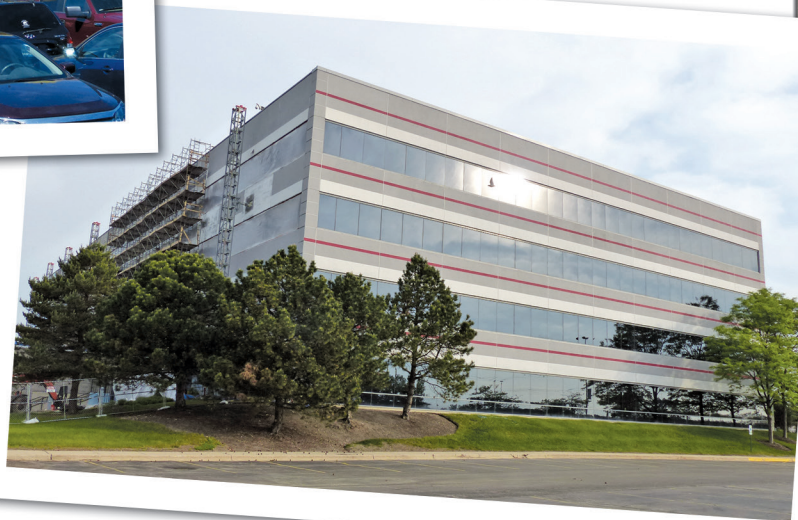
Figure 17 – East elevation during construction.

Figure 18 – Completed east elevation.

The first phase, which included the east elevation only (approximately 10% of the total façade area), was treated as a mock-up phase where the contractor worked through a learning curve in order to establish the most efficient sequencing (Figures 17 and 18). The first phase was completed in three months. The remainder of the building was completed over a five-month period the following year. Mast climbers were used for the

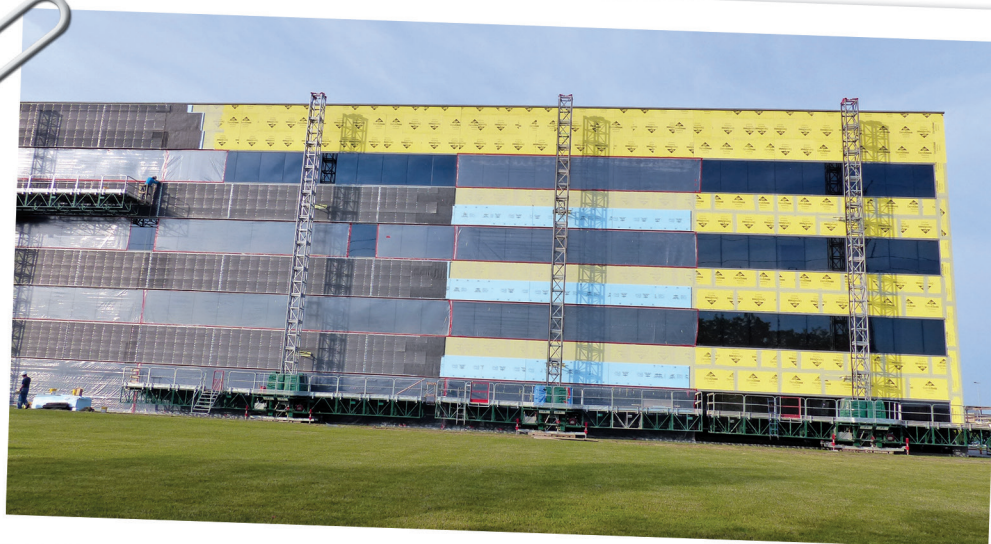
Figure 19 – Metal lath installation several days after sheathing and insulation.

During construction, EIFS panels were removed and new sheathing was fastened directly to the existing steel studs the same day. Metal lath, which also needed to be fastened directly to the steel studs, was typically installed several days after the sheathing fasteners had been covered by the subsequent layers of the stucco wall system (Figure 19). As such, the detailed fastener patterns previously discussed were critical to ensure adequate resistance to wind loads and to ensure proper staggering for the “blind” installation of the metal lath fasteners.

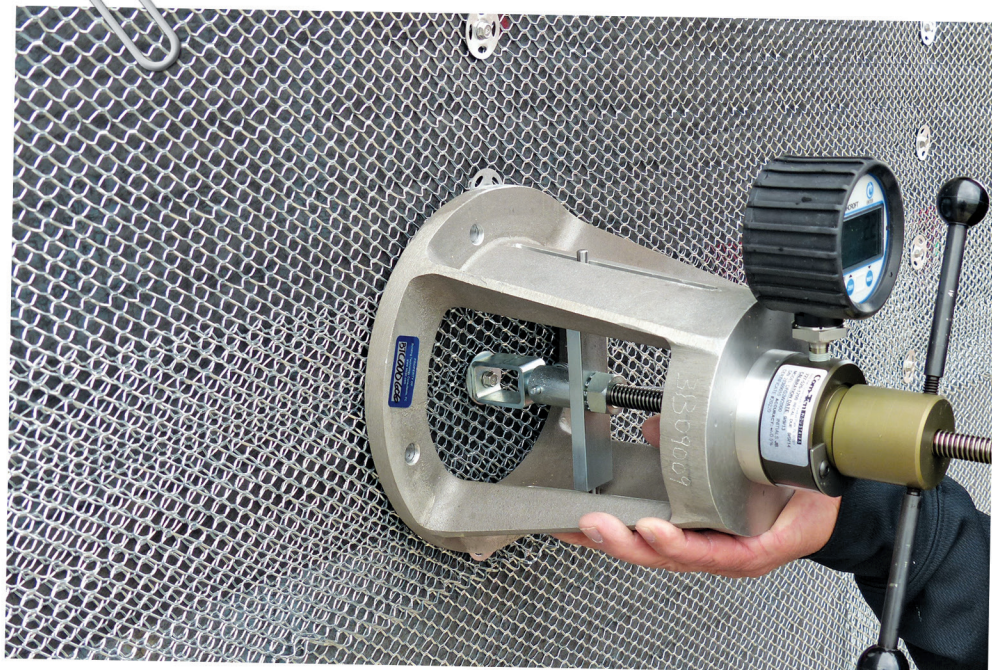
The fourth floor of the building was not occupied and was unfinished during the construction phase of the façade rehabilitation project. As such, fastener penetration into the studs could be verified from the interior on the fourth floor as a measure of quality control. Metal lath fasteners were also randomly tested for pullout resistance using a calibrated pull tester throughout the project to verify their attachment to the steel studs (Figure 20). Fasteners had engaged the steel studs at 100% of the tested locations.

Figure 20 – Fasteners tested for pullout resistance.

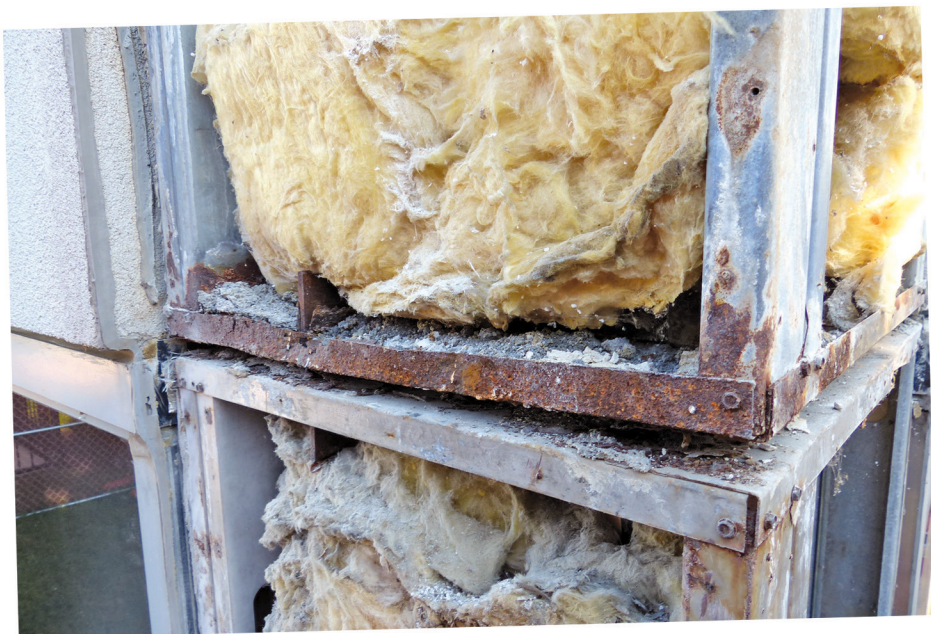
As removal of the existing EIFS panels progressed, some of the light-gauge steel-framing members were found to be severely corroded and needed to be reinforced (Figure 21). A detail was devel-

Figure 21 – Corroded light-gauge steel-framing members.

oped that allowed for a quick installation of reinforcement at corroded framing members to ensure openings could be closed the same day and still provide a sufficient substrate to which to fasten the stucco system components.
