# “LEAKY” EXHAUST VENTS - The 500-lb. Gorilla of Condensation Problems

By Philip D. Dregger, FRCI, RRC, PE

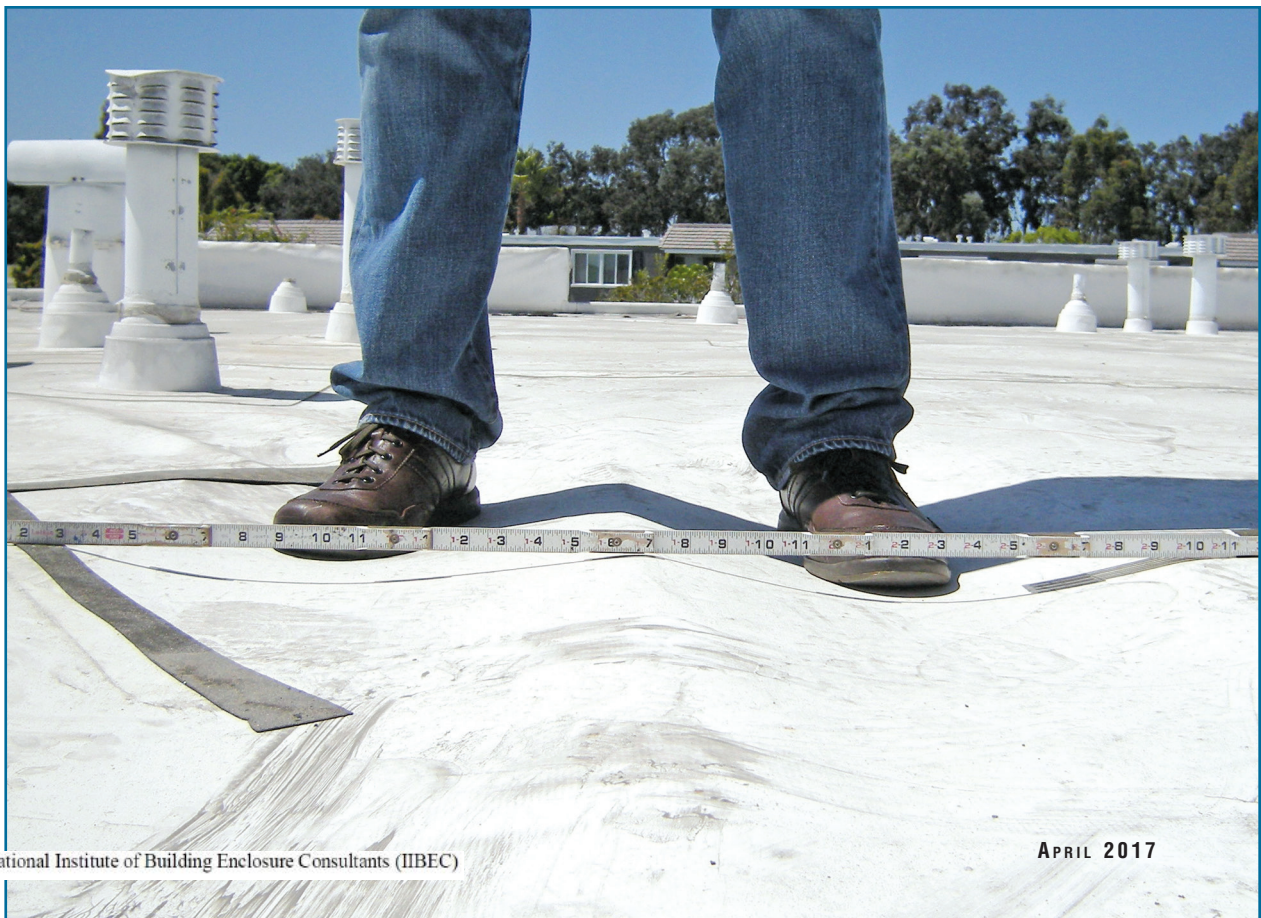
Serious condensation problems often start with someone noticing a soft spot like that shown in *Figure 1*. Typically, the soft spot is positioned near a “high” point on the roof, the roof construction contains air spaces with cold surfaces, and the reroof membrane is considerably more reflective than the old roof membrane. More often than not, the roof is installed over a residential occupancy.

*Figure 1 – Serious condensation problems usually start with someone noticing a soft spot.*

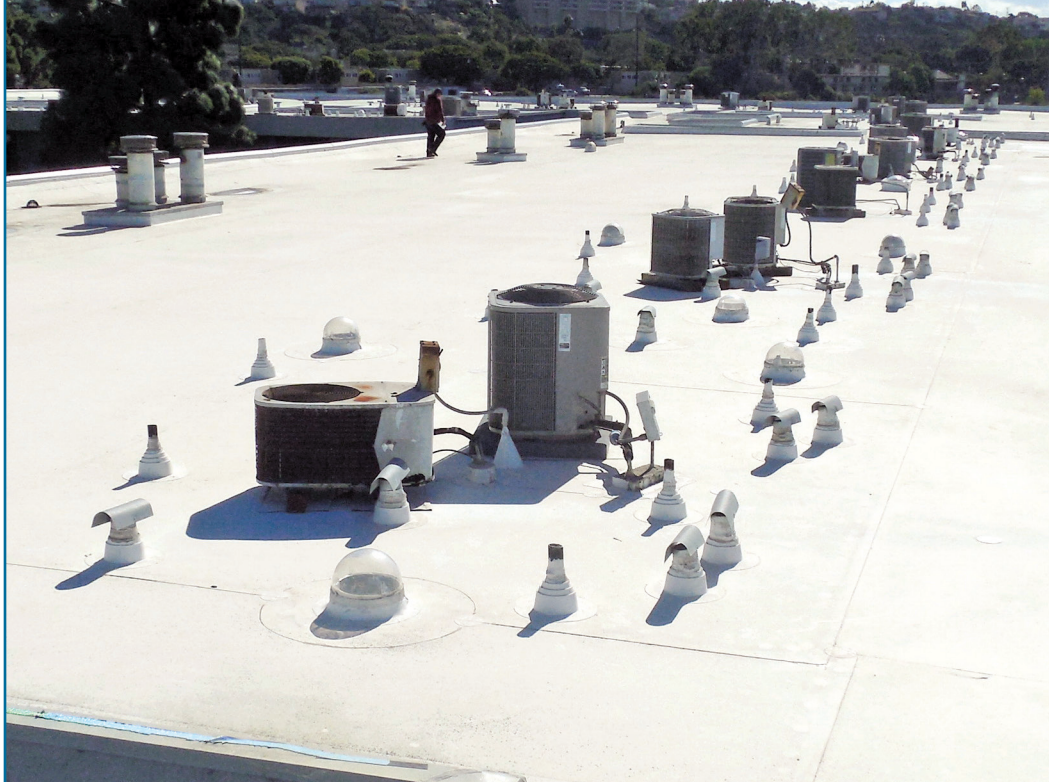
Figure 2 – A high concentration of exhaust vents on the roof of a three-story apartment building.

ment buildings) typically have two or three exhaust vents per unit—something like one or two every 1000 sq. ft. of roof area. Roofs over most nonresidential occupancies have far fewer exhaust vents. *Figure 2* shows a high concentration of exhaust vents on the roof of a three-story apartment building.

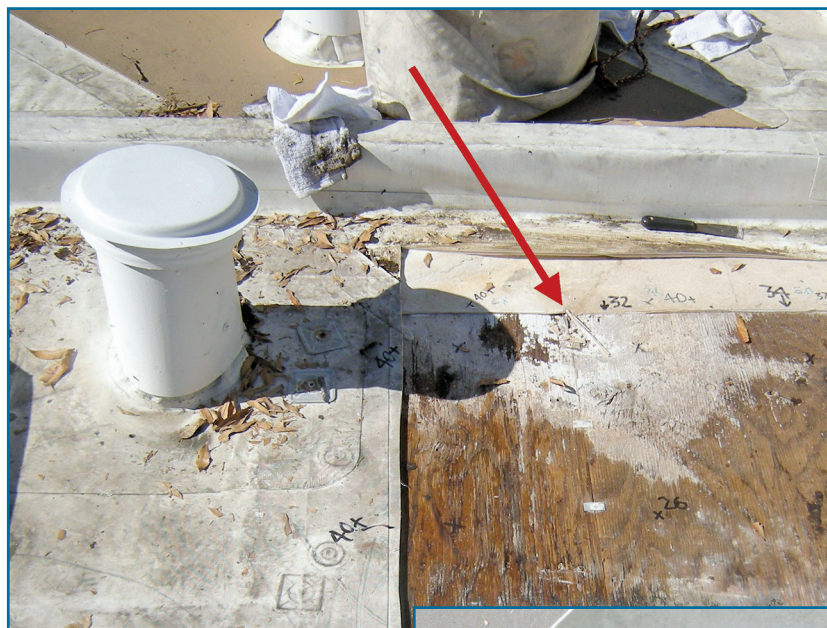
Figure 3A – A “soft spot” (red arrow) found next to an improperly terminated gas vent.

If the gas combustion products are completely vented to the outside, great. If not, you can get serious condensation and wood decay. *Figure 3A* shows a “soft spot” (red arrow) found next to an improperly terminated gas vent. *Figure 3B* shows the gas vent improperly terminated inside the roof flashing assembly very near deck level.

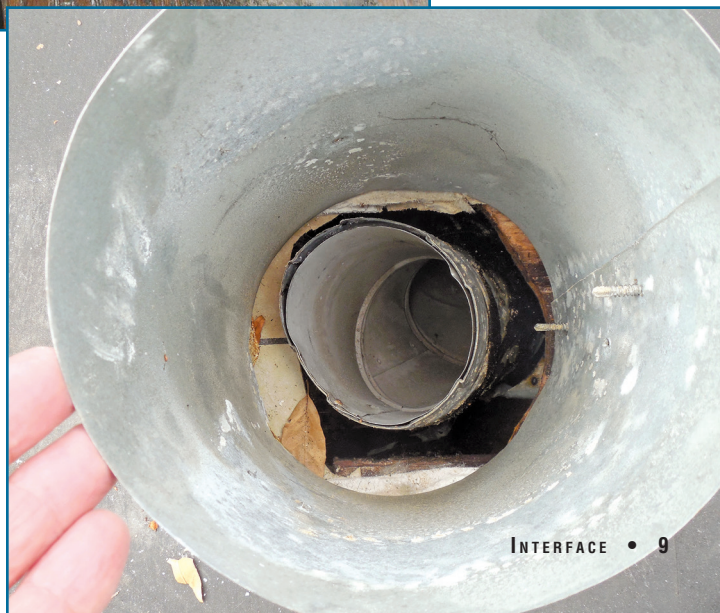
Figure 3B – A gas vent improperly terminated inside the roof flashing assembly very near deck level.

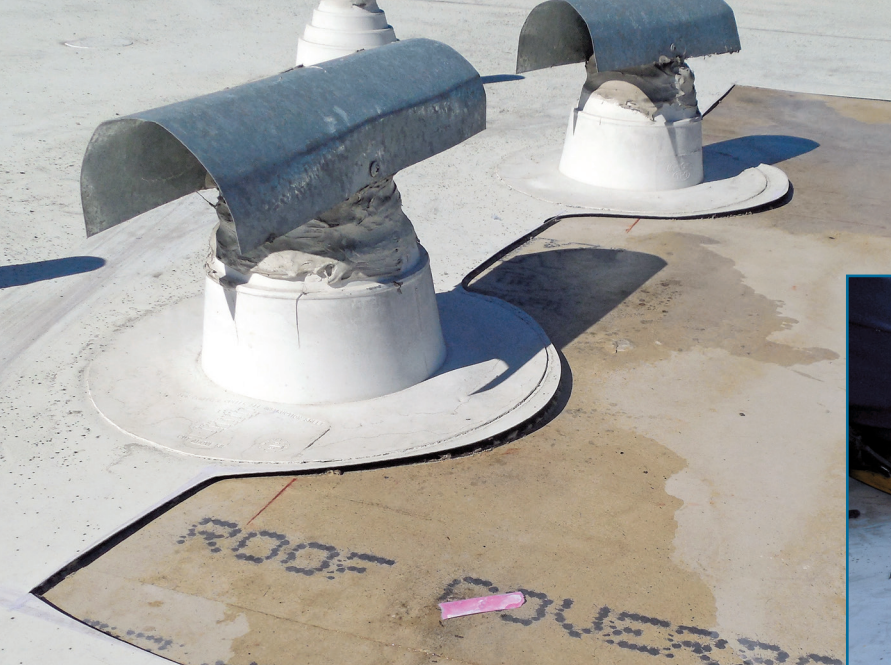
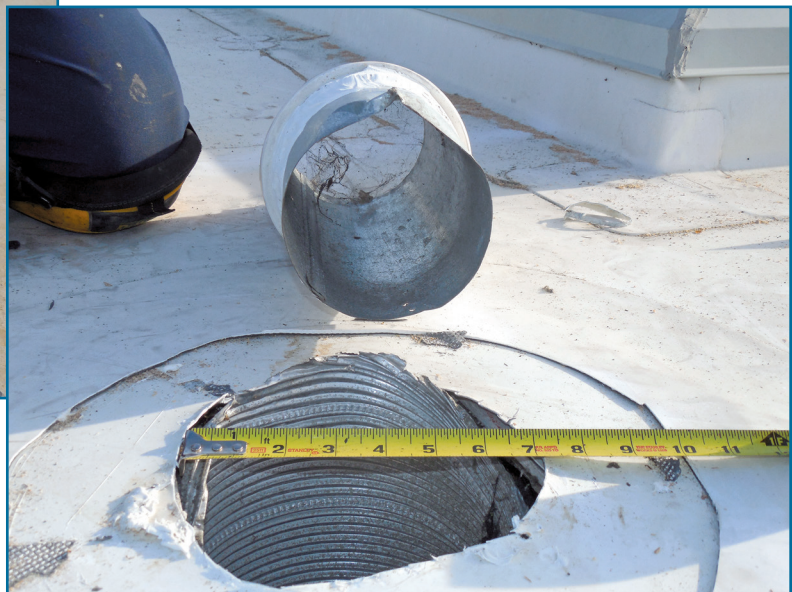
Figures 4A (left) and 4B (below) – A “wet” coverboard is shown next to 7-in. air ducts that terminate below 5-in. T-top flashings.

The conditions shown in Figures 4, 5, and 6 were all discovered while investigating “soft spots” on reroof projects. Figures 4A and 4B show a “wet” cover board next to 7-in. air ducts that terminate below 5-in. T-top flashings. Figures 5A and 5B show two air ducts positioned in one oversized deck opening and terminated inside one large roof flashing. Figures 6A and 6B (red arrows) show a rectangular air duct stopping at deck level and then “extended” upward using a round roof flashing.

It is not clear if the metal flashings installed over these air ducts would be considered extensions of the duct or not, or if the openings in the decks around the ducts would be considered “openings into the building.” Nevertheless, these duct terminations and flashing conditions were all strongly suspected to allow some portion of the exhaust air to flow back into the insulated rafter spaces and make a major contribution to the excessive condensation conditions present.

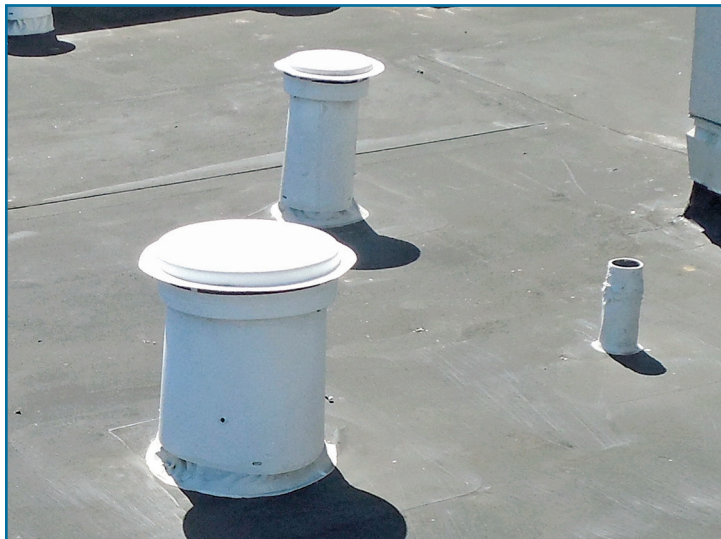
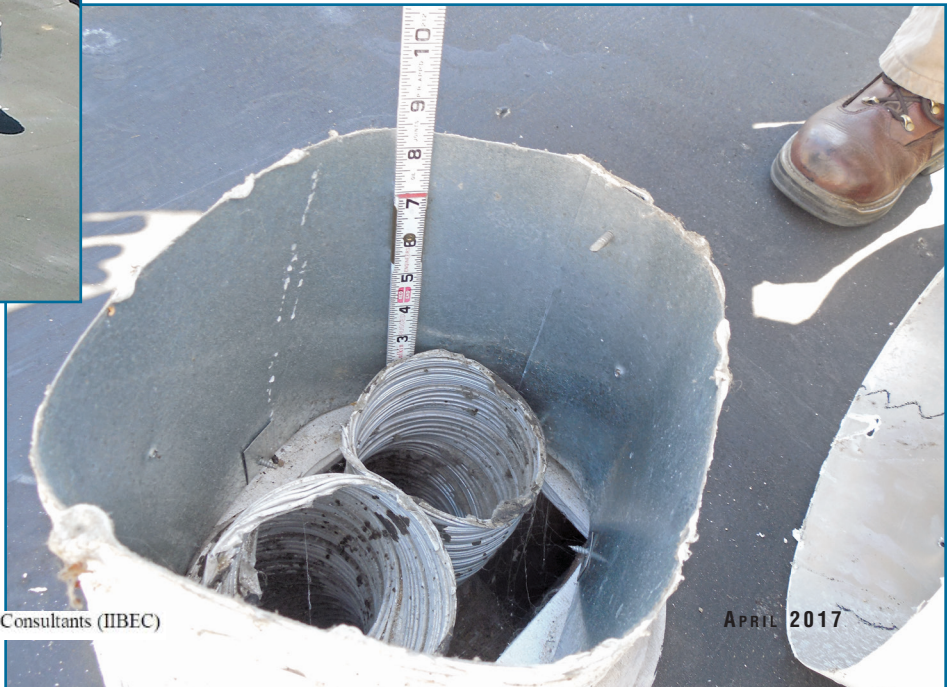
Figures 5A (above) and 5B (right) – Two air ducts are positioned in an oversized deck opening and terminated inside one large roof flashing.

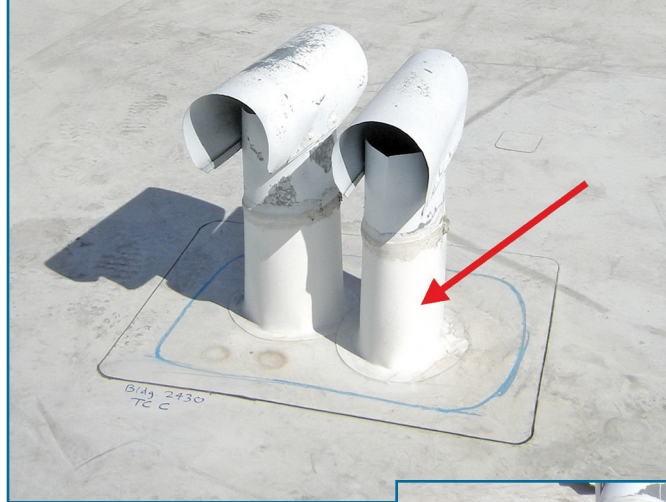
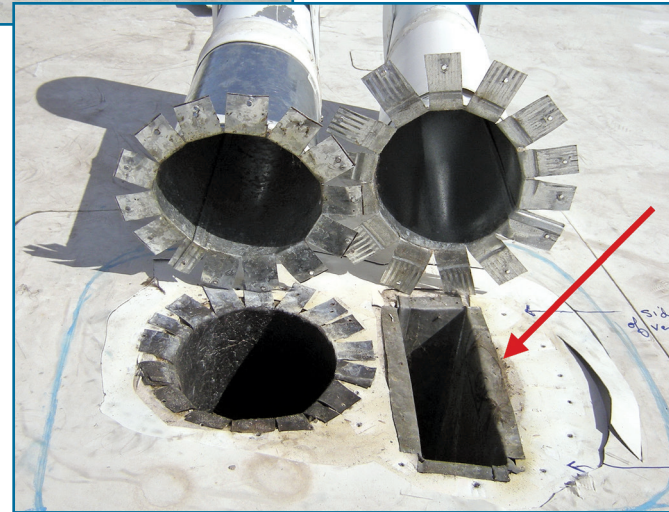
Figures 6A (left) and 6B (below) – Red arrows show a rectangular air duct stopping at deck level and then “extended” upward using a round roof flashing.

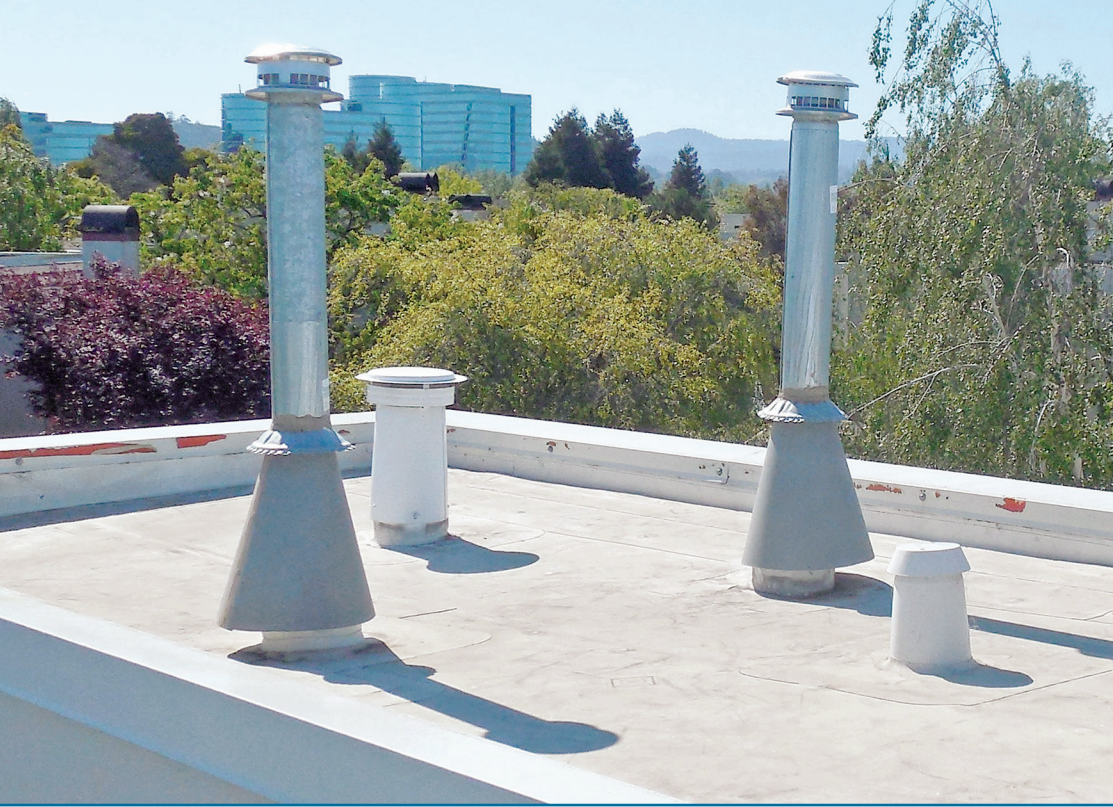
Gas vents have different termination requirements. The 2013 CMC, Chapter 8, requires gas vents to extend completely through roof flashings, extend to a height at least 12 inches above the roof deck, and have “listed caps.” Figure 7 shows two properly extended and terminated gas vents.

Figure 7 – Two properly extended and terminated gas vents.

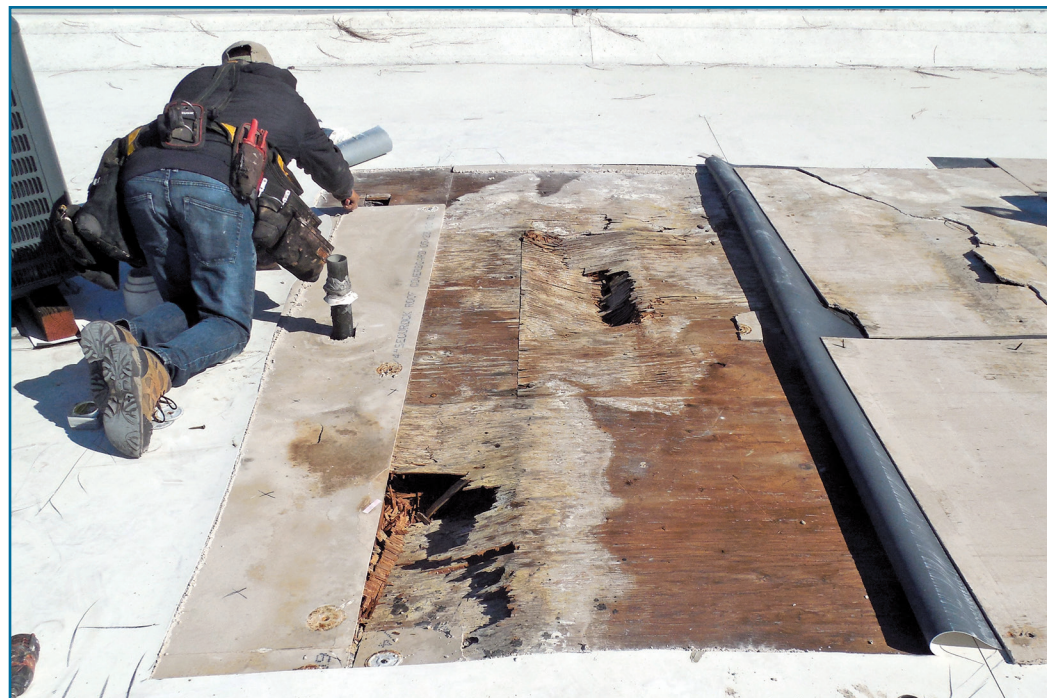
Figure 8 – An area of concentrated decay.

Figure 8 shows an area of concentrated decay. The area is not near a low spot or next to a penetration, but penetrations are nearby. No rain leaks were reported, and the top of the gypsum ceiling boards had

only limited stains. The decay is not reasonably explained by a roof leak; it is a telltale sign of an existing condensation problem.

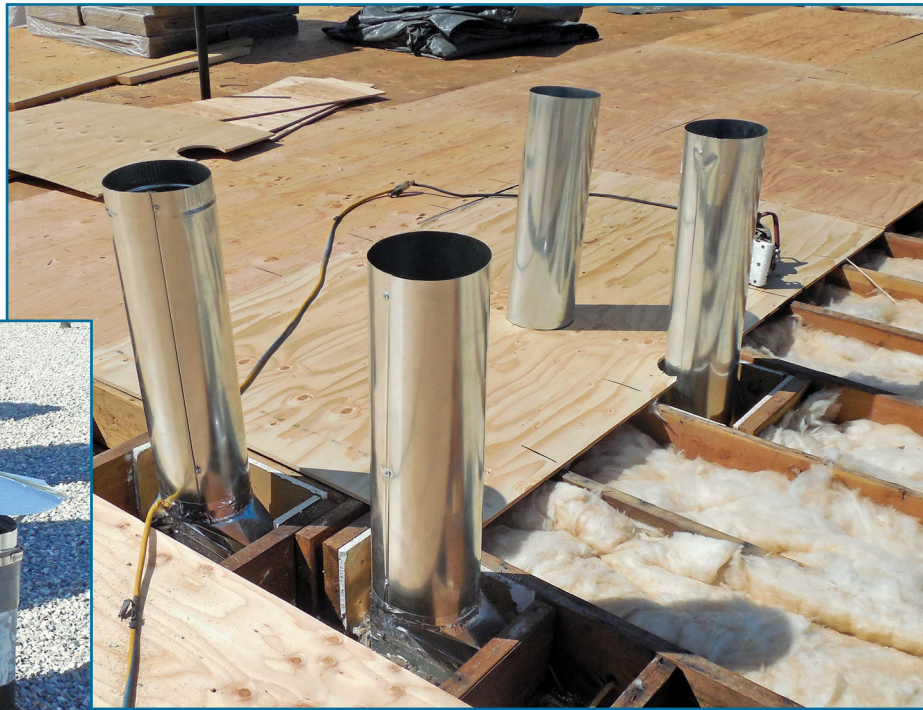
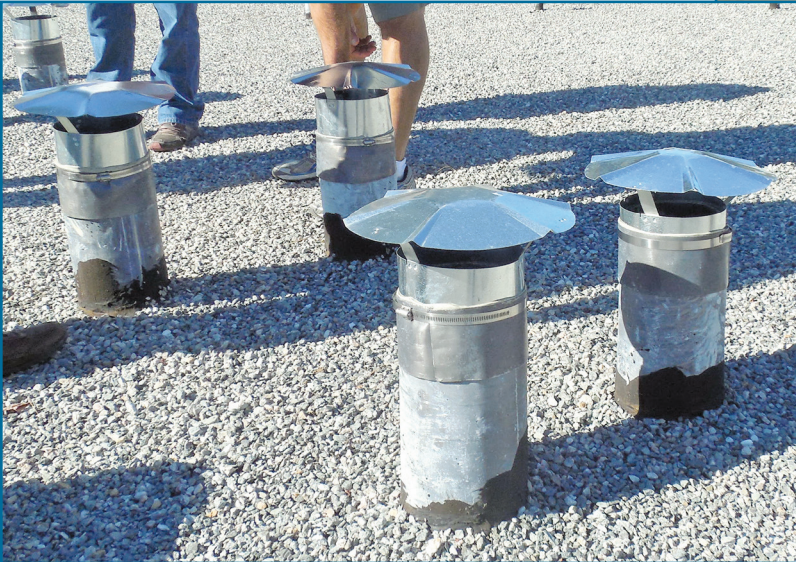
Figures 9A (right) and 9B (below) – Example of how existing low air ducts can be extended and flashed.

When “low-exhaust” vents are uncovered, extend them in accordance with code requirements. Obtain the assistance of a mechanical engineer or a design/build mechanical contractor as needed. *Figures 9A and 9B* show one example of how existing low air ducts can be extended and flashed.
