DUTCH LAP SLATE ROOFING

By Jeffrey Levine

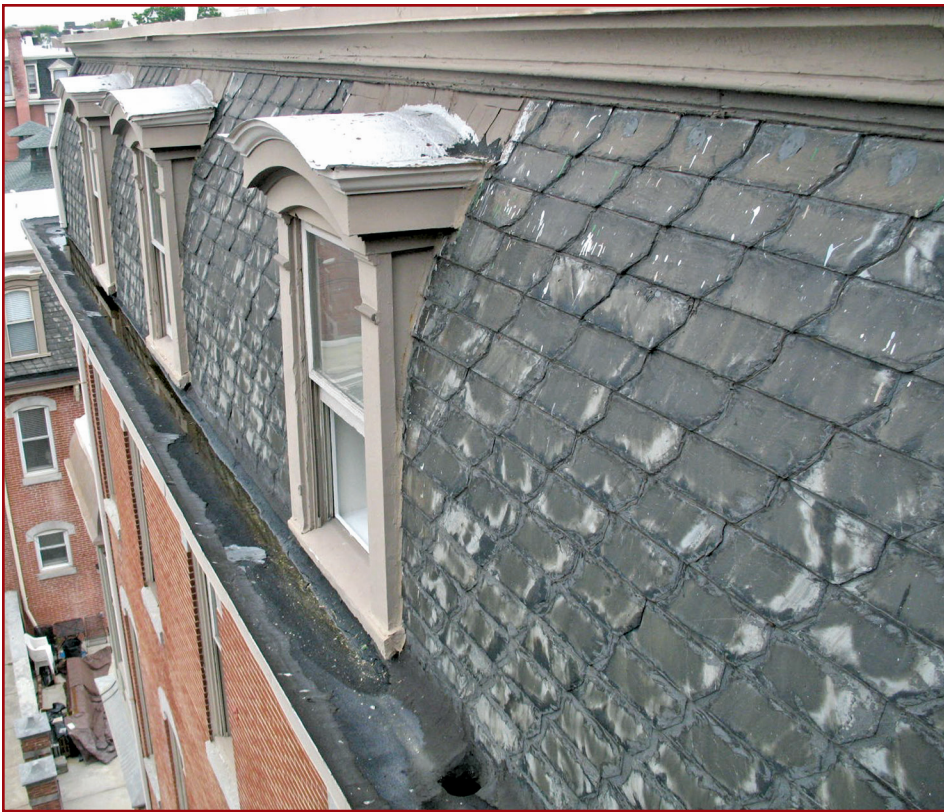
Figure 2 – Original Dutch Lap slates on the mansion’s convex mansard roof.

The roof on the lower portion of the mansard consisted of grayish-black slate shingles with slightly visible ribbons—likely Pennsylvania Hard-Vein (also known as Chapman) slate from Northampton County, Pennsylvania, and presumed to date from the original construction. The 16- x 8- x ¼-in.-thick slates were laid directly atop a tongue-and-groove wood roof deck and asphalt-saturated rag felt. To better accommodate the convex shape of the lower mansard, the slates were laid in a Dutch Lap pattern with clipped corners (Figure 2).

Curiously, all joints between slates at the Main House and Carriage House were covered with mastic. Was this just due to a misguided repair as suggested by one contractor, or a much-needed upgrade implemented after some particularly severe weather? We needed to know and were about to find out. With the major renovation of interior spaces nearly complete, the owner was anxious to replace the aged existing roof with a new, weathertight slate roof having a 100-plus-year service life.

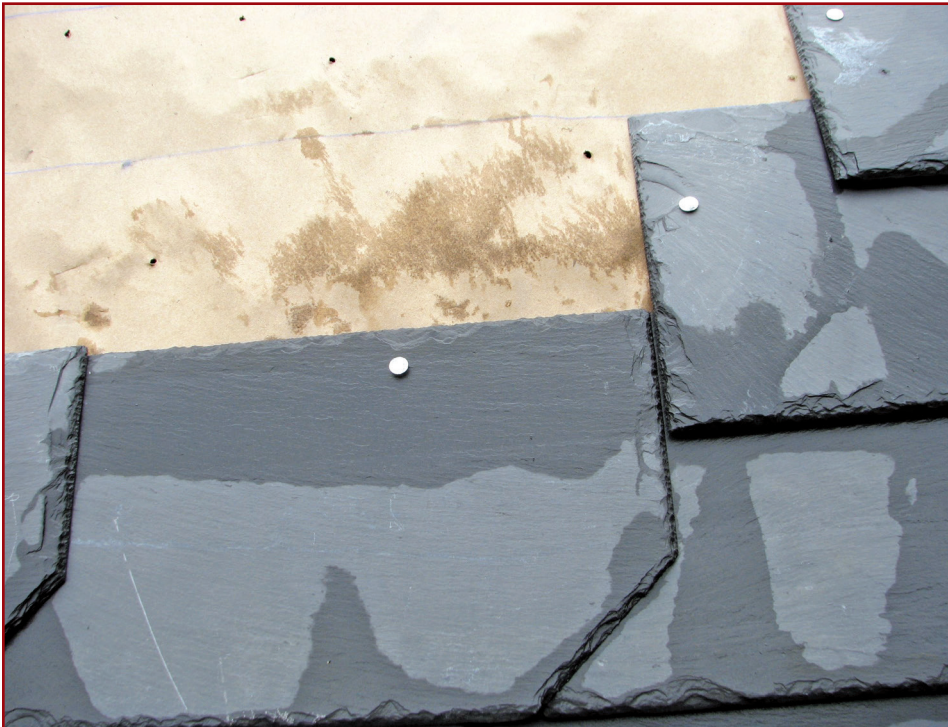
Water testing was carried out using a garden hose. Water was systematically sprayed at various angles (downward, straight on, at a slight side angle [i.e., into the side laps], and at an upward angle) for durations of three to five minutes. After each interval, slates were removed. When water was sprayed at a downward angle, the rosin paper was found to be dry. Some water did extend into the side and top laps of the slate, but not enough to reach the nail holes. When water was sprayed straight on and at side and upward angles (simulating wind-blown rains), areas of wetness on the underlying rosin paper were observed, and a significant portion of the concealed areas of the slates were wet, including areas around many of the nail heads (*Figure 5*).

Water testing confirmed our suspicion that in a steady rain with no wind, slates laid in the Dutch Lap pattern with a 4-in. side lap and 3-in. top lap will shed water with little, if any, moisture penetrating below the slate shingles. In a heavy rain

Figure 5 – Wetting of rosin paper and within top lap when water was sprayed at an upward angle.

or rain with driving winds, however, some water will penetrate below the slates. The specified double layer of #30 felt underlayment would shed most of this water. Over time, though, the felts would likely deteriorate, and some water would find its way to the wood roof deck or possibly even leak into the building. This was unacceptable.

Given the results of the water testing, Dutch Lap slate laid atop #30 felt was not a viable system for the long term. We, thus, went back to the owner with design options. These included the following.

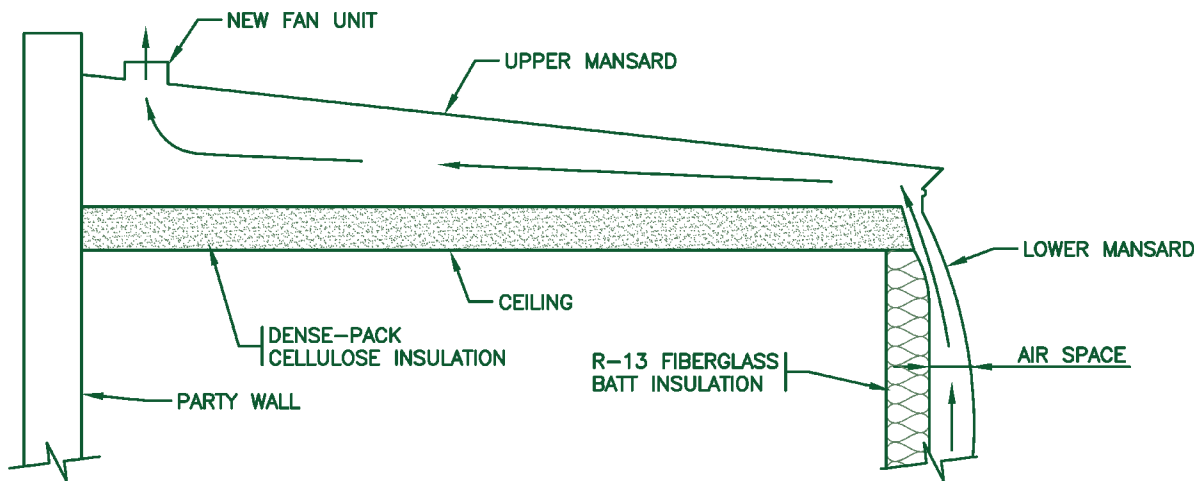
Figure 6 – Schematic section through front half of the mansion, showing continuous air space for ventilation.

mansards (Figure 6). It was agreed that we could ventilate this space and prevent or mitigate condensation on the underside of the roof decking.

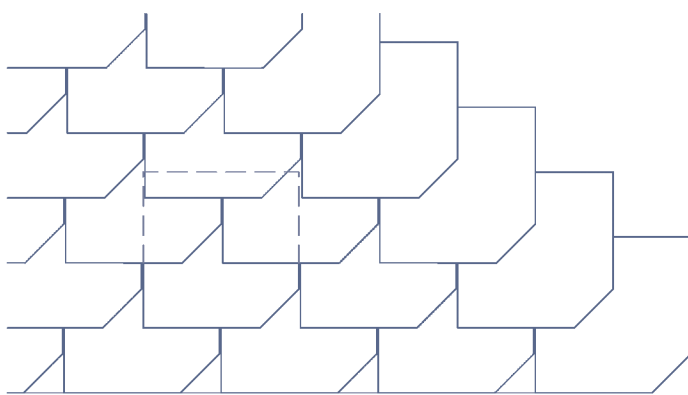
Figure 7 – Sketch provided to the owner showing what 12- x 12-in. slates with one clipped corner would look like when installed in the traditional manner. The exposure and the size of the clipped corners are the same as that of the existing slates. The appearance is quite different, however, compared to the Dutch Lap.

- 3) The pattern of the slate would change dramatically (Figure 7).

All of these factors lead to rejection of slate laid in the traditional manner.

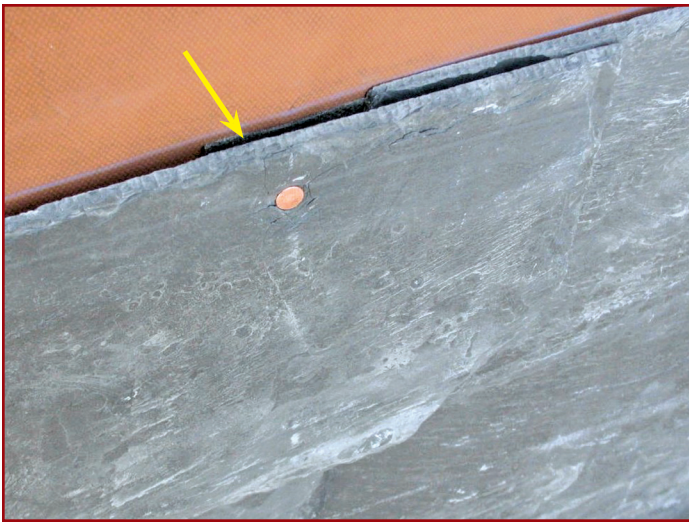
Figure 8 – Just prior to the installation of each slate shingle, a 4- x 4-in. piece of self-adhering tape was placed on the underlayment at each slating nail location to help seal around the nail holes.

lent dispersion coating, which, according to the manufacturer, can withstand repeated wet/dry cycling and still retain a service life equal to that of the slate shingles. It has a permeance of 550 perms (per ASTM E96, Procedure B, Water Method) and is supported by special tape accessories that were used to a) seal the heads of the cap nails employed to secure the underlayment to the roof deck, and b) seal around the slating nails (Figure 8).

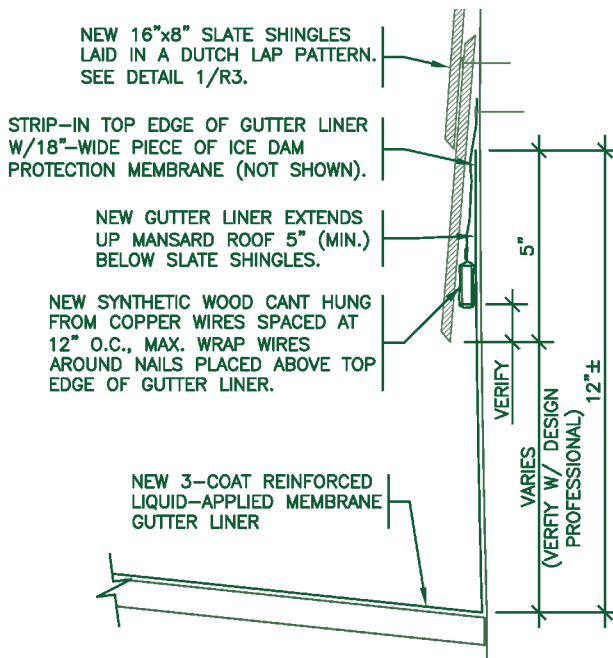
Figure 9 – Section showing cant and first course of slate above the gutter.

Similarly, a Dutch Lap slate roof needs a cant in order to “get the slates to lay,” but does not necessarily need a starter course. At the mansion, a new liquid-applied membrane gutter liner provides sufficient waterproofing below the first course of slate, such that a synthetic wood cant hung from copper wires could be used as a cant (Figure 9). In other situations where the roof underlayment might be a single or double layer of felt, a narrow slate measuring roughly half the length of the slate can be used as a combination cant and starter course. This is, in fact, the way the original roof at the mansion was detailed (Figure 10).

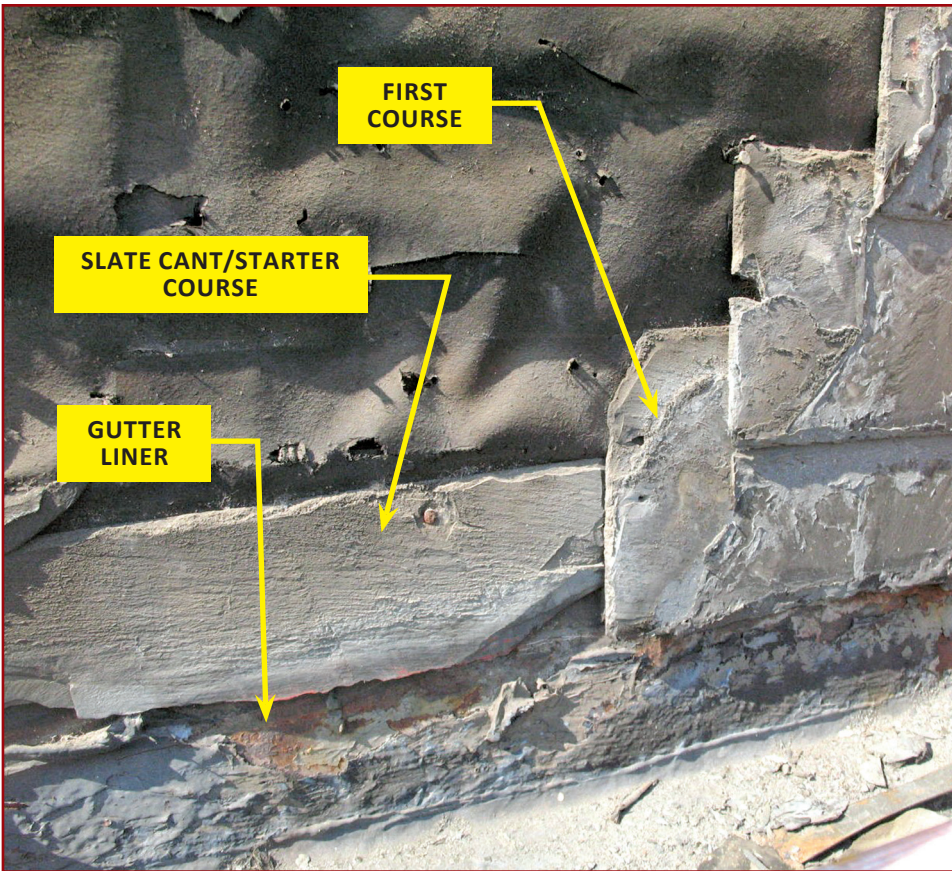
Figure 10 – Original combination cant and starter slate above the mansard’s gutter.

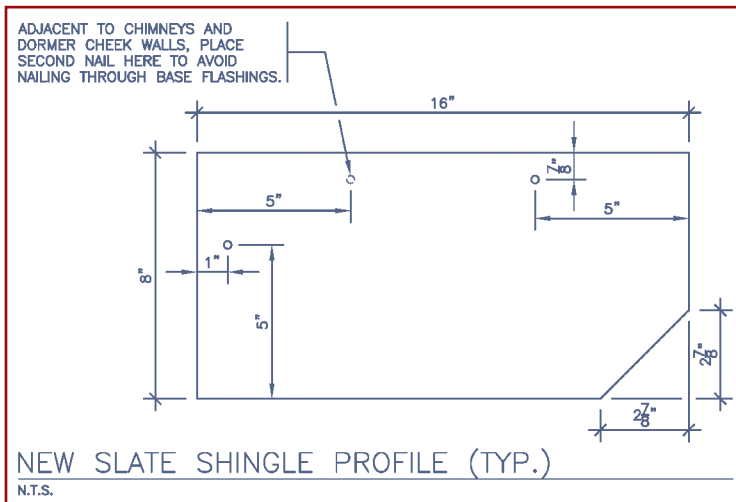
Figure 11 – Sketch of nail locations for a 16- x 8-in. slate shingle to be used in a Dutch Lap pattern.

One nail approximately $\frac{7}{8}$ in. down from the top edge of the slate and in from the leading edge of the slate a distance equal to one-third the width of the slate, minus around $\frac{1}{2}$ in. (in this case, 16 in./3 minus $\frac{1}{2}$ in. \approx 5 in.). The second nail is positioned 1 inch in from the trailing end of the slate and a distance up from the bottom edge of the slate equal to the exposure. Where slates overlap base flashings, as at chimneys and vertical walls, the second nail location at the side of the slate cannot be used. Instead, to avoid puncturing the underlying flashings, a second nail should be added along the top edge of the slate (Figure 11).

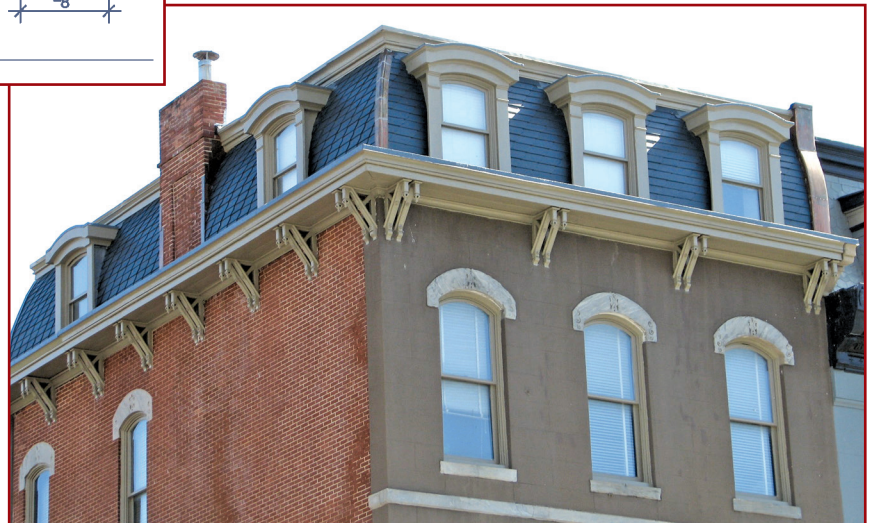
Figure 12 – View of new right-handed Dutch Lap slates at the mansion.

The slates in a Dutch Lap roof are directional due to the side laps. Right-handed slates appear to point to the right and are installed from right to left. Left-handed slates appear to point to the left and are installed from left to right. Slate direction is purely an aesthetic consideration, but once selected must be continued on any given slope until a natural stopping point, such as a hip or vertical wall, is reached. The slates on the mansion were originally all right-handed, and the owner elected to replicate this aesthetic in the new roof (Figure 12).

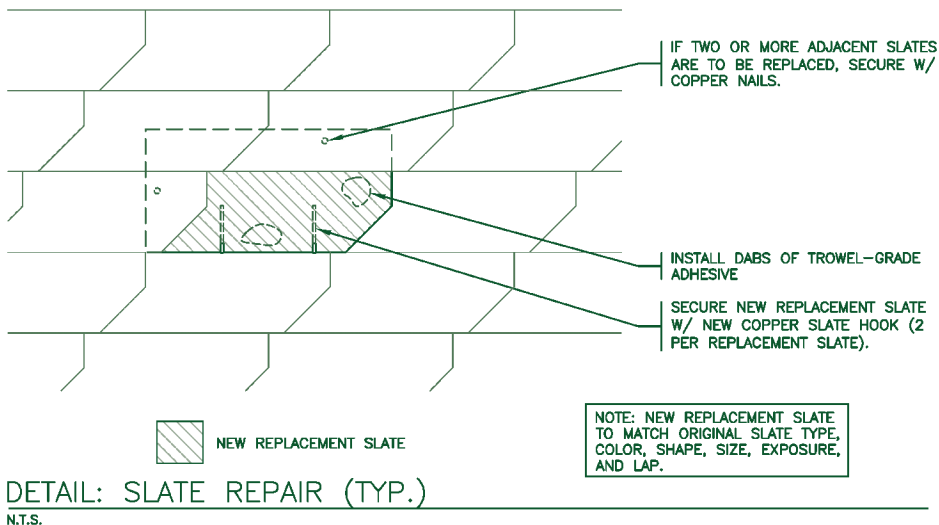
Figure 13 – Slate repair in a Dutch Lap roof.

roof because there are no true bond lines in which to insert a nail and bib. Therefore, every effort should be made to avoid damaging the shingles during the construction process. If a shingle is broken, however, a pair of slate hooks and a couple of dabs of trowel-grade adhesive or sealant adhesive (to help prevent wind chatter) can be used to form an effective repair (Figure 13).
