BUILDING ENVELOPE TECHNOLOGY SYMPOSIUM

CAN A POOR AIR SEAL CAUSE ROOF FAILURE?

**TIMOTHY A. MILLS, PE, CIT II, LEED AP,
CERTIFIED ABAA AUDITOR**

TAM CONSULTANTS, INC.

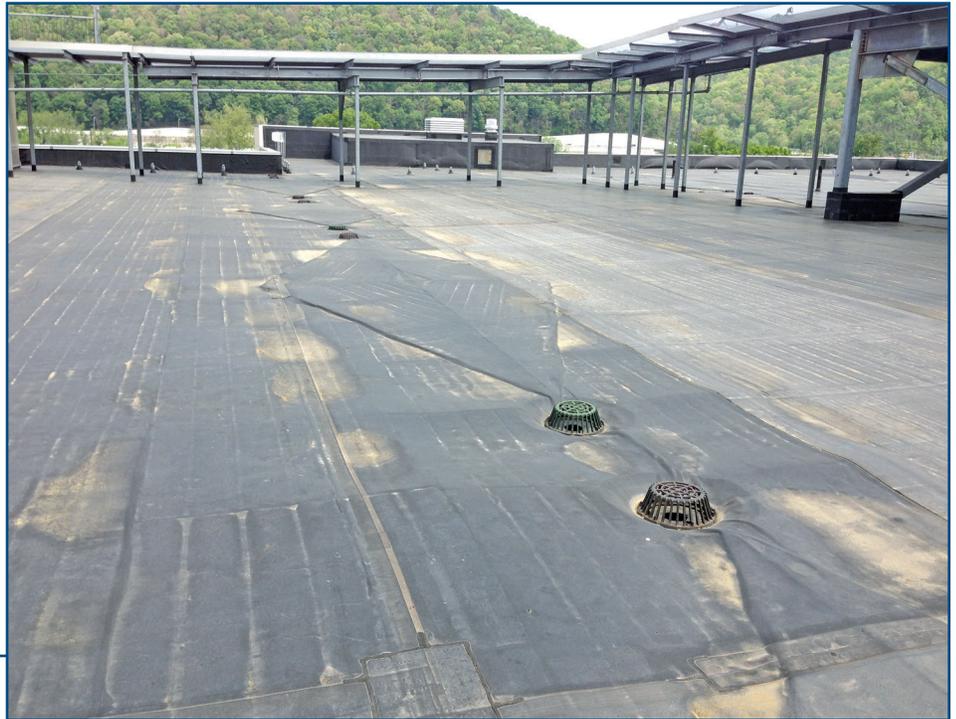
Figure 1 – View of failed roof system. The photo does not convey the large amount of insulation deformation. Note dirty spots where ponding frequently occurs.

there had been widespread bowing, cupping, delamination, or debonding in large areas of the roof insulation. This was readily visible on approximately 30 percent of the roof area. This damage to the roof insulation occurred lengthwise along the long direction of the insulation boards, as is typical. The displacement of the insulation was severe enough that it created many ponding areas across the roof and impeded water flow, preventing the roof from easily draining.

The final recommendations included replacing the entire roofing system and ensuring an airtight seal between the roof deck and the parapet walls and at all other penetration locations so that the transfer of interior building air into the roof assembly is mitigated. The final recommendations also included sealing of all of the drain holes in the structural steel tube columns.

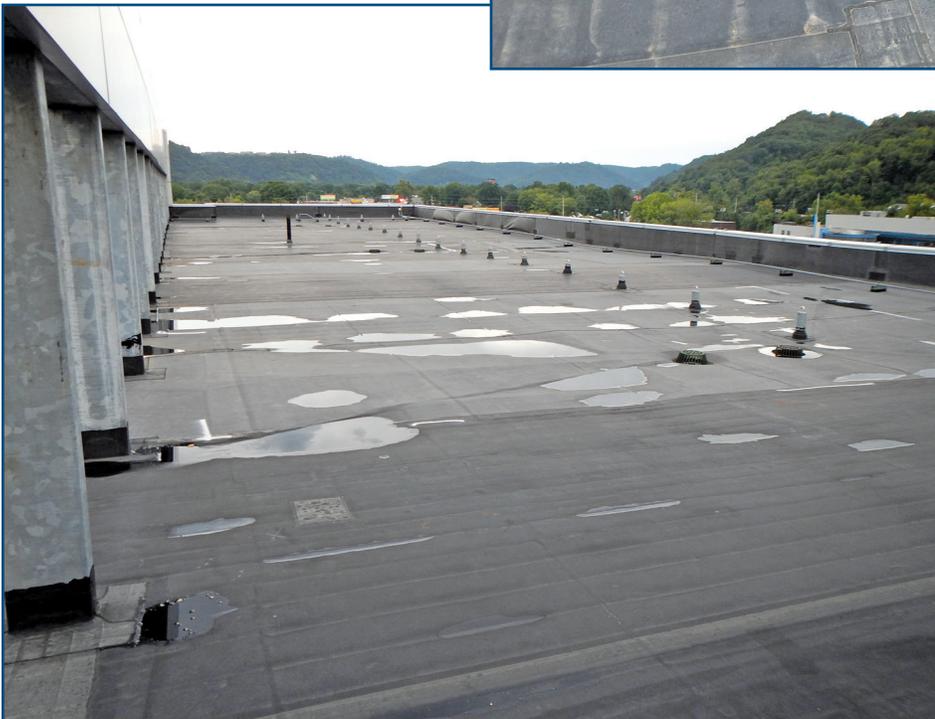
Figure 2 – View of roof area following a storm event, where ponding areas and insulation deformation are more evident.

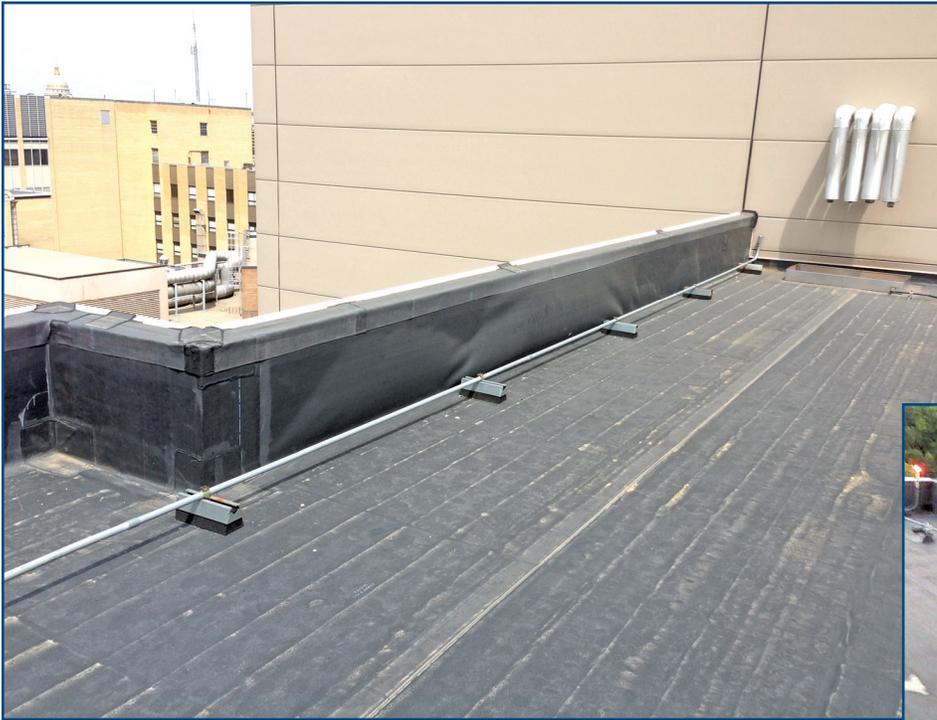
Figure 3 – View of a parapet wall where EPDM membrane has debonded from the wall surface.

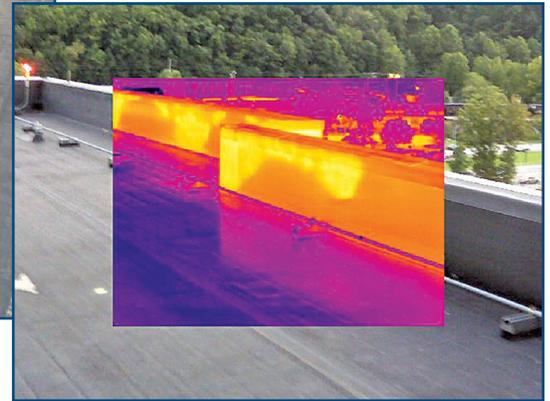
Figure 4 – Thermal image of parapet wall where membrane separation is clearly visible.

It was observed that the fully adhered roof membrane had separated from the precast parapet walls in many areas around the entire perimeter of the building. During the inspection of the roof membrane lap seams, it was determined that, in general, the EPDM roof membrane seams appeared to be in serviceable condition with very few deficiencies noted, and were in need of perhaps a small amount of maintenance. It was also observed that interior building air pressurization from the mechanical system was affecting the roofing system to the extent that where the roof membrane had become debonded on the parapet walls, the membrane was ballooning out due to internal building pressure. In addition to the observed debonding of the membrane from the parapet walls (Figure 3), the membrane had also become debonded from the reinforced EPDM strip at the base of the wall where the roof membrane turns up the wall and is adhered to the EPDM strip (Figure 4).

The result of the IR study found only four small areas of wet surface insulation, and those areas were adjacent to penetrations and not located in areas where the failed and delaminated roof and insulation had occurred. The thermal imaging survey also clearly revealed areas of debonded roofing membrane at the parapet walls around the entire roof area.

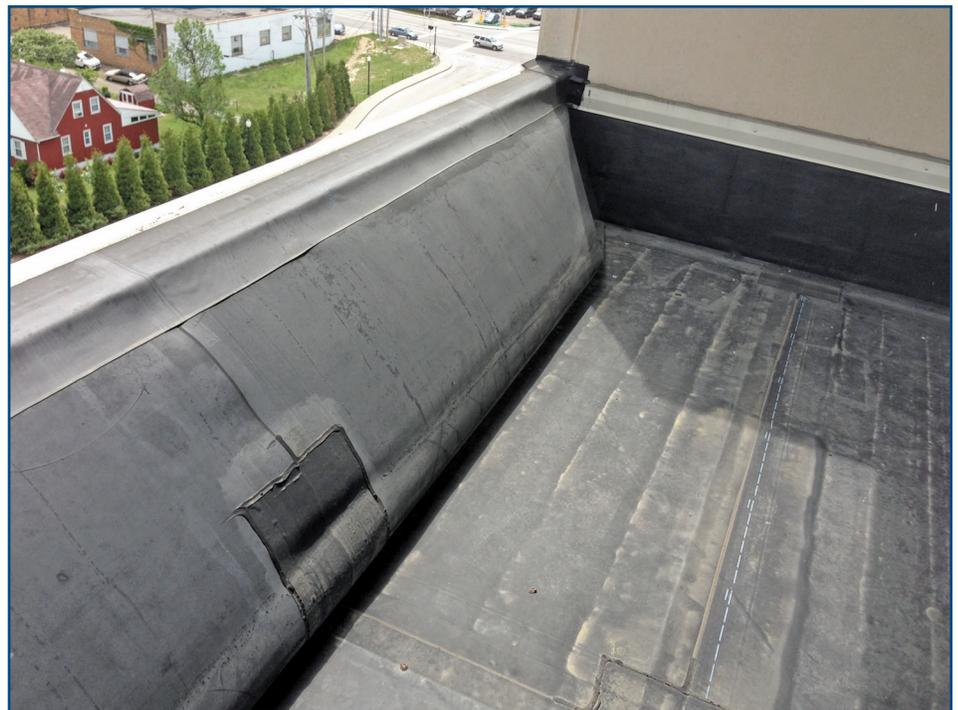
Figure 5 – View of parapet wall where membrane is ballooning out and has debonded from the pre-cast concrete wall.

manufacturer had emphatically made the claim that the building's HVAC system was positively pressurizing the roofing system with enough pressure to cause "structural damage" to the roof system, including the membrane and the insulation debondment, delamination, and overall failure (Figure 5). Therefore, as part of the evaluation and using a micromanometer, pressure measurements were taken at various areas around the building, particularly at the parapet walls to measure the differential pressure between the interior and the exterior of the building across the roof membrane (Figure 6). This differential pressure was taken on a windless day and represents the pressure induced by the HVAC system and any pressure associated with the stack effect due to the height of the building. Wind effect, if measured, would have greatly increased the pressure readings.

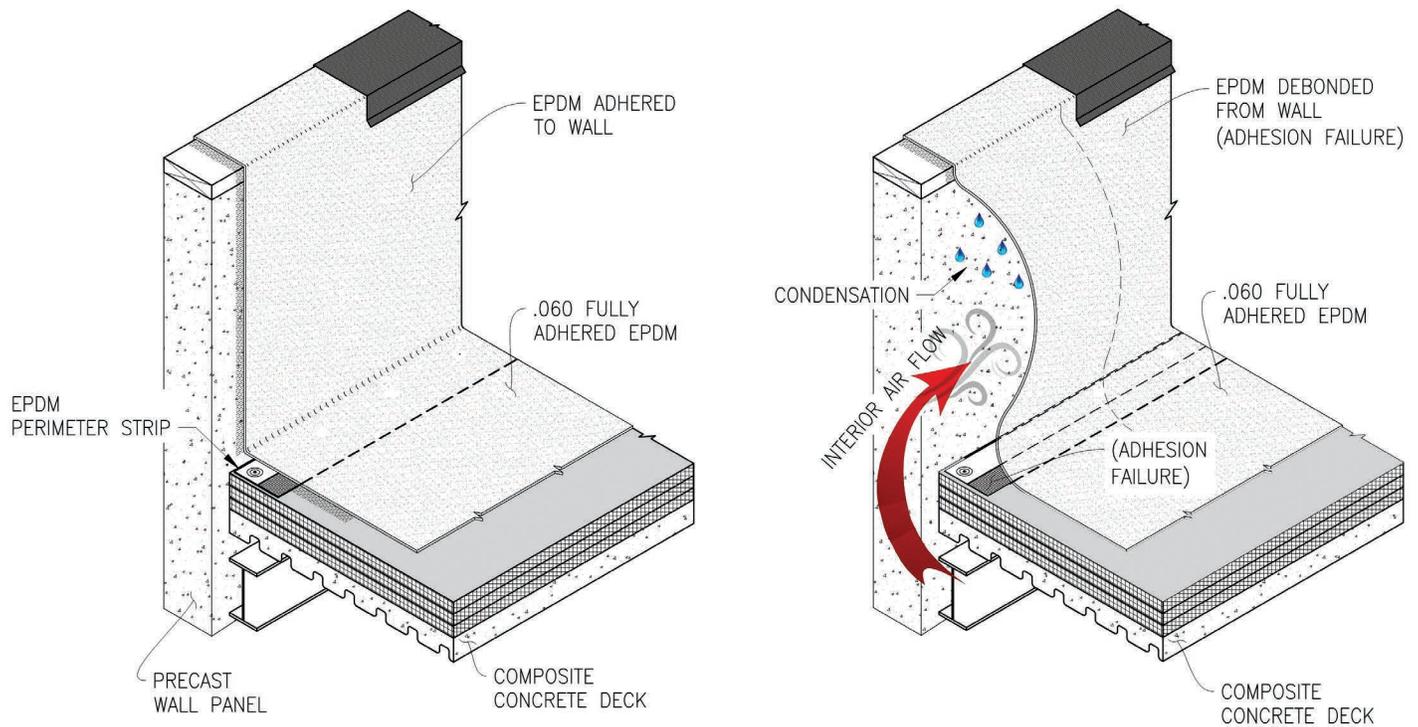
Figure 6 – Sketch of parapet wall condition before and after system failure where pressurized interior building conditioned air has easy access into the roof assembly, causing condensation and ultimately adhesive or product failure.

The investigation continued to search for answers that explained what the observed conditions demonstrated. Following a review of the construction documents and an under-deck inspection, it became evident that the designer of record had failed to provide detailing to ensure that there was an adequate air seal between the roof deck and the adjacent pre-cast parapet walls; in fact, there was a large gap at the intersection.

This condition of uncontrolled air flow via exfiltration through the roof assembly very likely caused condensation during the cold winter months. This helps explain why so much of the adhered parapet wall membrane has failed as well. The lack of air sealing at the parapet wall is a highly undesirable condition where interior building conditioned air, particularly in the winter months, has clear access to the roof system via gaps between the concrete deck and the adjacent pre-cast parapet wall system. This condition can cause condensation on the roof membrane, and, over the long term, cause membrane adhesive to fail, leading to debonding of the roof membrane at the parapet wall. This condition was greatly affected by the presence of numerous small holes in the structural steel tube columns allowing constant air flow to occur across the roof system from the parapet walls towards the interior where the structural steel columns are located.

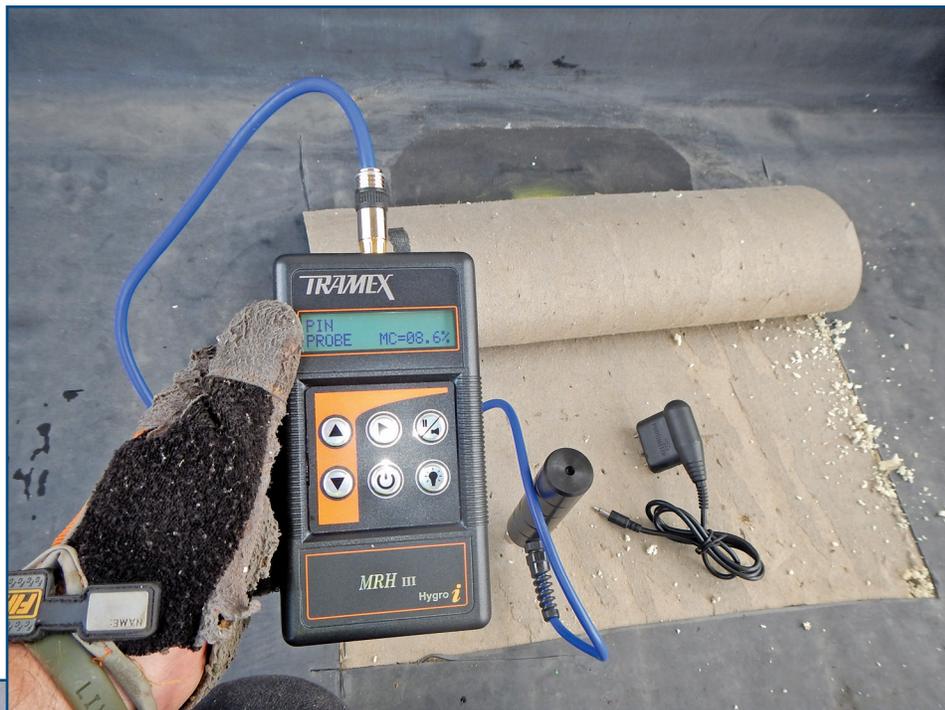
Figure 7 – Using a moisture meter for a quick check for moisture content at both the surface and deep layers of insulation.

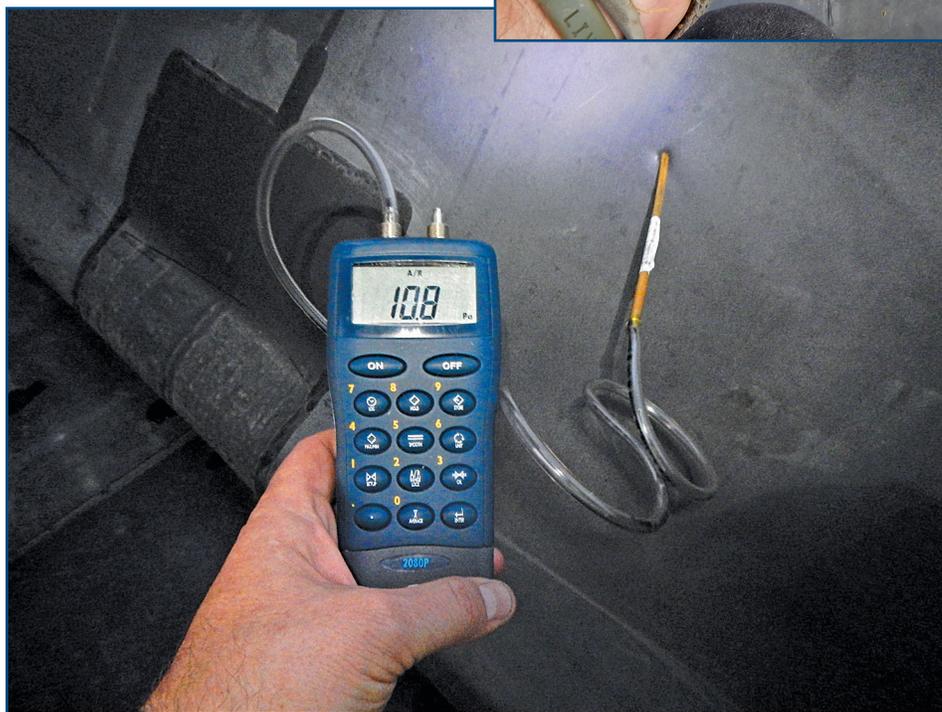
Figure 8 – View of the use of a micromanometer and pressure probe to measure the air pressure difference across the parapet wall roof membrane.

Using a micromanometer, pressure differentials between the interior and the exterior building were measured between 10 and 15 pascals positive where the interior of the building was positively pressurized relative to the exterior at the roof level. Although elevated, these pressures are not uncommon. (See Figures 7 and 8.)

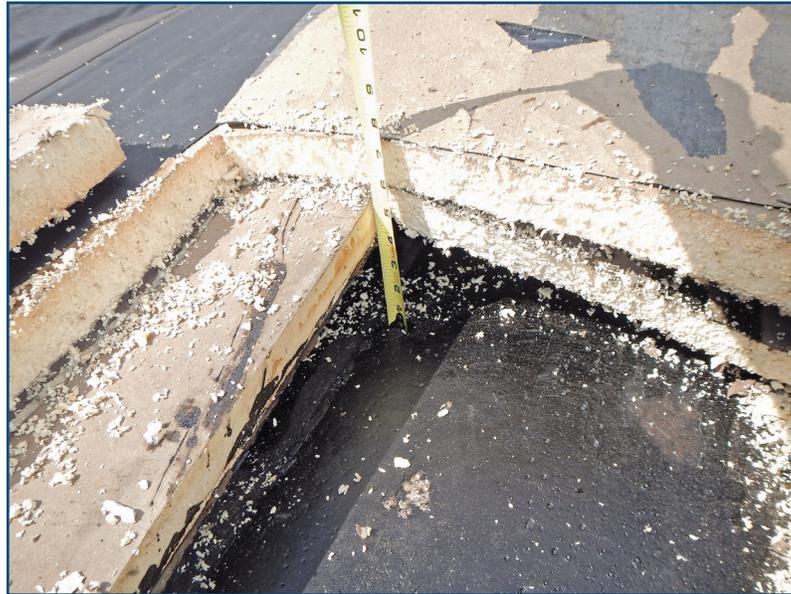
Figure 9 – View of deformed polyisocyanurate insulation.

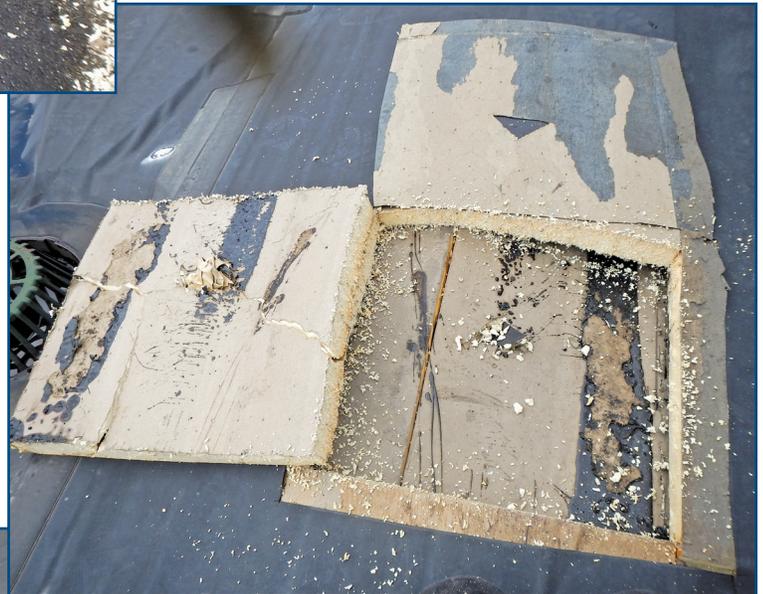
Figure 10 – View of poor interlayer adhesion between insulation boards.

The roof core cuts indicated that by and large, the EPDM roof membrane was well adhered to the top layer of insulation at all locations. What the investigation also found, though, was that there was poor adhesion between the layers of insulation (Figure 10), ranging from 25 to 75 percent coverage at all locations surveyed. At the parapet wall core cut, it appeared that the roof membrane had been fully bonded to the parapet wall but had become debonded following installation. In all of the roof cut areas, even though insulation had been badly deformed (Figure 11), only one roof cut yielded saturated insulation, and only at the bottom of the assembly. In all locations there was a strong odor

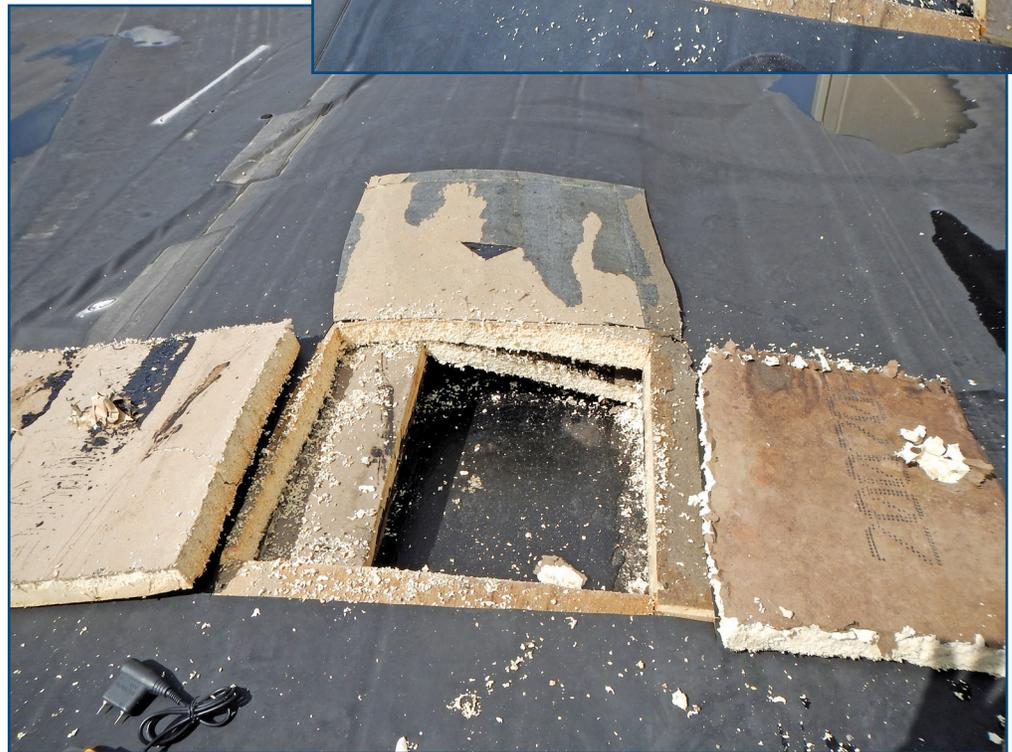
Figure 11 – View of large deformation in the insulation. Note evidence of water staining even though insulation was dry.

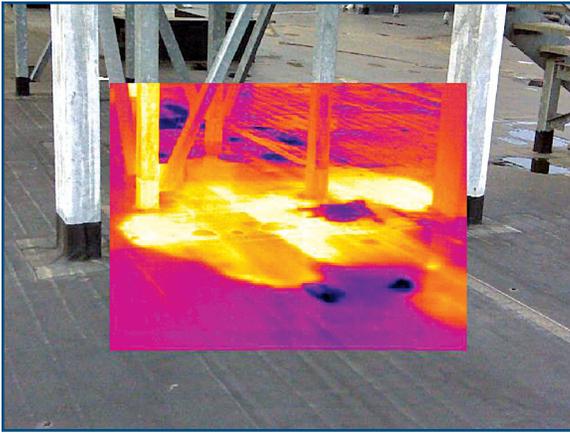
Figure 12 – Thermal image of saturated roof insulation adjacent to galvanized steel columns where drain holes are allowing water entry into the roof system.

As determined from the IR study, there were four areas of saturated surface roof insulation adjacent to structural steel tube column penetrations. Further evaluation of the steel structures revealed small 3/4-in.-diameter drain holes in the tube steel members. More often than not, when galvanized structural tube steel is used for creating roof features, as part of the galvanizing process, drain holes are installed at both ends of the tube steel assembly in order to allow the steel assemblies to drain once they are lifted from the galvanizing dip tanks.

These drain holes are not part of the design documents and sometimes don't show up on shop drawings but are required for the production and galvanizing process. Some galvanizing shops will seal those holes with a plug, but often they are never sealed. This frequently results in misdiagnosed roof leaks for years because the holes are facing up or otherwise hidden from view or are high above head level and not noticed (Figure 12).

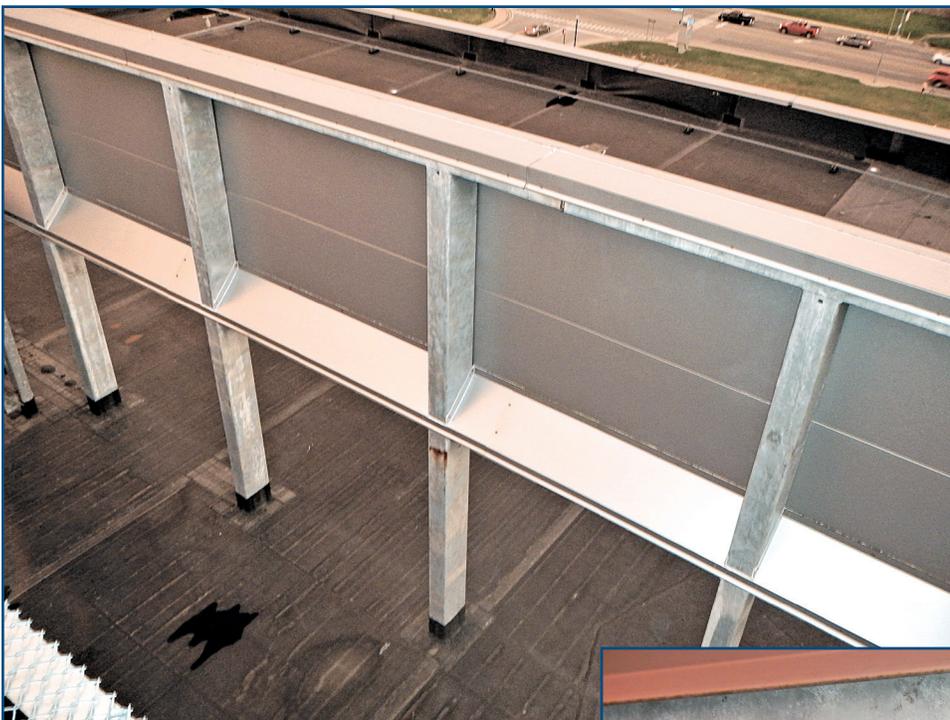
Figure 13 – View of mechanical screen galvanized steel columns with exposed drain holes at the top of each column.

During the course of this study, it was determined that the installed galvanized tube steel columns supporting the heliport, walkways, outside stair, and mechanical screening all had open drain holes—either at the top or sides (near the top) of the structural steel members (Figures 13 through 16). Many of the members were protected from direct rain entry but were still left with open holes. This observation yielded two

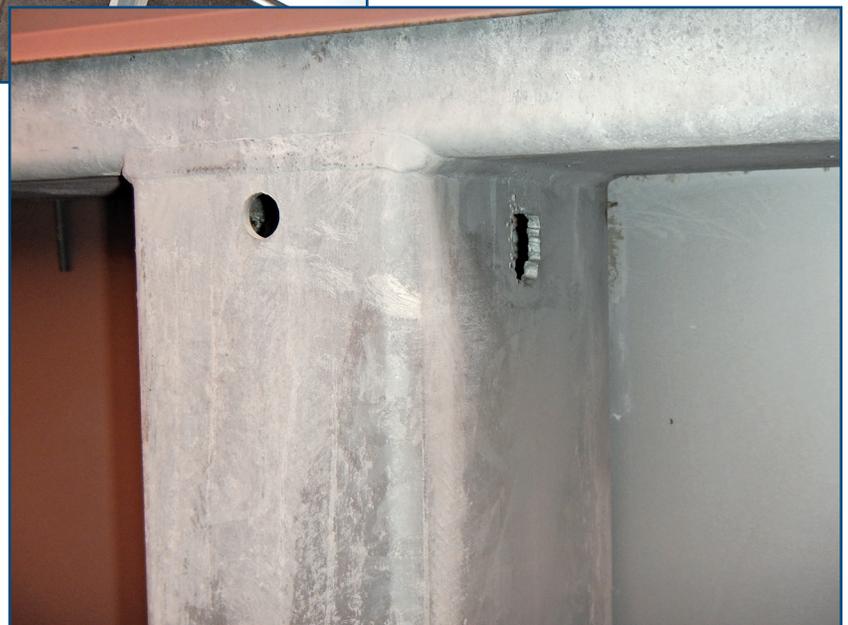
Figure 14 – Close-up view of exposed drain holes in the galvanized steel columns, allowing direct water infiltration and air exfiltration. Note some holes are drilled and some are cut with a torch.

conclusions: 1) any water that got into the structural steel tube sections was directed to the bottom of the roof assembly directly to the concrete deck where the column base plates were attached to the deck, and 2) each structural column was acting like a tiny chimney, providing a direct air path from the roof assembly to the exterior—a highly undesirable condition.

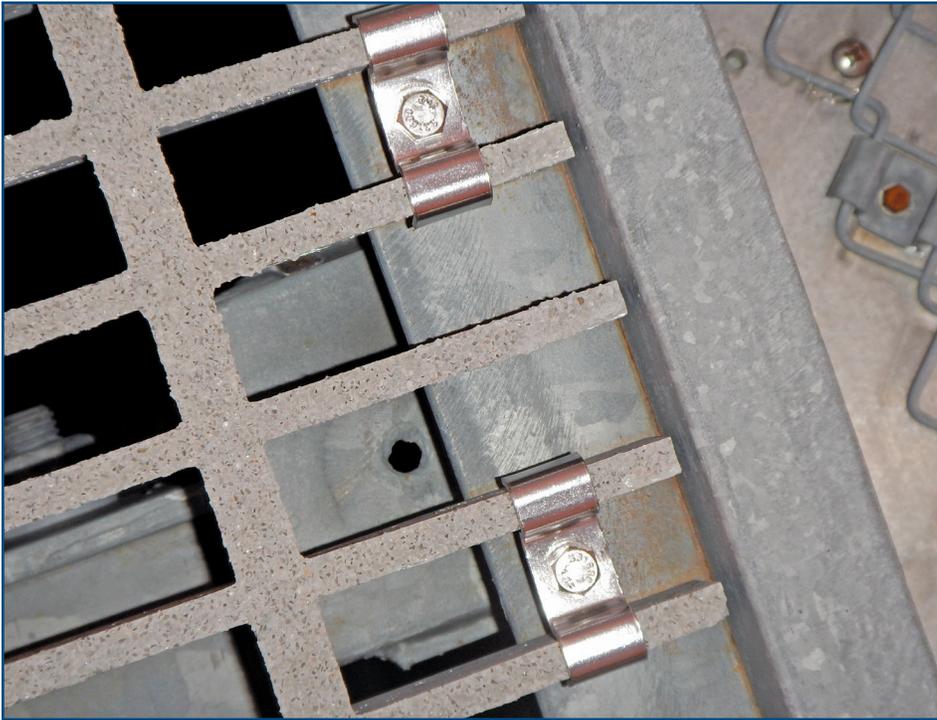
Figure 15 – View of upward-facing drain hole in a galvanized steel column.

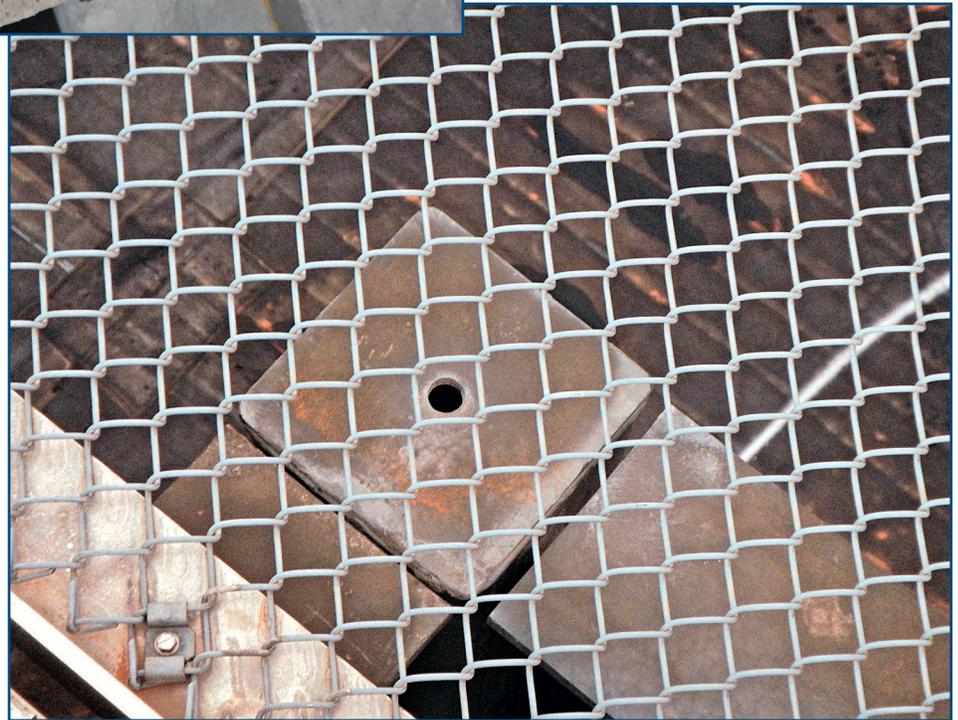
Figure 16 – View of upward-facing drain hole in a galvanized steel column.
