# Preservation of Ruins at Sweetwater Creek State Park Mill

By Mickey S. Leso, PE, LEED Green Associate;  
and Mark Girton

NOVA Engineering and Environmental (NOVA) and Stevens & Wilkinson (S&W) teamed up to provide forensic engineering evaluation, repair design, and construction administration services at the historic Sweetwater Creek State Park Mill Ruins in Lithia Springs, Georgia.

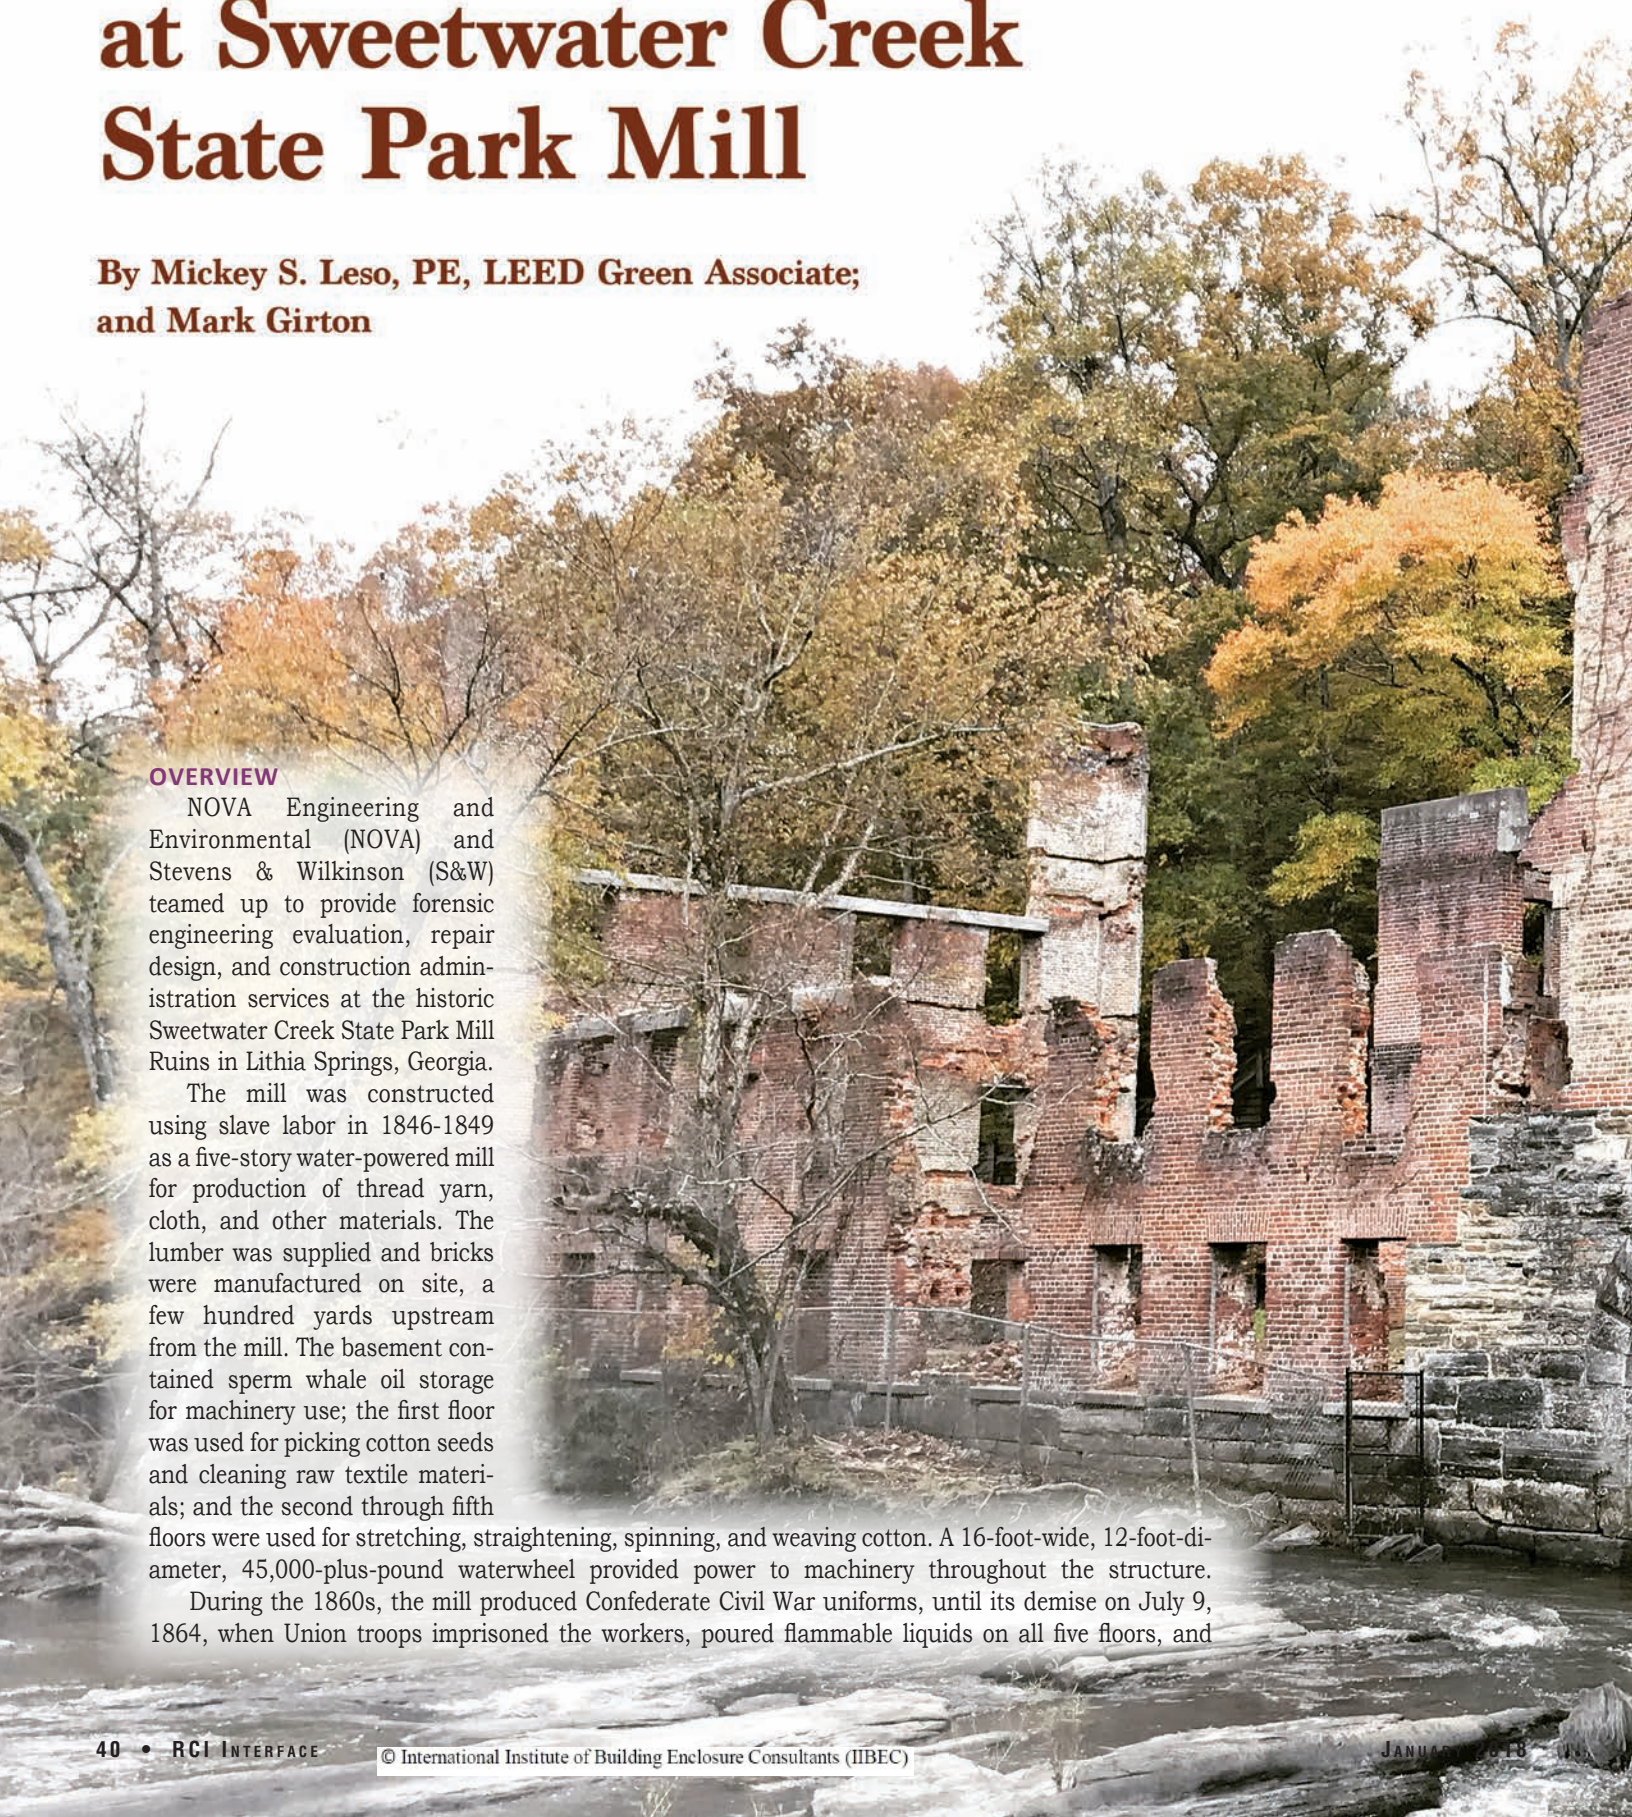
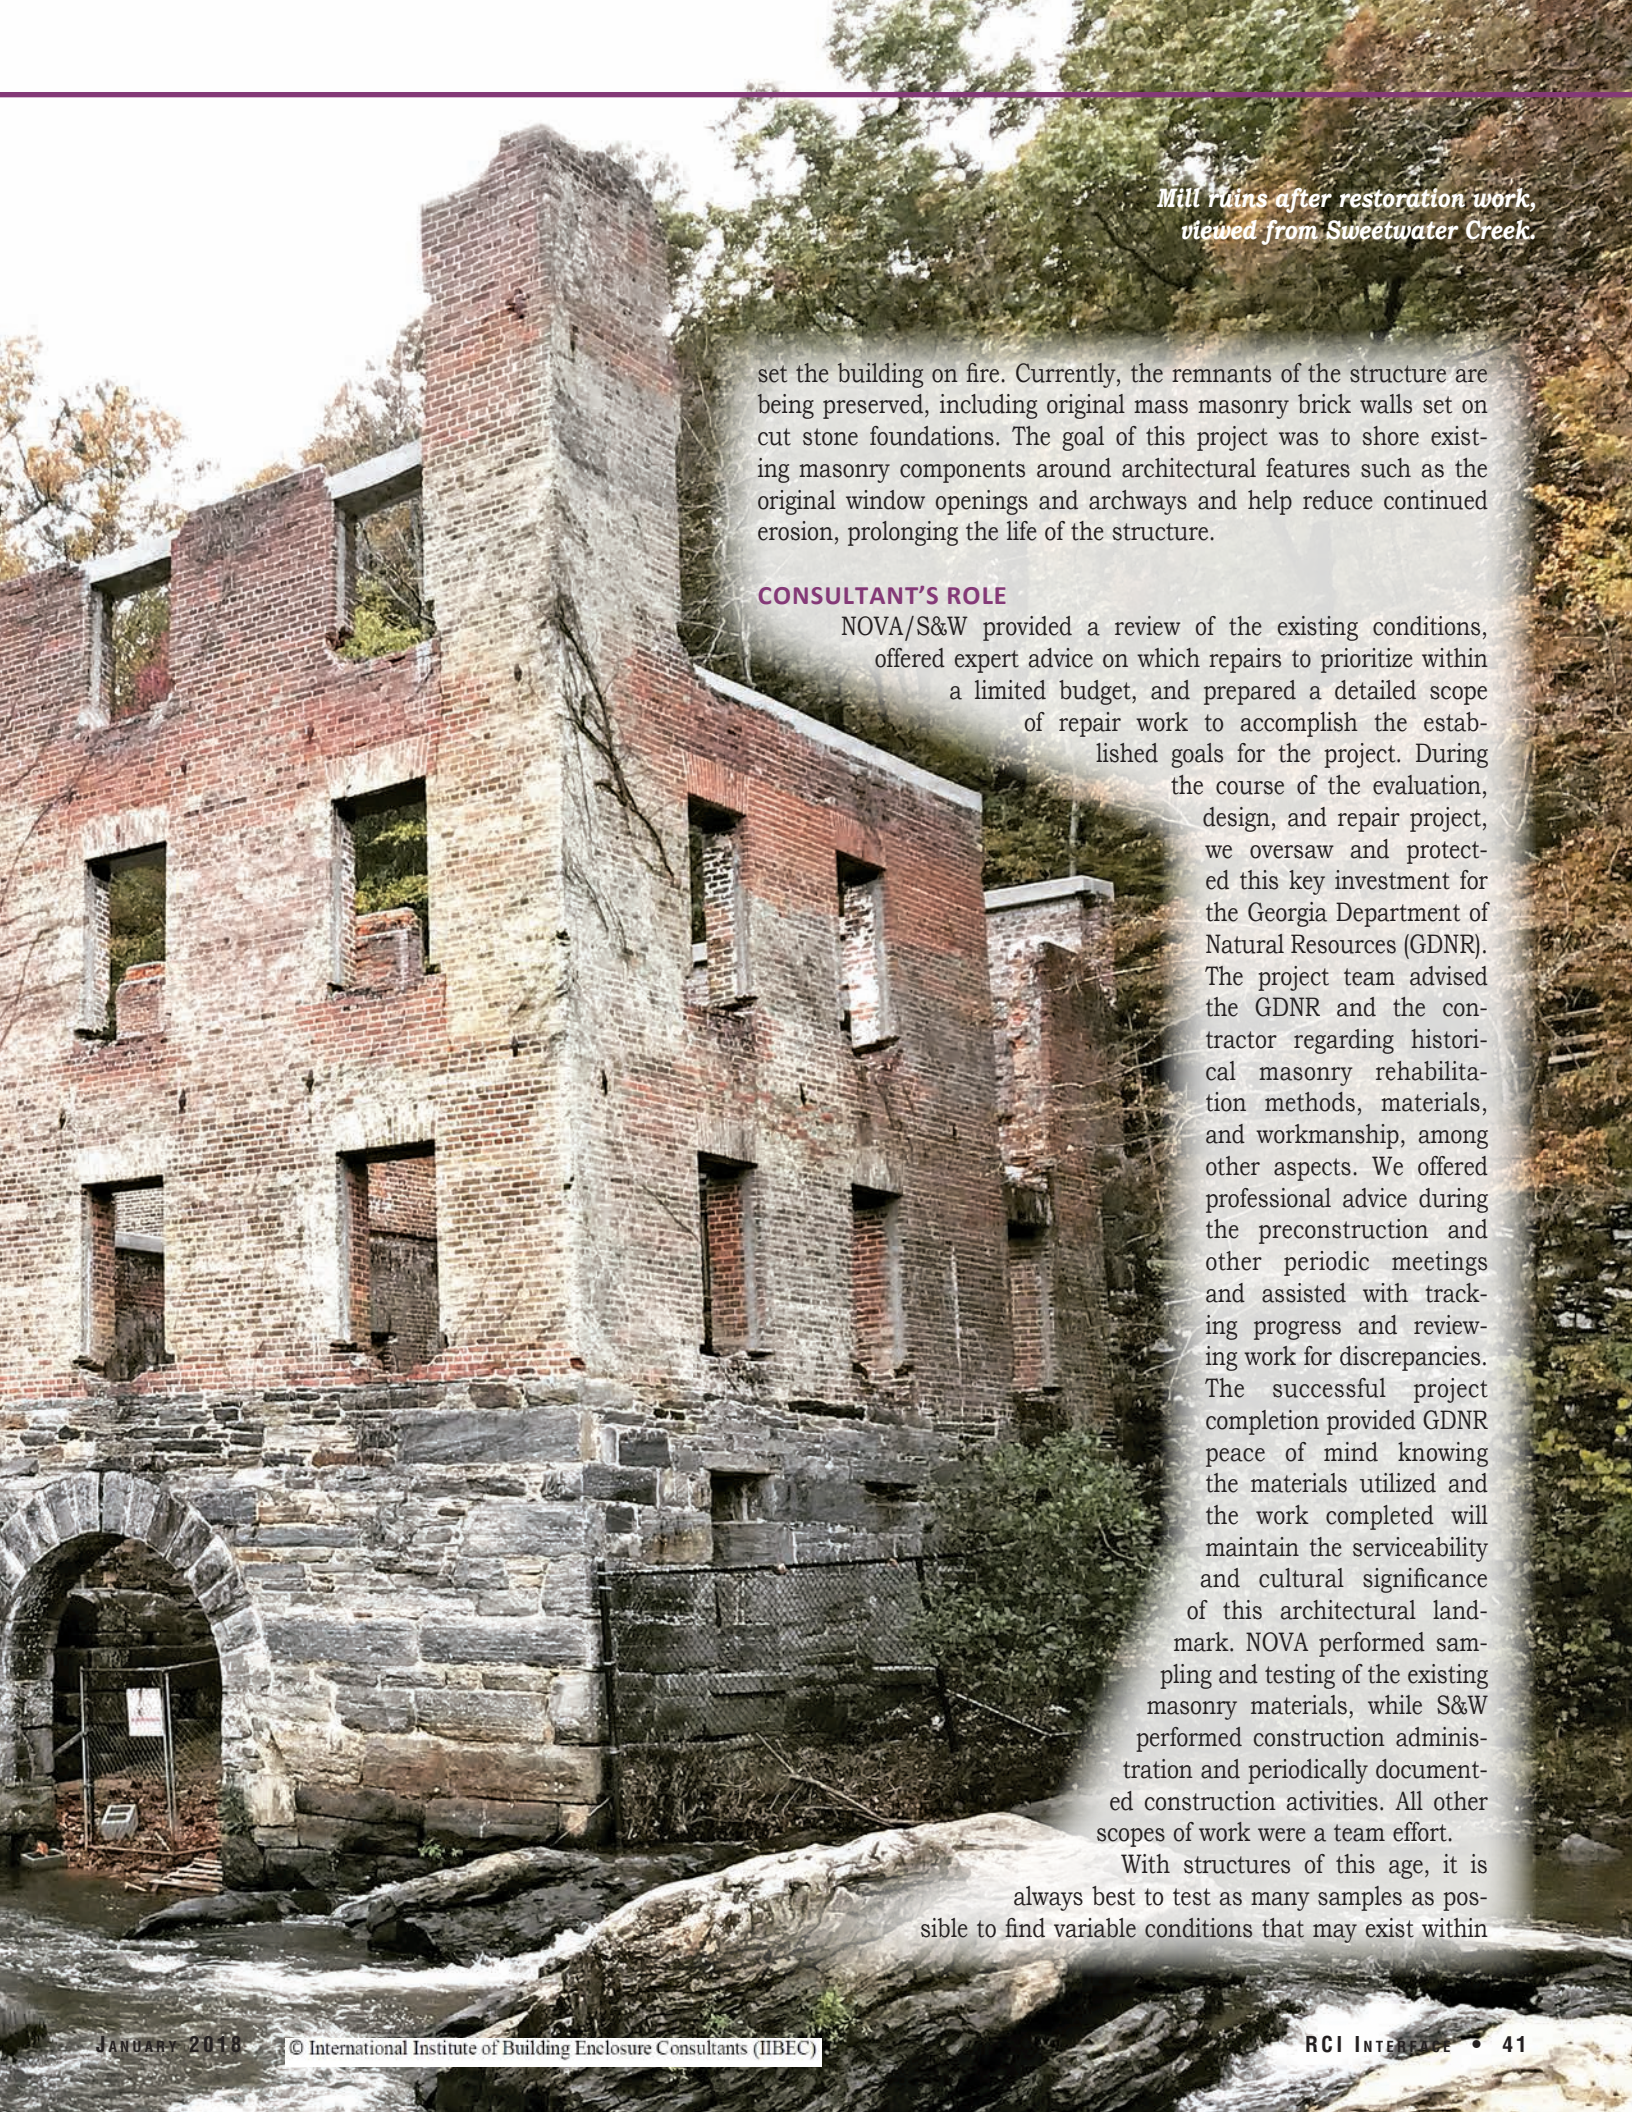
*Mill ruins after restoration work, viewed from Sweetwater Creek.*

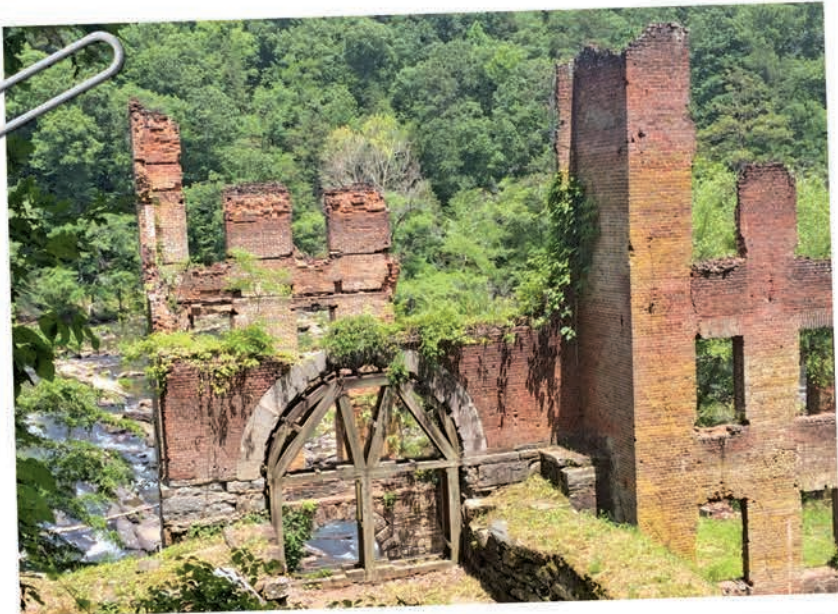
*Photo 1 – View of original water-powered mill archway before timber framing removal.*

The project team visited the site in the summer of 2016 to gather information about the history of the structure, including previous attempts to stabilize the walls (*Photos 1-3*). The wall heights range from second-story level to just above the fourth-

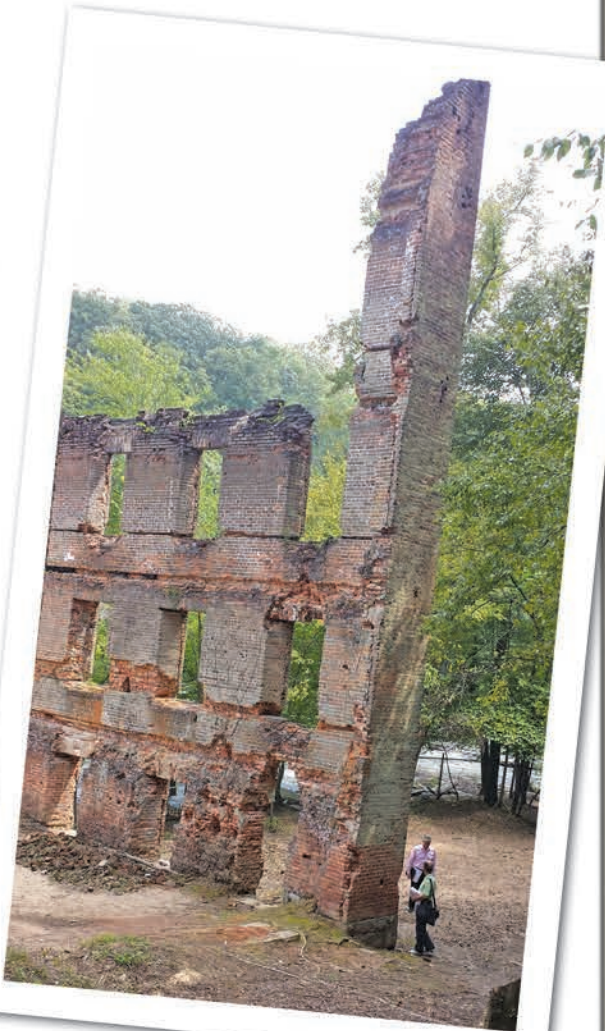
*Photo 2 – View of five-story brick masonry piers, three stories of which are free-standing.*

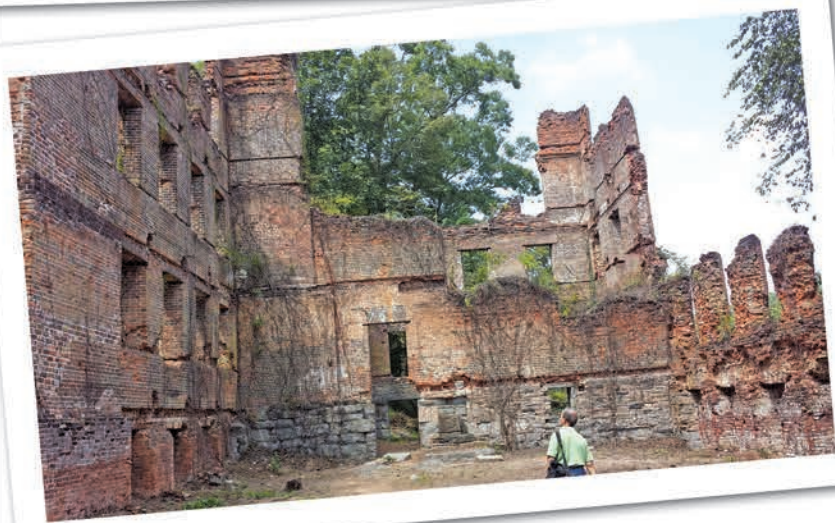
*Photo 3 – View of mill interior before repair.*

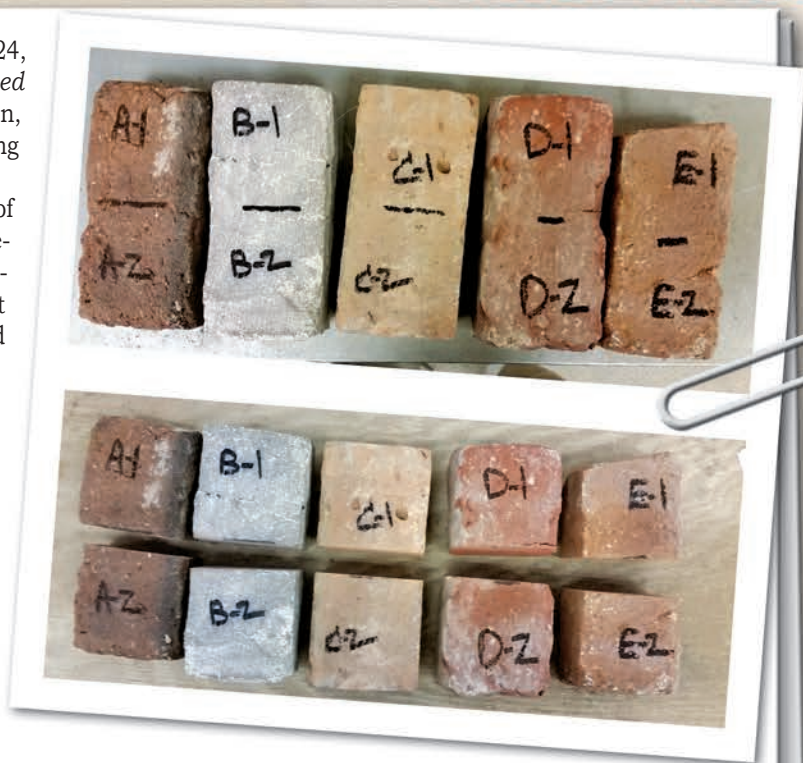
The project team removed five brick units and several mortar samples from the site for the purpose of determining the average rate of absorption and the average compressive strength of the brick units (Photo 4). Three of the brick units were from exposed conditions, and the remaining two samples were from areas not commonly exposed to direct weathering. The mortar samples were taken from the east wall in a location within the wall not exposed to normal weathering. Laboratory testing included ASTM C67, *Standard Test Methods for*

ASTM C67 typically requires no fewer than ten bricks. To reduce costs in this particular case, five brick units were selected for a modified test procedure—some from worst-case erosion conditions and others selected from areas with limited wear. The brick units typically had a compressive strength ranging between 690 psi and 1110 psi. A single outlier brick unit tested to 3750 psi. Testing of the samples concluded that the mortar had a low compressive strength, thereby indicating the use of portland cement in the mortar was unlikely.

The tested absorptive qualities of the brick reflected percent absorptions ranging from 9.7% to 22.1%. Results beyond 20% are considered high and will likely affect the long-term performance of the brick. U.S. Heritage Group assisted with testing and analysis. One brick sample tested exceeded 20% absorption.

Photo 4 – Brick samples collected and analyzed per ASTM C67, Standard Test Method for Sampling and Testing Brick.

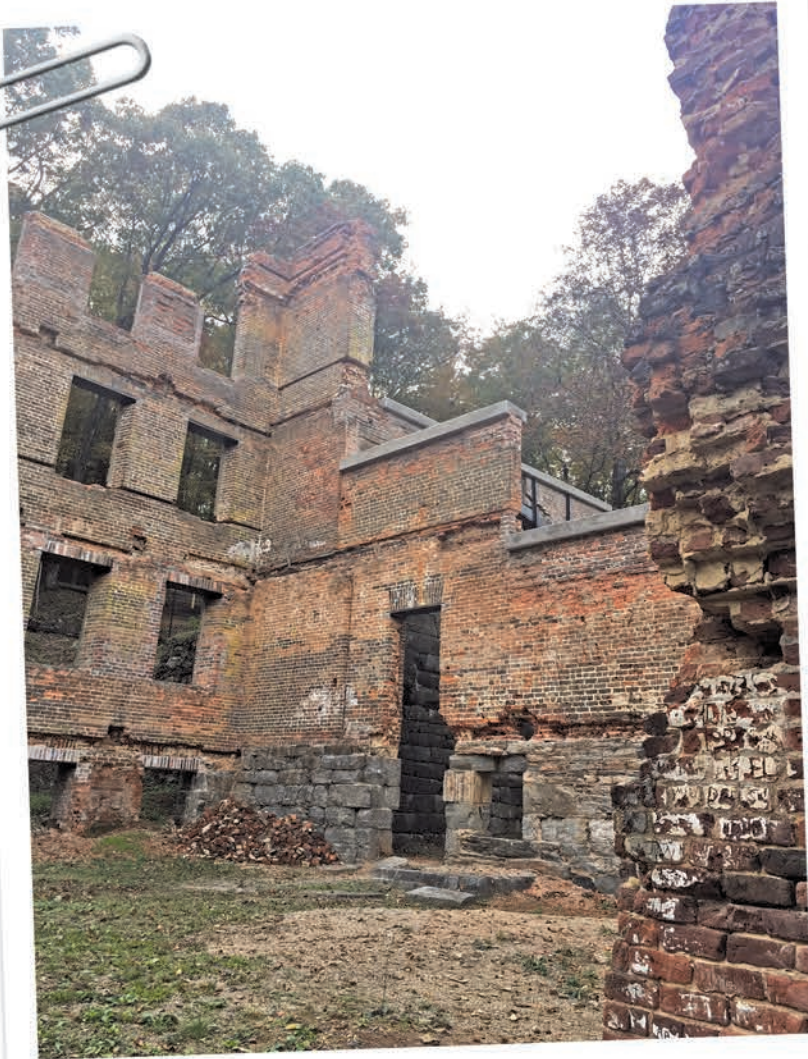
Over the years, the absence of a roof and crumbling of the structure have left horizontal surface areas of brick masonry exposed where water collects. The water migrates into the masonry assembly, accelerating the erosion process. Other areas of possible water collection include pockets in the walls that previously served as framing pockets for wood beams, joists, and/or lintels above window openings. The jagged tops of the wall structure also likely retain water pools.

*Photo 5 – Sloped concrete caps installed to protect walls and shed standing water.*

We discussed the scope with GDNR and agreed upon the following repair work, which was then presented to bidding contractors in the form of specifications and drawings. A quantity of the original brick units were salvaged and utilized to perform repairs. This included removing and rebuilding unstable brick units exhibiting advanced deterioration. A sloped, low-profile, generally moisture-resistant concrete cap was placed on horizontal surfaces to alleviate standing water (Photo 5). Other repair areas included

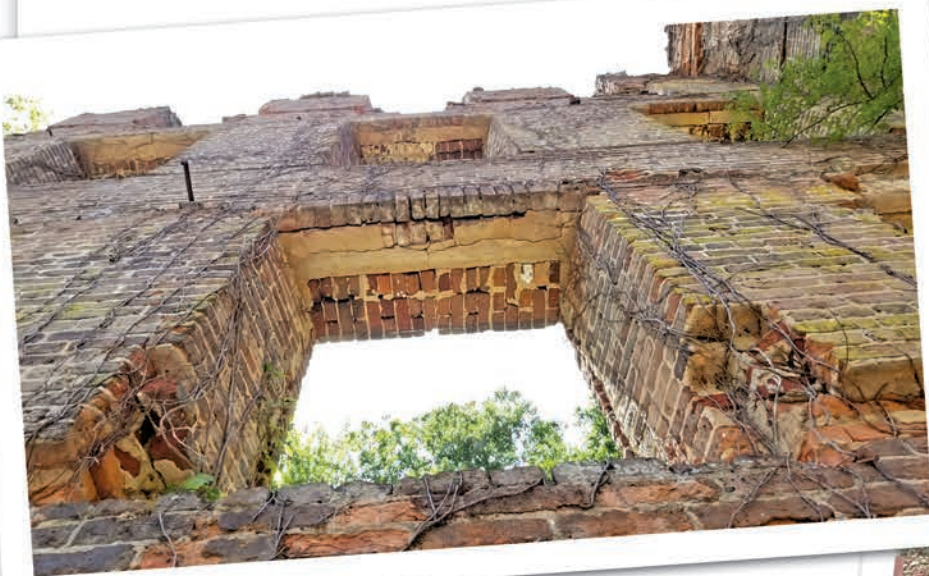
*Photos 6 and 7 – Window openings with brick masonry repairs and steel plate lintels.*

bracing brick headers and freestanding brick piers with concrete lintels, installing new concrete lintels at severely deteriorated openings, and infilling voids above lintels with original brick. New steel lintels and architectural steel plates were installed to support less-deteriorated brick headers exhibiting horizontal cracking and granite stone block arches (Photos 6-9). Vegetative growth was removed from wall surfaces. Mortar joints were repointed with abnormal lime putty and sand mortar formulations (Photo 10). The existing material has lasted over 150 years with little to no maintenance, despite being subjected to high temperatures during the 1864 burning. Introduction of a mortar with common cements could be destructive to the existing mortar, the softened brick masonry, and, in our opinion, would produce further and accelerated moisture damage.

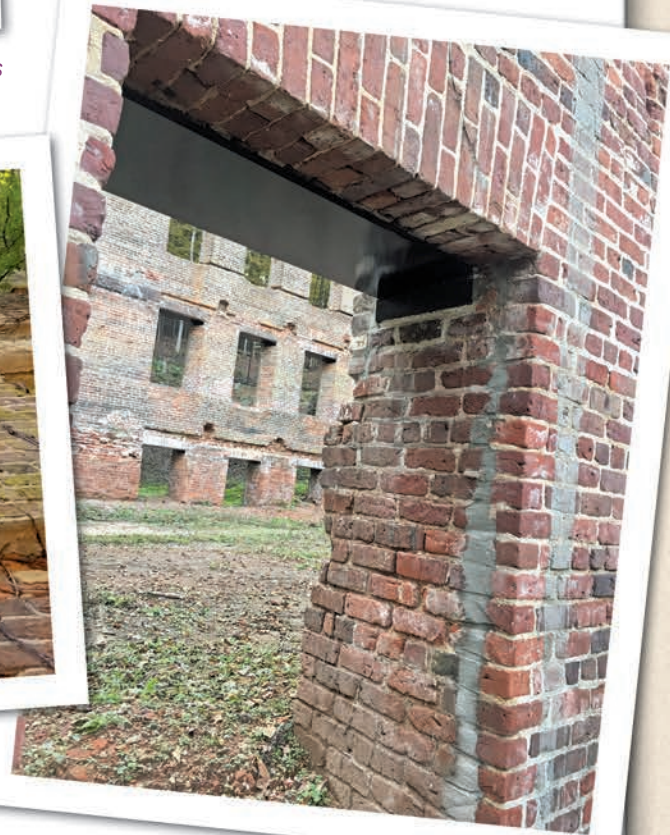
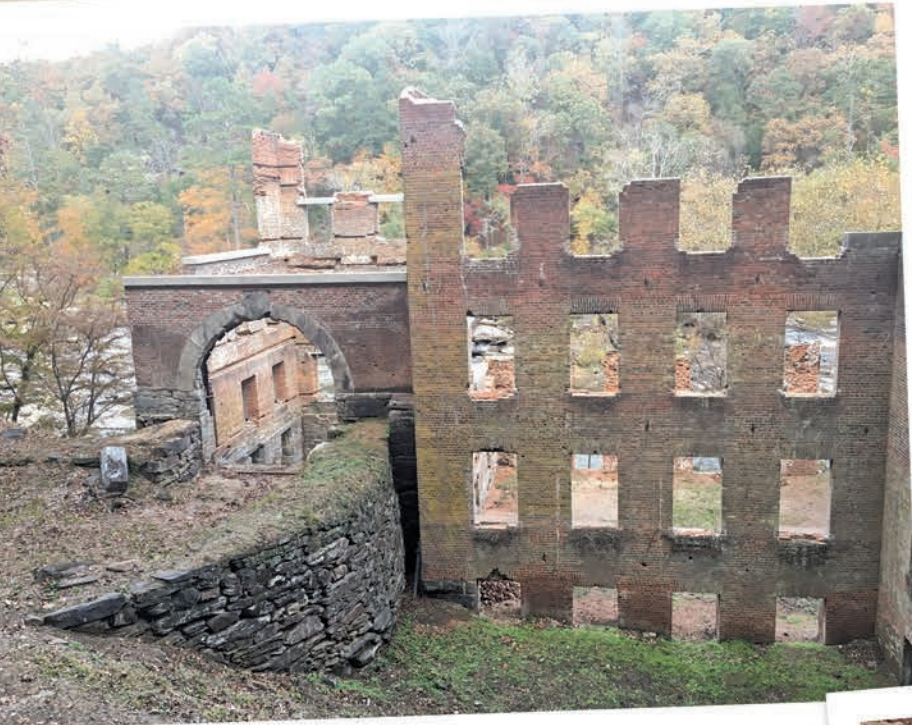
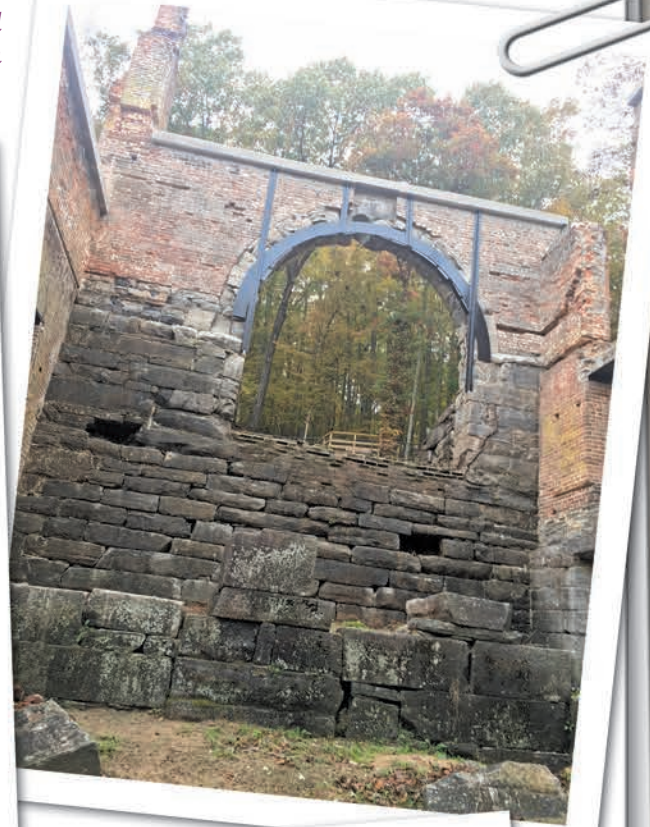
*Photos 8 and 9 – Granite arch after restoration, as viewed from hiking trail. Note timber framing has been replaced with architectural steel bracing (hidden from public view).*

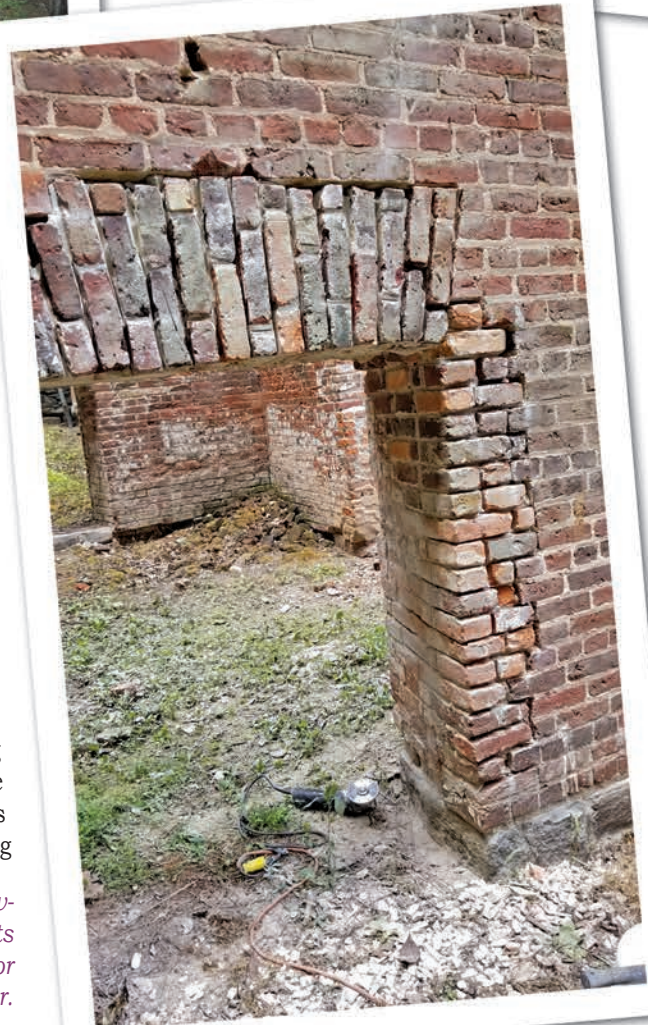
*Photo 10 – Saw-cut mortar joints in preparation for tuckpointing mortar.*
