# Hail Events and Structural Decking

– A CASE STUDY –

By Dziugas Reneckis, PhD, PE, MStructE; and Remo Capolino, PE, RRC

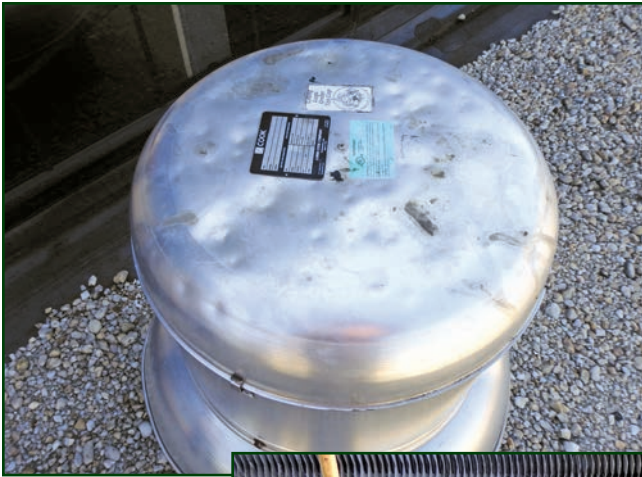
Figure 3 – Dented exhaust hood.

The investigation began with the roof assembly. There were all the classic and obvious signs of a hail event: dents, deflections, and shattering of rooftop accessories such as exhaust fan hoods (*Figure 3*), A/C fins (*Figure 4*), K-style gutters, and—on this building—solar panels (*Figure 5*). There

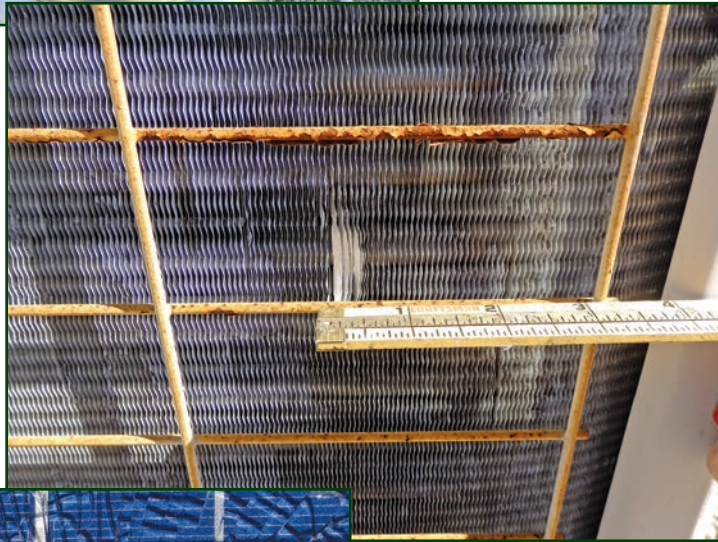
Figure 4 – Damage to A/C fins.

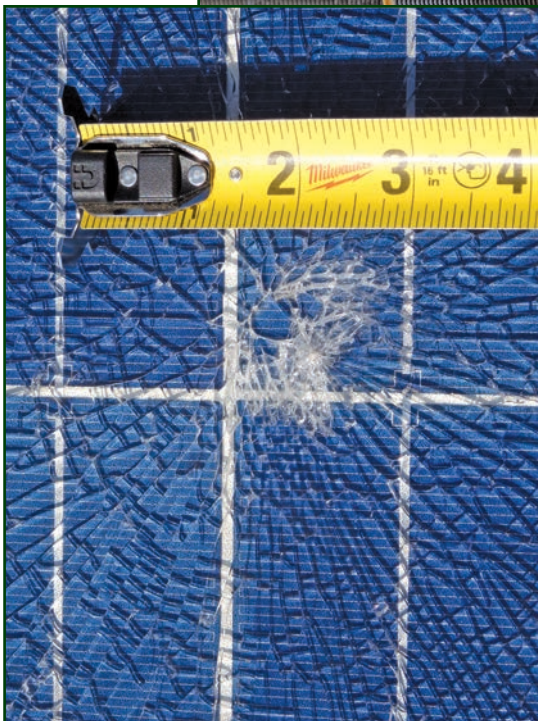
Figure 5 – Damaged solar panel.

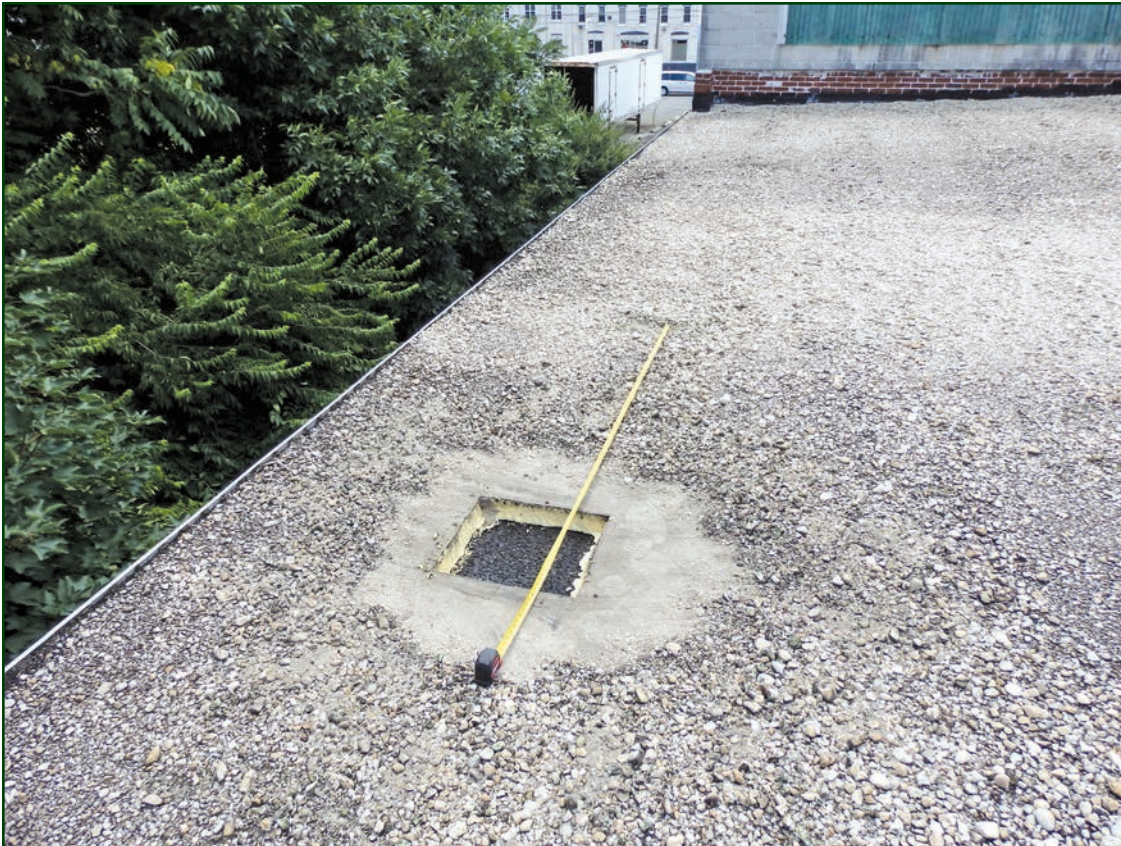
Figure 6 – Overview of roof assembly at low-bay area.

high-bay building is a loose-laid and ballasted EPDM installed over 3-in.-thick isocyanurate (iso) insulation that was laid directly over the original slag-covered coal tar pitch roof membrane (*Figure 6*). The

gravel ballast was relatively heavy, approximated at 20 pounds per square foot, but included a large amount of fines.

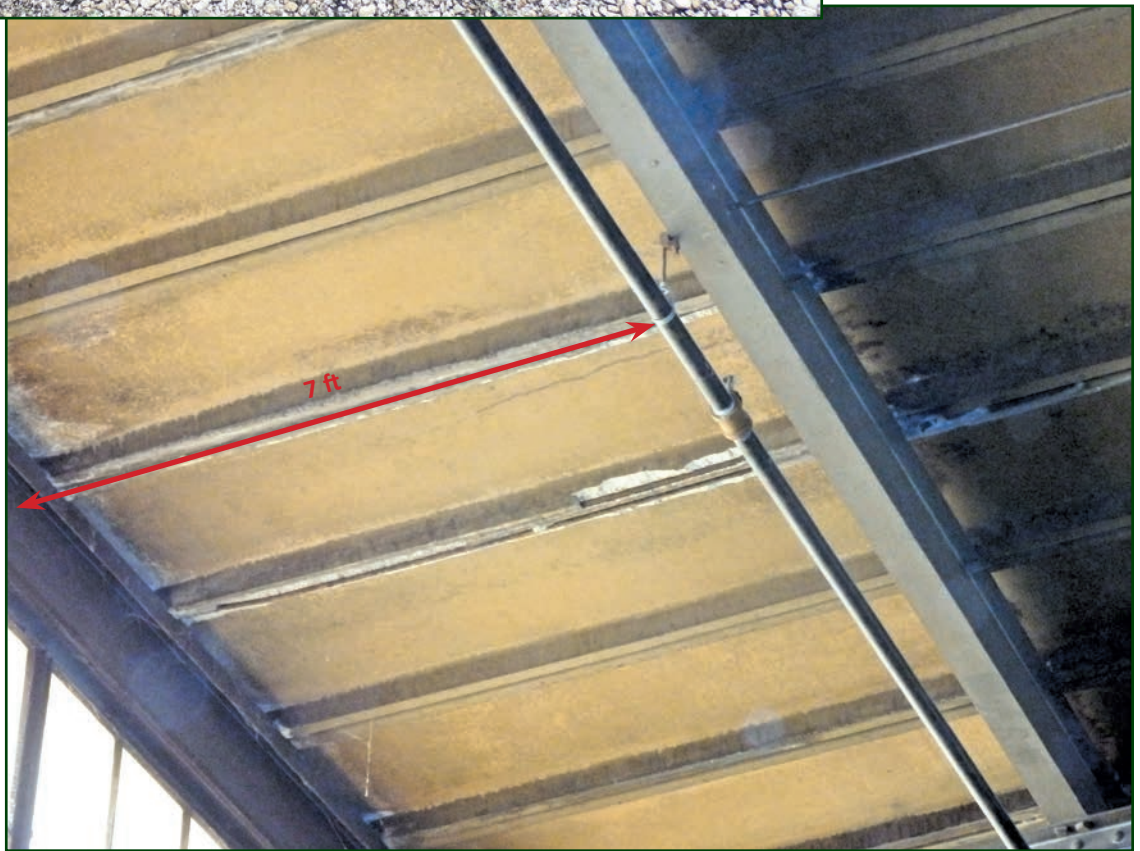
Figure 7 – Precast concrete channel slab planks at the roof deck.

The roof decking below the EPDM and coal tar pitch is precast concrete channel slabs that are gravity-set with retaining clips, spanning approximately seven feet between steel purlins (Figure 7). These precast planks are common throughout the roofing industry—not because they are typically installed today—but rather because they were often installed prior to World War II and they are so durable that if the building remains, so, too, do the precast concrete planks. The concrete planks on this building are two feet wide by seven feet long and are one inch thick at all areas except the two long edges where the concrete was thickened to three inches thick. This effectively gives the planks the shape of a blunted “C.” The planks in question were weighed and measured and were determined to have been made with lightweight structural concrete with #4 reinforcing steel bars located at the thickened edges (Figure 8).

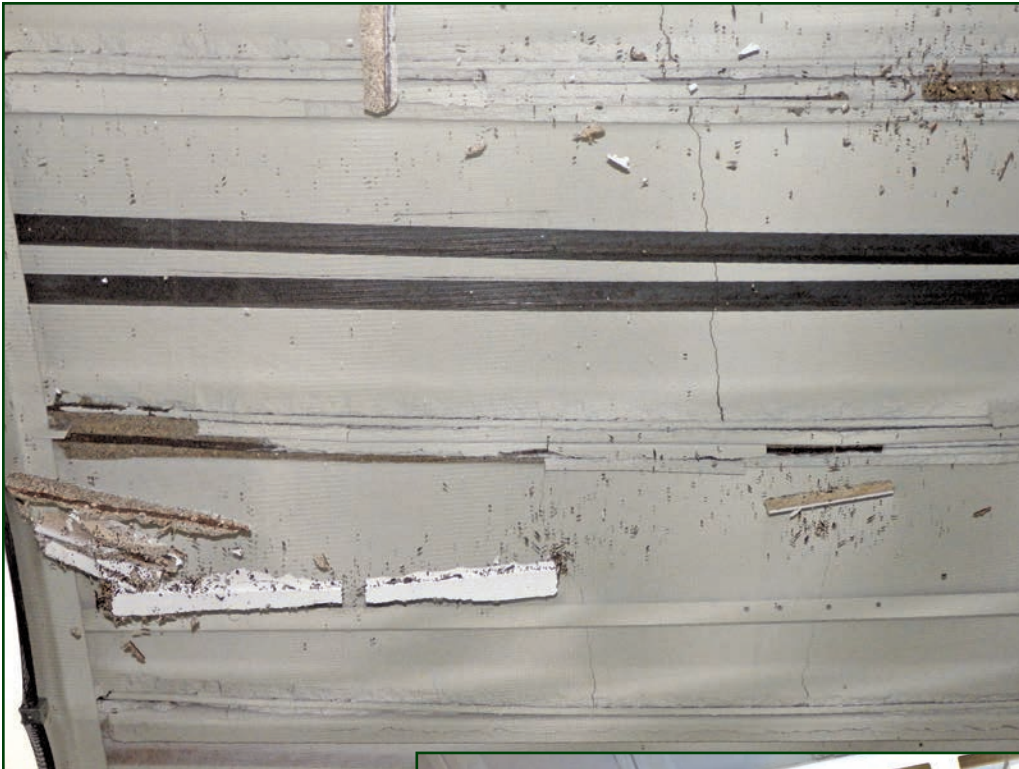
The condition that was cited and claimed as damage to the concrete planks was the loss of cover concrete at the underside of the #4 steel reinforcing bar. This area of spalled concrete was pervasive throughout the building; however, it was not uniformly distributed. Also, the exposed steel and concrete of the plank were observed to be in very different conditions. Some areas of the building had an interior renovation prior to the storm. At these locations, the underside of the planks were painted white and netting was installed under the planks. When the netting was inspected after the storms, large sections of concrete cover were found in the netting, the underside of the concrete plank had many areas of unpainted concrete, and corroded reinforcing steel was exposed (Figure 9).

The date of the interior renovation and painting allowed us to determine that the spalled concrete occurred after the renovation; however, we could not determine if it existed prior to the storm. Other areas of the deck were observed, and we found

Figure 9 – Spalled concrete caught in netting with exposed unpainted concrete and reinforcing steel.

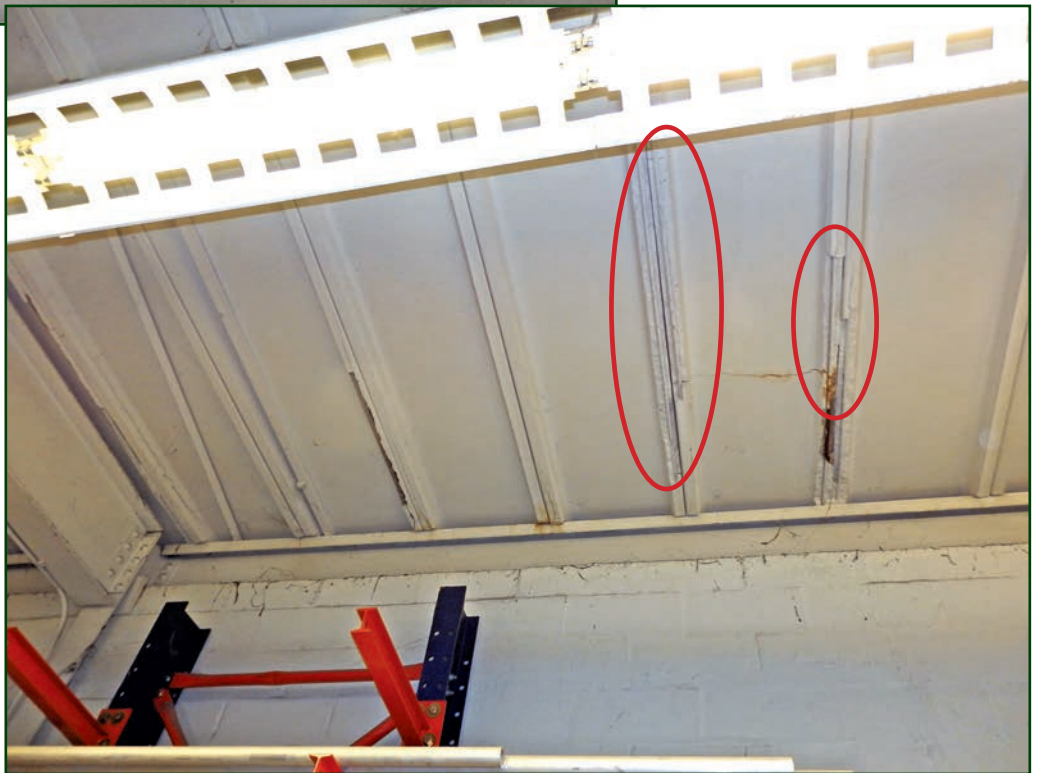
spalled concrete and the exposed #4 reinforcing steel, but these areas were painted white, indicating they were in this condition prior to the hail events (Figure 10). With these conflicting observations, it could not be determined with a reasonable degree of engineering certainty that the hail did or did not cause the spalling of the concrete plank. As a result, further investigation was required.

Figure 10 – Spalled concrete and exposed reinforcing steel with paint from interior renovation completed prior to storm.

Once the structural analysis proved it was not the applied loading that led to the damage, it was fairly simple to show that long-term corrosion of the reinforcing steel caused rust-jacking that caused the concrete to spall and expose the steel. This causation of the damage was corroborated by the fact that many areas of spalled concrete were painted white (indicating that

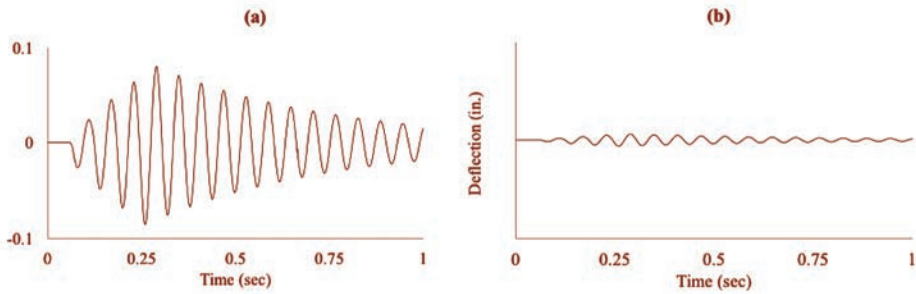
the resultant deflections, shear force, and bending moments were determined and are plotted in Figures 13 through 15. All calcu-

lated loads were marginal when compared to the plank structural capacities that were initially calculated.

Figure 13 – Deflection results for Case 1 (a) and Case 2 (b).

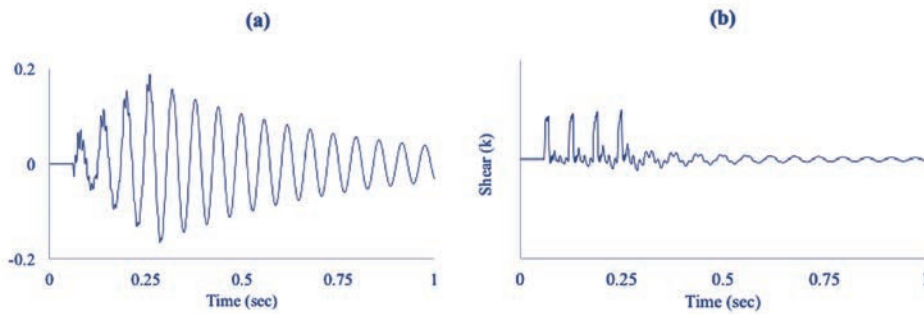
As can be seen in Table 1, the worst-case scenario is when the planks' shear service capacity is 61% utilized when the plank is loaded at center span.

Figure 14. Shear force results for (a) Case 1 and (b) Case 2.

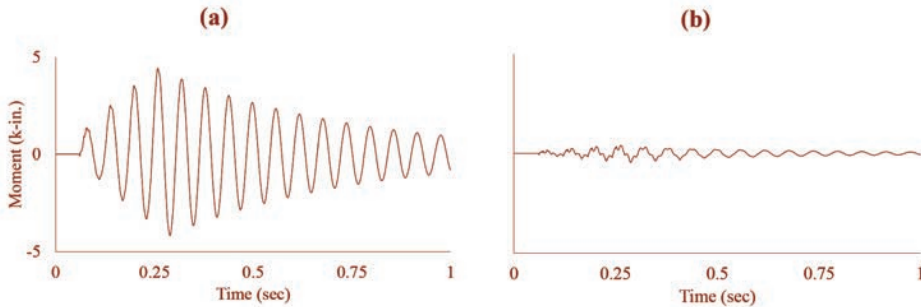
Since the allowable/usable moment and shear capacities were always 40% or more than the applied loading, assuming all worst-case scenarios, it was concluded that the loading due to hail did not cause the damage to the concrete planks.

Figure 15 – Bending moment results for Case 1 (a) and Case 2 (b).

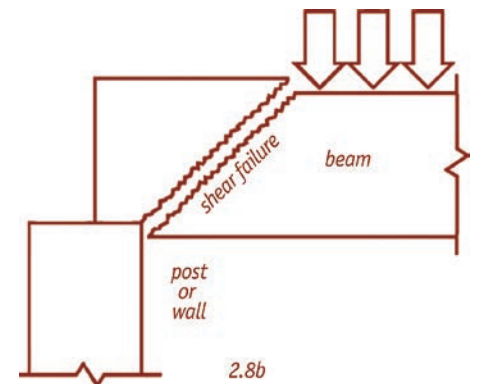
The fact that the shear capacity of the planks will be reached/exceeded by exterior loading before the moment capacity of the planks can be reached is enlightening. Shear and moment failures of concrete planks result in very different types of failures. "Classic" moment failures of concrete planks are when the concrete at center span deflects downward and develops cracks on the bottom surface and can result in loss of reinforcing steel cover as was seen at the site. However, since these planks are limited in strength by shear, excessive loading failure should be evidenced by shear failures. Classic shear failures are ones where the concrete plank fails at or immediately adjacent to the support and are very different from the conditions observed at the site (Figure 16).

Figure 16 – Location of a shear failure is at support, not mid-span of structural member. Graphic courtesy of <http://boulderlibrary.net/timber-framing-for-the-rest-of-us-rob-roy/shear-and-shear-failure.html>.
