Water Intrusion Mitigation at Historic Center for Puppetry Arts Facility

By Mickey S. Leso, PE, LEED GA and Mark Girton

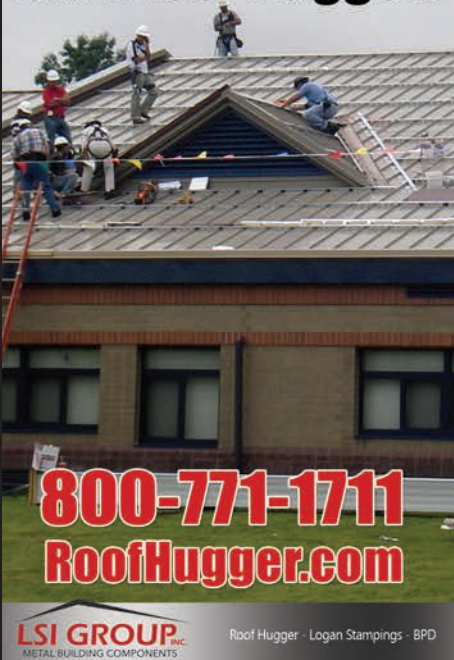
800-771-1711
RoofHugger.com

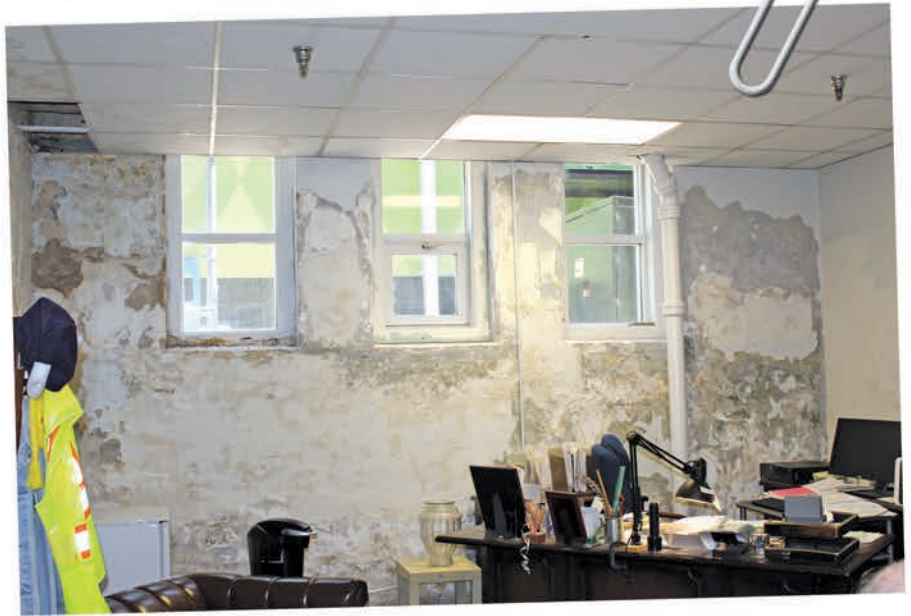
Figure 3 – Water damage on interior basement walls of east elevation, as a result of masonry, parapet wall, and roof scupper flashing defects.

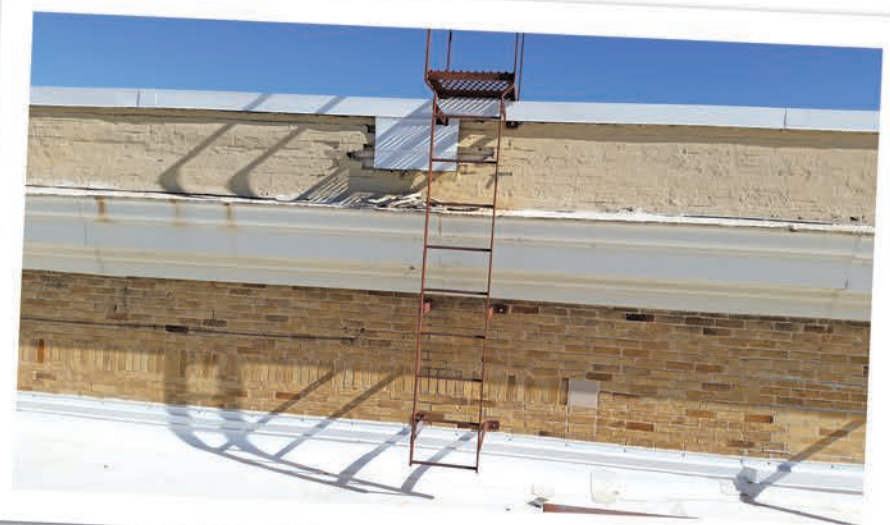
Figure 4 – South elevation parapet wall and access ladder conditions. Sheet metal hides displaced masonry.

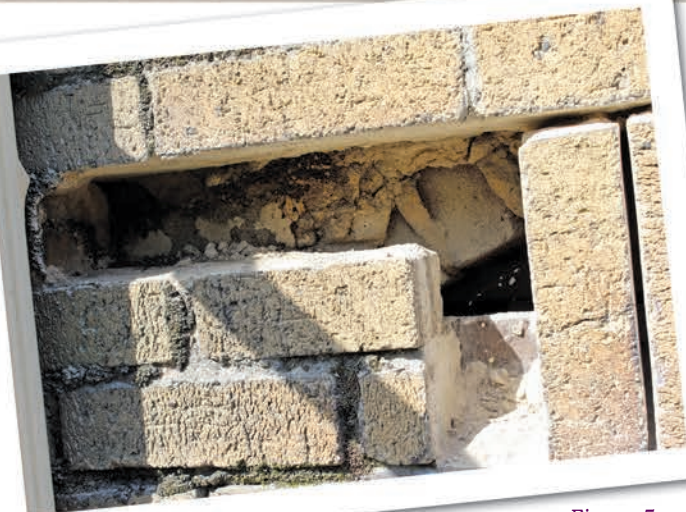
Figure 5 – Hidden arched window openings from the original façade design behind the adjoining terra cotta veneer.

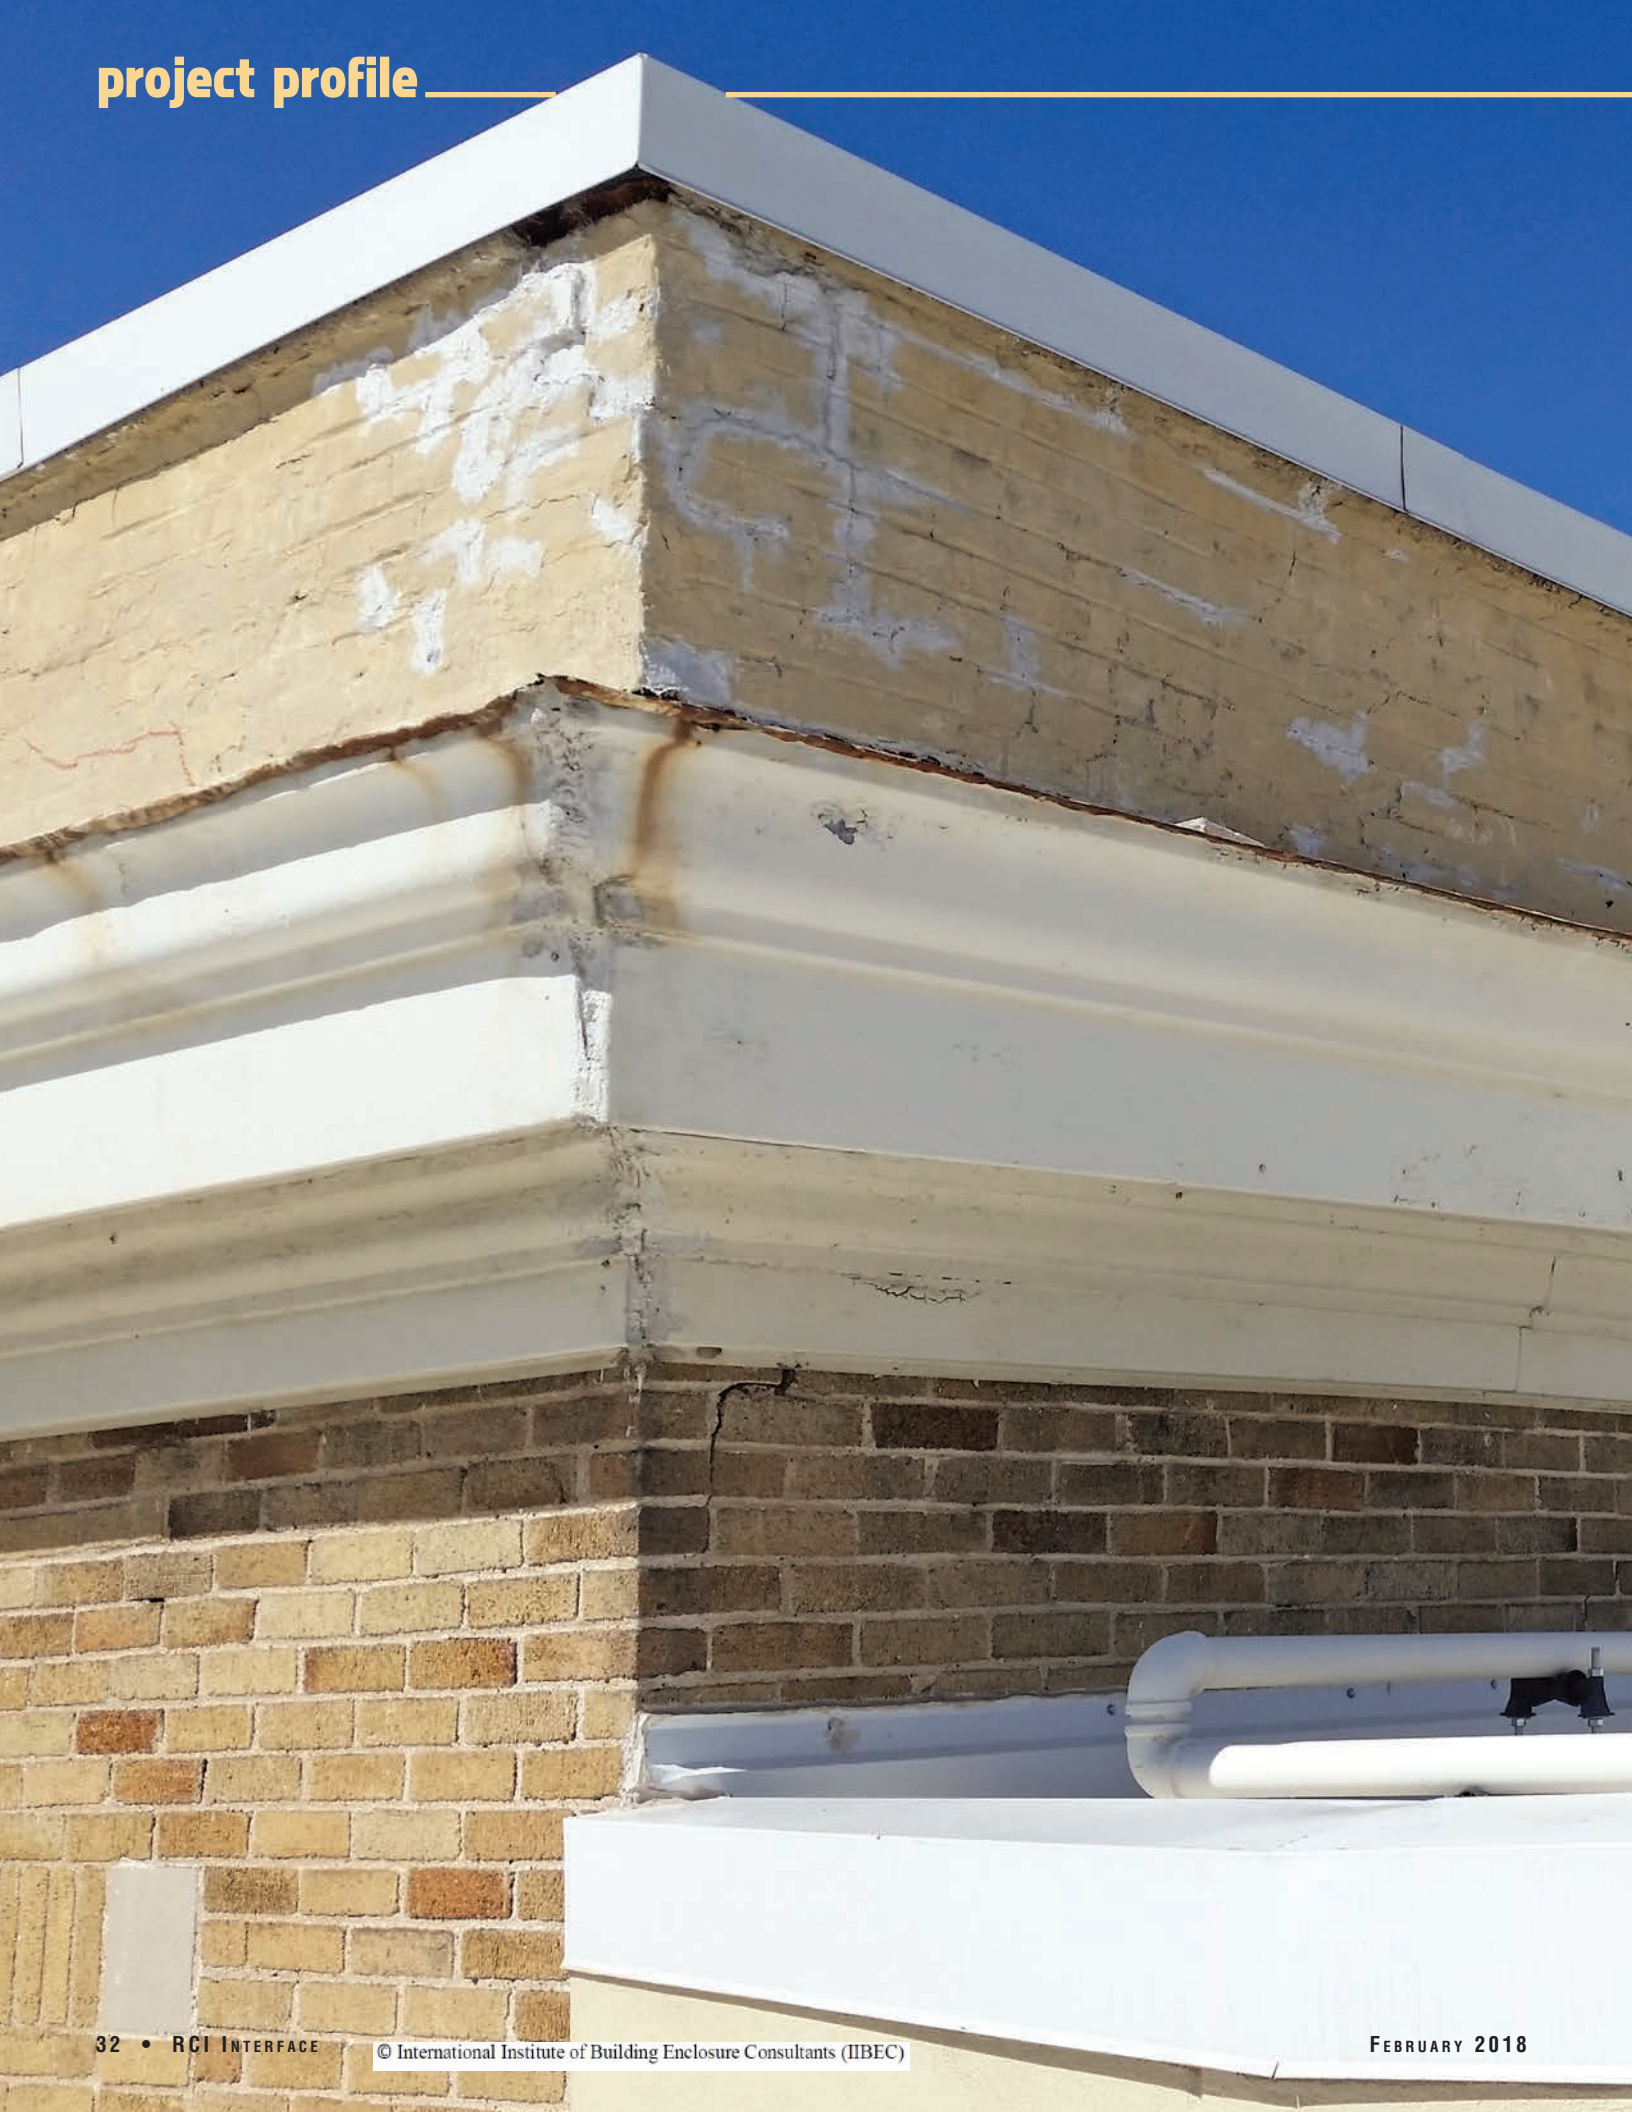
by performing several inspection openings within the exterior wall assembly to observe the existing concealed masonry and flashing conditions. Our openings revealed many issues, the most concerning being defects in the exterior surface and voids in the backup masonry walls. This issue was further exacerbated because, as was typical in that era and type of construction, no continuous weather barrier/waterproofing membrane was installed between the terra cotta and the brick masonry and around various penetrations, such as windows. As part of our envelope condition assessment, we sampled and tested various materials to ensure future repairs would be compatible with the historic struc-

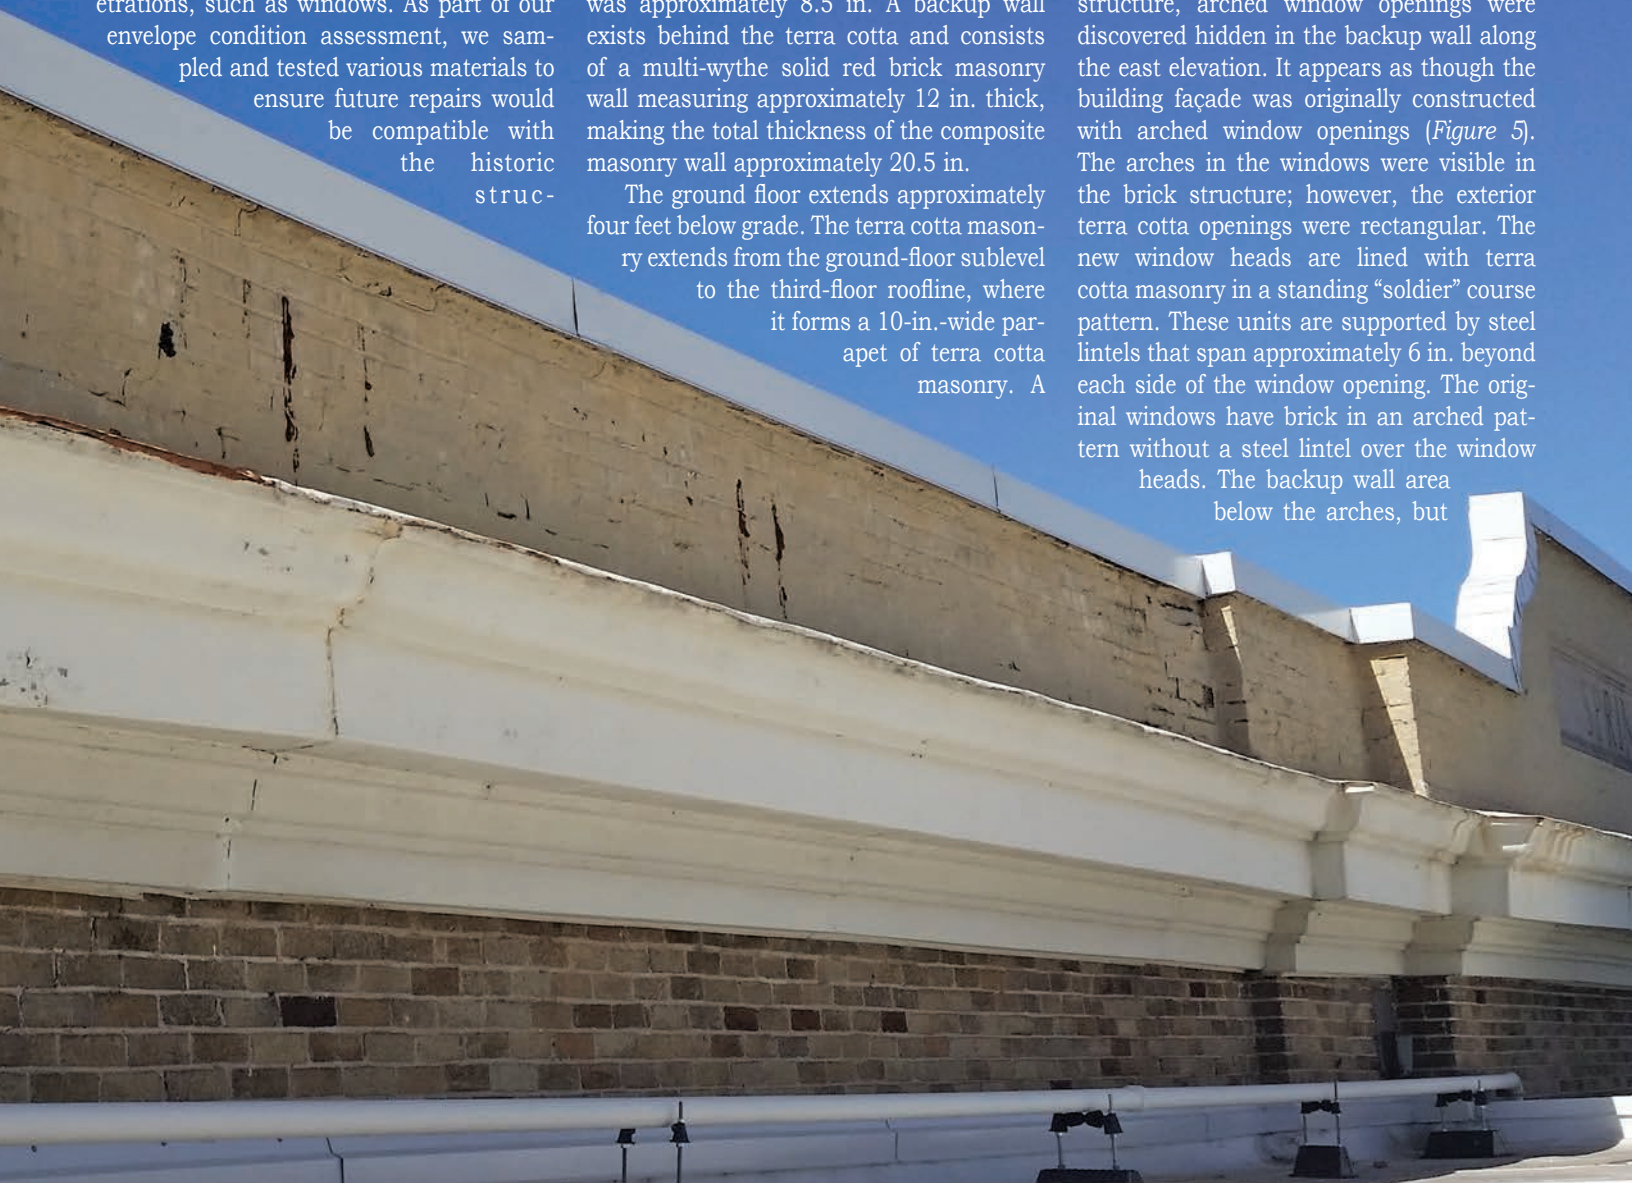
Figure 7 – View of east elevation parapet wall deterioration at time of evaluation.

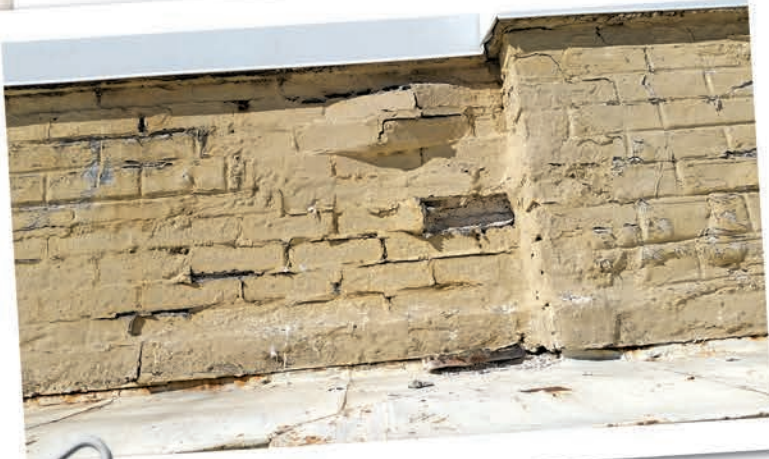
Figure 8 – Example of cracks and bulging masonry causing discontinuity of parapet wall coating.

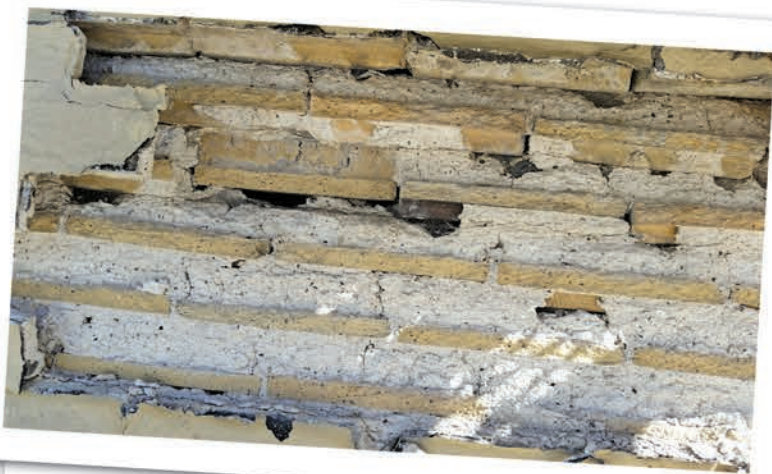
Figure 9 – Example of spalled terra cotta masonry at parapet walls.

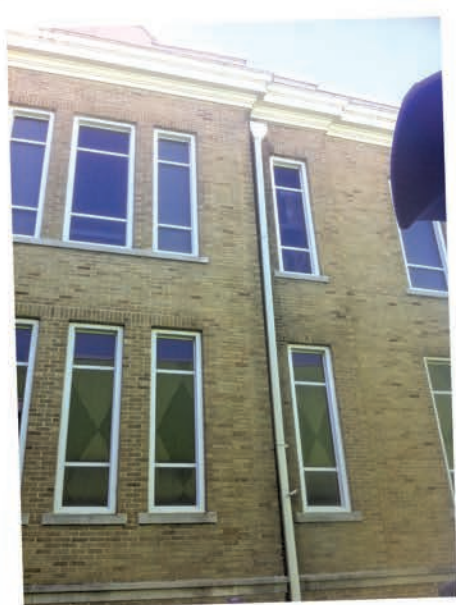
Figure 10 – Exterior view of roof scupper/downspout and stained masonry (second and third floors) above Figure 4 basement location.

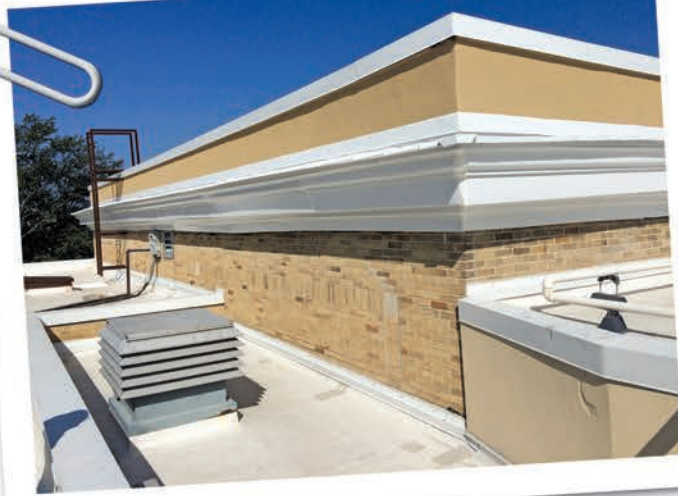
Figures 11 and 12 – View of south and east elevation parapet wall and original Spring Street School entablature after repairs and new breathable coating to protect original masonry.

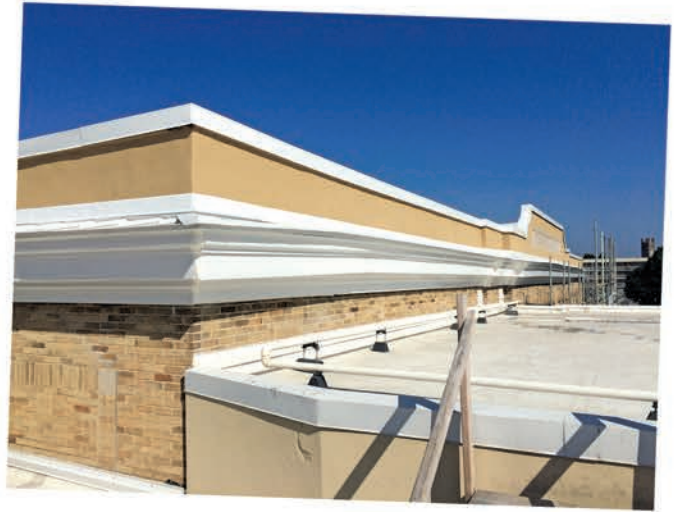
of a full set of construction documents, construction administration services, and on-site observations of the installed repairs. Due to the historic nature of the structure, development of compatible repair methods and materials was of high importance.
