# FAÇADE STABILIZATION: *Expect the Unexpected*

By Stefan Nespoli, PEng

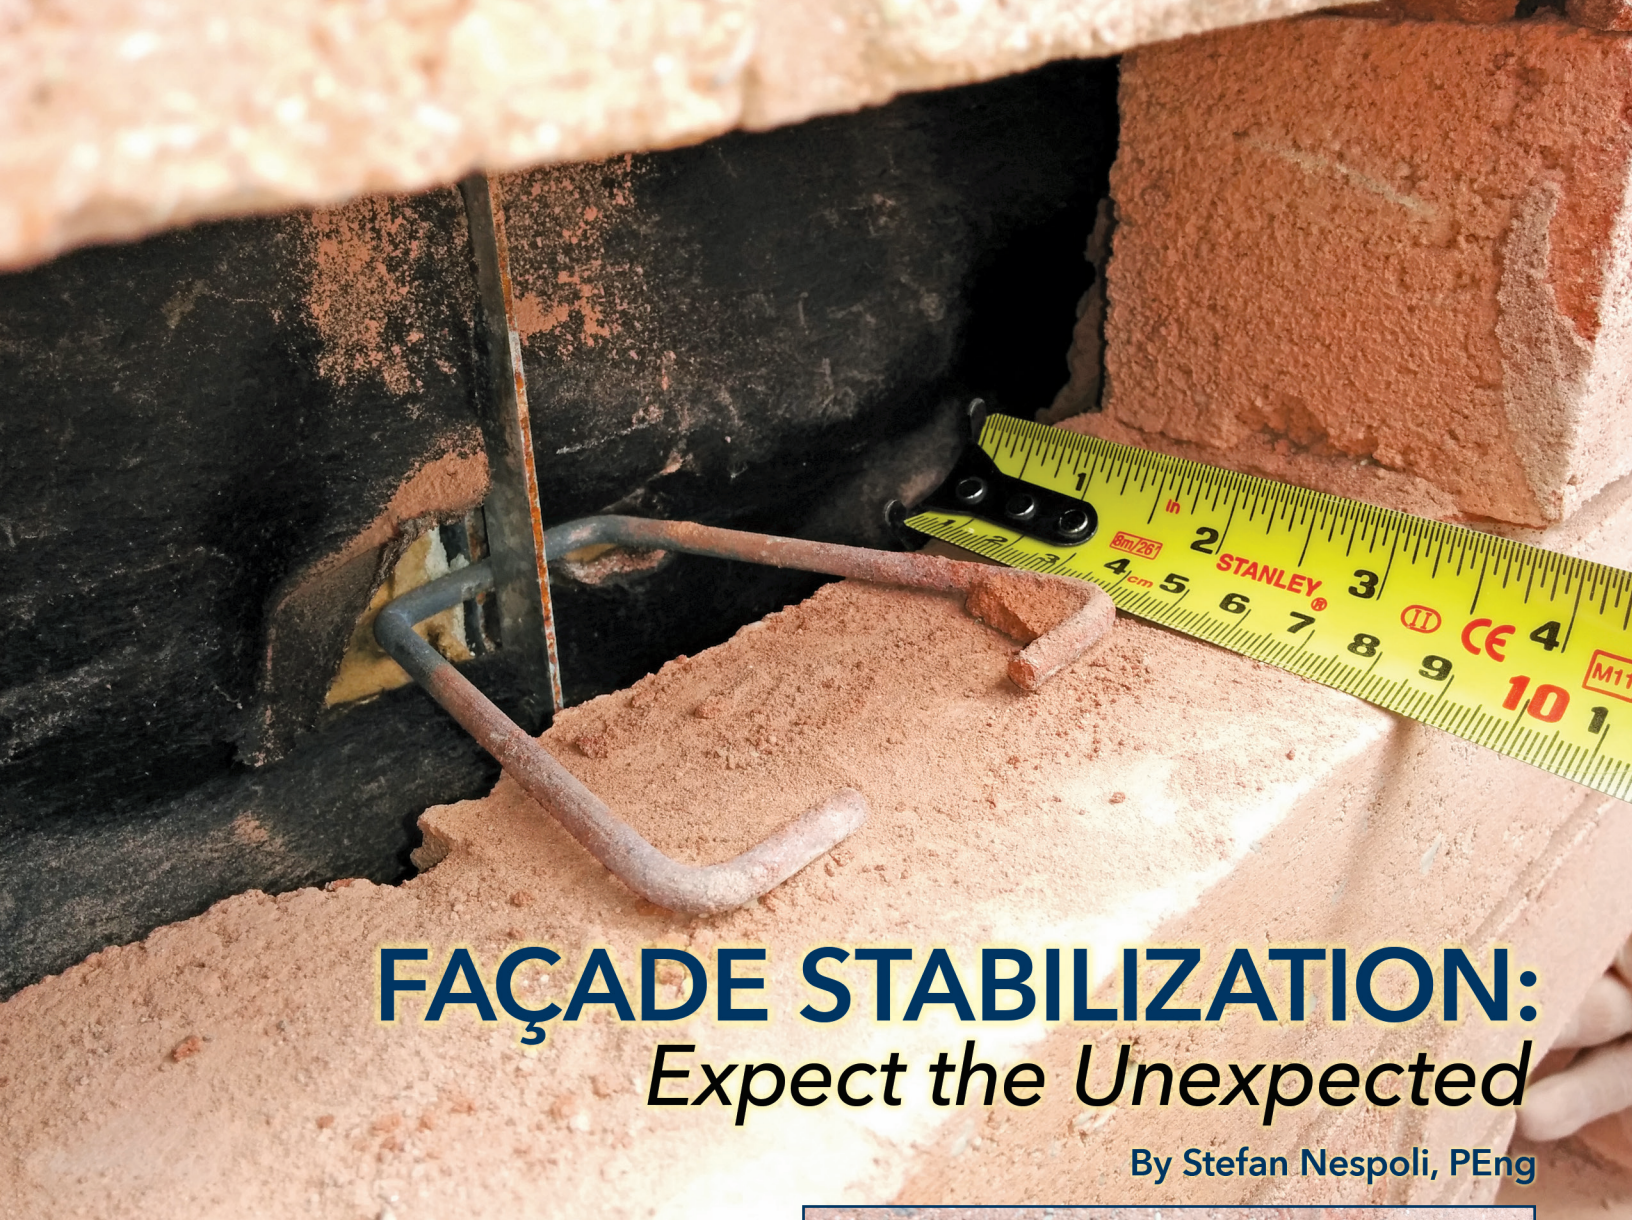
*Figure 1 – Correct installation at existing wire-and-plate brick tie at steel stud backup.*

to accommodate the wire tie, which is embedded in mortar (Figure 1). The existing tie spacing was 16 in. horizontally by 24 in. vertically. The horizontal spacing is consistent with interior metal stud spacing.

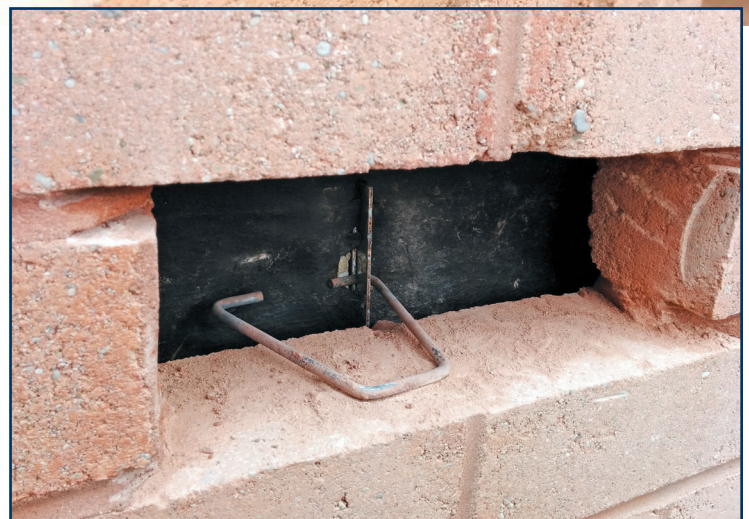
*Figure 2 – Improper installation at existing wire-and-plate brick tie at steel stud backup.*

At over 50% of the locations reviewed, wire ties were installed backwards, relying only on the back-turned leg of the tie to provide lateral support (Figure 2). Furthermore, we uncovered disconnected plate connections at steel stud backups (Figure 3) at 12% of interior test openings performed.

Lateral support would be re-established with new stainless steel retrofit helical brick ties at both steel stud and concrete backup. These ties are installed by first pre-drilling a pilot hole through the mortar joint and backup (Figure 5), then drilling the helical tie through the mortar joint and into the backup structure (Figure 6). A small mortar joint repair to conceal the

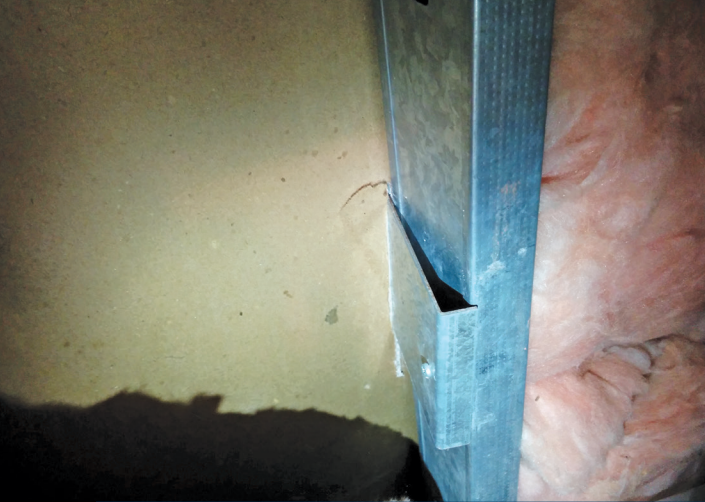
Figure 3 – Existing wire-and-plate brick tie failed connection to metal stud backup.

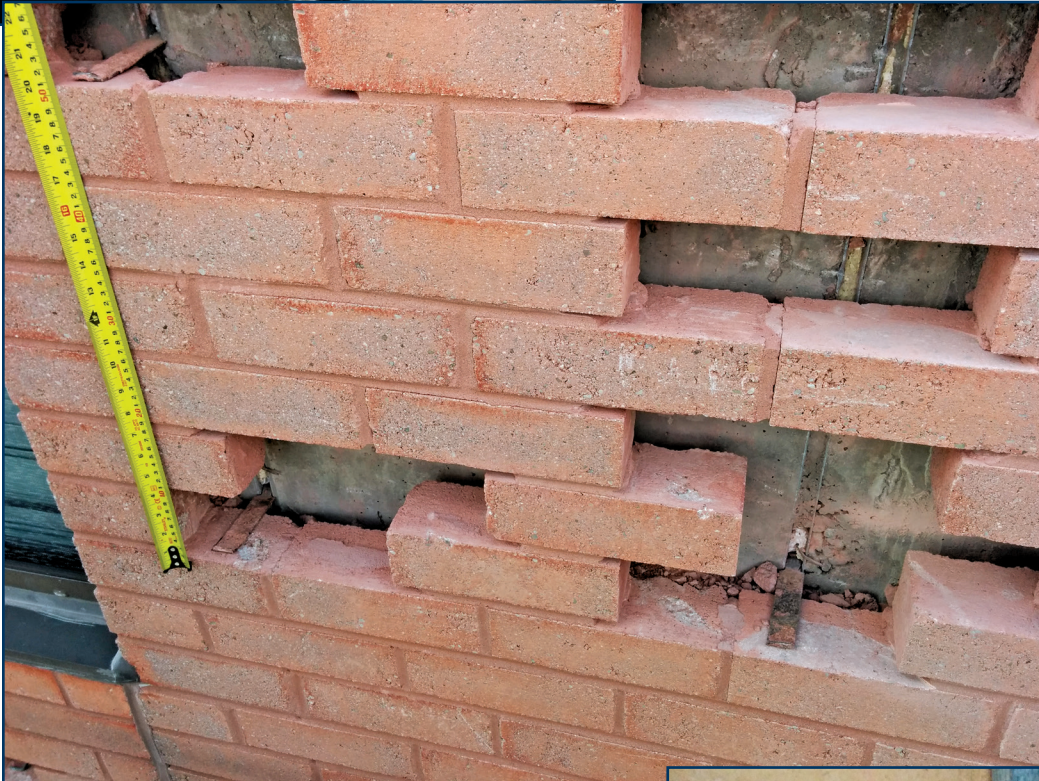
At areas with cast-in-place concrete backup, dovetail-style brick ties were installed (Figure 4), but similar to the wire-and-plate ties, there were issues with the original installation. The dovetail tie spacing was inconsistent in both

the horizontal and vertical directions. The dovetail ties are installed in vertical metal tracks that are cast into the wall structure. During our review, we discovered track spacing varying from 19 to 26 in. horizontally, and vertical tie spacing varying from 12 to over 50 in.

Based on loading calculations, it was determined that the inconsistent tie installation dictated that the existing system could not be reasonably relied upon.

Figure 4 – Existing dovetail brick tie at concrete backup.

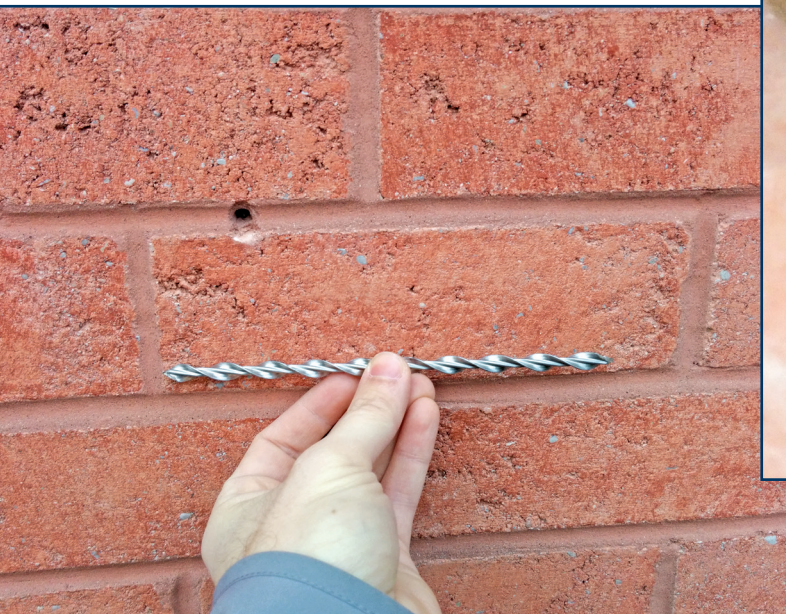
Figure 5 – Pilot hole through a mortar joint and helical tie.

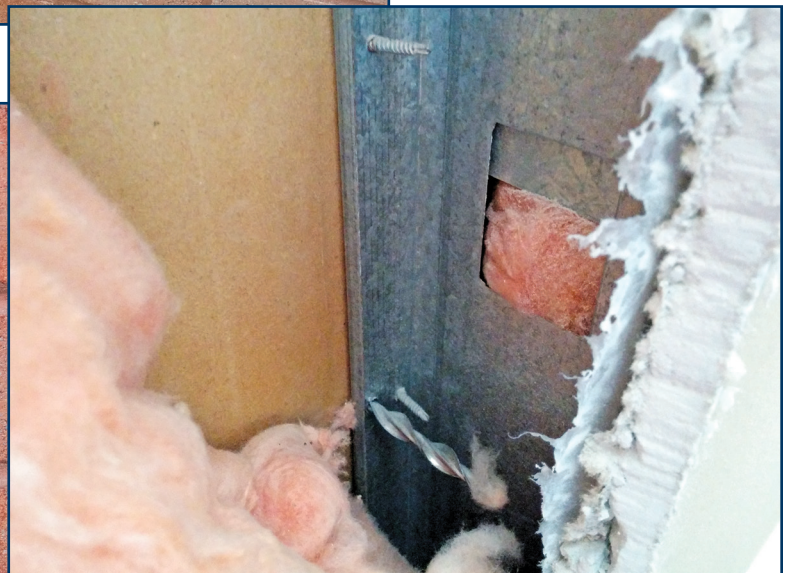
Figure 6 – New retrofit helical brick ties engaged at metal stud backup.

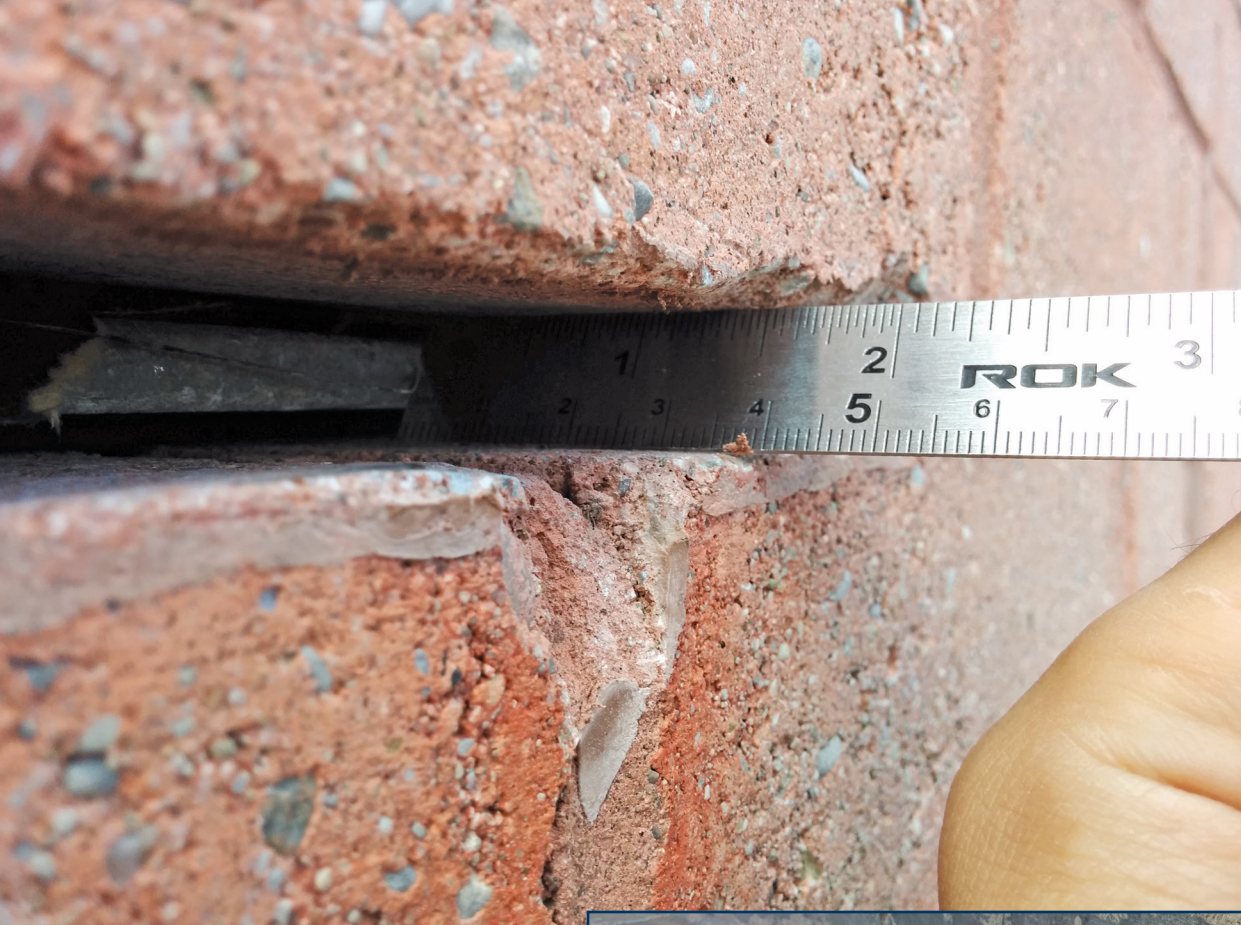
Figure 7 – Checking shelf angle overhang (1¼ in. depicted).

Full exposure of all shelf angles to check overhang would have been unduly costly. Instead, we performed localized openings at shelf angle toes to measure overhang

(Figure 7). We observed some locations where the shelf angle was providing inadequate support, and some locations where the shelf angle was providing no support at all (Figure 8).

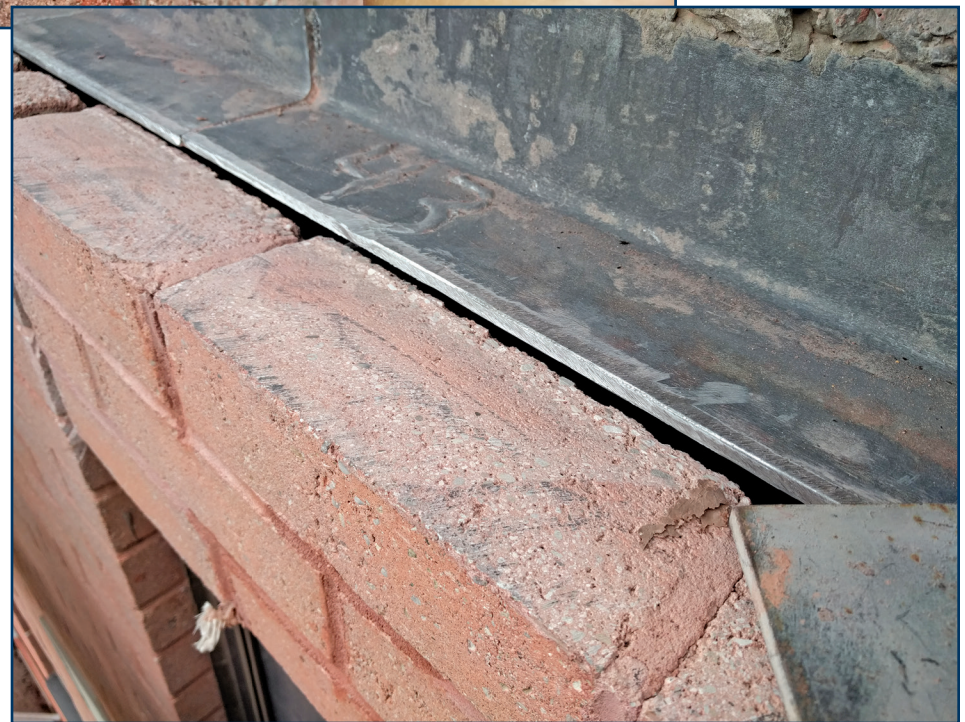
Figure 8 – No support at existing shelf angle.

be engineered joints—a gap between the angle and brick sealed with a flexible sealant—at the top of each brick panel to accommodate movement. In many areas, bricks had been installed beyond the toe of the shelf angle so far that the engineered joint was instead filled with mortar to provide support to the brick above. Of course, this use of mortar also facilitated load transfer to the shelf angles below, resulting in possible

Where repairs were required, shelf angles were extended and reinforced in place with welded steel extension and stiffener plates, custom-sized based on the repair location and existing overhang (Figure 9). Stiffener plate spacing was designed to accommodate existing brick coursing. Repaired shelf angles were then waterproofed, and bricks were reinstated (Figure 10).

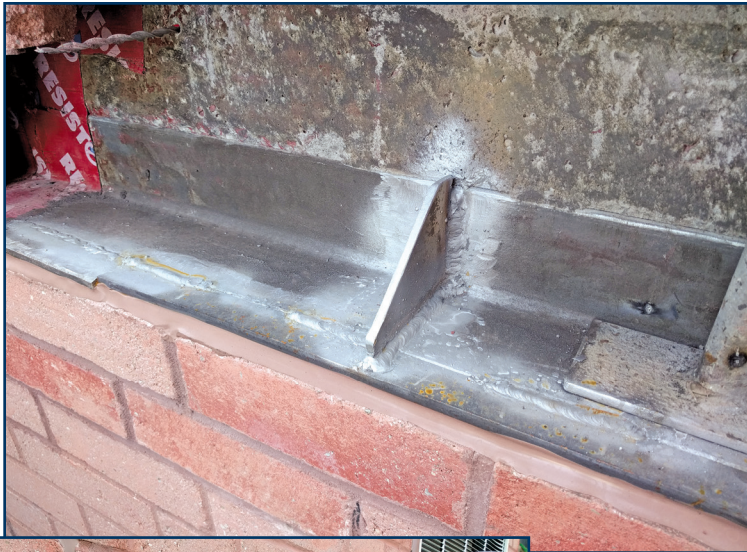
Figure 9 –  
New shelf angle  
extension and  
reinforcing.

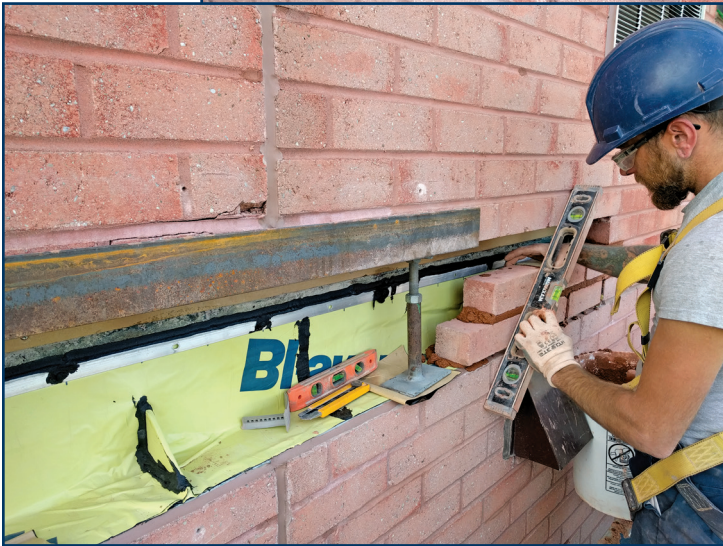
Figure 10 –  
New through-  
wall flashing and  
brick  
reinstatement.

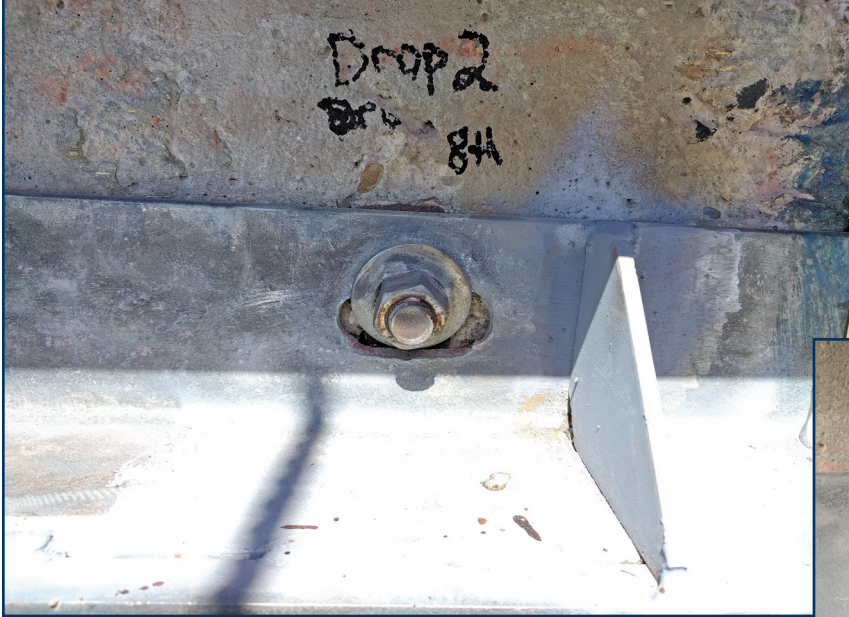
Consistent with the workmanship from original building construction previously described, the shelf angles appeared to have been crudely modified on site during installation to accommodate bolt locations and masonry coursing. These modifications required repair, since they resulted in bolt slots that were oversized or too close to the edges of the shelf angle.

At areas with oversized bolt slots, the existing washers were not making full contact with the shelf angle around the bolt slots (Figure 11). Fortunately, we were able to back off the existing nuts to provide a new, larger washer (Figure 12).

Figure 11 – Existing bolted shelf angle. Washer not making full contact due to oversized bolt slot.

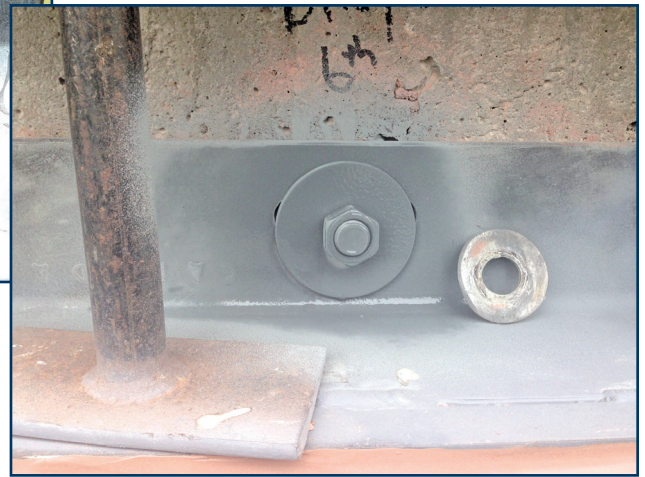
Figure 12 – Bolted shelf angle with replacement washer, making full contact with shelf angle. Original washer on right for size comparison.

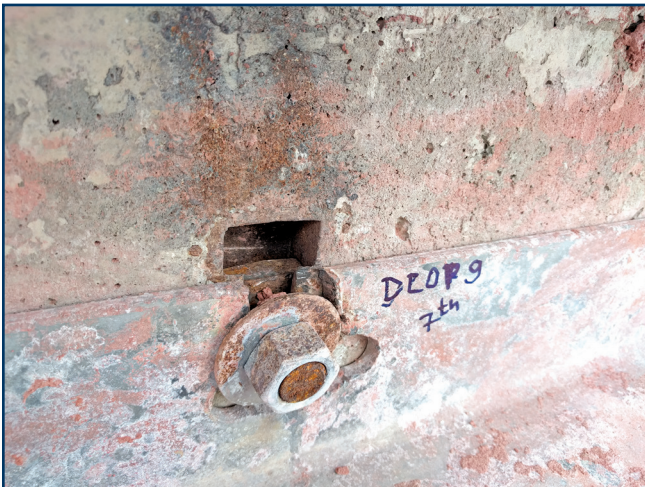
Additionally, some shelf angle modifications included full (or near full) removal of

the vertical leg of the angle to accommodate bolt placement (Figure 13). These locations were repaired by providing a new welded steel plate above the vertical leg of the shelf angle, restoring adequate edge distance (Figure 14).

Figure 13 – Existing bolted shelf angle cut to accommodate securement.

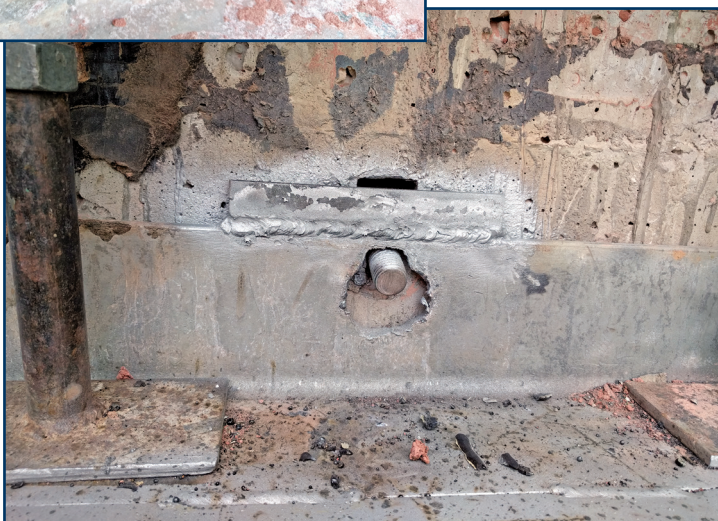
Figure 14 – Repair at cut shelf angle.
