# Why Does My Roof Pond?

By Scott D. Coffman, PE, SECB

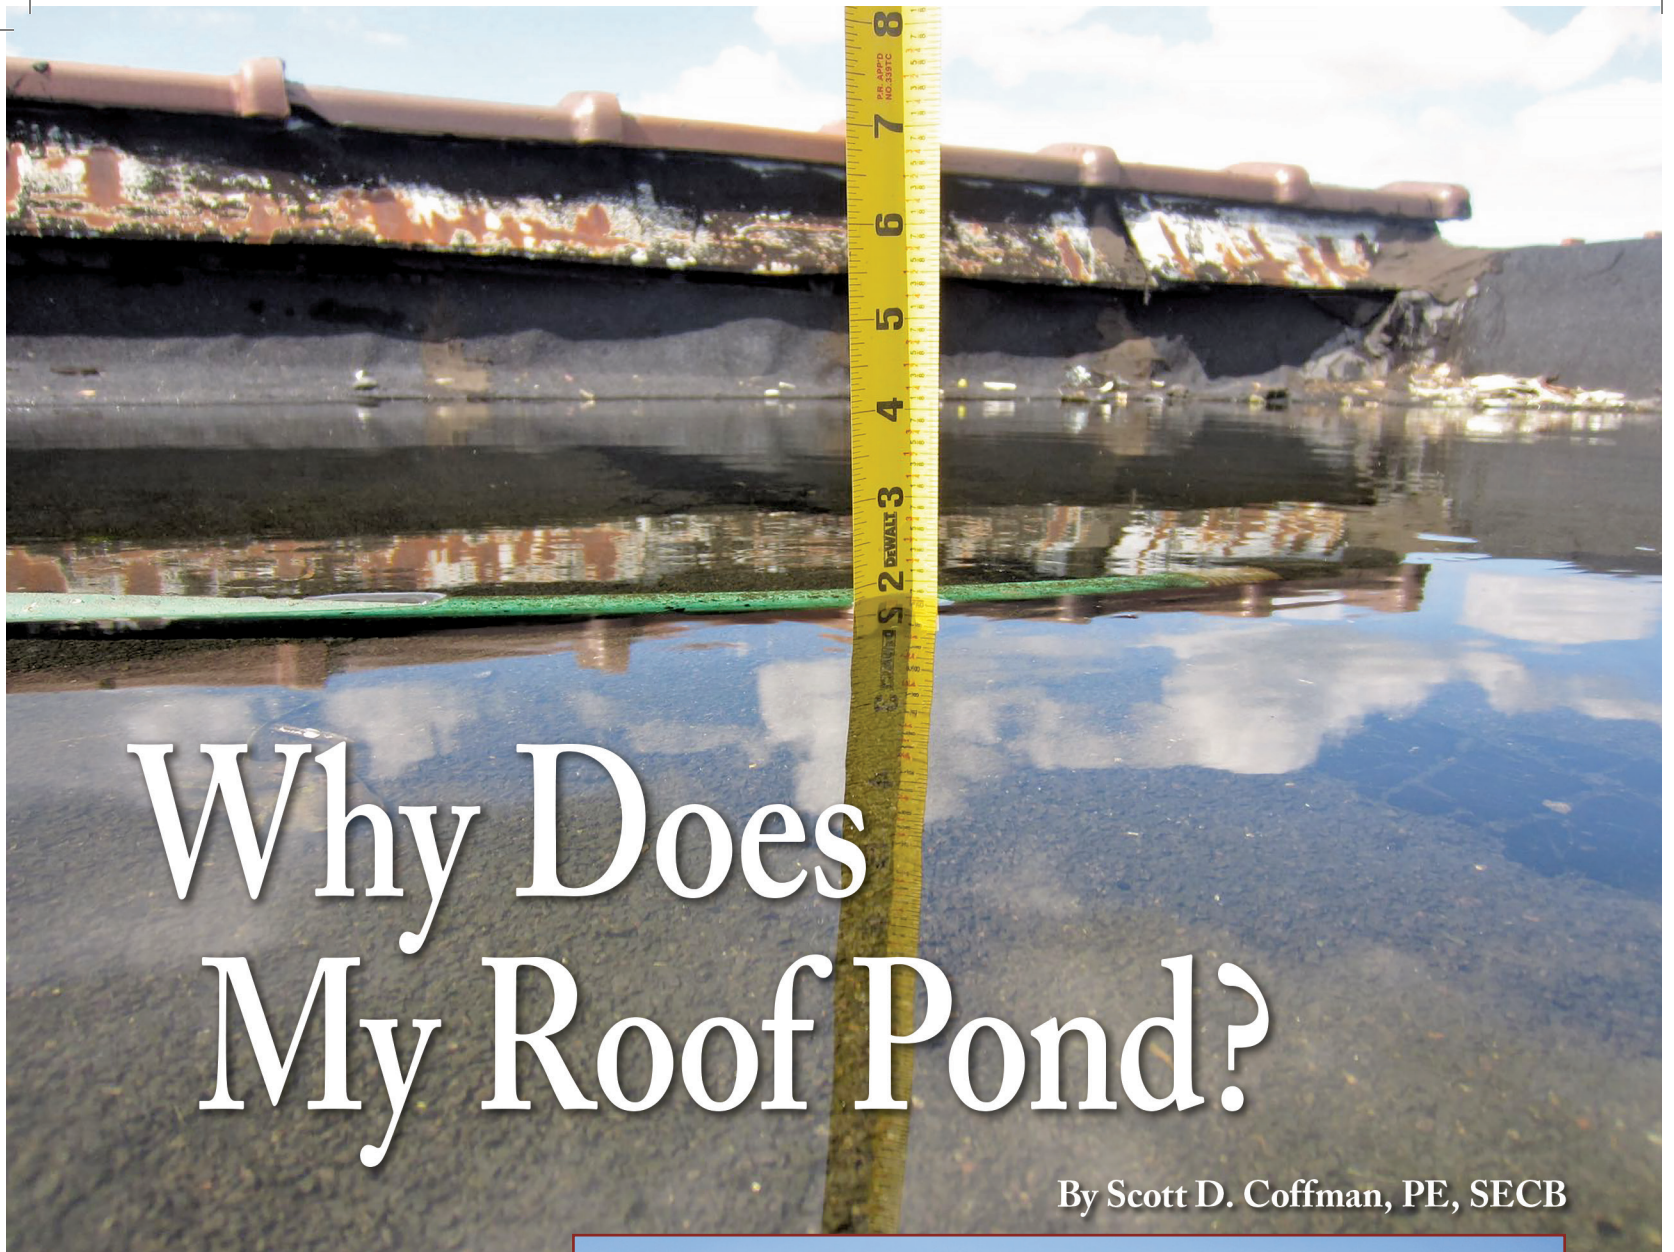
*Figure 1 – Excessive ponding water on a roof.*

In evaluating building enclosure problems, the author has encountered many newly constructed, wood-framed, low-slope roofs and exterior balconies and decks that exhibit excessive/sustained ponding of water (*Figure 1*). These conditions can lead to interior water damage through premature deterioration of roof coverings and/or excessive deflection of roof framing members. The ponding (and associated creep of the framing) can be so significant that it may ultimately lead to failure of the roof framing.

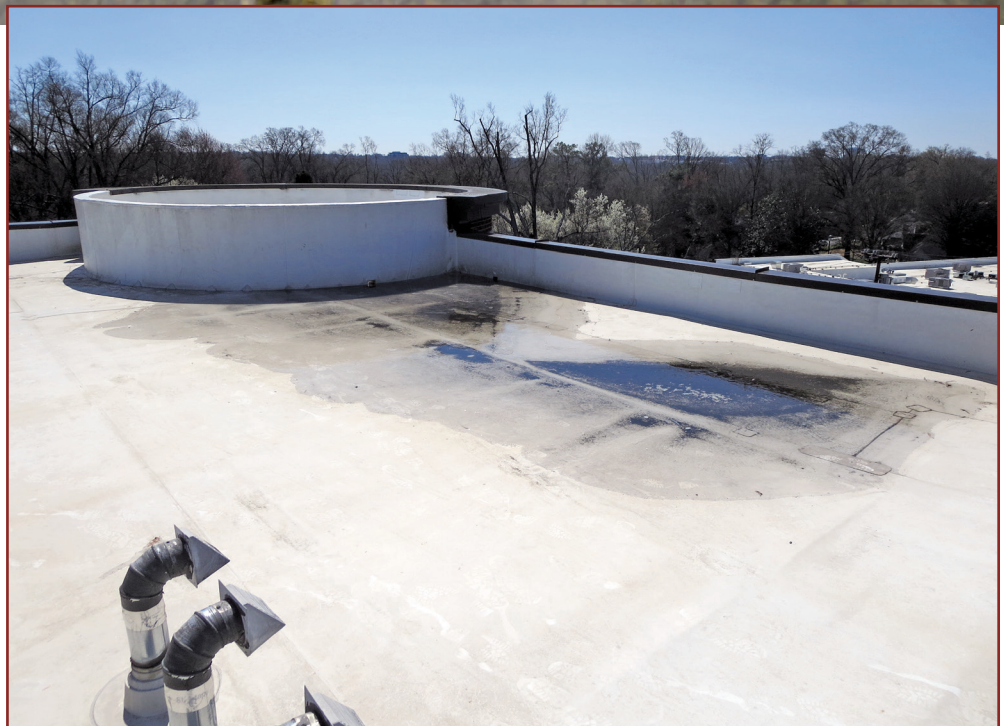
*Figure 2 – Ponding typically occurs prior to reaching discharge points.*

The stated and intended purpose of the code-specified  $\frac{1}{4}$ -in-12 slope is to provide drainage; however, ponding water is often observed on these low-slope roofs—even when the initial slope appears to have been provided during original construction. Specifically, water ponding occurs some short distance prior to reaching the free edge, scuppers, and/or drains (Figure 2). Four primary reasons are identified that contribute to the observed ponding. Each reason for the disparity between the intent of the design and the resulting condition is discussed.

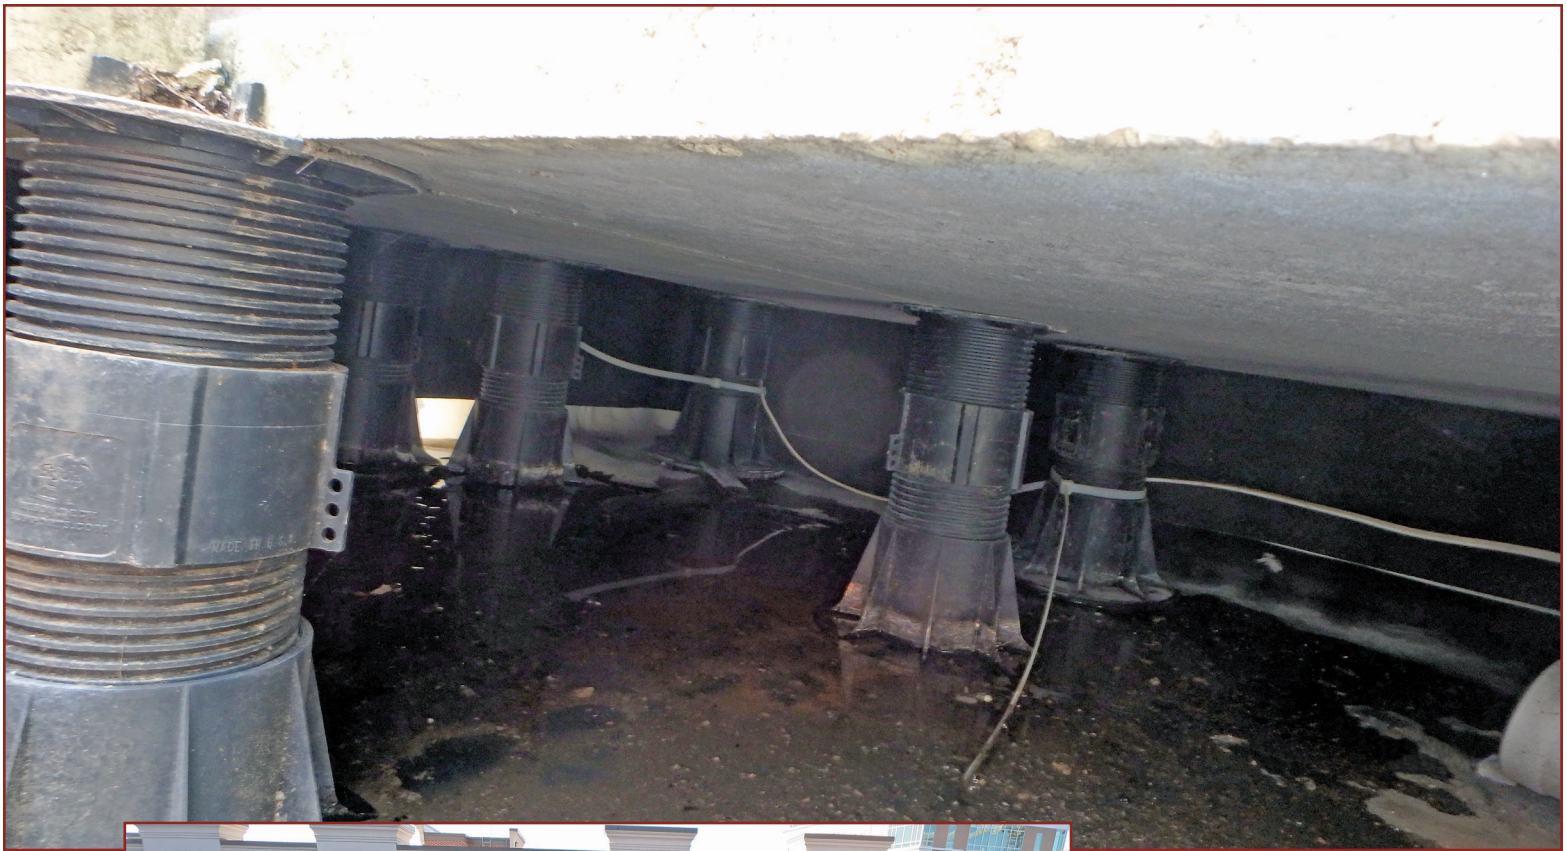
Figure 3 – Dead load from paver system.

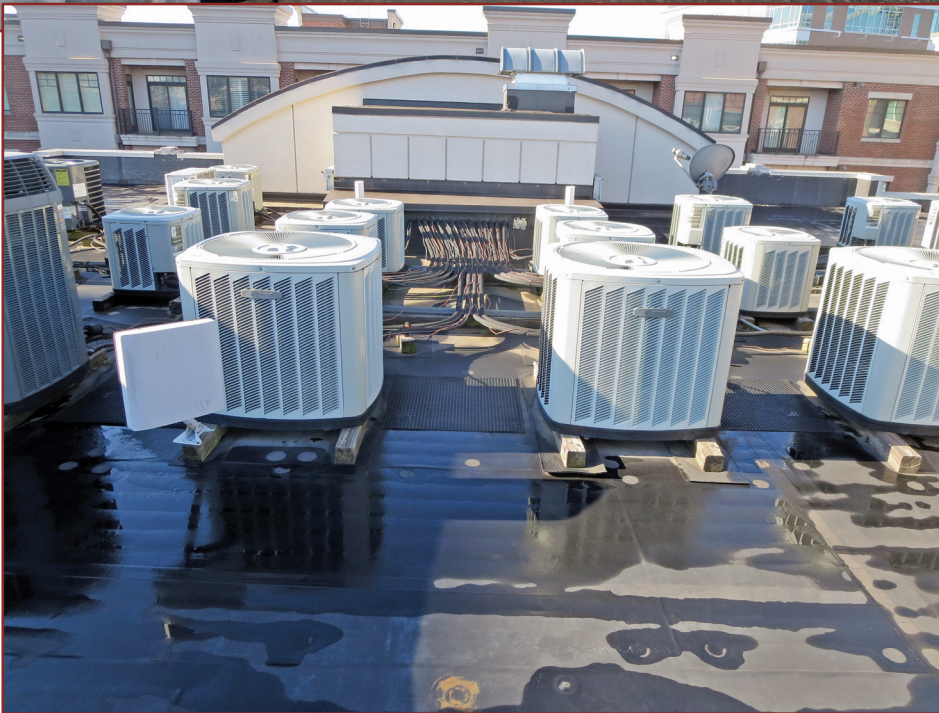
Figure 4 – Dead load from mechanical units.

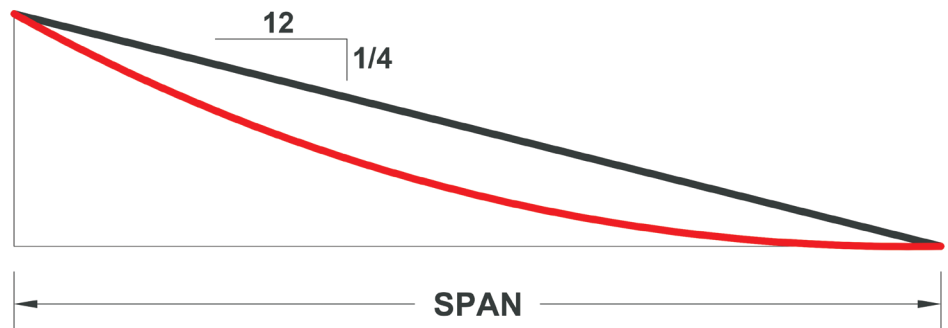
Field observations and investigations by the author have found members installed to a “design slope” of 1/4 in 12 often deflect from the initial dead load to create a “flat” area toward the low end (Figure 5). The author investigated the deflected shape of a member when the maximum midspan deflection was set to published code-deflection ratios.

Figure 5 – Deflected shape of low-slope roof.

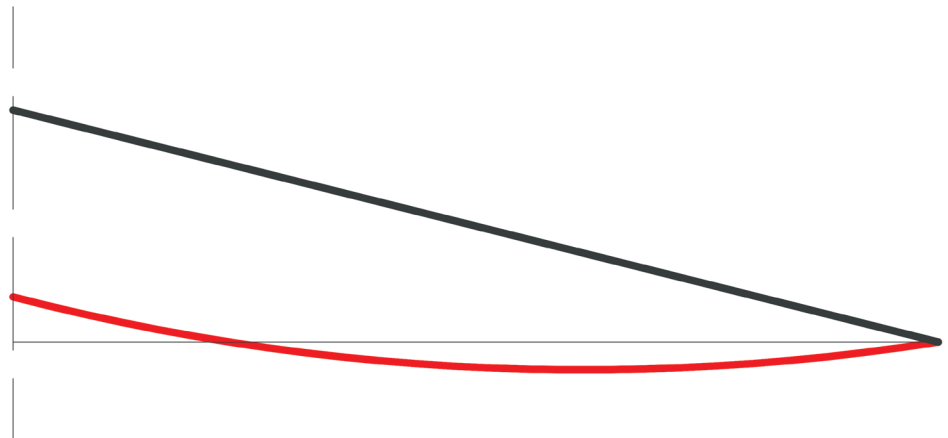
Figure 6 – Low-end “bowl” created for code-permitted roof deflection ratios.

The relative “flat” region retards and/or prevents free drainage. As the code-permitted L/120 or L/180 ratios are approached, the deflection curve extends below a horizontal datum to create a “bowl” (Figure 6). The “bowl” becomes more prominent for structural members susceptible to long-term deflection (creep). The author found the “bowl” is eliminated for members designed to the ASCE 7-16 maximum deflection-to-span ratio of L/240. However, the deflection curve remains relatively “flat” (less than ¼ in 12) at the low end to inhibit free drainage.

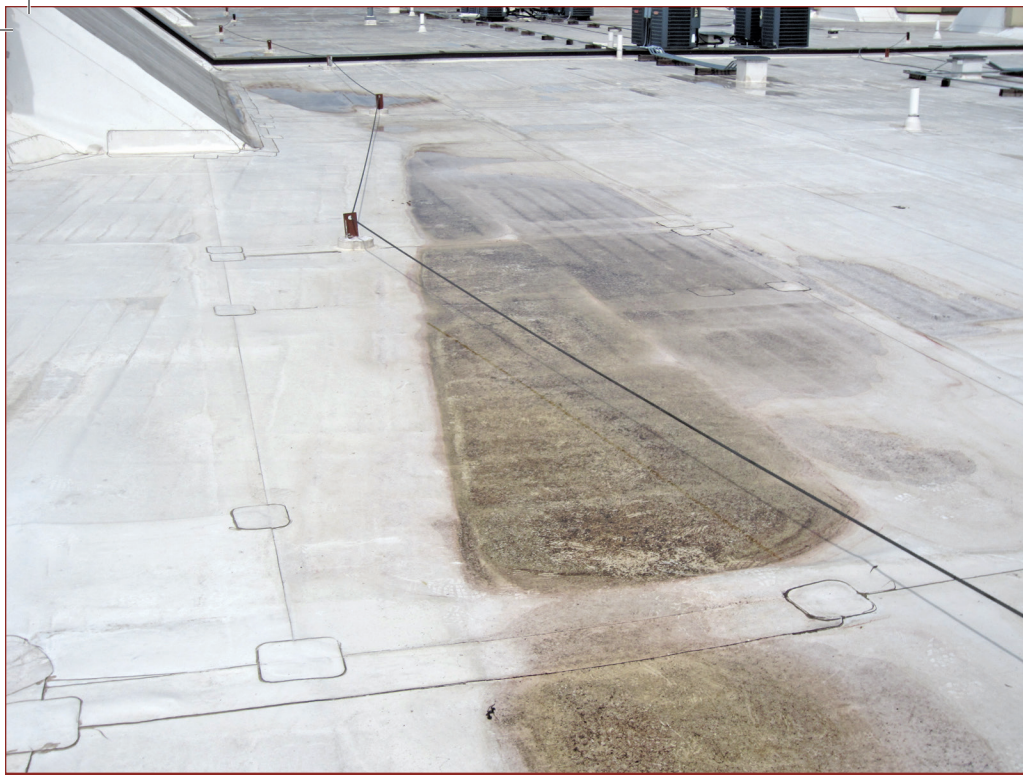
Figure 7 – Roof valley ponding.

ASCE 7 defines the ¼-in-12 roof surface to be toward the free drainage edge. The phrase “toward points of free drainage” is critical because it gives meaning to what is meant by a slope of ¼ inch per foot. A valley is not a free edge; it simply redirects the flow towards a drainage point. Additionally, the valley slope will always be less than the primary roof slope into the valley (Figure 7). For example, two roofs designed to a ¼-in-12 slope that intersect perpendicularly create a valley slope of approximately ⅓ in 12. Therefore, the primary roof slope should be increased to ensure a valley slope is sufficient for drainage.

In addition to the increased “design slope,” total load deflection checks should include short-term dead load, long-term dead load, and design live loads. At minimum, the calculated deflection should be compared to the L/240 ratio found in the ASCE 7-16 commentary. Roofs designed to a ½-in-12 slope and L/240 maximum total load deflection mitigate the flat area and “bowl” at the low end, which promotes drainage. The increased slope ensures a valley functions as intended by directing water to the designed drainage point.

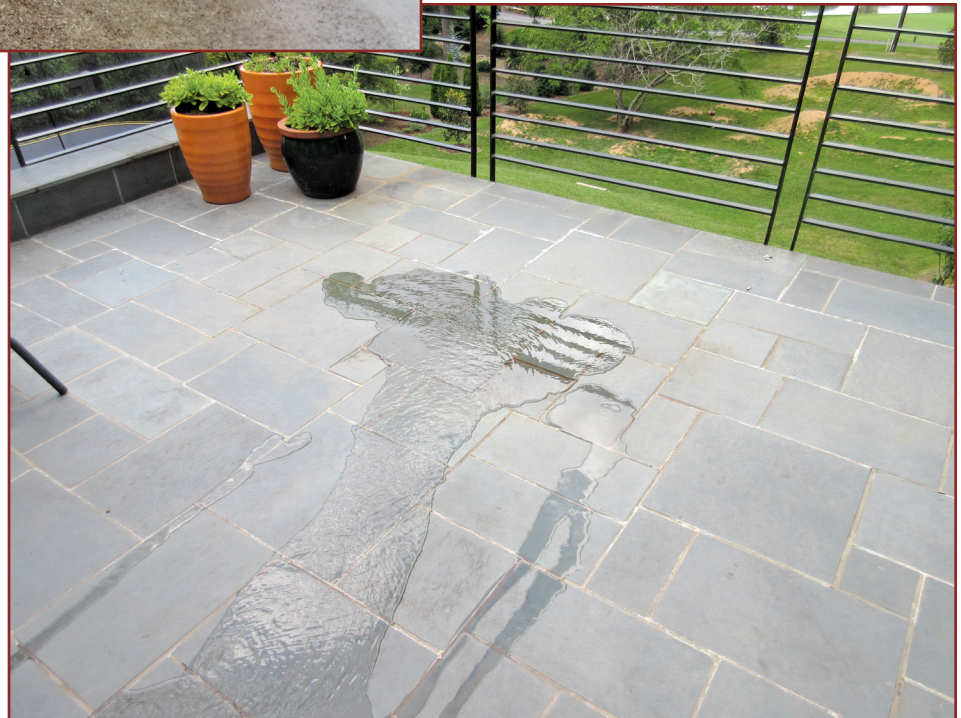
Figure 8 – Balcony ponding.

ters are often the default. The ¼-in-12 may originate from the historic Uniform Building Code section for waterproofing weather-exposed areas that included balconies and occupied roofs. However, ponding characteristics common to roofs are found on exterior balconies (Figure 8).

With respect to balcony design and construction, the author suggests the supporting floor structure be sloped to provide positive drainage that permits the moisture-permeable surface to be installed at minimal, if any, design slope. This is consistent with the aforementioned 2018 IBC. In the absence of specific code parameters, the balcony framing members may be sloped between ⅓ in 12 and ½ in 12, depending on

the finish slope of the moisture-permeable finished surface. The ½-in-12 slope should be used for a “level” finished surface. An L/480 or stiffer deflection-to-span ratio is suggested for the total load deflection check. The total load includes short-term and long-term dead load and design live load. The dead load should consider the “taper” thickness of the moisture-permeable surface supported by the framing member installed on a slope when the finish surface is “level.”
