From Hurricanes Andrew to Michael:

Lessons Learned for Residential Roofing

By Michael Fischer

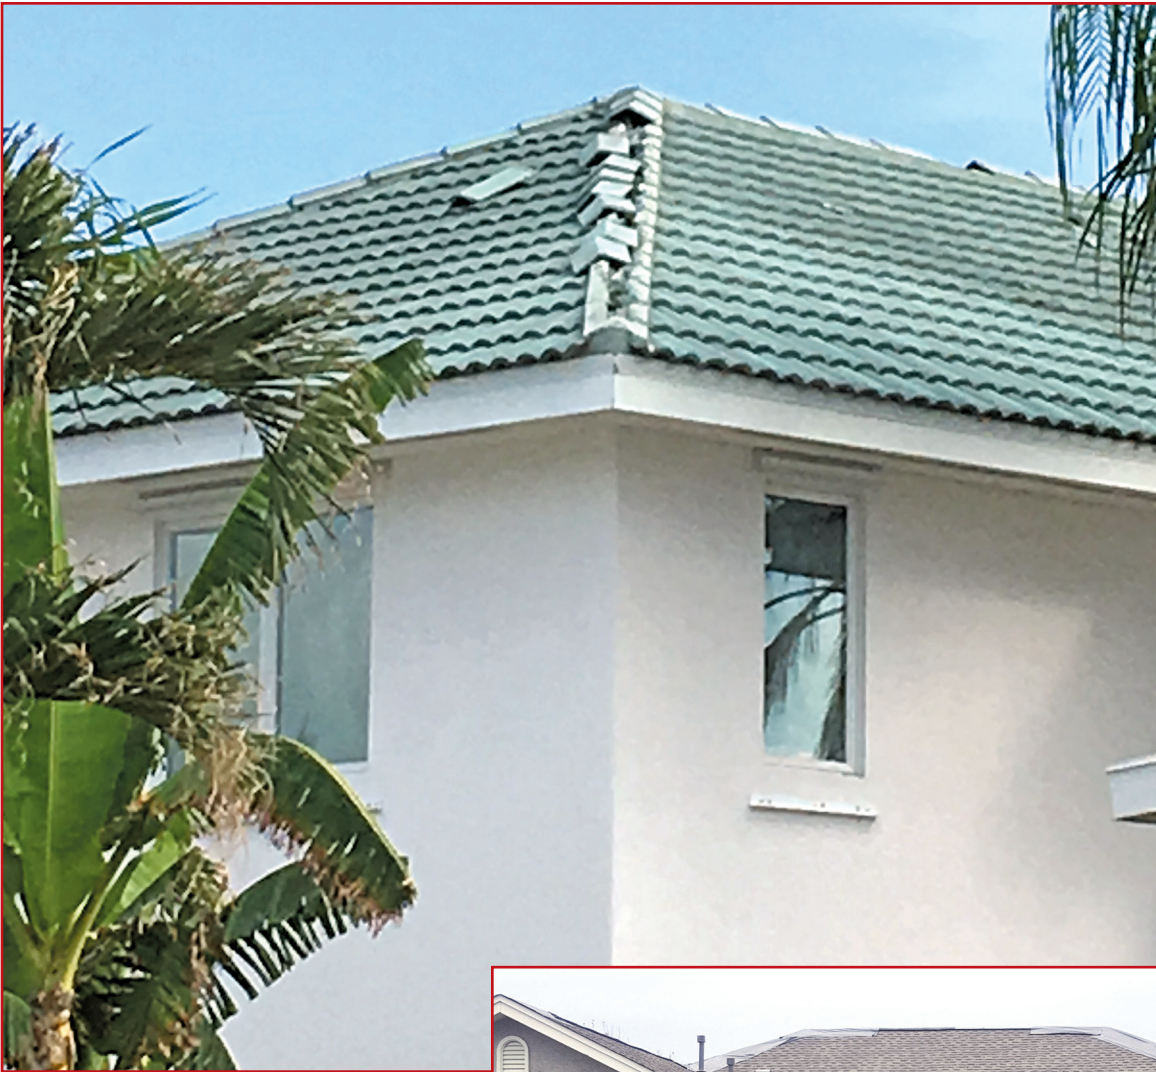
vations described varying levels of damage, but did not assess the market penetration of any specific roof covering in order to provide a weighted analysis of the damage likelihood based on material type. There were some common damage modes across all roof coverings, notably hip and ridge areas (Figures 2 and 3), edge and fascia details at rakes and eaves, and soffit loss. Soffit performance was not directly related to the type of roof covering, but is noted here because soffit failure can be connected directly to fascia materials at roof eaves.

Figure 2 – Hip damage to tile roof. Courtesy of ARMA.

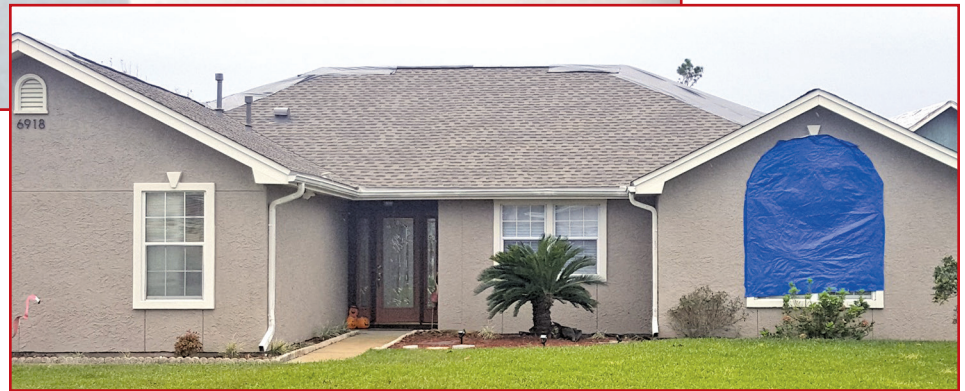
Figure 3 – Hip and ridge damage to asphalt shingle roof. Courtesy of ARMA.

Despite the improved structural performance noted by FEMA after Michael, roof coverings from older as well as newer installations exhibited damage. As with Irma, damage to hip and ridge shingles and ridge vents appeared to be widespread; these observations are not unexpected due to higher pressures typically generated at these locations on roofs during wind events. Because the roof decks at ridge vents are installed with a gap, loss of the roof covering at these locations can provide an easier point of entry for water.

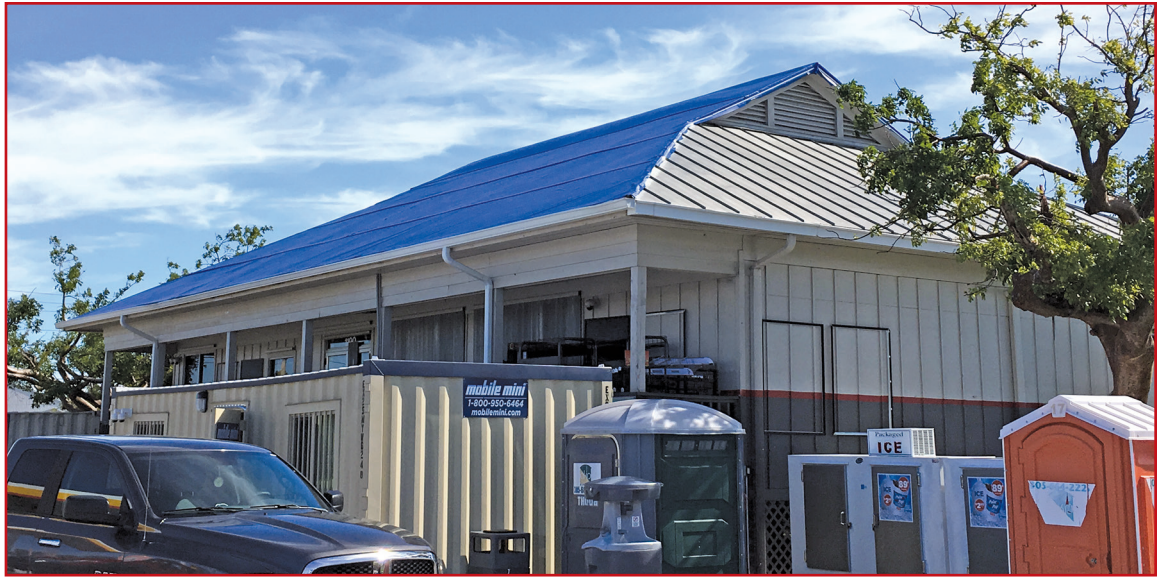
On one noteworthy project, the installation of an architectural standing-seam panel roof on a convenience store was underway (Figure 4). This roof replacement project included new decking, as well as metal panels; it appeared during a visual inspection from floor level that the roof deck and panel attachment were not compliant with the Florida Building Code, based on the lack of fastener penetration through the wood deck.

Figure 4 – Damaged architectural standing-seam roof on convenience store.

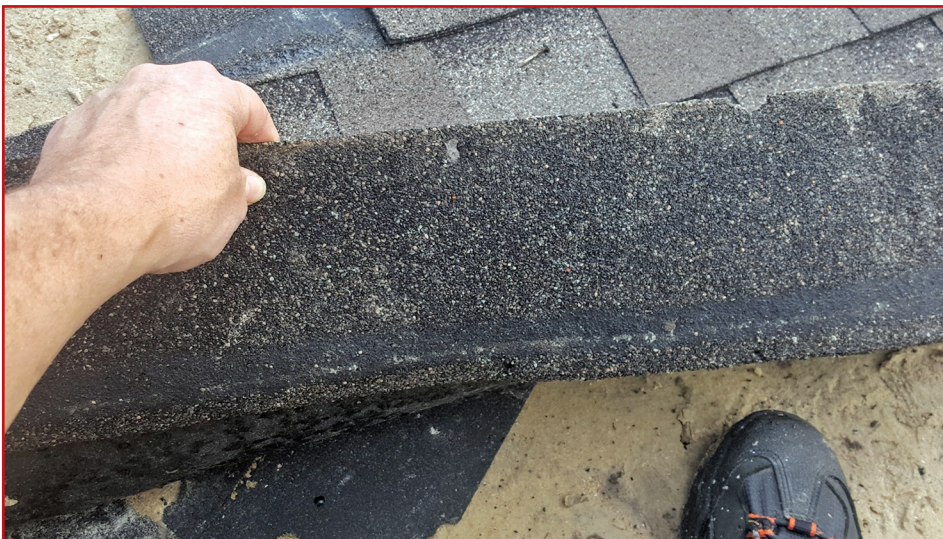
The examination of asphalt shingles in the debris pile highlighted two areas of concern from FEMA's perspective; the first is a widespread occurrence of improperly located fasteners (Figure 5). If nails are not properly located, the shingle is unlikely to perform as intended. The Florida Building Code requires that the shingles be installed in accordance with the manufacturer's installation instructions. The second observation is the absence of roofing cement on hip and ridge shingles in the debris pile. While this application method is not required outside of the High-Velocity Hurricane Zone (HVHZ) in Florida, FEMA recommends its use.

Figure 5 – Damaged asphalt shingle showing incorrect fastener location. Courtesy of ARMA.

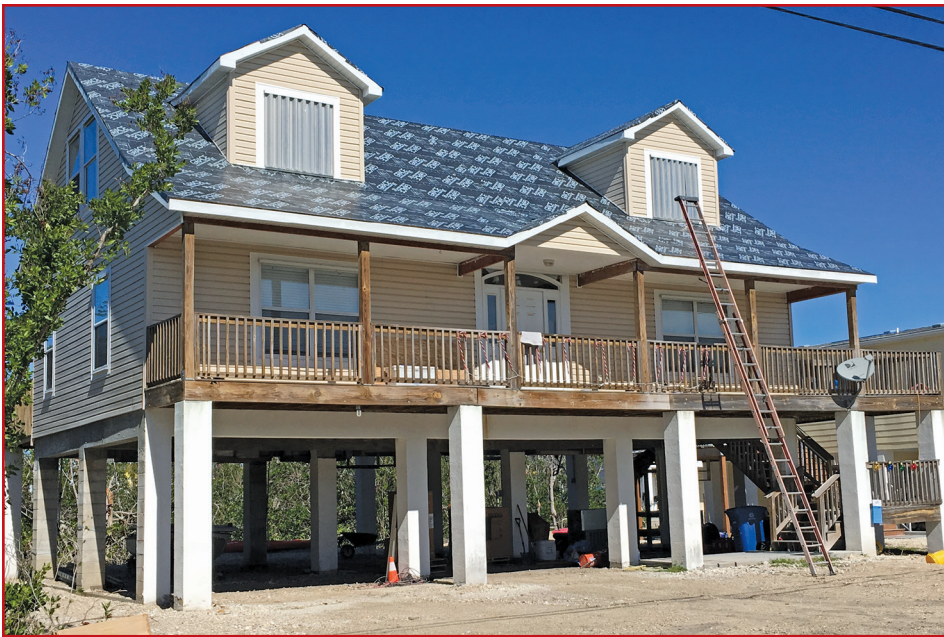
Figure 6 – Reroofing project using fully adhered underlayment. Courtesy of ARMA.

be undertaken by building experts and the industry to address opportunities to improve performance of installed roof coverings. One of the recent efforts to strengthen codes has been the introduction of a secondary water barrier under the roof covering through the use of double layers of underlayments, or by employing a sealed roof deck. Applying a layer of self-adhered underlayment on the entire deck (Figure 6) can help reduce water penetration if the roof covering is compromised.
