# Low-Slope Roofs Are Rotting: Case Study Resolution

By Dwight D. Benoy, PE;  
Pamela Jergenson, CCS, CCCA, BECxP, CxA+BE;  
and Gary C. Patrick, RRC, AIA

The buildings that were repaired were actually two four-story, wood-framed buildings called Coborn Plaza Apartments in St. Cloud, MN. Each building has retail space on the first floor with student housing for nearby Minnesota State University on the upper three floors. J.A. Wedum Foundation is the owner of the complex. Granite City Roofing, Inc. of St. Cloud was the reroofing contractor. Inspec was the architectural/engineering firm. This reroofing project proved to be one of the most challenging in Inspec’s 45-year history from a design and constructability standpoint.

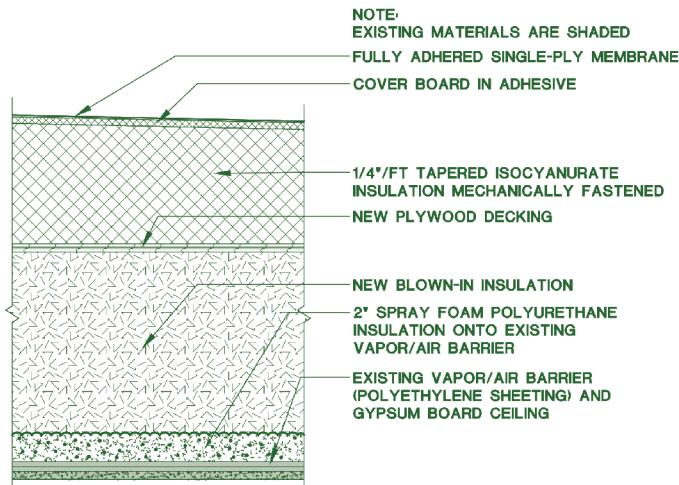
Figure 1

This option (Figure 1) was intended to create a complete vapor/air barrier by installing spray foam over the existing polyethylene sheeting and bottom chord of the truss. This required the removal of the existing roof system down to the structural roof deck and removal of a significant portion of the roof deck to facilitate vacuuming the existing blown-in insulation out of the truss space, and installation of the spray foam insulation and new blown-in insulation. New tapered insulation and roof membrane above the structural roof deck were part of this solution.

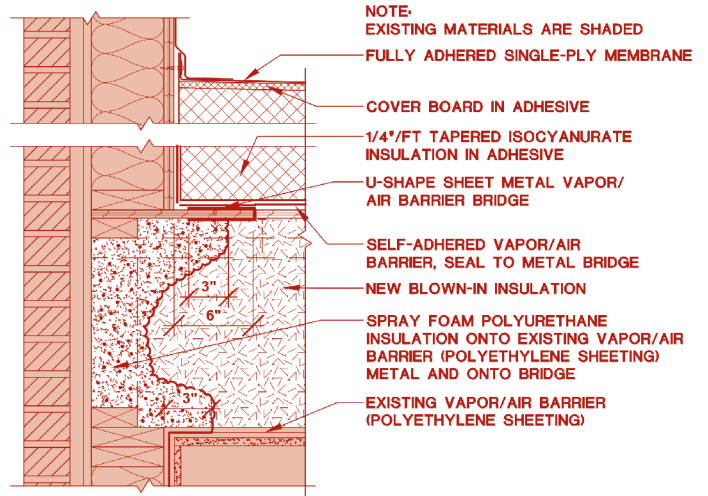
Figure 2

Option 2 (Figure 2) required removal of the existing roof system down to the structural roof deck, and replacement of any wet, rotted, and/or moldy deck and blown-in insulation. A roof vapor/air barrier would be applied on the structural roof deck.

Spray foam insulation of a minimum 3-in. thickness applied to the rim area was determined to be the most effective way in situ to transition the vapor/air barrier (polyethylene sheeting) from the exterior walls to the roof vapor/air barrier. The rim area is at the top of the exterior walls at the level of

Sufficient insulation needed to be added above the structural roof deck to get the dew point temperature above the roof vapor/air barrier. This insulation also needed to be tapered to provide roof slope to the existing interior primary and secondary (overflow) roof drains. The hygrothermal analysis showed a minimum of 4 in. of isocyanurate insulation was required to keep the dew point temperature above the roof vapor/air barrier. This meant all roof drains would need to be raised to accommodate the increased insulation thickness.

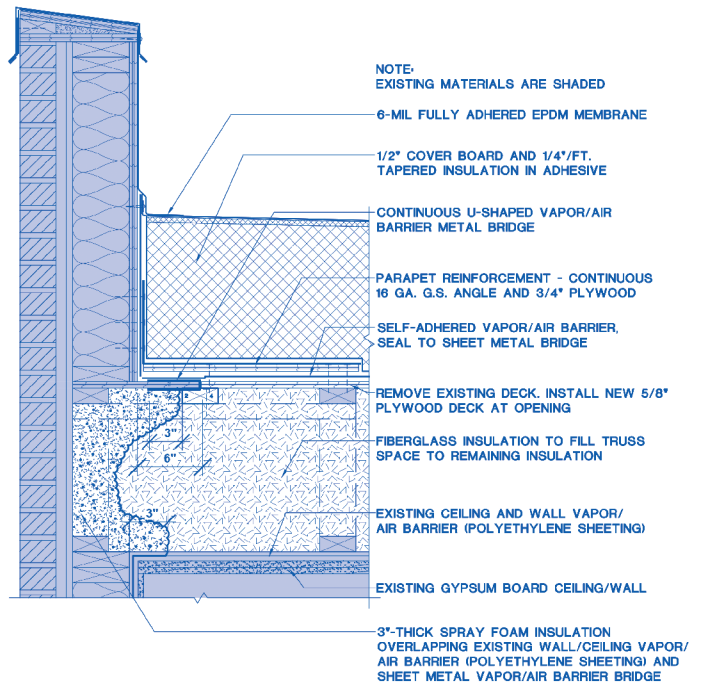
Figure 3 – Detail from winning Option 2.

Option 2 is the solution that was ultimately selected and developed into construction documents for bidding and construction (Figure 3). This was the best solution to achieve the goal of a complete vapor/air barrier. It also exposed all the existing roof assembly to allow for the removal and remediation of wet, deteriorated, and moldy roof components. This option also maximized the reuse of the structural roof deck and blown-in insulation that was still in acceptable condition.

- The parapet varies in height, with some of the low parapet design being challenged by the additional insulation thickness.
- The trusses run parallel and perpendicular to the parapets, which causes variations in the rim area conditions.
- The structural roof deck removal along the parapets compromised the structural integrity of the roof perimeter at some conditions, so an engineered solution was required that included continuous steel angles and plywood sheathing being added

to reinforce the structure (Figure 3).

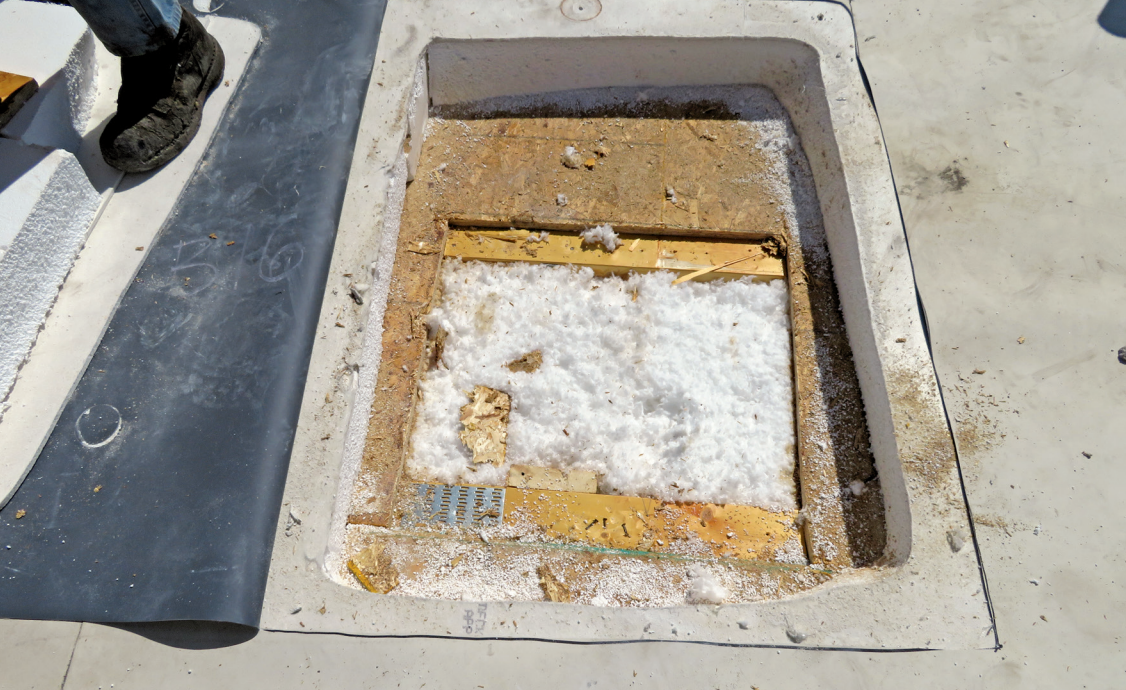
Figure 4 – Typical invasive inspection opening above trusses.

During the design phase, based on investigation-generated test results and observations, it was decided to make 60 invasive inspection openings prior to the start of construction to provide an idea of where the deck and insulation would need to be replaced (Figures 4 and 5). This would help the contractor better plan the construction work. The contractor awarded the reroofing project would make and repair the inspection openings.

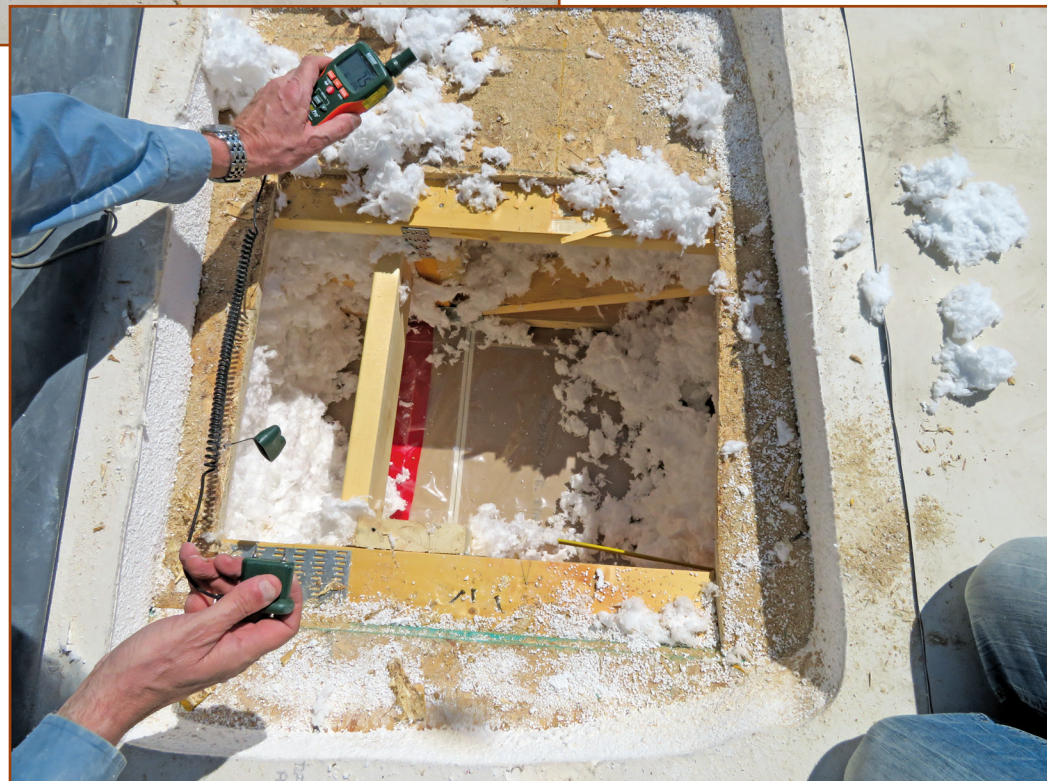
Figure 5 – Typical invasive inspection opening below roof deck sheathing.

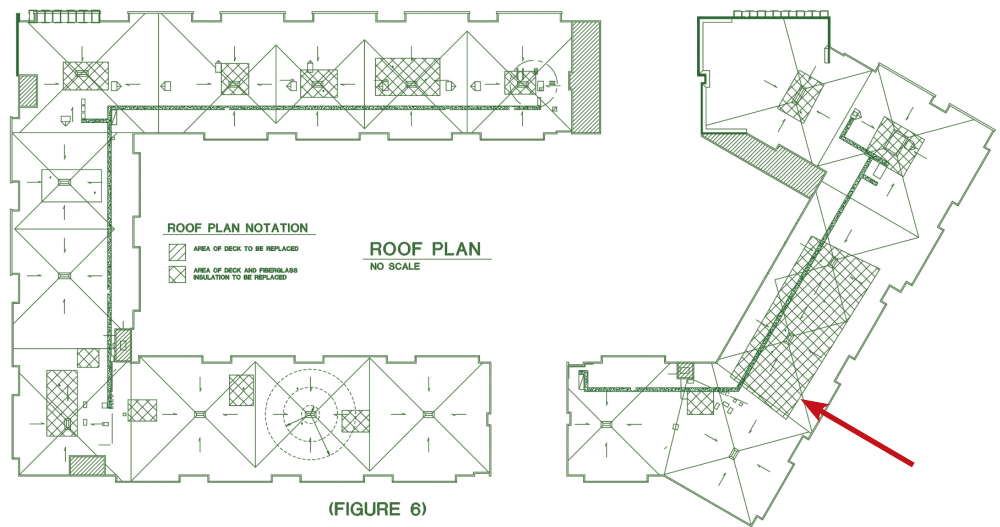
Based on the 60 invasive inspection openings, test results, and observations, a roof plan was developed showing the approximate areas where roof deck sheathing and blown-in insulation would most likely require replacement (Figure 6). The final determination of what needed replacement would be made by the contractor when each area was opened daily. While on site, performing their periodic observations, the A/E assisted the contractor to determine what needed to be replaced. A hand-held moisture meter was utilized daily, which worked well in determining the

Figure 6 – Approximate areas of roof deck and insulation replacement.

moisture content of the OSB structural roof deck. Industry convention indicates that a 16% moisture content would be the threshold for requiring replacement.

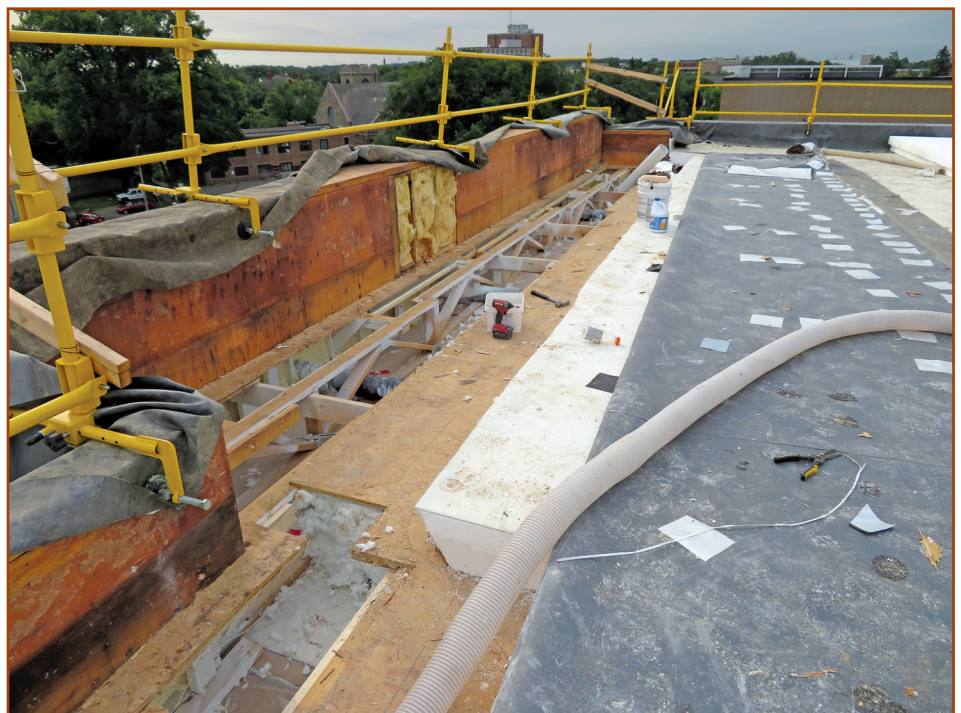
Figure 7 – Typical work at roof perimeter.

The contractor elected to do the perimeter work prior to the replacement work in the field of the roof (Figure 7). The perimeter work proved to be time-consuming and would have significantly reduced the size of the area that could be reroofed on a daily basis if it was done in conjunction with the field of the roof. The contractor could also schedule the perimeter work on days when

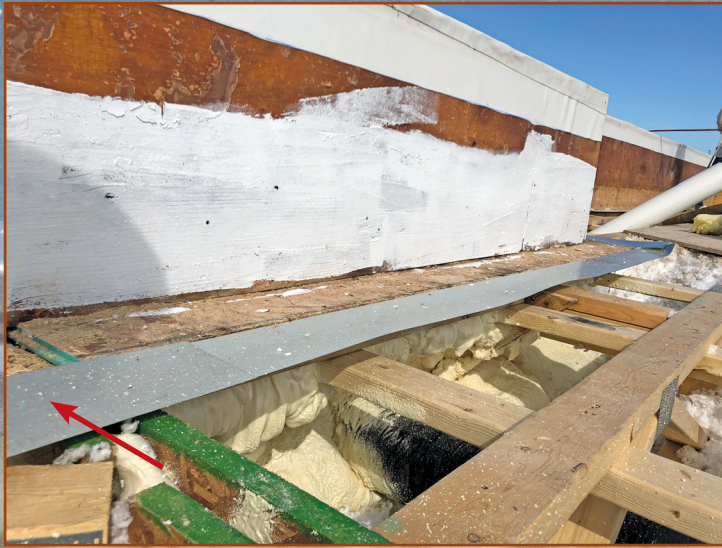
**Figure 8 –  
Z-shaped  
vapor/air  
barrier  
transition  
metal.**

The contractor fabricated a Z-shaped transition metal instead of a U-shaped transition metal that served the same purpose as a vapor/air barrier transition material (*Figure 8*). However, there were areas of the previous mold remediation where additional framing done as part of that work interfered with the installation of the Z-shaped metal. Therefore, a two-piece U-shaped metal was installed with the connection between the pieces accomplished with aluminum tape (*Figure 9*).

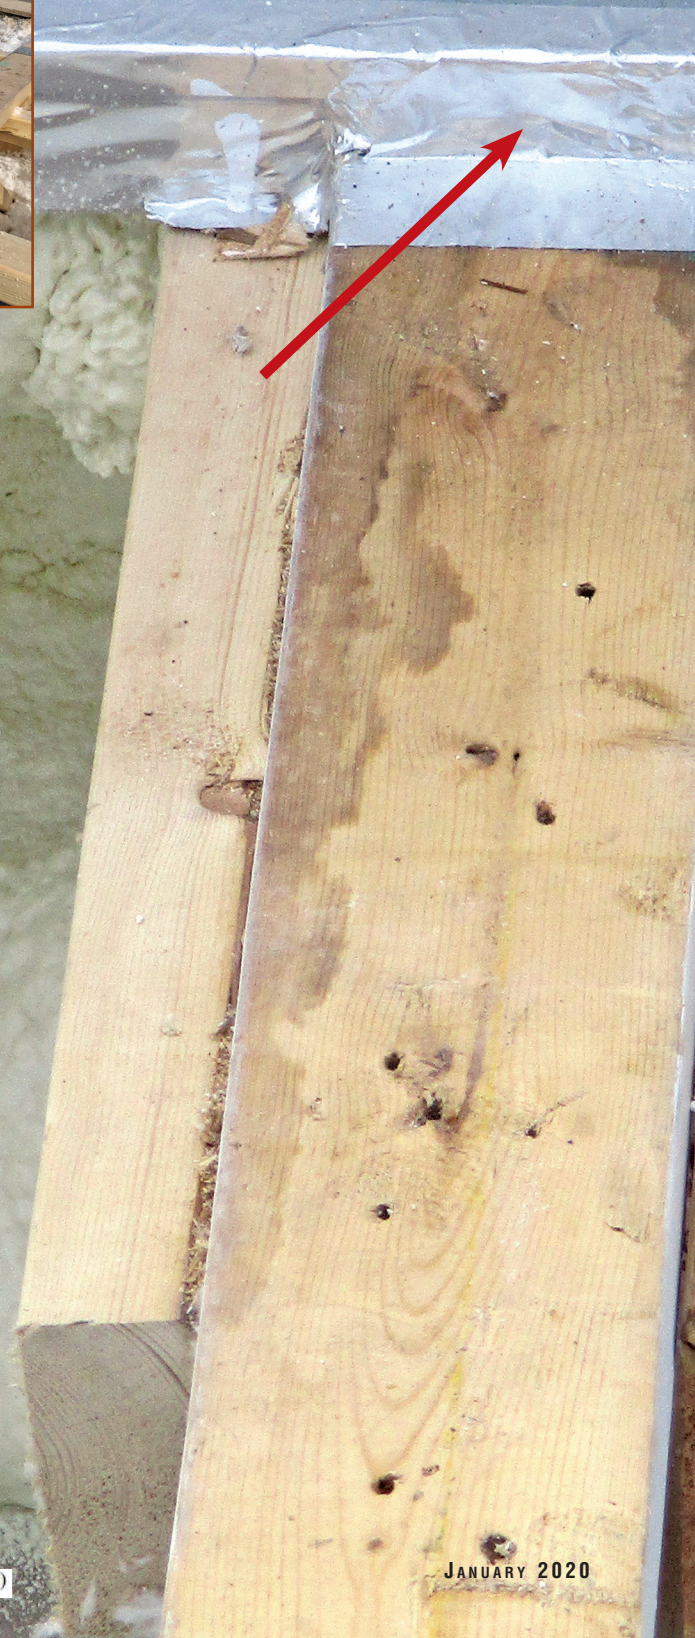
**Figure 9 – Two-piece U-shaped  
vapor/air barrier transition metal.**

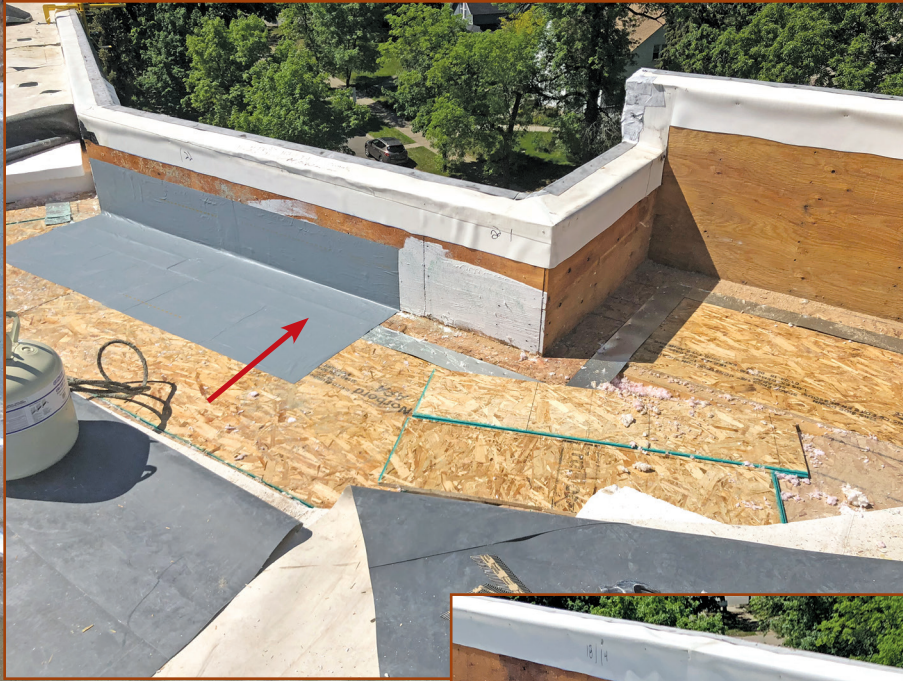
**Figure 10 - Roof vapor/air barrier at roof perimeter.**

After the Z-shaped transition flashing was installed, a short width of vapor/air barrier was installed (*Figure 10*), and then a parapet reinforcing assembly of plywood and sheet metal angle was installed (*Figure 11*), followed by the field of the roof vapor/air barrier (*Figure 12*).

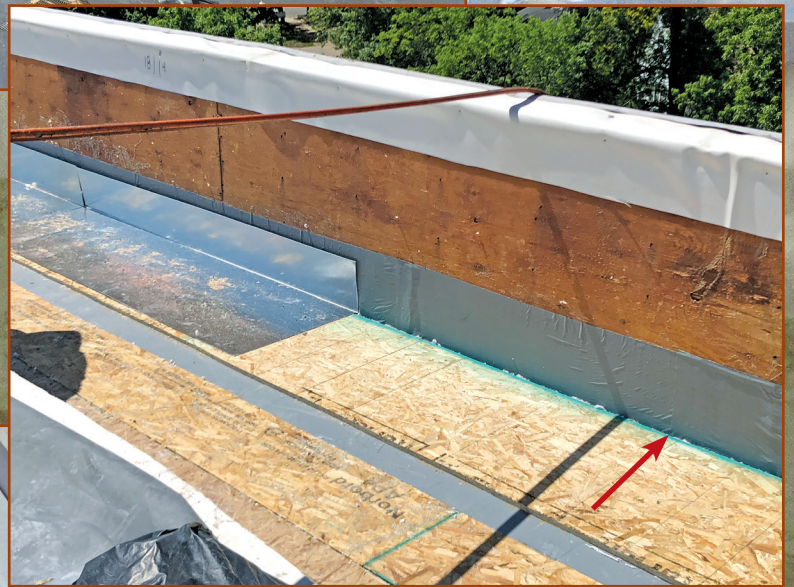
**Figure 11 - Plywood and sheet metal angle parapet reinforcement.**

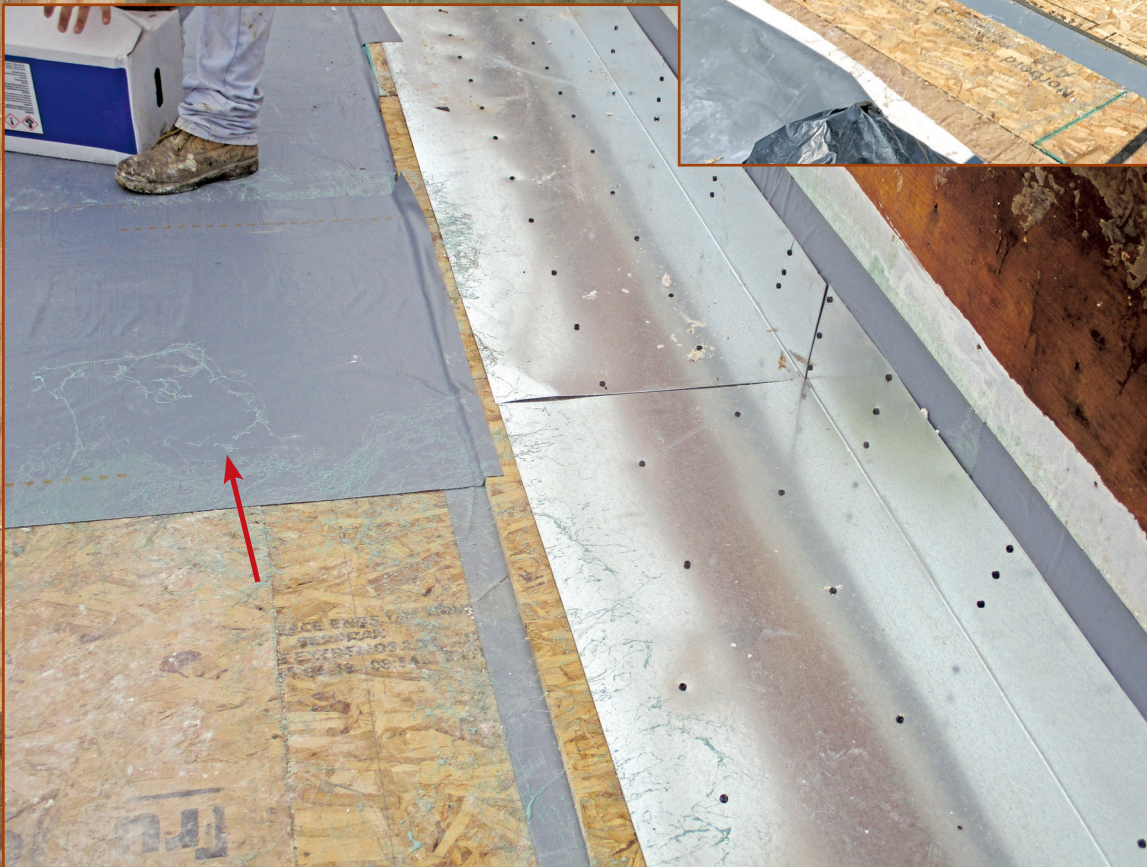
**Figure 12 - Vapor/air barrier applied to field of roof.**

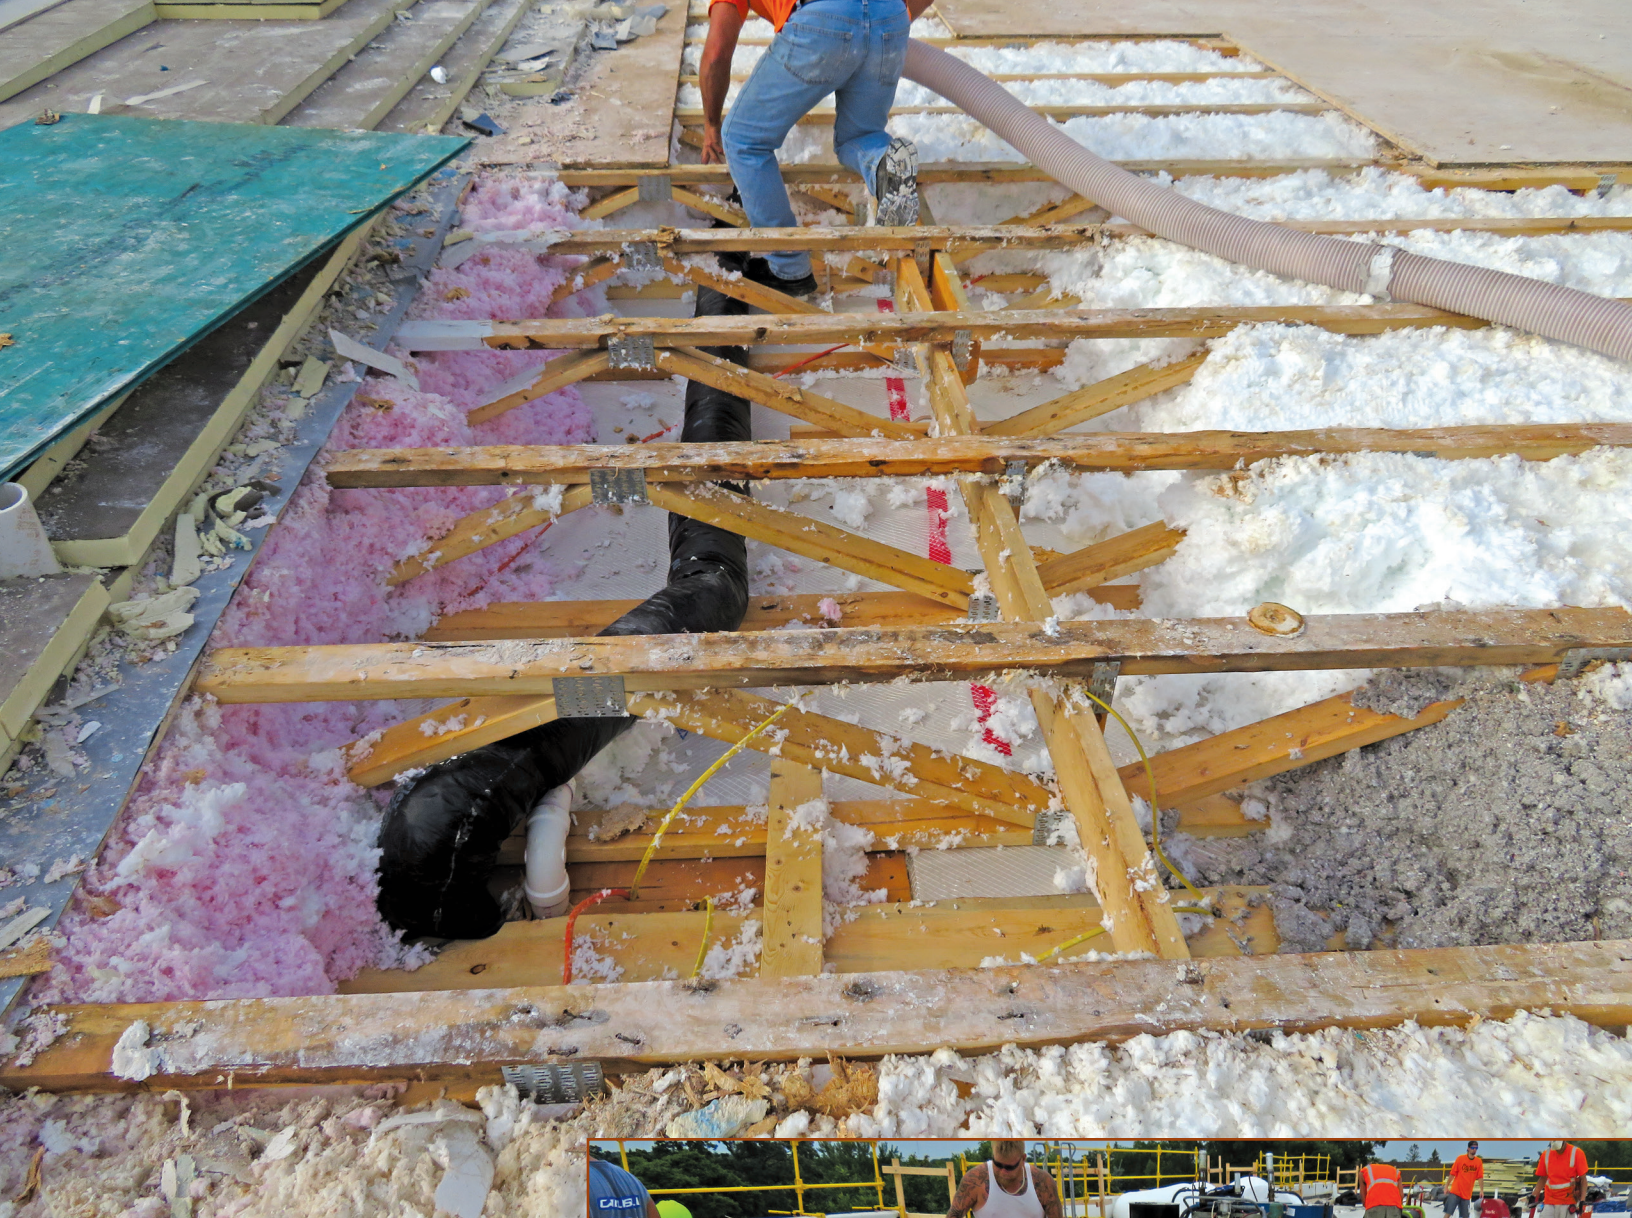
Figure 13 – Blown-in insulation.

Perimeter work required the insulation subcontractor to be on site to vacuum insulation, install the spray foam insulation in the rim area, and install new blown-in insulation on each day of perimeter work (Figure 13).

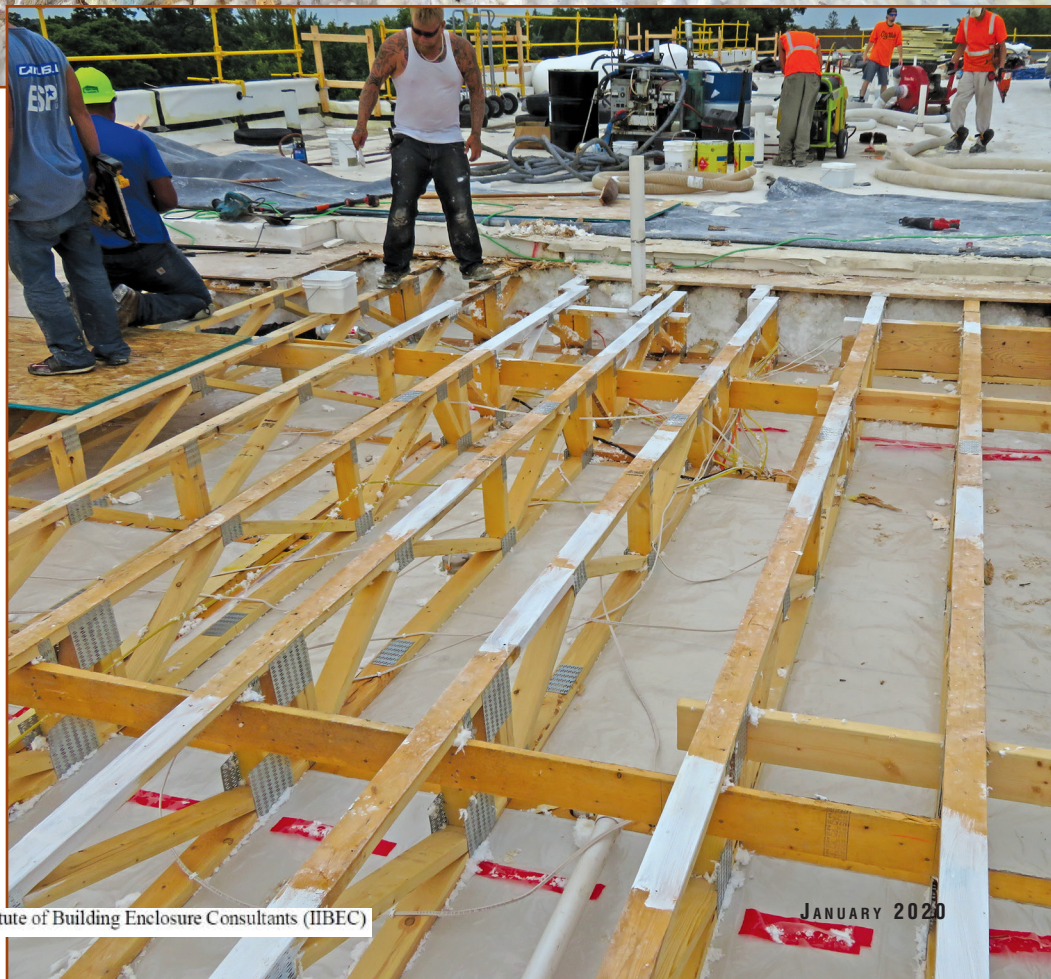
Figure 14 – Mold remediation paint.

Mold remediation was handled by the contractor, alleviating the need for a specialty contractor. This eliminated coordination and delay issues. The contractor cleaned any discolored areas that were within moisture content limits, then painted these areas with an antimicrobial paint (Figure 14). Most of the parapet that was left in place was remediated when the perimeter work was constructed, which proved to be the most efficient.

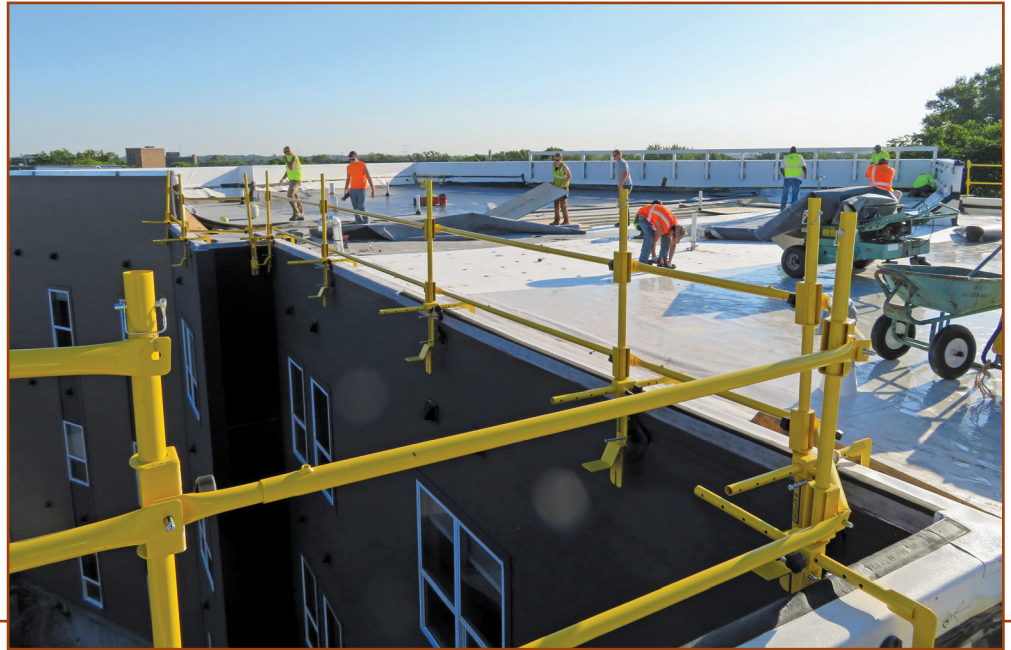
Figure 15  
– Perimeter  
safety rails.

Perimeter safety was primarily accomplished with rails attached to the parapet (Figure 15). A safety monitor was also assigned to work with the crew applying the low-rise foam adhesive for the insulation attachment.

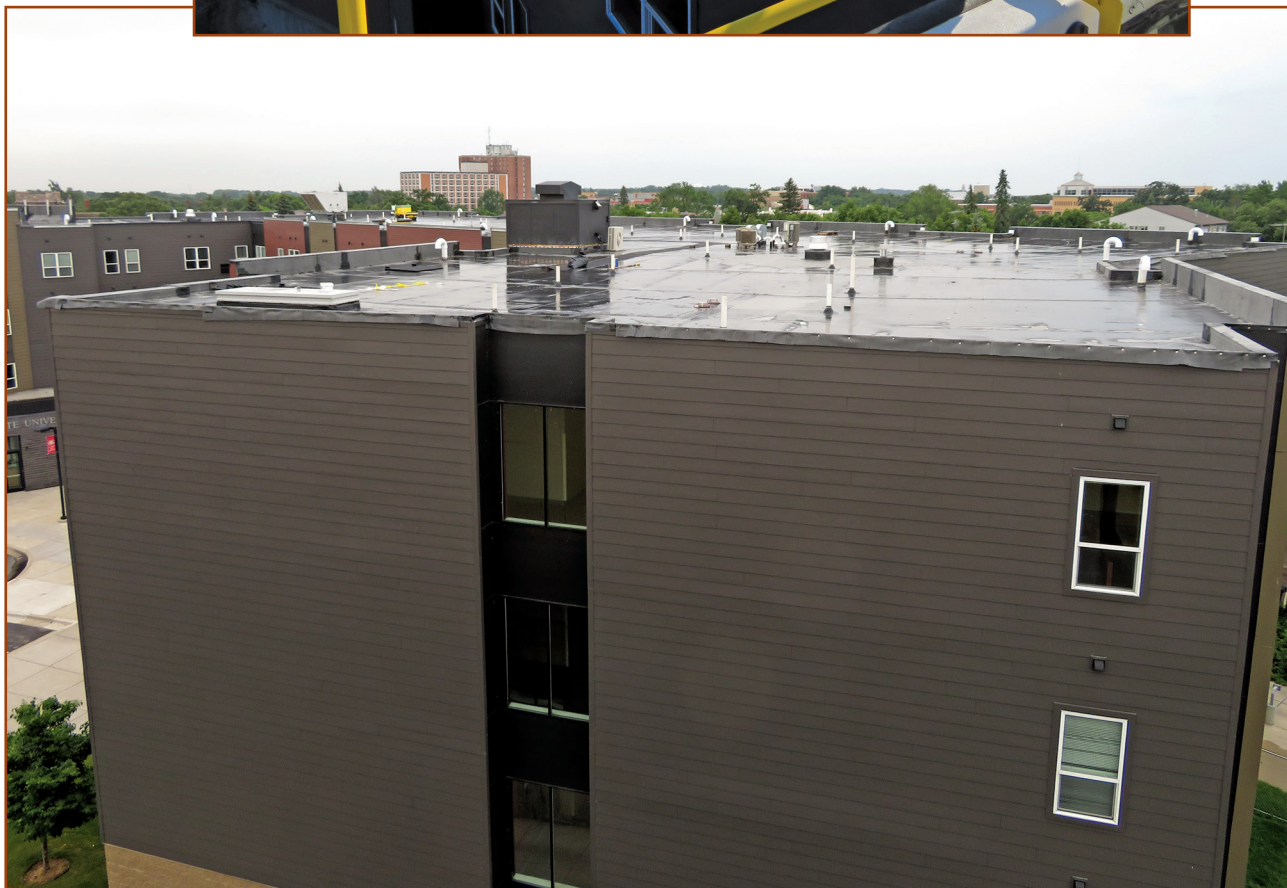
Figure 16 – Completed roof.

The fully adhered EPDM membrane

over the tapered insulation system provided a fully draining roof with a finished appearance (Figure 16). Even with all of the construction challenges, the roof was completed in a timely manner.
