“Shake-Style” Asphalt Shingles

Design Defect Prone to Hail Damage

By Dustin Smoot, RRC, RRO

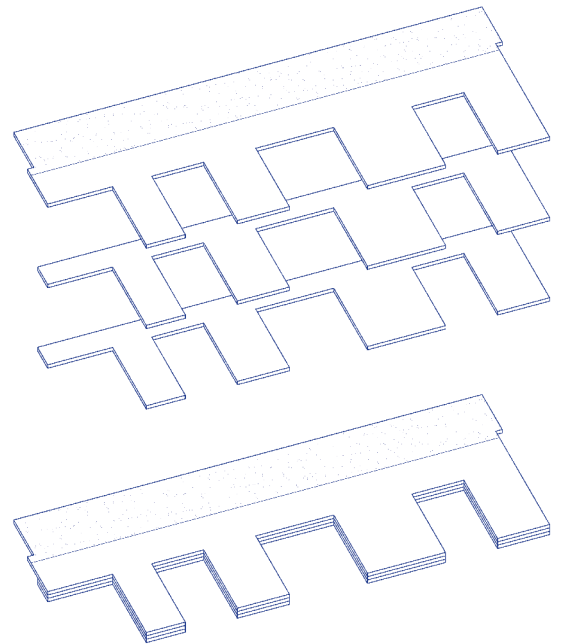
Figure 1 – Isometric view of shake-style shingle layers and assembled shake-style shingle.

Shake-style shingles start with a notched layer of an asphalt strip shingle, and one or two layers of appliqué are applied to the bottom side of the shingle notches to create a dimensional product with two or three layers (Figure 1).

As shown in *Figure 1*, the shingles were constructed with one or two additional layers of appliqué added to the bottom 6 to 8 in. of the shingle. However, at the notches, up to 10 in. of the underlying shingle is exposed. This exposes a section measuring 2 in. or more within the notches that is only one layer of strip shingle, with an abrupt edge of the underlying appliqué below. Refer to *Figure 5* for a photograph of a shingle view, and to *Figure 6* for the highlighted view. The green highlights are the areas with multiple layers of shingles—typically the lowest 6 to 8 in. of the shingles' exposure. The red highlights are the vulnerable areas, with only one layer of shingle material exposed.

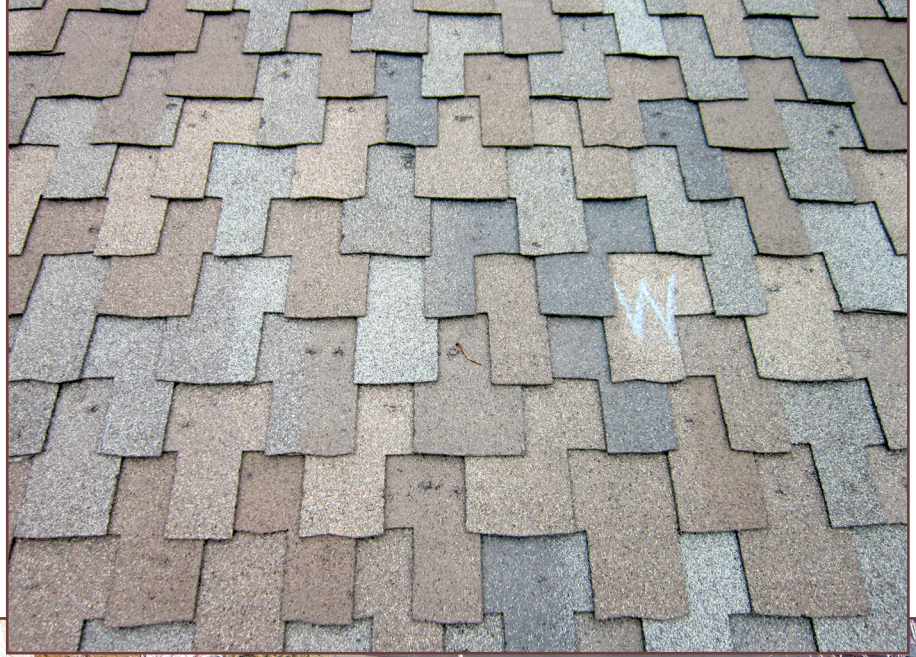
Several projects by multiple manufacturers across the country in which this style of shingle had been installed were observed with hail impact damage. Most of them had been installed within the last two years. Typically, hail within the ¾-in. to 1-in. diameter range had fallen on the properties. With a few exceptions, the impact damage that was observed was located within the notches of the shingles and not on the tabs of the shingles themselves. Refer to Figures 2 and 3, where the patterning of the hail impact damage is visible. Refer to Figure 4; the notches of

Figure 2 – Visible, patterned hail damage at the notches of shake-style shingles.

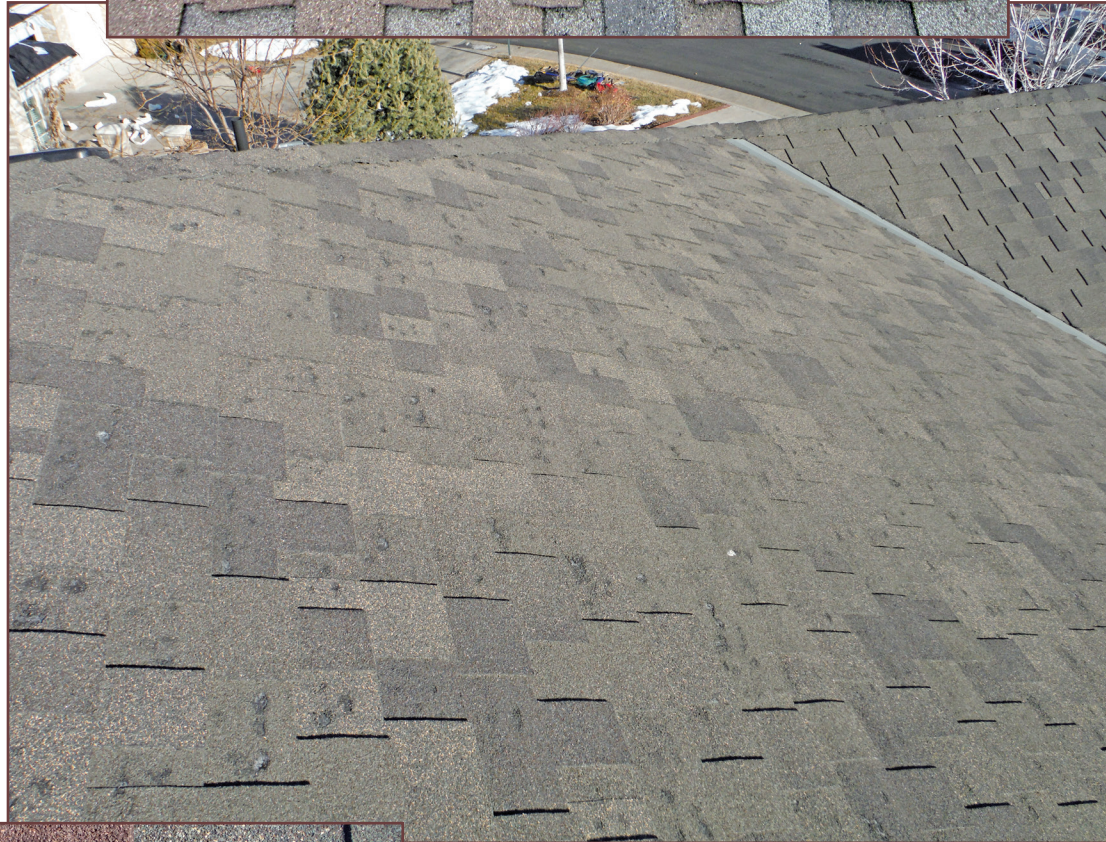
Figure 3 – Visible, patterned hail damage at the notches of shake-style shingles.

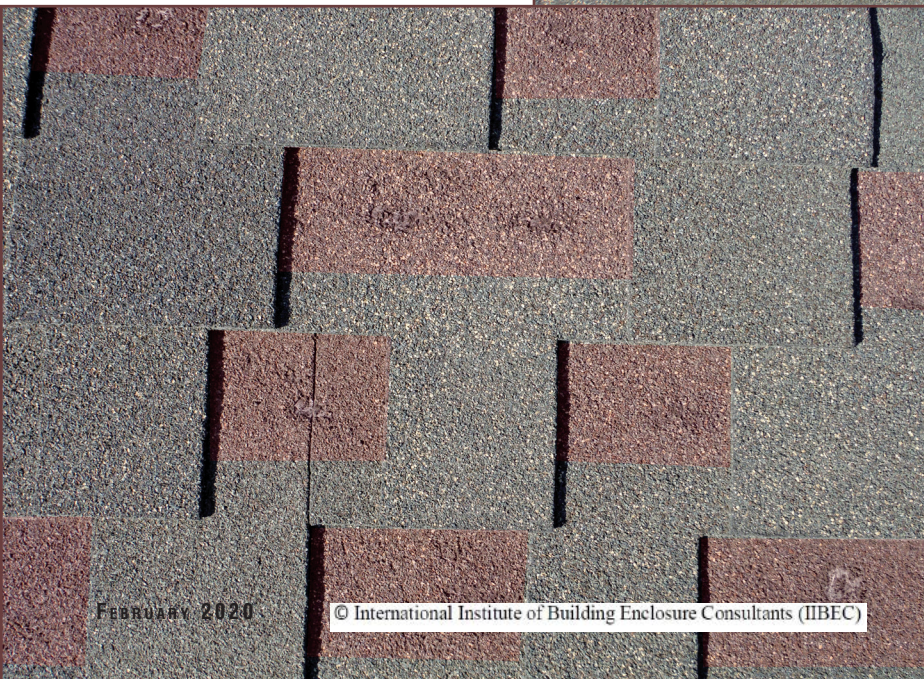
Figure 4 – Visible, patterned hail damage at the notches of shake-style shingles. Note notched areas were highlighted in red for clarity.

the shingles have been highlighted to illustrate that there is impact damage in every notch, while no damage is present at the tabs.

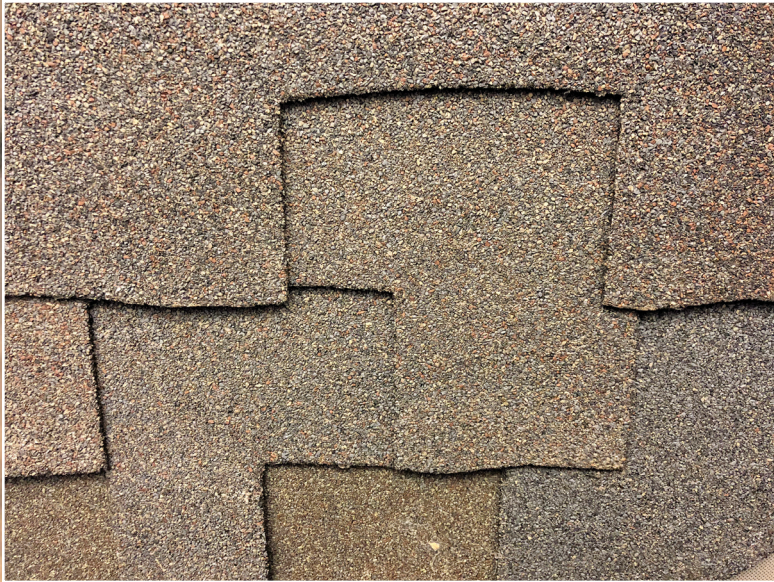
Figure 5 – Shingle view.

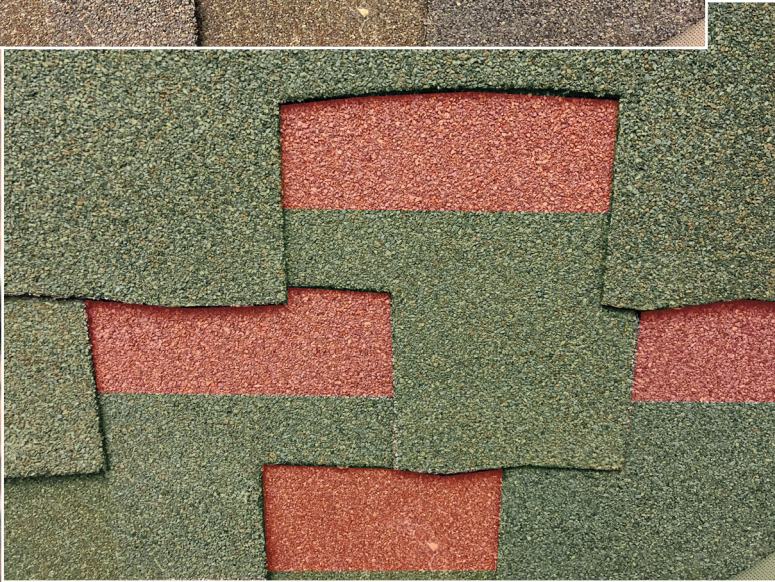
Figure 6 – Highlighted view.

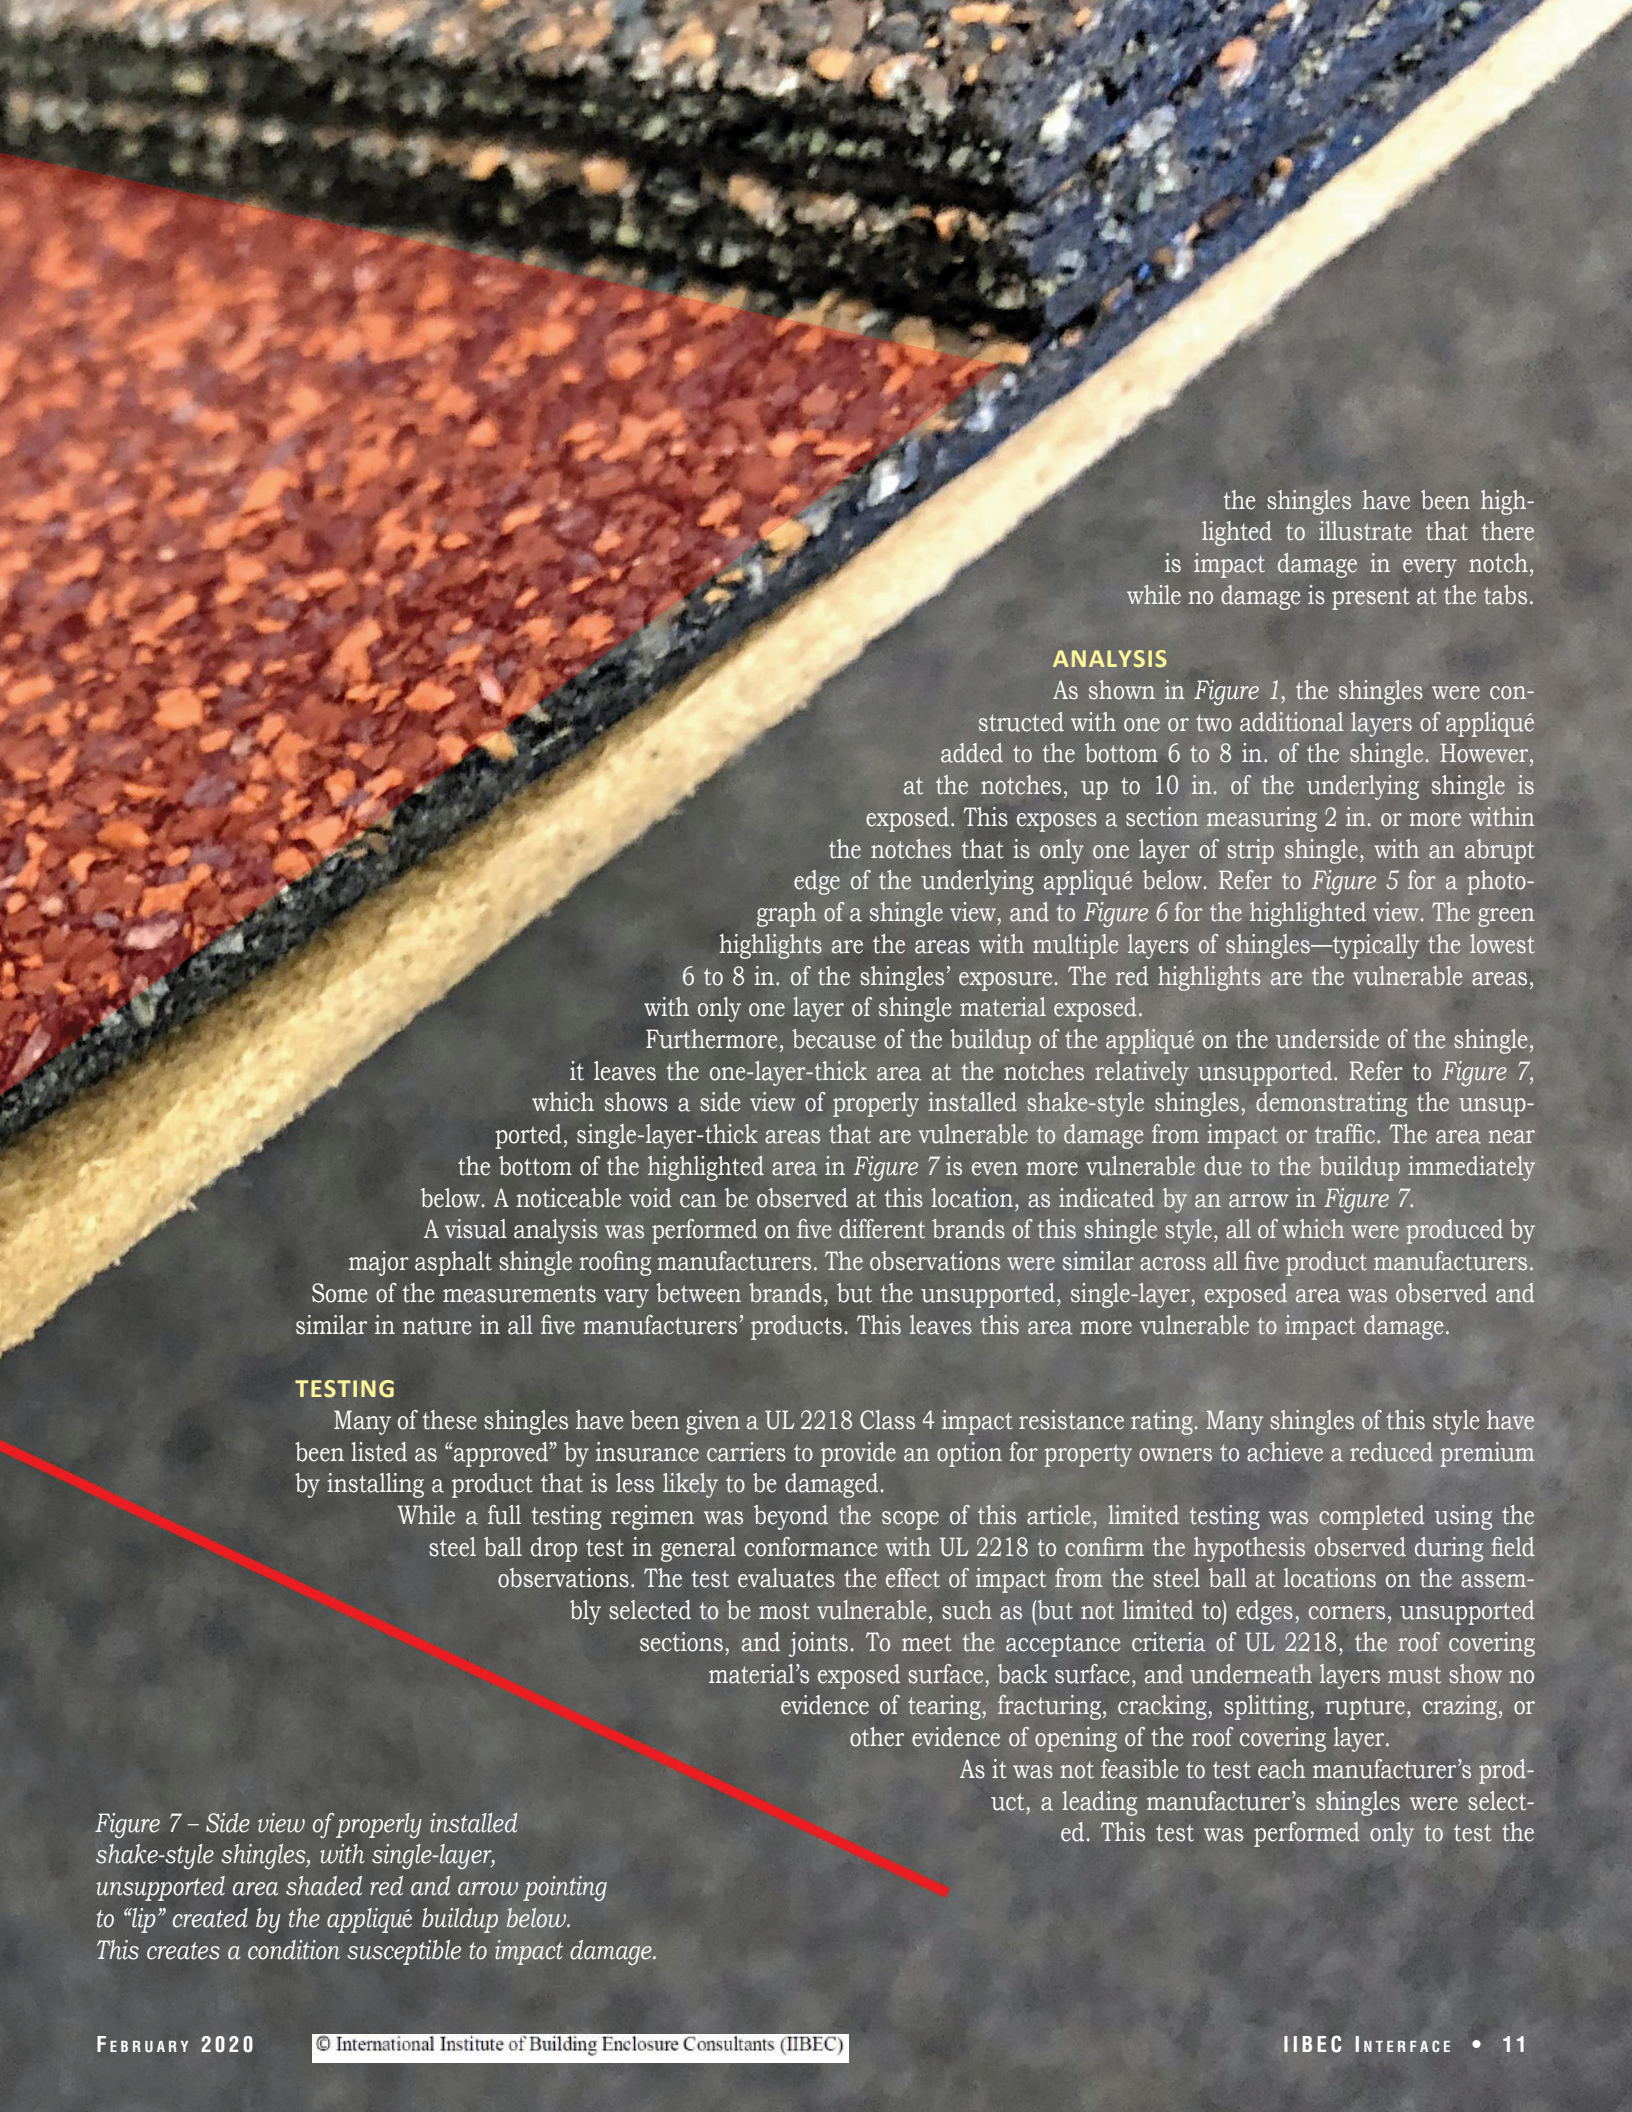
Furthermore, because of the buildup of the appliqué on the underside of the shingle, it leaves the one-layer-thick area at the notches relatively unsupported. Refer to *Figure 7*, which shows a side view of properly installed shake-style shingles, demonstrating the unsupported, single-layer-thick areas that are vulnerable to damage from impact or traffic. The area near the bottom of the highlighted area in *Figure 7* is even more vulnerable due to the buildup immediately below. A noticeable void can be observed at this location, as indicated by an arrow in *Figure 7*.

Figure 7 – Side view of properly installed shake-style shingles, with single-layer, unsupported area shaded red and arrow pointing to "lip" created by the appliqué buildup below. This creates a condition susceptible to impact damage.

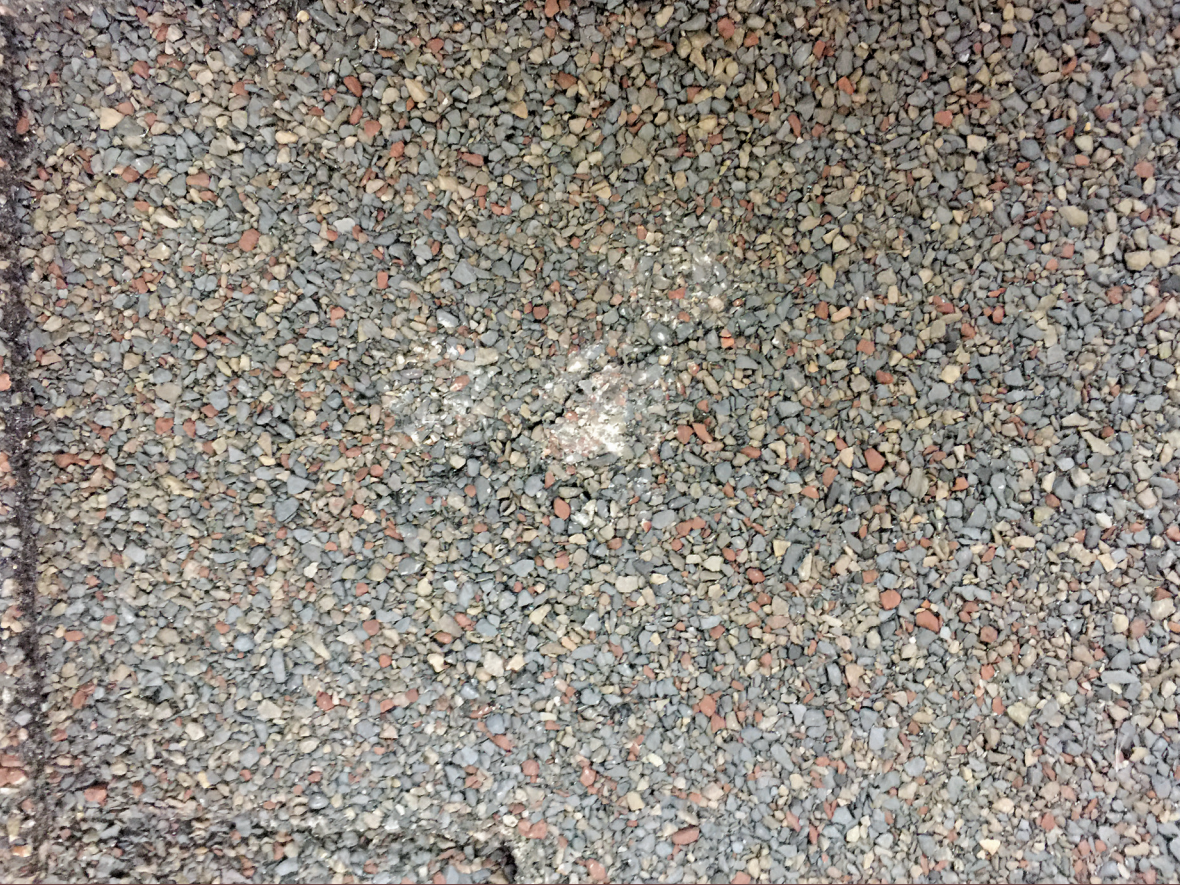
Figure 8 – Crack in the shingle after performing UL 2218 steel ball drop test.

theory that this single-layer exposed area was vulnerable to damage, not to provide an actual impact rating. A 2-in.-diameter steel ball was dropped from 20 ft. twice at each single-layer, unsupported, exposed area of the shingle sample. A clear crack in the shingle was observed on the top side of the shingle after the test, coincident with the ball impact location, as exhibited in Figure 8.

More testing should be completed by an independent testing agency to determine if these shingles meet the requirements set forth in UL 2218.
