Aluminum Windowsill Anchorage and Supplemental Waterproof Flashing Design Practices

By Rocco Romero, AIA,
and Kenneth M. Itle, AIA

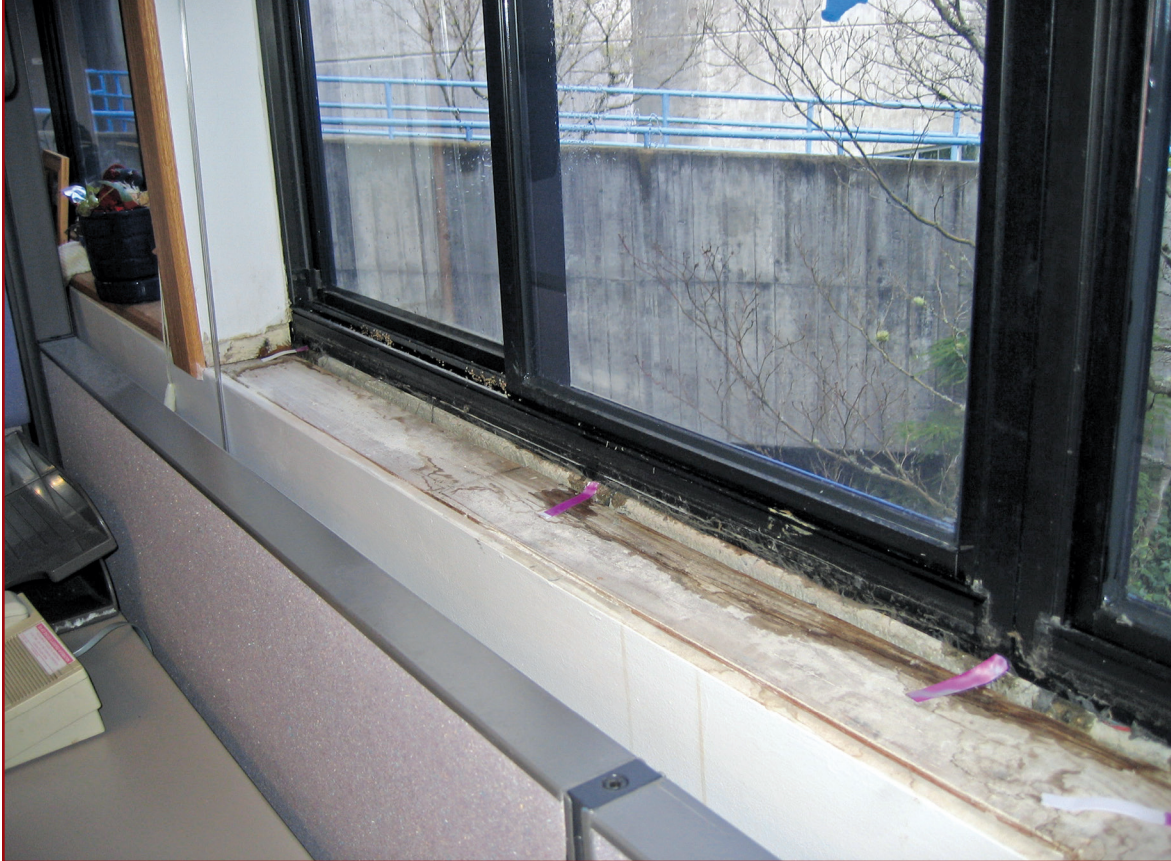
Figure 1 – Water leakage paths indicated by pink paper strips at interior after removal of wood stool.

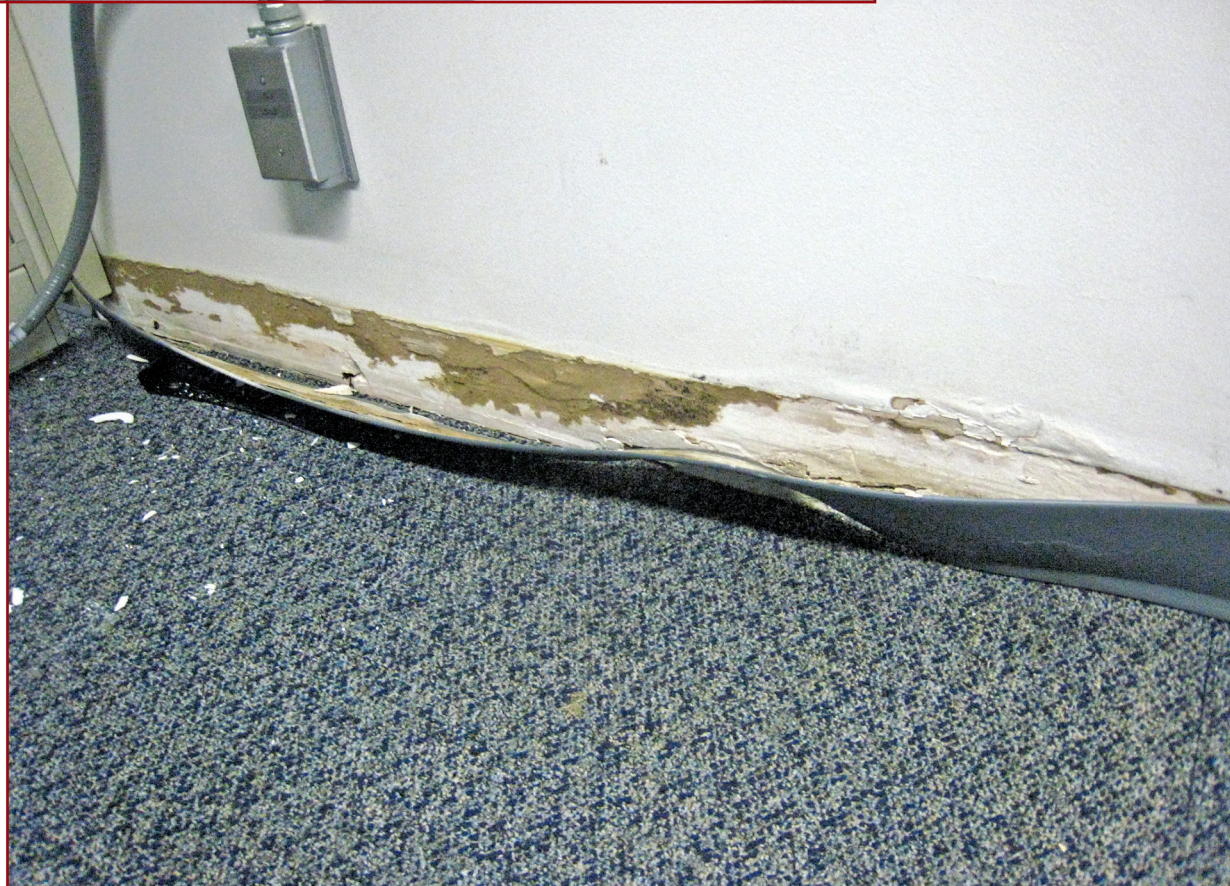
Figure 2 – Debonded vinyl base-of-wall molding.

ed and lead to organic growth on the gypsum wall board and on the adhesives beneath the vinyl base (*Figure 2*). Water that becomes trapped within the exterior wall stud cavity leads to accelerated deterioration of wall components, including corrosion

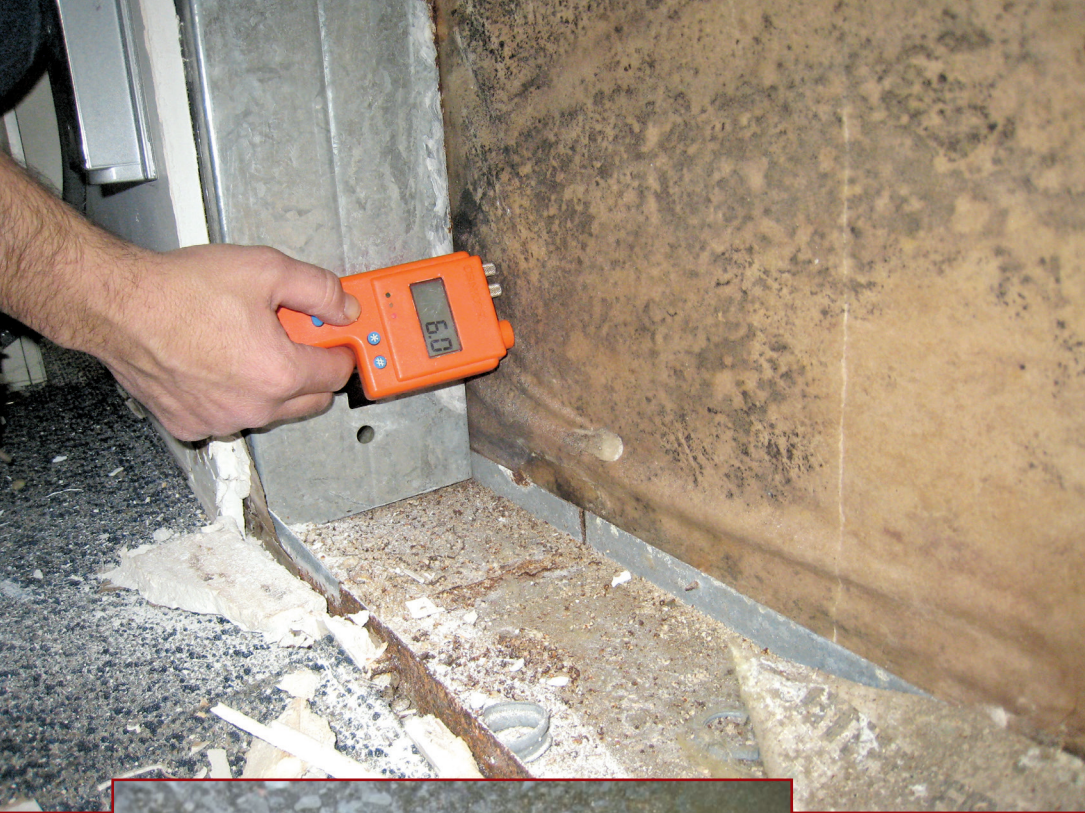
Figure 3 – Cavity side of exterior gypsum sheathing displays organic growth and rippling (debonding) of the paper facing.

paper facing has debonded (Figure 3), which may affect the fire rating of the sheathing. Removal of interior finishes can also help reveal water leakage paths, such as at screw fasteners that penetrate window flashings and exhibit corrosion (Figure 4).

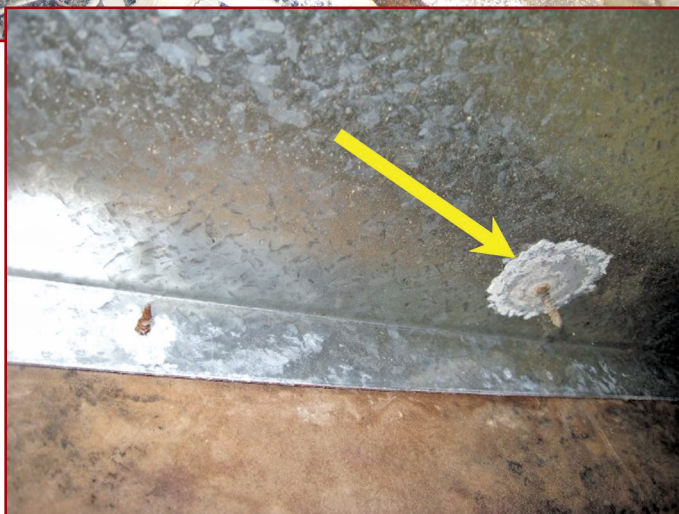
Figure 4 – Removal of finishes at metal stud track directly below windowsill revealed water staining and corrosion of fasteners.

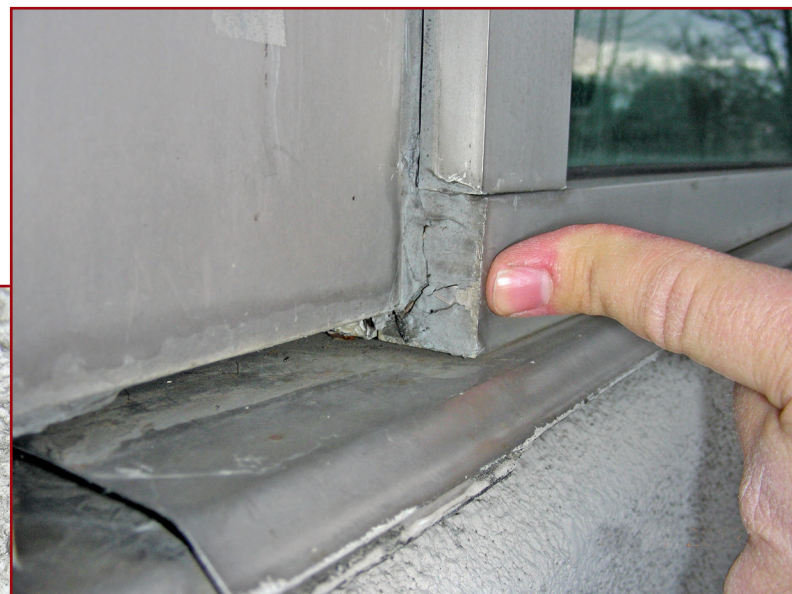
during the window installation (Figure 6), which typically fails to bond to or separates from the extrusion. These conditions can contribute to water leakage to the building interior.

Figure 6 – Sealant pumped into open end of sill component extrusion.

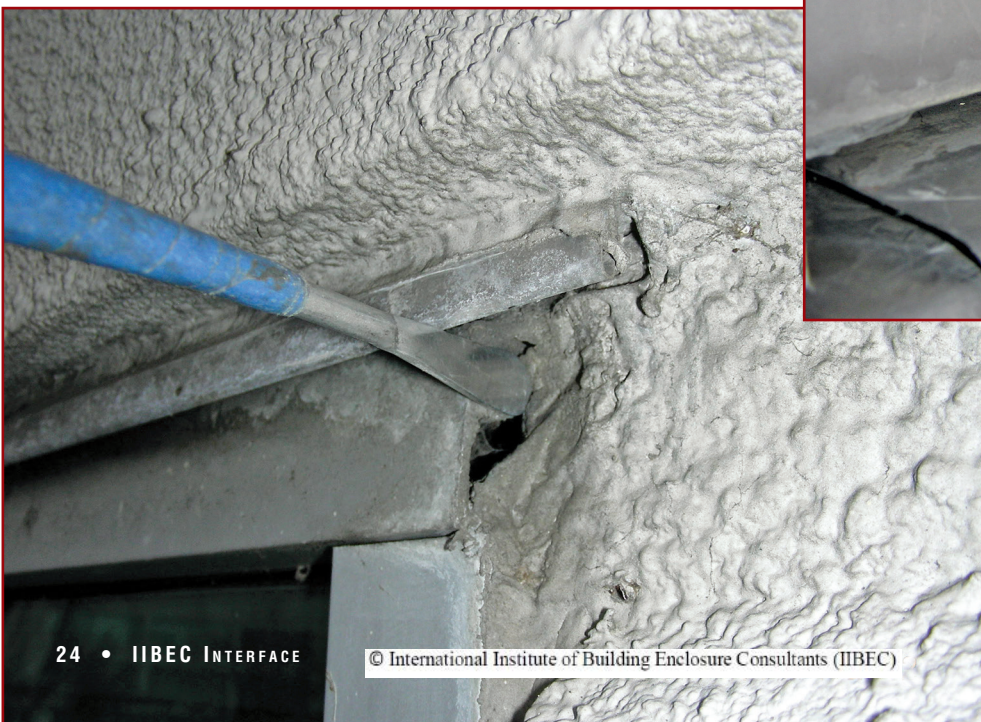
Figure 5 – Gap in perimeter sealant at head-to-jamb intersection of window frame components.

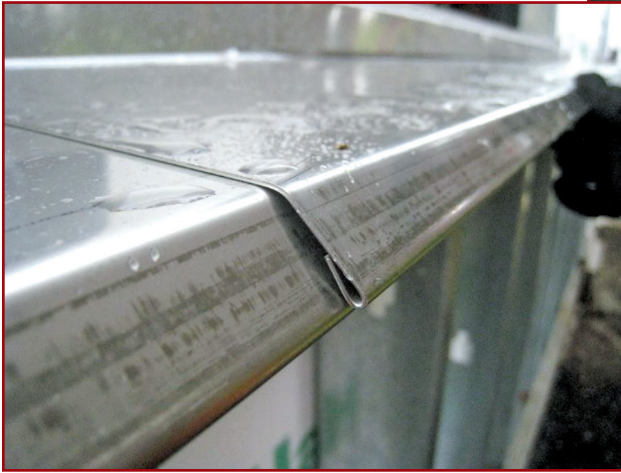
Figure 7 – Hemmed drip edge not properly integrated with adjacent flashing component at lap.

window systems, deficiencies are often observed in laps where the hemmed drip edge results in a buildup of material, causing a gap at the lap (Figure 7). If the lap is not properly sealed (Figure 8), water leakage can occur.

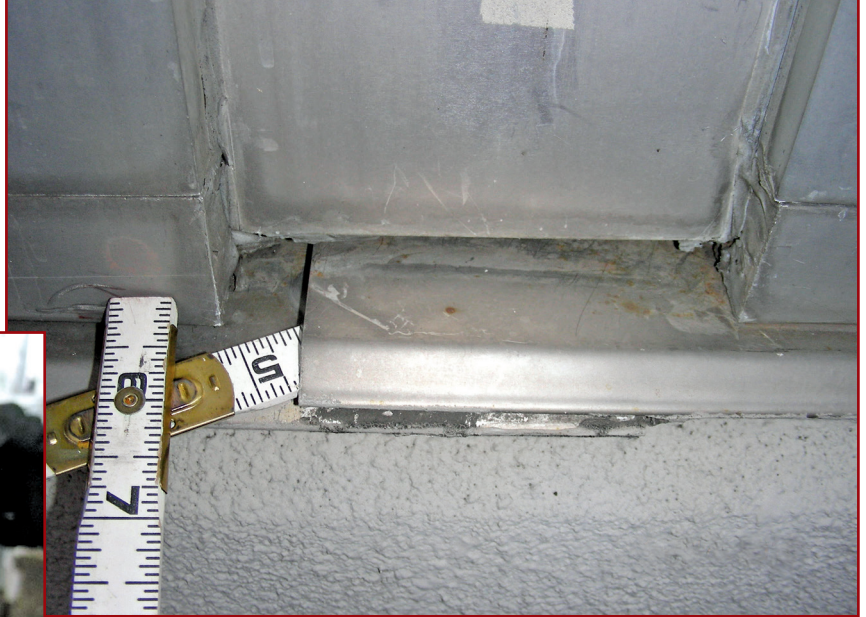
Figure 8 – No sealant installed in flashing lap.

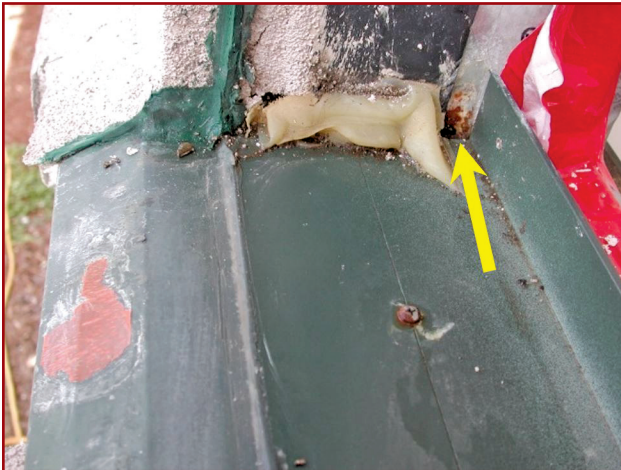
Figure 10 – Debonded sealant end dam. Note sealant does not continue to the back dam interface (arrow).

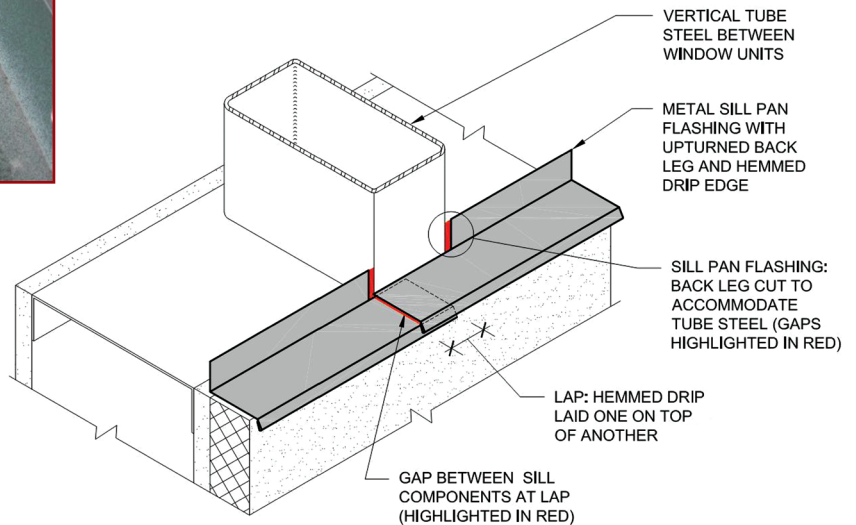
pan flashing system, resulting in a flashing that is cut or modified in the field by the installer to fit around the column. This approach can result in a poorly installed flashing that is not watertight and leads to water infiltration into the wall system (Figure 9).

Figure 9 – Deficiencies in pan flashing at tube steel column obstruction.

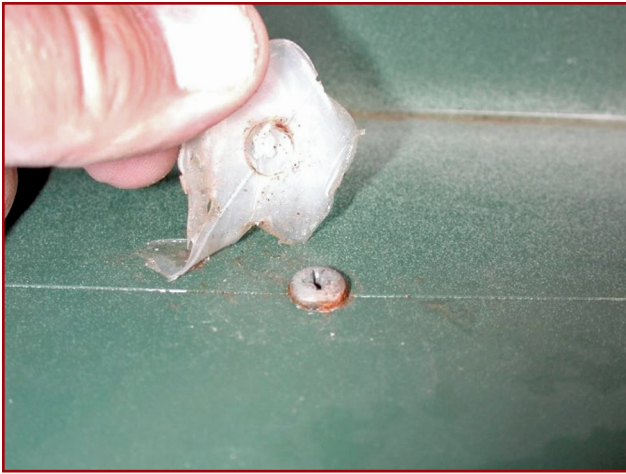
Figure 11 – Sealant debonded from fastener head at metal pan.

11) or if the sealant is damaged by the subsequent installation of the windowsill component. Inspection openings in the interior of the wall may reveal that water leakage occurs at these fastener penetrations.

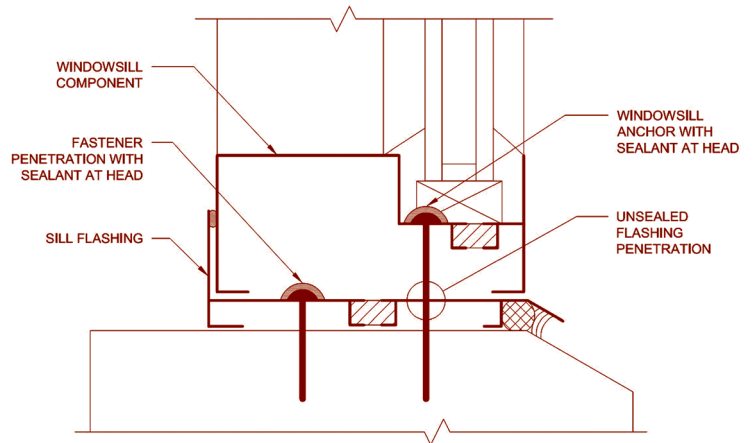
while the heads of the exposed anchors can be encapsulated in sealant, the penetration of a subsill component that is in the drainage area of the subsill can still lead to water leakage into the building interior (Figure 12).

Figure 12 – Unsealed penetration at sill flashing.

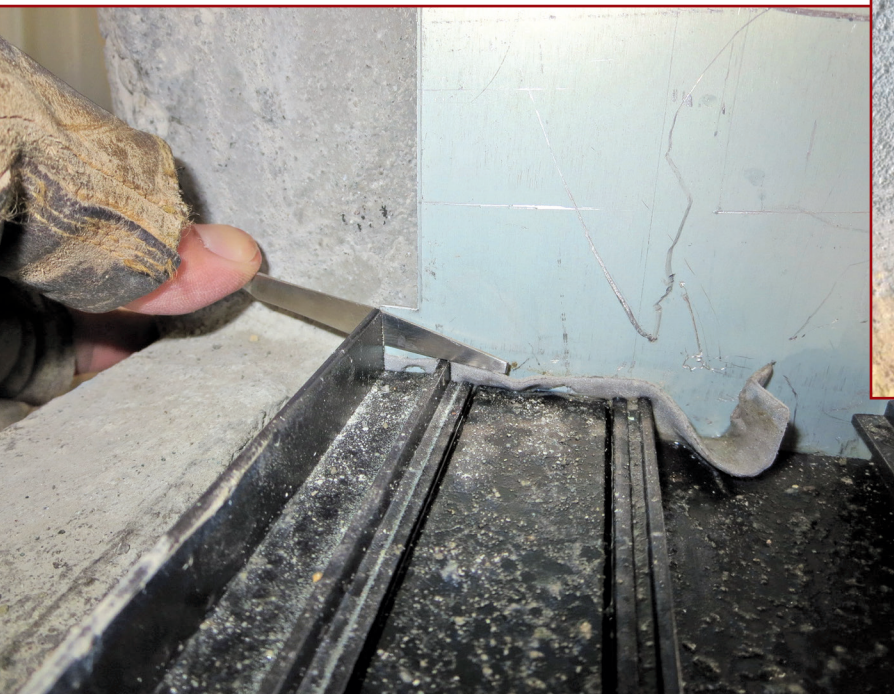
Figure 13 – Damaged foam gasket and gap between back dam and end dam.

gaskets are often damaged during the end dam installation process. In addition, the back-dam-to-end-dam transition is often not fully sealed by the gasket, due to lack of compression at the top portion of the end dam (Figure 13). Typically, the end dams are held in place at their bottom edge only, by screw fasteners that engage raceways at select points in the underside of the subsill. These fasteners do not provide adequate compression of the foam gasket.

For a more robust installation, consideration can be given to shop-welding end dams onto the subsill ends. An advantage to this approach is that the subsill can be properly cleaned of aluminum filings and debris in a contractor's shop and the end dam installation performed under controlled shop conditions. This also allows the end dams and back dam to be welded watertight. If needed, sealant can also be applied at the end-dam-to-sub sill transition and, after the sealant is allowed to cure properly, the assembly can be water-tested. Although this construction method will cost more to fabricate, it provides a more robust end dam that is not easily damaged during window installation.

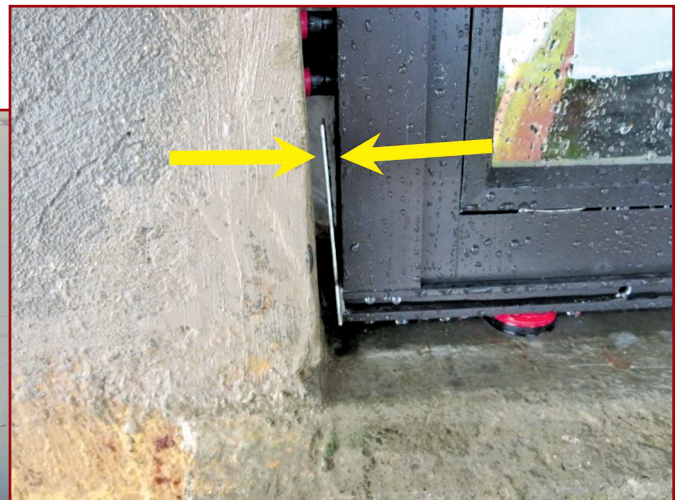
Figure 14 – Gap between top of end dam and window jamb.

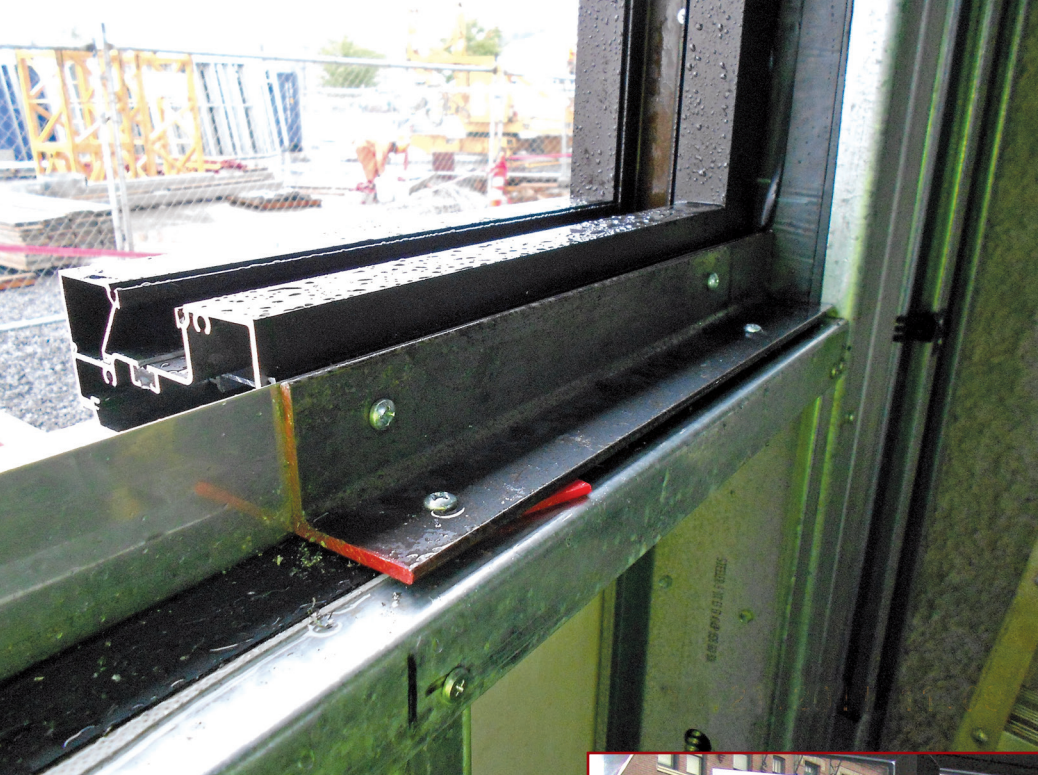
Figure 15 – Metal angle used to anchor through vertical surface of window frame.

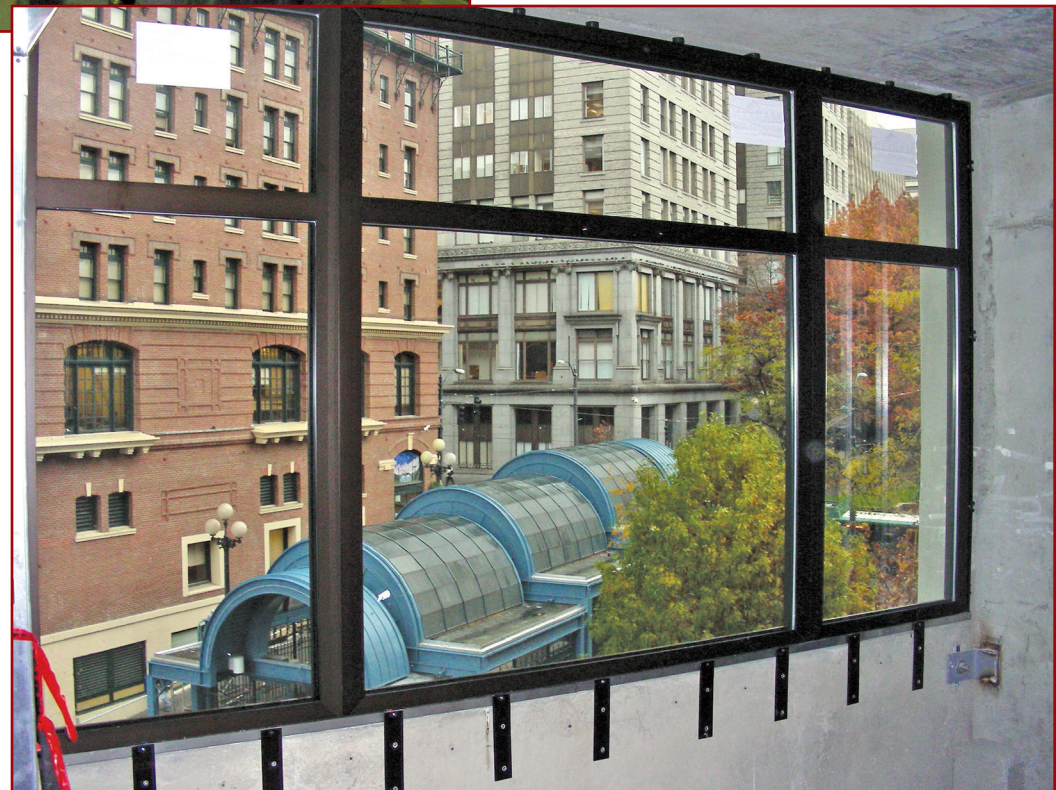
Figure 16 – Brackets used to anchor window frame to substrate.

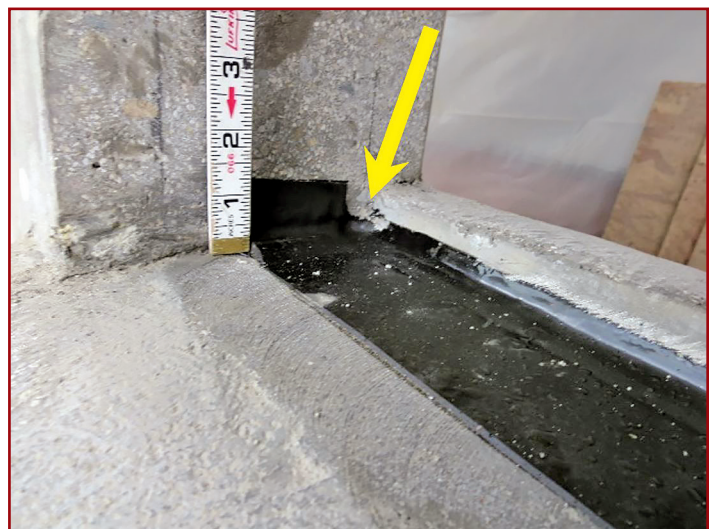
(Figure 21). Several mock-ups were performed to establish best practices for the fluid-applied membrane installation. Initial mock-ups revealed areas where the membrane was applied too thinly, not applied over the full height of the back dam, and had voids at the inside corners (Figure 22).

Figure 22 – Voids found in waterproofing mock-up at inside corners (arrow).
