Testing Field-Aged TPO Roofs; Demonstrating Real-World Performance

By Thomas J. Taylor, PhD and Jennifer Keegan, AAIA

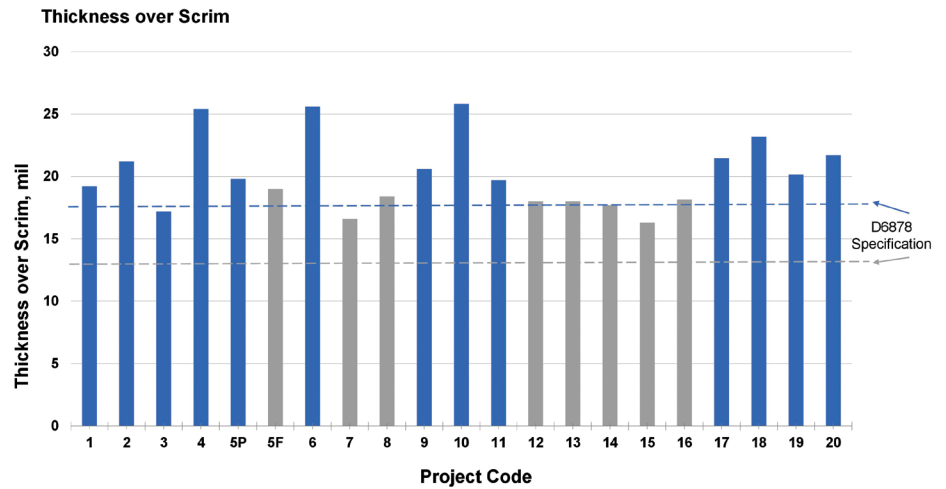
As indicated in *Figure 7*, Sample 3 is 1 mil below the current ASTM minimum for TOS. However, this sample would have complied with the published ASTM requirements at the time of manufacture.

Figure 7. Membrane TOS 60-mil samples in blue, 45-mil in gray, with their respective ASTM D6878 minimum specification. Note that for Project 5, 60-mil membrane was installed at the perimeter and 45-mil membrane was installed in the field.

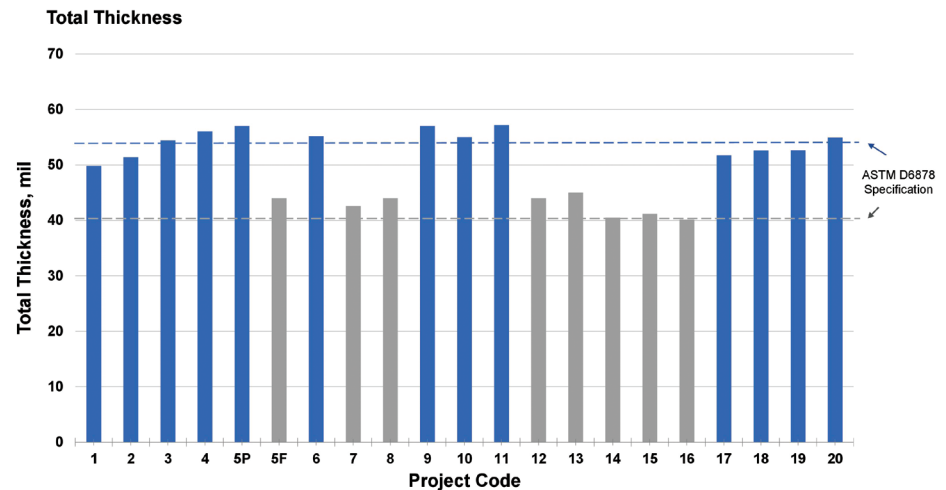
Figure 8 – Membrane thickness, nominal 45-mil in gray, nominal 60-mil in blue. Samples taken within the field of the roof. Note Projects 1 and 2 used a 50-mil membrane and comply with the ASTM thickness requirements.

As can be seen, some of the samples are below the overall ASTM D6878 minimum thickness. Total membrane thickness in Project 17 (an 18-year field-aged membrane) is 2 mils shy of the requirement for new ASTM membranes, while Projects 18-19 are 1 mil shy of the requirement.

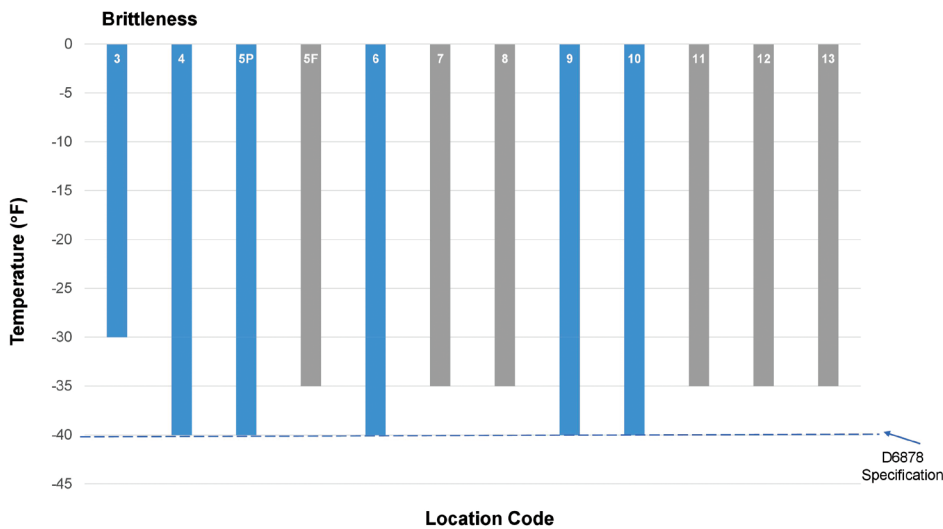
Figure 10 – Brittleness point of tested samples – nominal 45 mil in gray, nominal 60 mil in blue. Not all samples were tested for brittleness.

ASTM standard D6878 requires new membranes to have a brittleness point of -40°F or lower. All except one of the 60-mil samples tested still meet cold temperature flexibility requirements after field aging. The 45-mil samples showed initial signs of cracking at -35°F . The slight rise seen for these samples is indicative of low-temperature stiffening due to oxidative crosslinking. Roofing membrane issues caused by rising brittleness point were previously observed with early versions of PVC, which exhibited cracking and shattering during winters.¹⁵ However, such issues were essentially eliminated by improving the formulations and by the use of reinforcing scrim. The scrim used in TPO is the same basic design and type as used in PVC, and the small changes in brittleness point observed in some of the sampled TPO roofs are not a cause for concern. However, the data support the use of thicker membranes for longer-term performance.

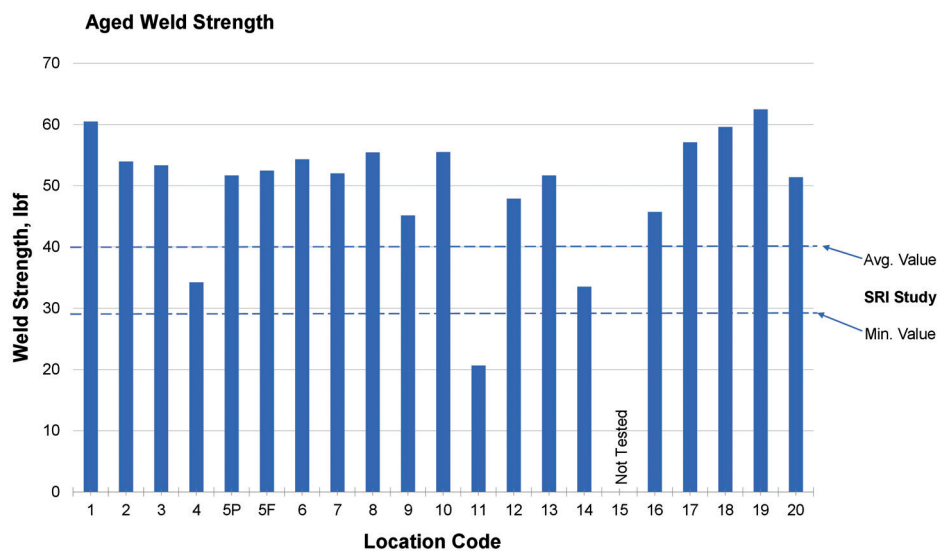
Figure 11 – Weld strengths of the aged roof samples.

All of the samples except Location 11 had comparable values to the SRI Study. For Location 11, the value of 20.7 lbf is indicative of a suspect-quality weld and would require further investigation. This is also suggested by the film-tearing bond data, summarized in Figure 13.

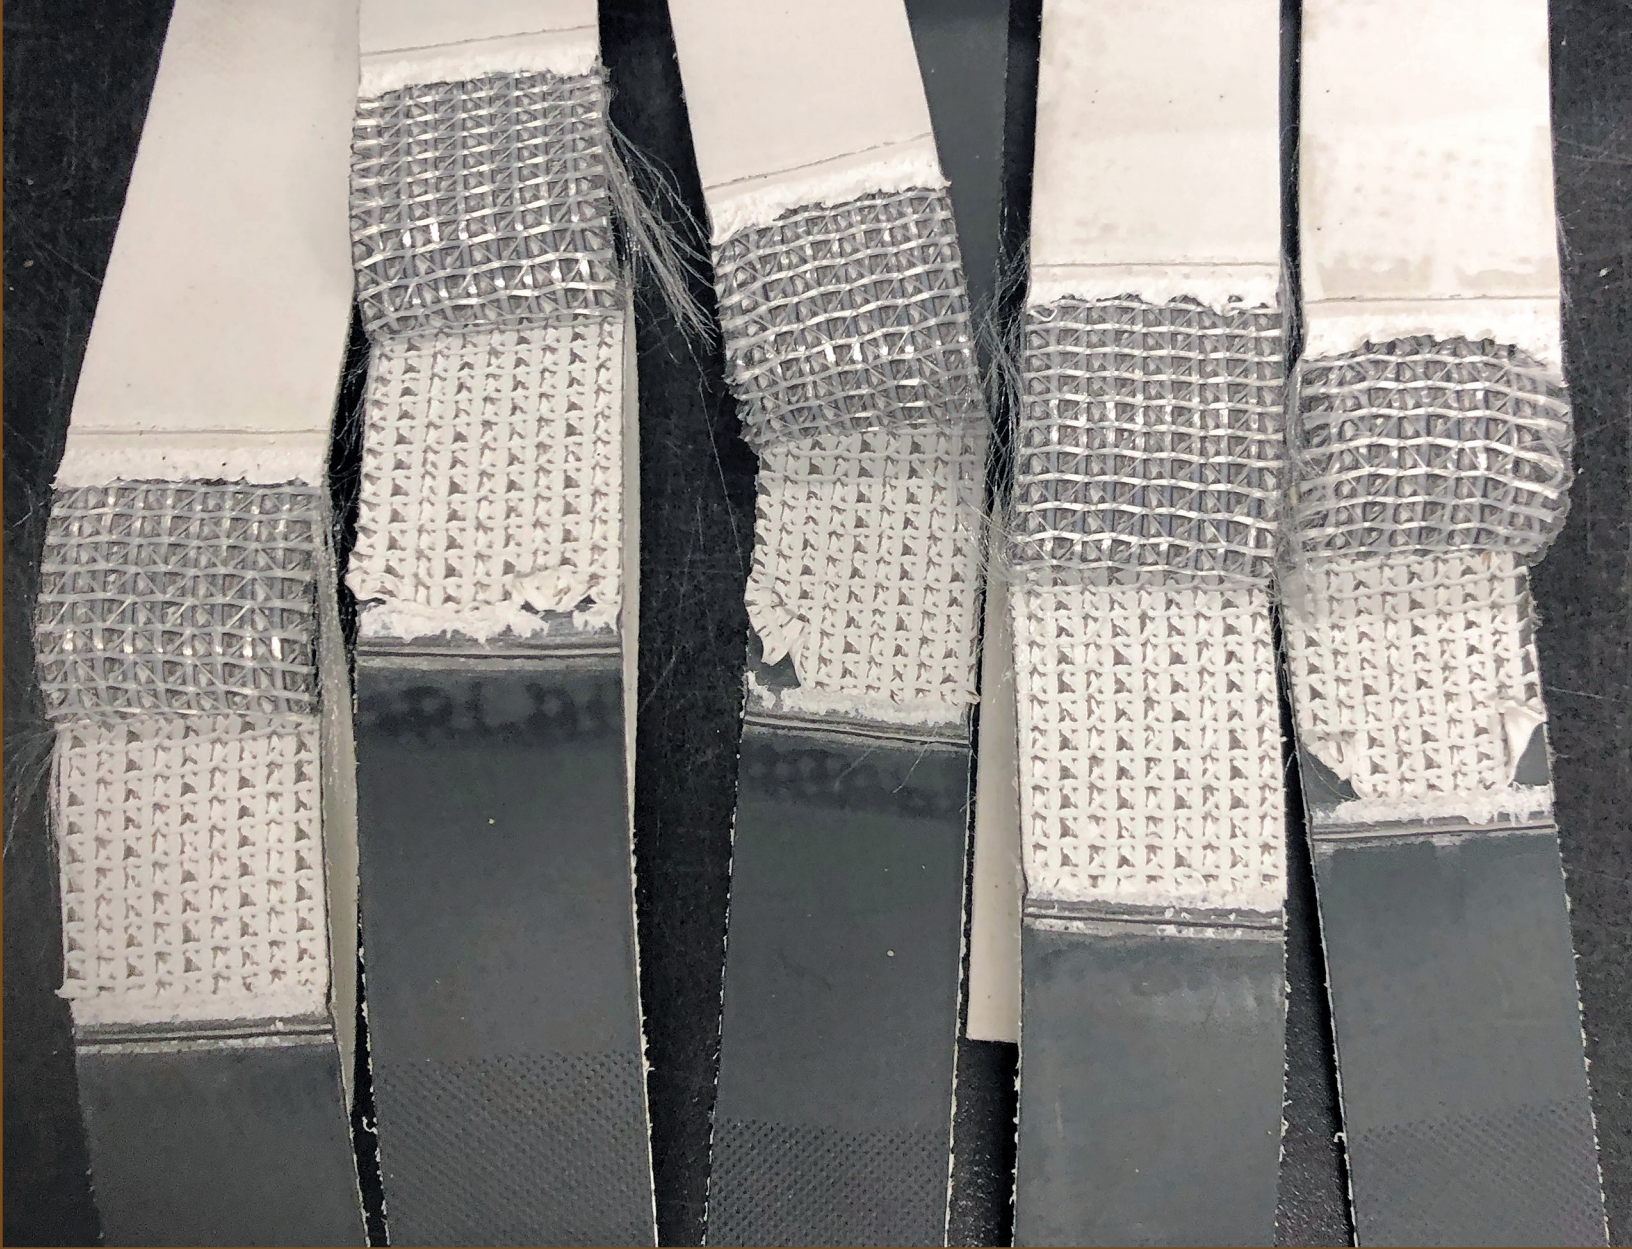
Figure 12 – Film tearing bond of nearly 100 percent, from Location 6.

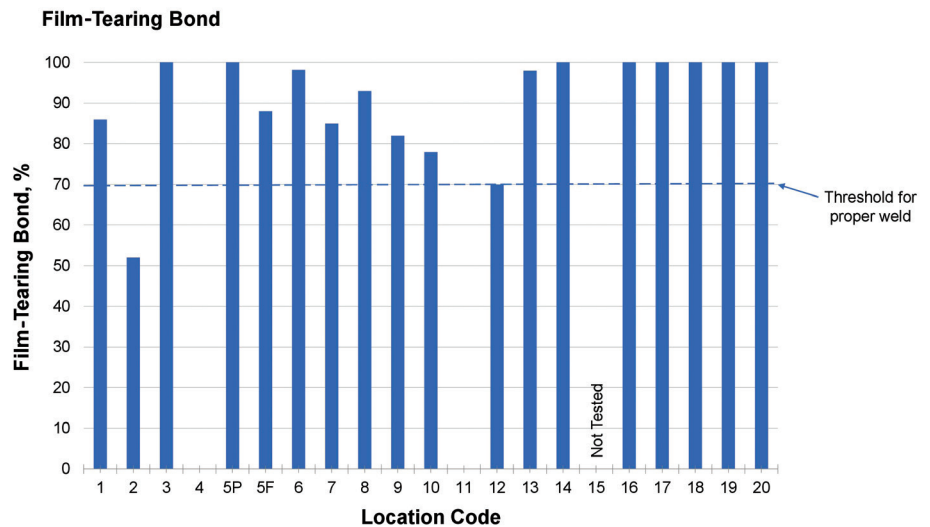
All of the samples except Locations 4 and 11 met the threshold requirements for percent film-tearing bond. Comparing the weld strengths and film-tearing bond percent, it is clear that the roofs at Locations 4 and 11 might warrant further investigation due to the combination of low weld strength and film-tearing bond. In the case of Location 2, the aged membrane has a weld strength of 53.9 lbf with a film-tearing bond less than 70 percent. This suggests that the issue on this roof could be local-

Figure 13 – Percent film-tearing bond of the aged roof samples. Zero film-tearing bond at Locations 4 and 11 suggest poor-quality workmanship.

In a few instances, the film-tearing bond was below expectations. The data suggest that there were issues with the workmanship in these few cases, which points to the importance of weld quality checks throughout a roof installation. These would involve test welds to determine the percent of film-tearing bond.

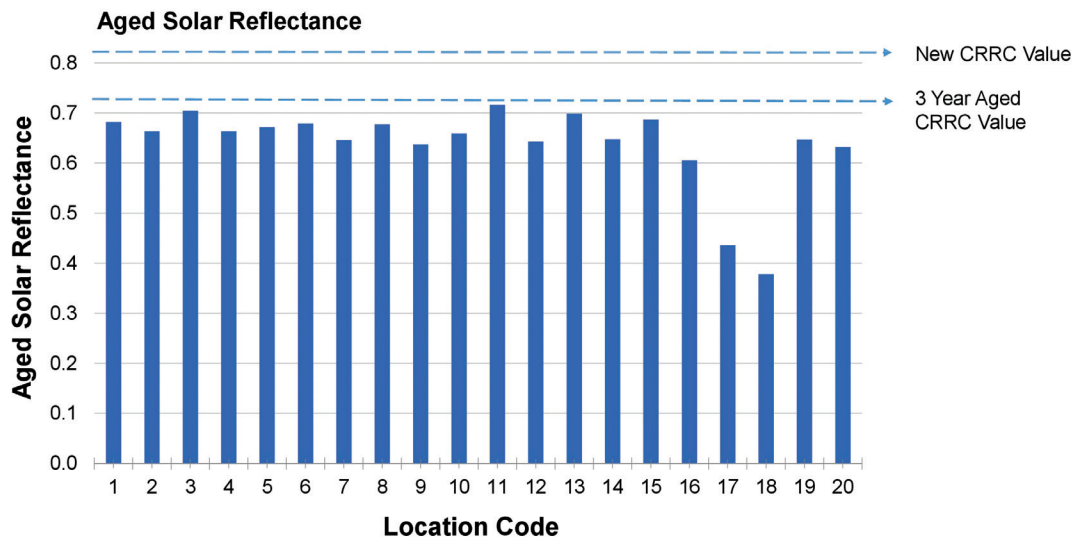
The aged solar reflectance values are shown in Figure 17. With the exception of Locations 17 and 18, the roofs showed an average value of 0.665. This is only slightly below the three-year aged solar reflectance of 0.68 reported by the Cool Roof Rating Council (CRRC) for this membrane.¹⁹

The 0.44 and 0.38 values exhibited by Locations 17 and 18, respectively, suggest that the area sampled was particularly contaminated—a condition that could possibly be resolved by cleaning. Many roofs have localized

Figure 17 – Solar reflectance values of the aged cool roof membranes.
