BELOW-GRADE WATERPROOFING FAILURES

– Case Study

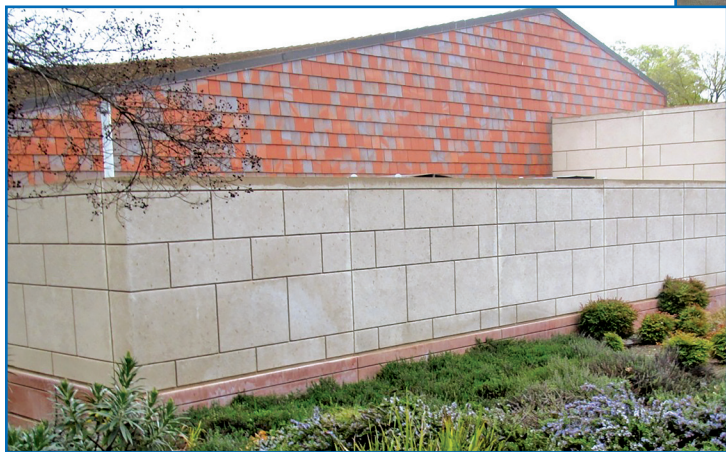
Figure 1 – Boiler room has perimeter cast-in-place concrete walls (commencing below the reddish precast panels) extending down to the concrete footings. (Whitish precast concrete panels extend up from the red panels.)

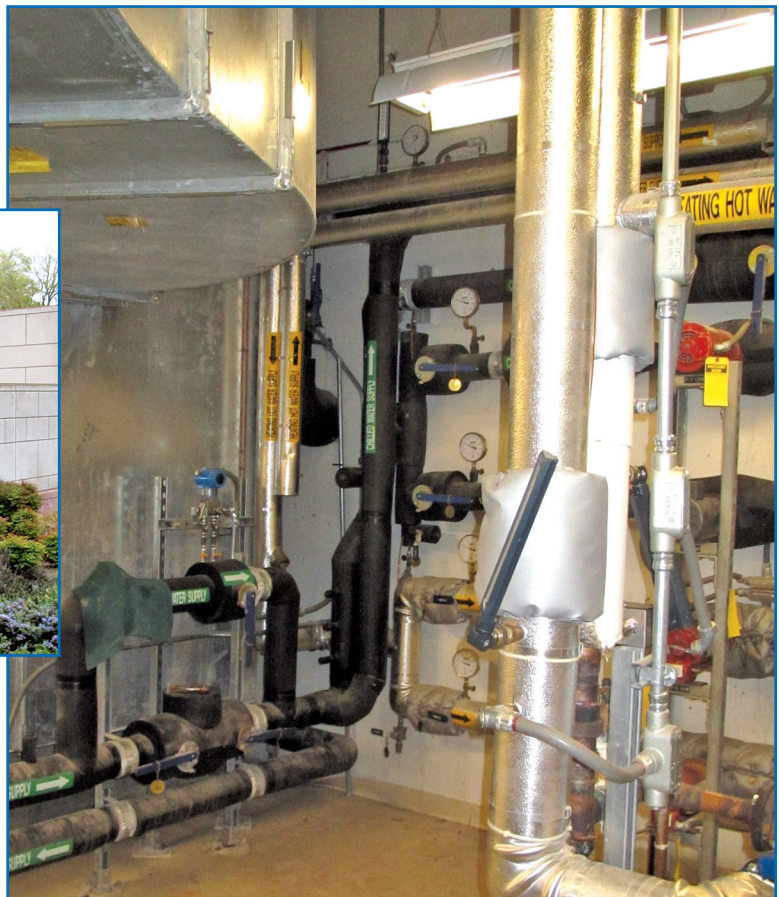
Figure 2 – A cast-in-place concrete wall encloses a 70-ft.-long boiler room that serves the entire campus.

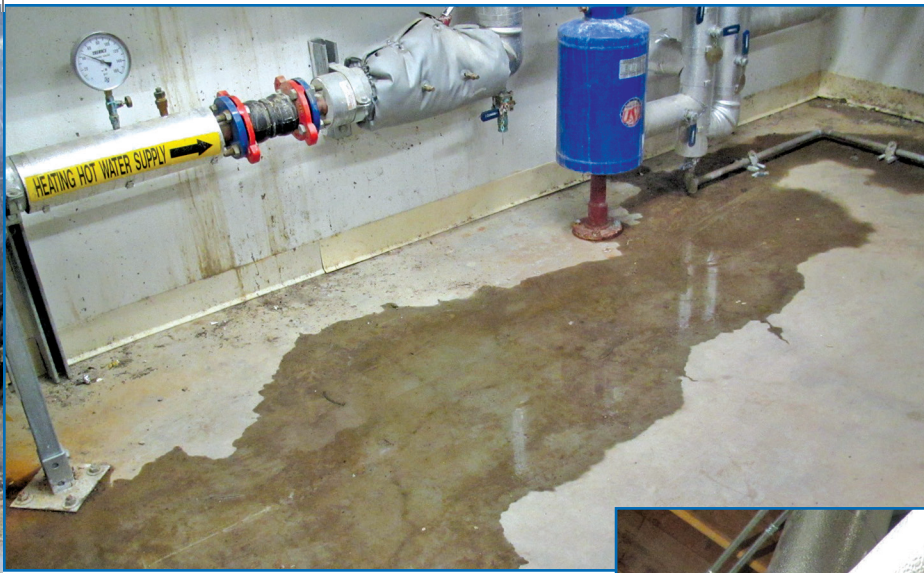
Figure 3 – Even during dry weather, groundwater infiltrated the boiler room at floor-to-wall transitions. The water stains at the lower cast-in-place wall (at left) resulted from leakage occurring at the top of the concrete wall (see Figure 4).

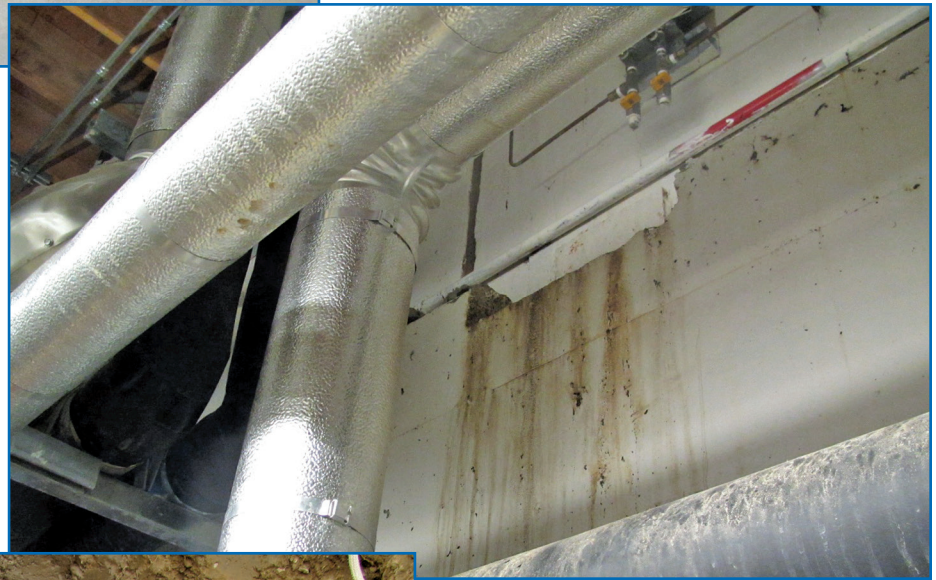
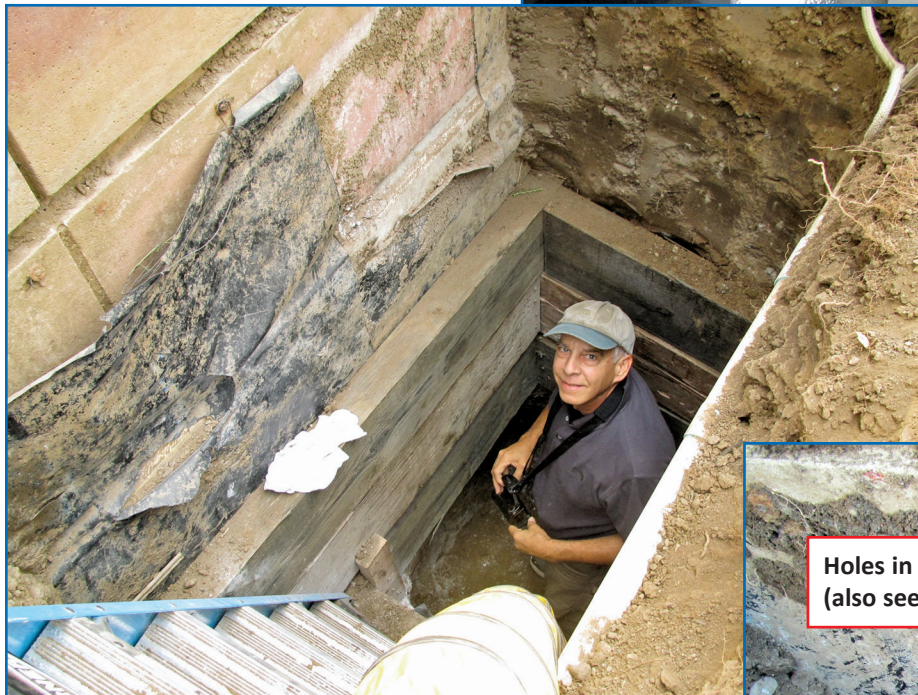
Figure 5 – Upon commencing the excavation process, a raggedy, poorly attached, and extensively torn sheet waterproofing membrane was exposed. (The missing section at the top of this photo was extracted by our crew for sampling purposes.)

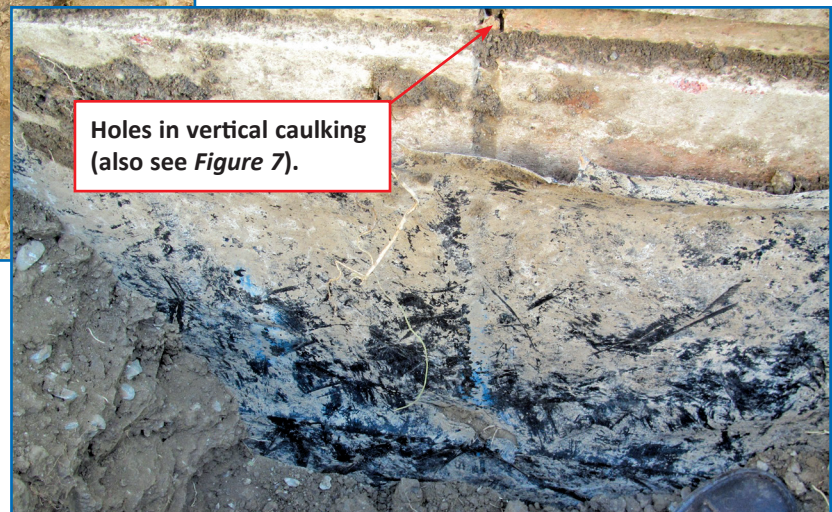
Figure 6 – The sheet waterproofing had been “shot-pinned” to the reddish precast panels without a termination bar that would have served to prevent the membrane from tearing loose during later backfilling. (Note at the top of this photograph the holes in the vertical caulking separating two of these panels; also see Figure 7 and Figure 8.)

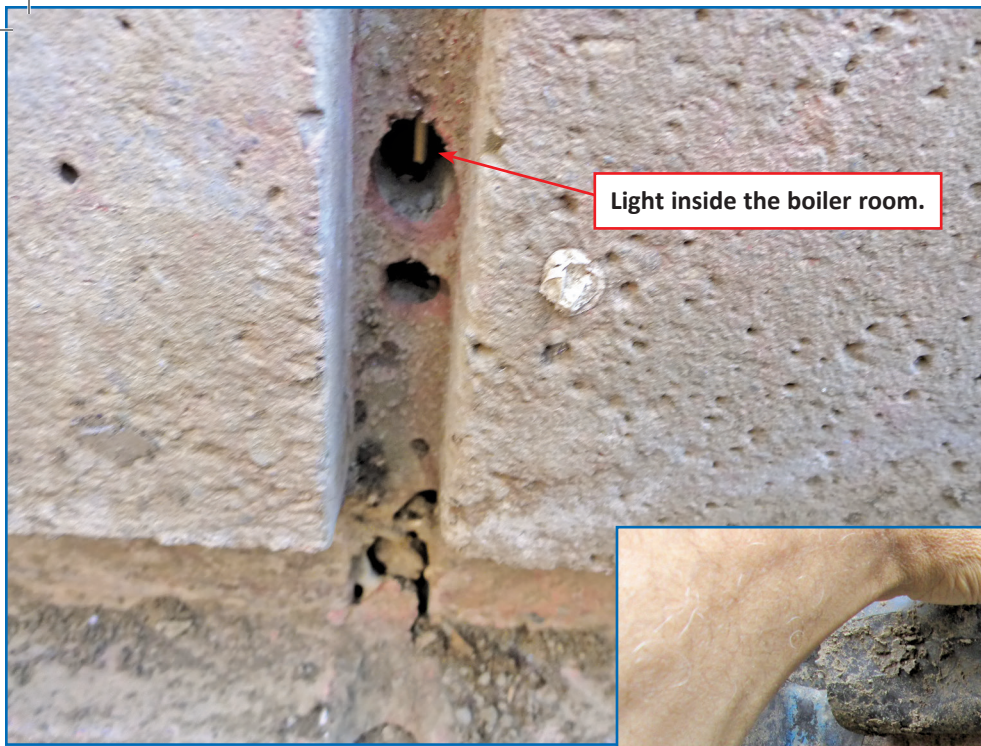
Figure 7 – (Same caulk joint seen in Figure 6.) The defense argued that these below-grade holes were caused by snails. At the upper hole, light from inside the boiler room can be seen.

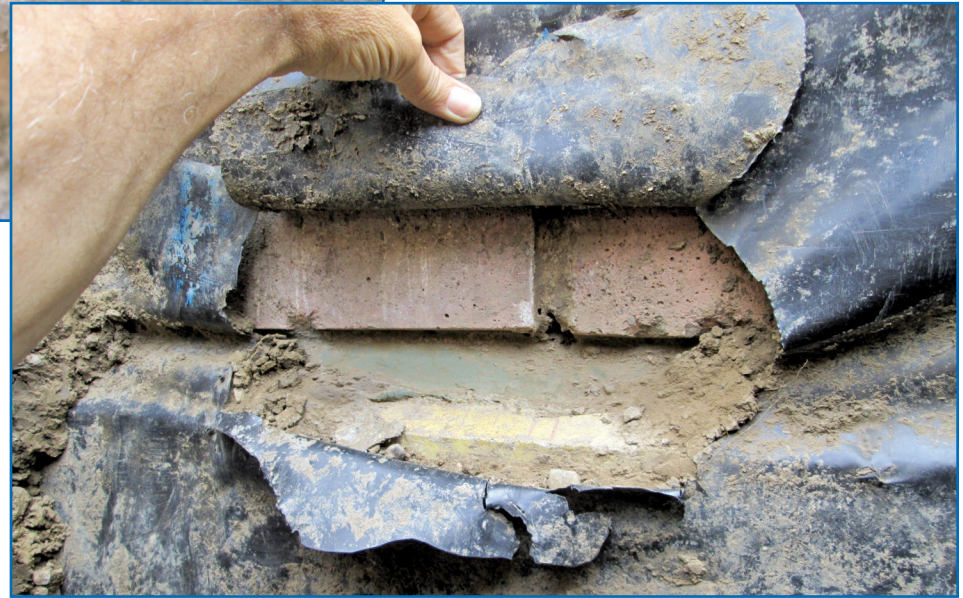
Figure 13 (very near the bottom), contractor(s) had extensively damaged the sheet waterproofing membrane during the backfill process.

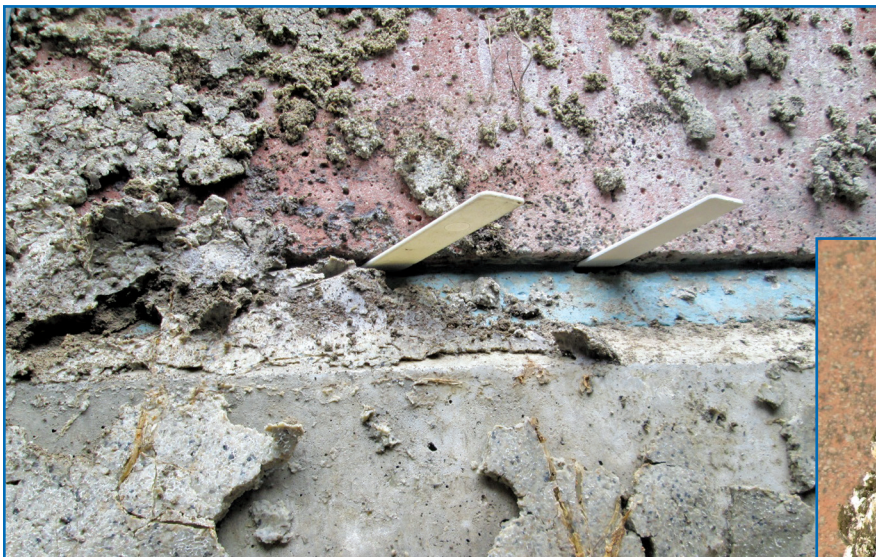
Figure 10 – The caulk joint between the two wall systems was not watertight due to failed bonding at the precast panels.

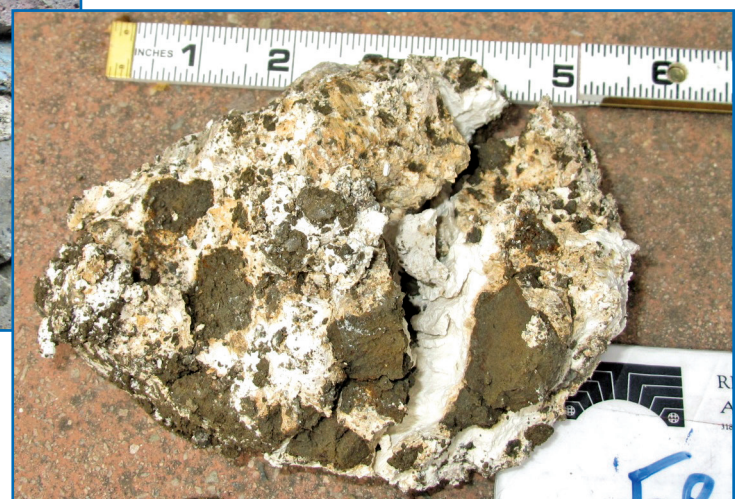
Figure 9 – During excavation, we found this clump of bentonite clay directly below the ripped membrane seen in Figure 8.

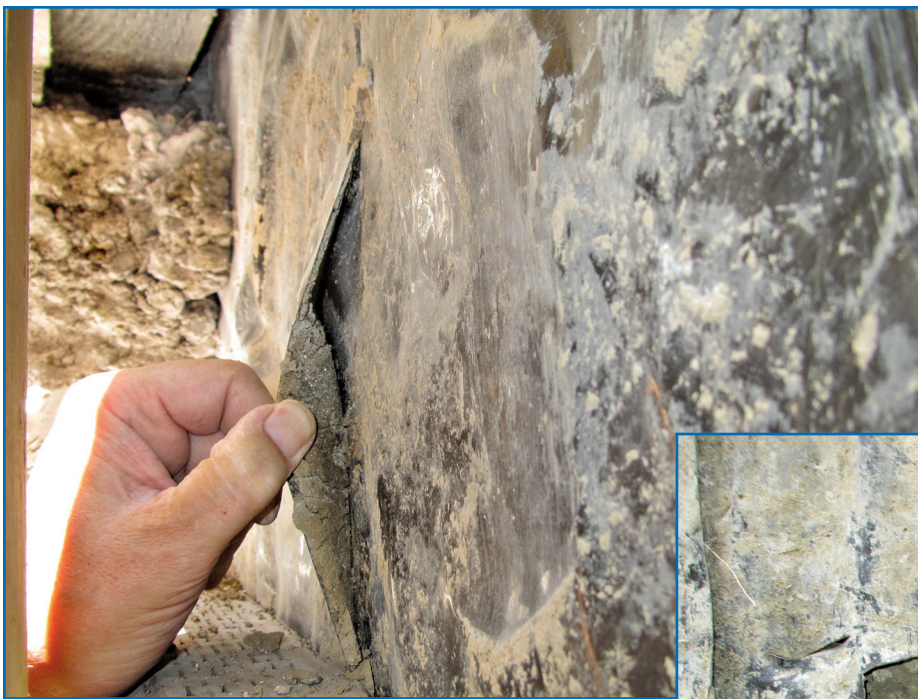
Figure 11 – Multiple breaches in the membrane due to damage during backfilling were observed at all levels of the excavation.

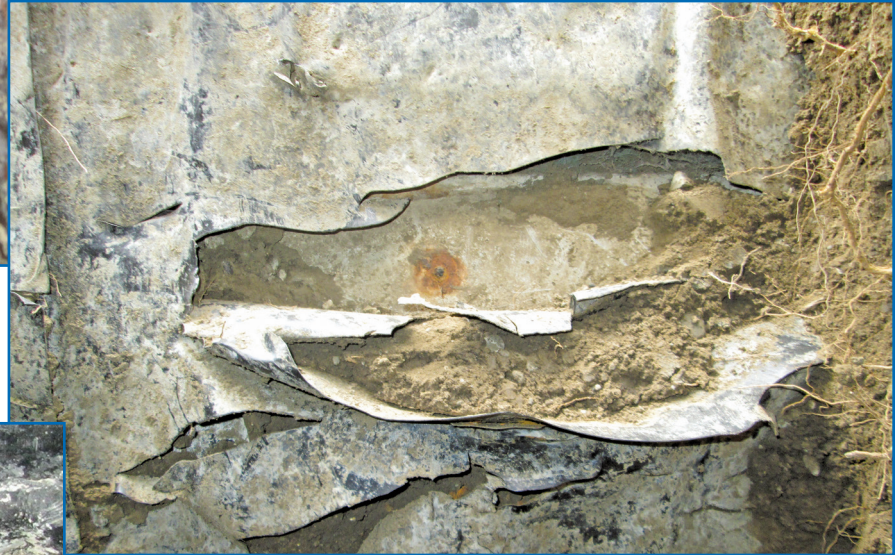
Figure 13 – (below) Near the bottom of the excavated trench, breaches in the waterproofing still remained prevalent.

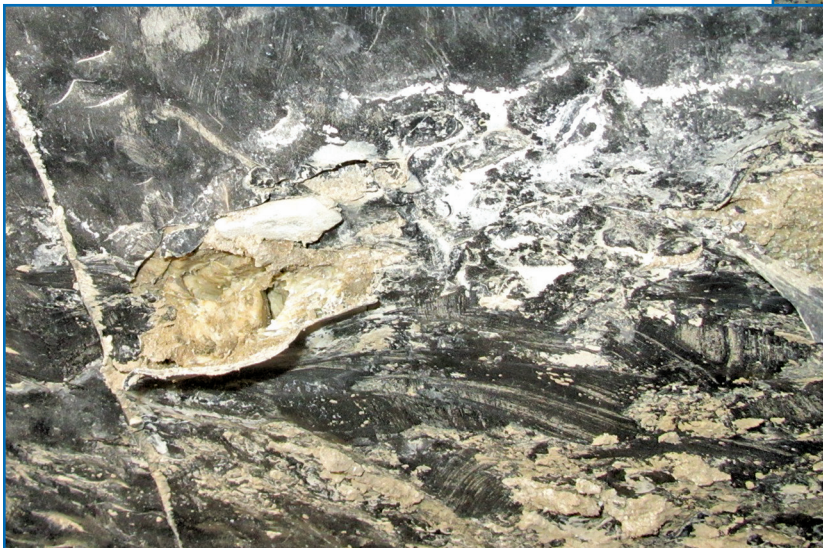
- to thereby relieve hydrostatic “head pressure” against the extensively ripped sheet membrane caused by ground-water trapped in the poorly draining clayish backfill.
