# A MODERN MAKEOVER –

## A Failed, Tired Masonry Façade Gets a New High-Performance Look

By Timothy A. Mills, PE, LEED AP, CIT II

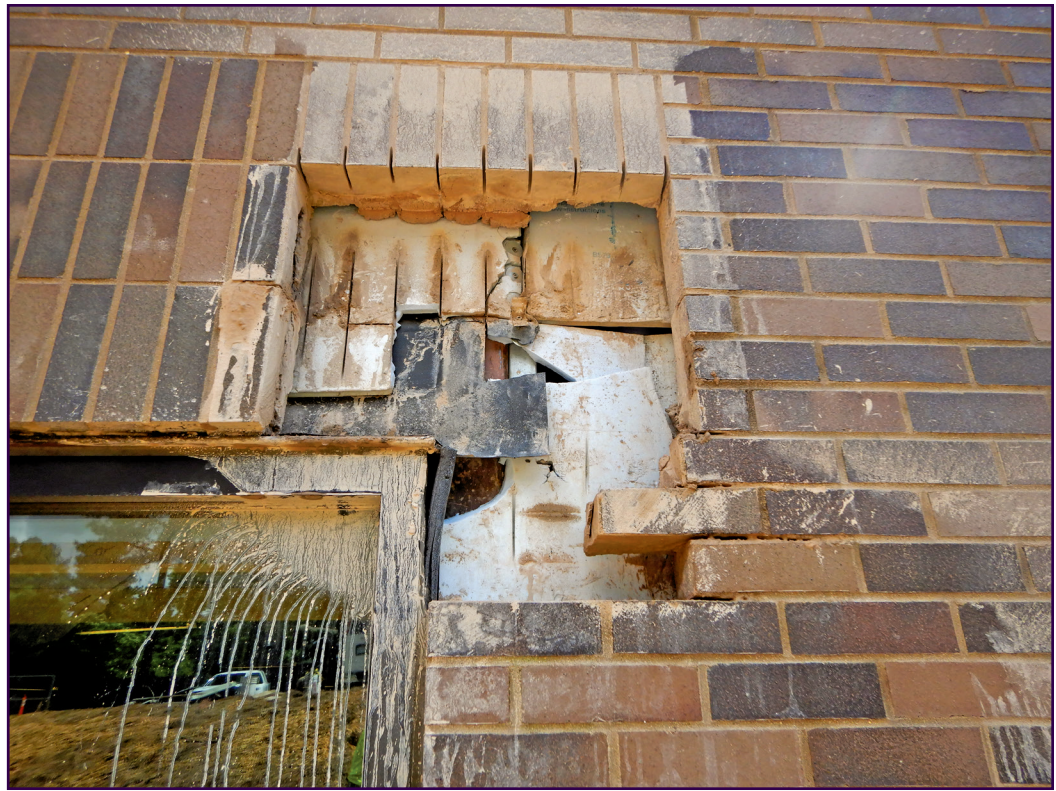
*Figure 4. Inspection location at a window head corner revealing the condition of the loosely placed rigid foam board sheathing and poorly installed PVC flashing.*

loosely with screws and washers with no efforts made to seal joints or provide any sort of weather or air barrier. In most instances, masonry cavities were found to be bridged with excessive mortar.

Through-wall flashings were found to be composed of a plastic PVC membrane sheet, which was loosely fastened to the foam board insulation or run up behind it where gaps occurred between adjacent insulation boards. The plastic flashing had long since lost its flexibility and was brittle and easily damaged.

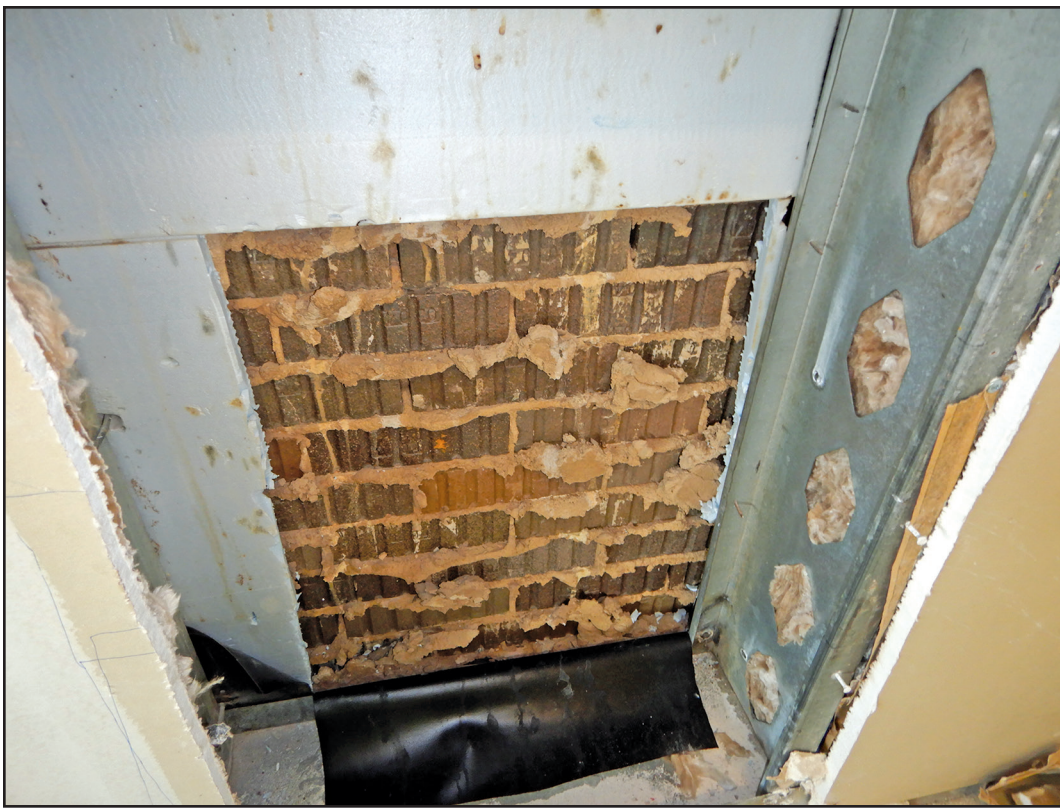
**Figure 5.** Forensic study image where the brick cladding was inspected from the inside of the building by removing interior finishes and sheathing. Note through-wall flashing at bottom of photo.

side of the brick cladding, sheathing, and construction of the entire wall assembly (Figure 5).

condition of several of the building cladding, structural, cavity, and wall assembly elements. It became apparent that the as-constructed condition of the brick did not provide for any masonry control joints. Masonry control joints were not shown on the original plans. There were no vertical control joints near corners, at openings, or at the ends of the brick panels supported by steel relief angles. There were no soft joints (backer rod and sealant joints) in any of the masonry cladding systems. The lack of soft joints at critical areas to allow for a certain amount of stress relief in the masonry cladding, for differential movement between brick cladding that is footing supported, and brick cladding that is building-frame supported, was determined to be the primary cause of the horizontal and vertical

cracks on the building. Horizontal cracks in mortar joints occurred at every relief angle location, and vertical cracks occurred close to building corners, as might be expected in the

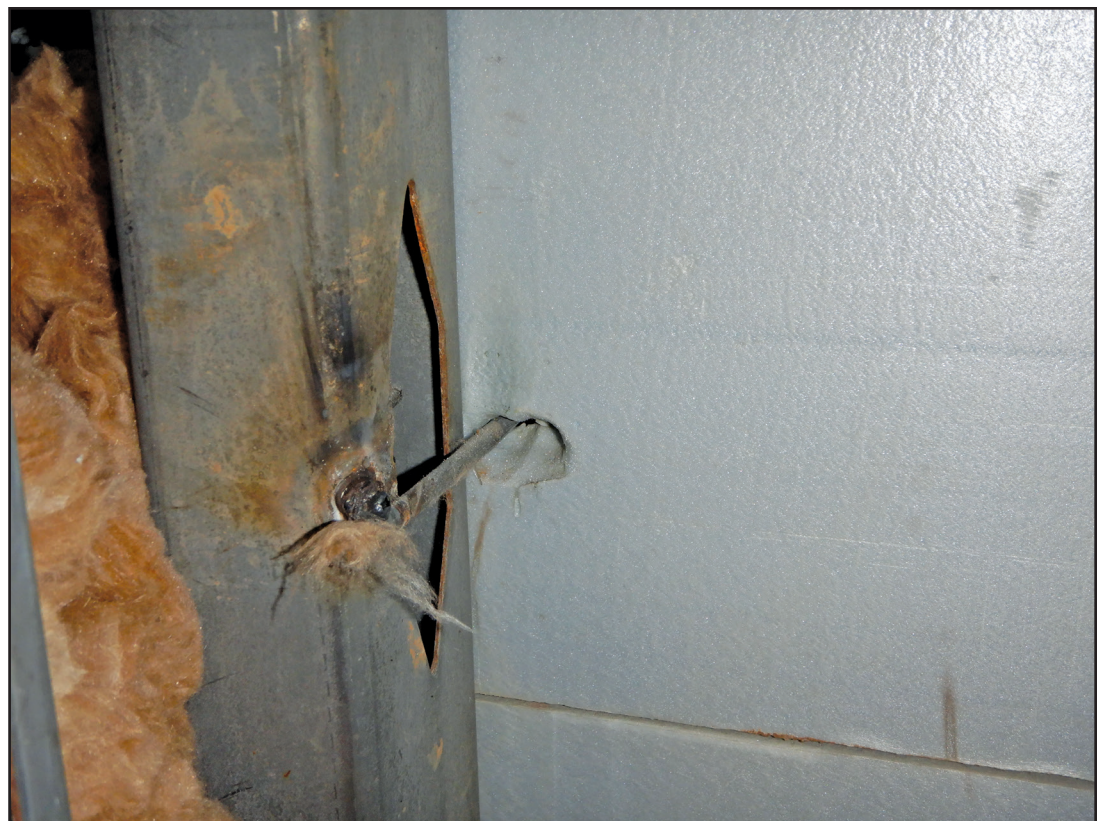
**Figure 6.** Forensic image of one of the methods used, fastening brick cladding anchors to the steel studs where the anchors were field-welded in place; note large hole melted in the foam sheathing.

Findings also included some unique features where the brick masonry ties were welded to interior studs or welded to steel washers, which were welded or screw-fastened to the interior studs (Figure 6).

This technique must have required pushing the masonry anchors through the exterior extruded insulation board to allow the anchor to be welded to the studs. This construction technique created thousands of holes in the exterior sheathing, as well as burn marks and melted insulation due to the welding activities.

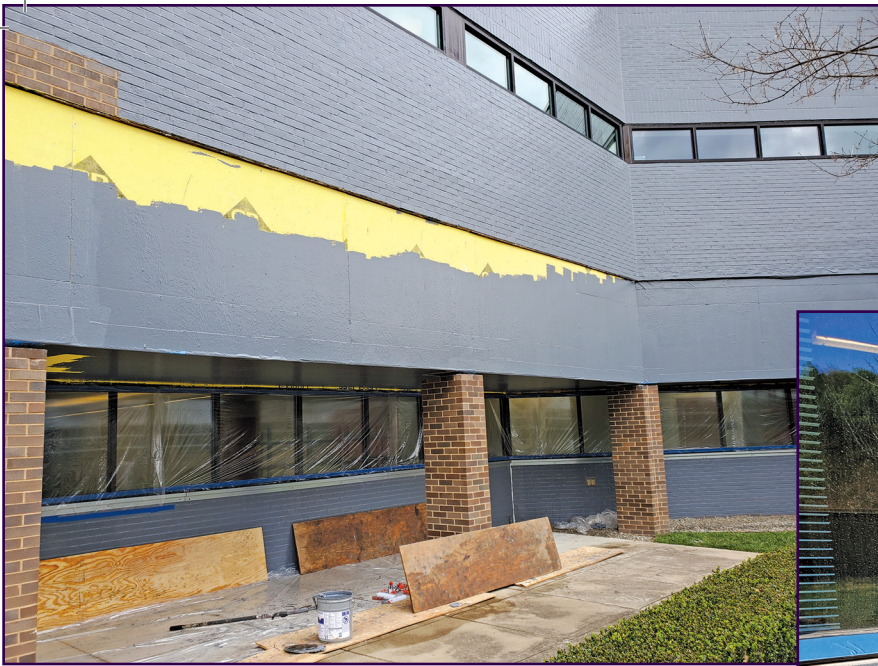
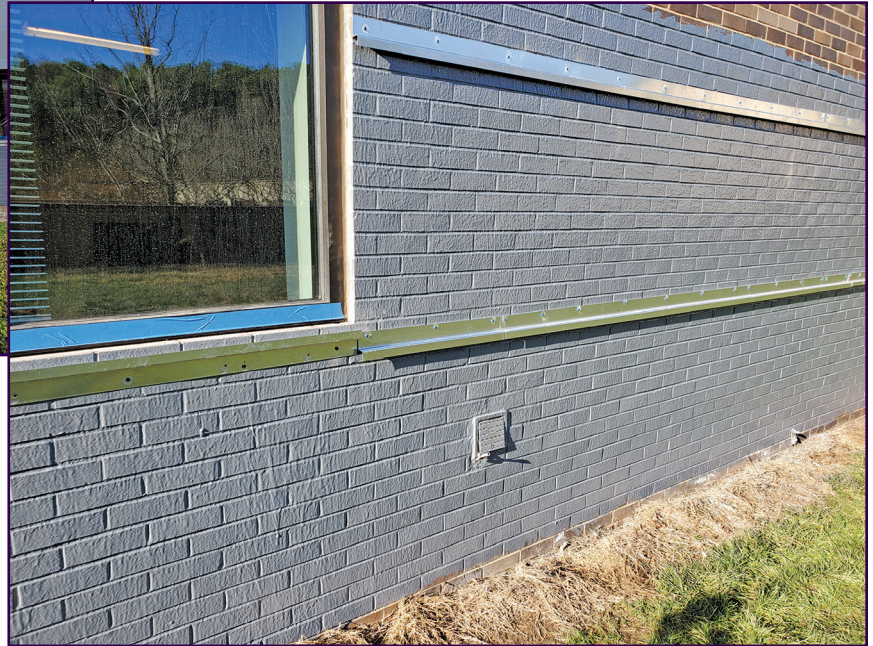
*Figures 7 and 8. Ongoing installation of the liquid-applied vapor-permeable air and weather barrier being applied to exterior gypsum sheathing and brick cladding.*

new stainless steel and brass masonry repair anchors were installed to properly support the cladding at these areas. The new design included the selection of a prefinished metal cladding system, including both vertical and horizontal panel selections with a custom layout and custom accent colors. The new assembly included a vapor-permeable liquid-applied air barrier installed over the existing brick (Figure 7), horizontal or vertical light-gauge Z members (Figure 8), and an additional layer of mineral wool insulation (Figures 9 and 10).

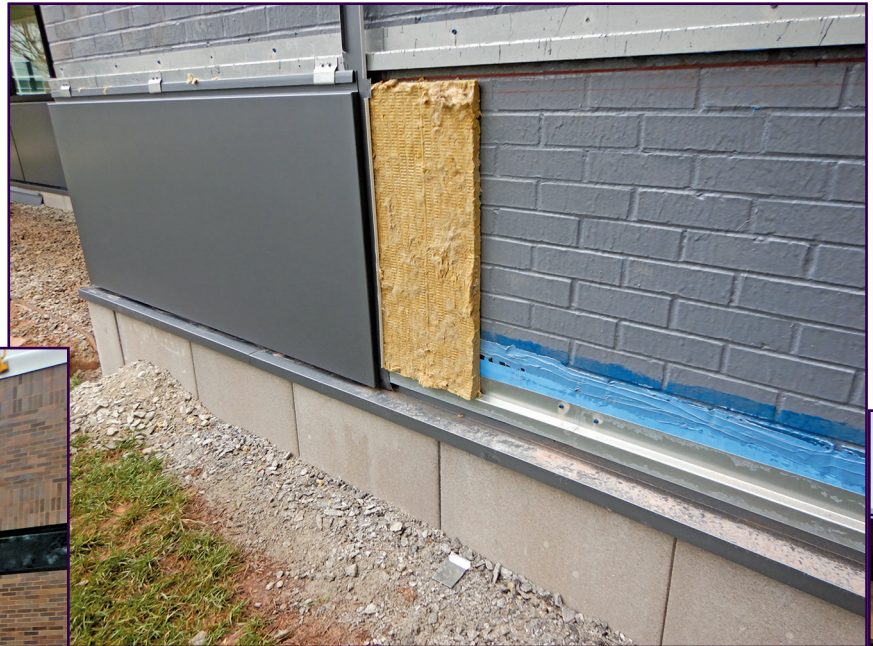
*Figure 9. Base-of-wall condition where through-wall flashing is secured to the primed air-barrier membrane to flash out water before the base-of-wall insulated concrete panels below.*

The architect also elected to provide additional thermal insulation at the base-of-wall condition, tying the new metal cladding system to an insulated concrete panel system using extruded insulation that extended to below grade (Figure 9). At some locations, a new below-grade bentonite-based waterproofing system was also installed. The architect went to great lengths to detail as many of the as-built conditions as possible and tie the new system into the existing building elements. Finally, water-hose nozzle testing was used to field-verify weathertightness of the new installation (Figure 11).

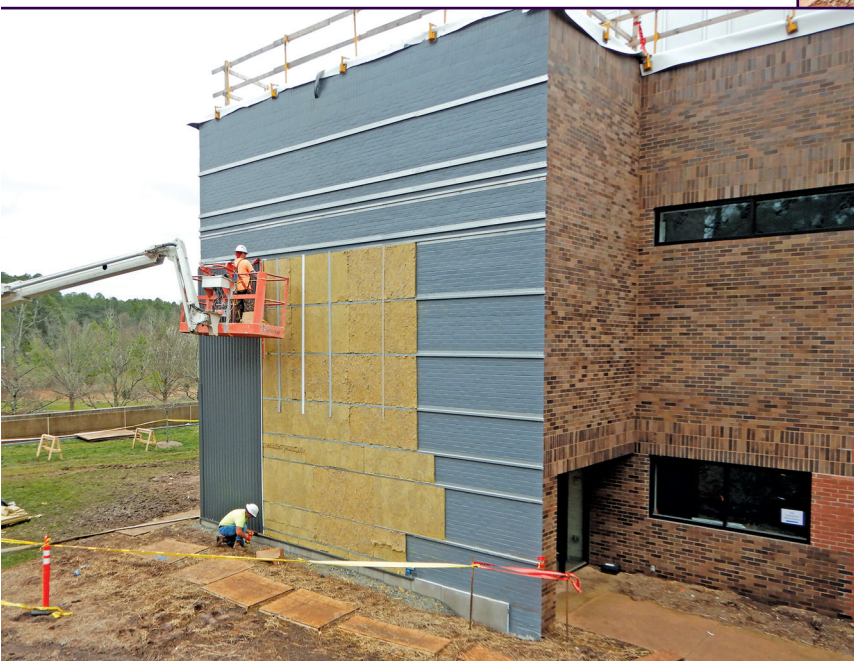
*Figure 10. Ongoing work where the liquid-installed air barrier is visible, as well as horizontal Z tracks and thermal insulation prior to installation of metal wall panels.*

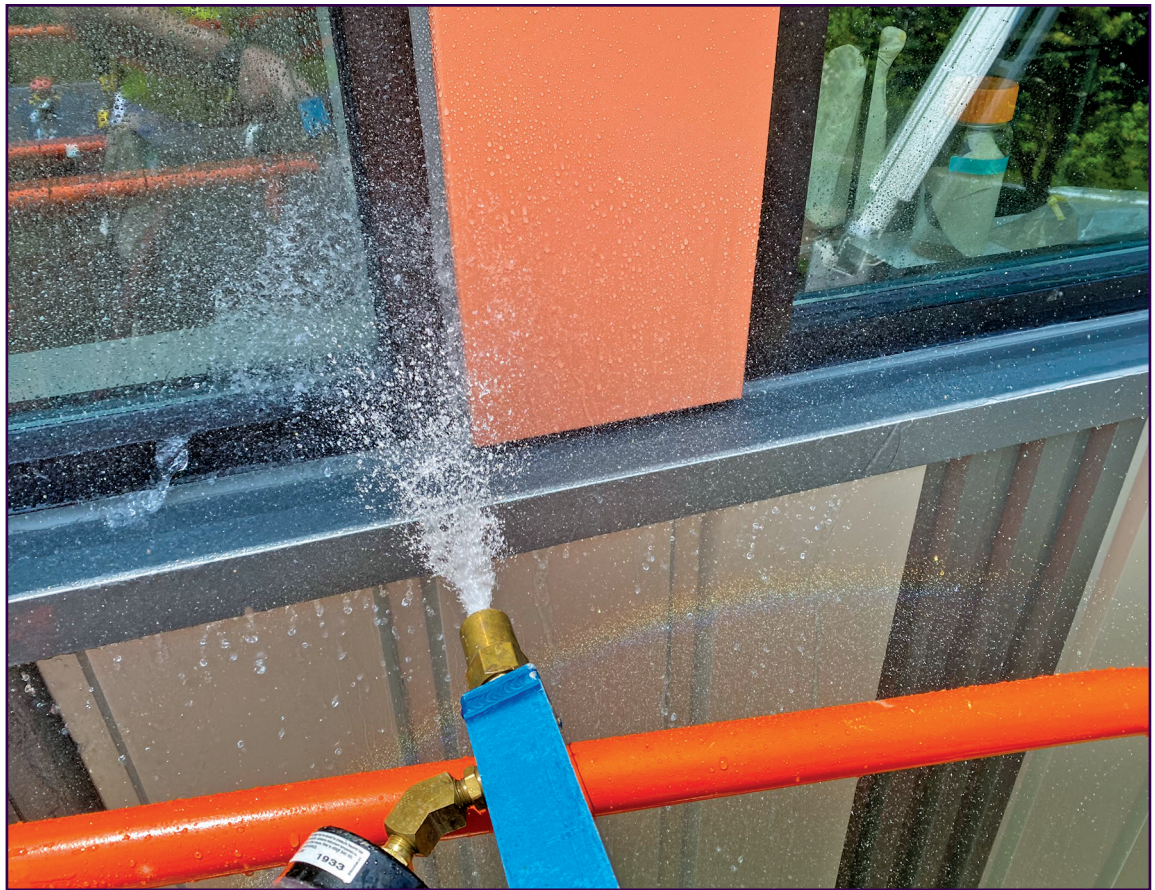
*Figure 11. The installed cladding system was tested using ASTM spray nozzle techniques.*
