What (Not) to Expect When You Are Expecting New Fenestrations

— A Case Study

By John C. Wylie, REWC, RRD, PE

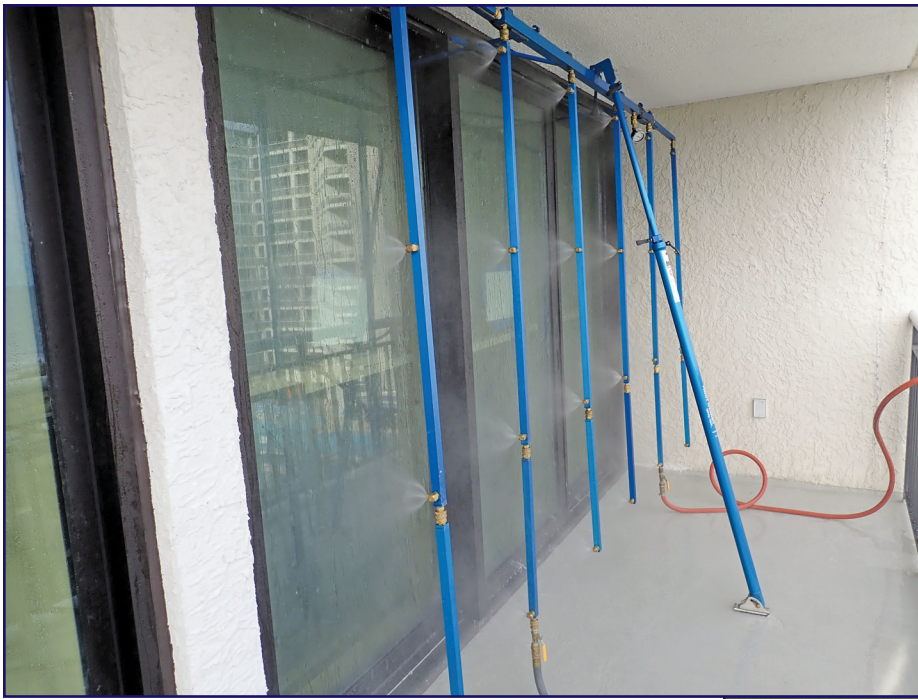
Figure 2. View of water penetration testing.

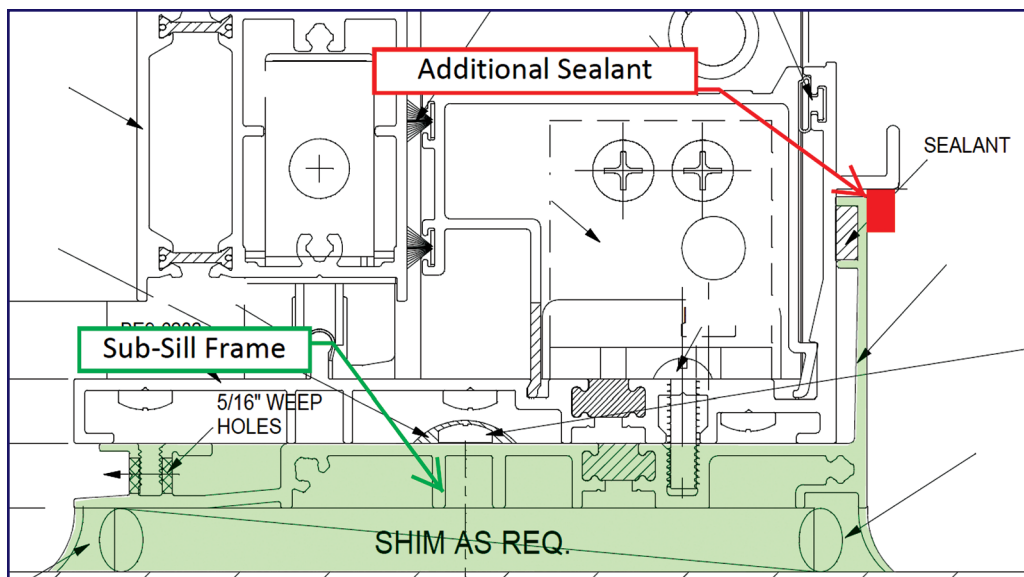
Figure 3. View of location of sealant.

During a water penetration testing session, a sliding glass door with an architectural window (AW) product performance class was subjected to Procedure 'A' of AAMA 502. During the 15-minute static-air water penetration resistance test, evidence of water leakage was observed at the intersection of the fenestration-to-sub-sill framing. When the two different framing systems are intimately joined together, it is critical to ensure that the joints are properly sealed to prevent water intrusion. For this particular repair project, the critical location was at the rear vertical leg of the sub-sill where a bead of sealant was installed into a prefabricated slot

to ensure intimate contact with the fenestration framing (Figure 3). However, during installation, the fenestration framing can move slightly, creating small voids or holes in the sealant. These small voids or pinholes can be exposed during water testing, especially when the interior chamber pressure is significant.

Following discussions with the manufacturer and contractor, an additional bead of sealant was installed on the exterior surface of the fenestration-to-sub-sill intersection. This supplemental bead of sealant was then installed at all previously installed and newly installed sliding glass door locations, resulting in a mode of failure that was not observed during subsequent water penetration testing. Though these types of fenestrations experience rigorous manufacturer laboratory testing, unforeseen errors in the installation can result in the potential of future water intrusion issues, if left in an uncorrected condition.

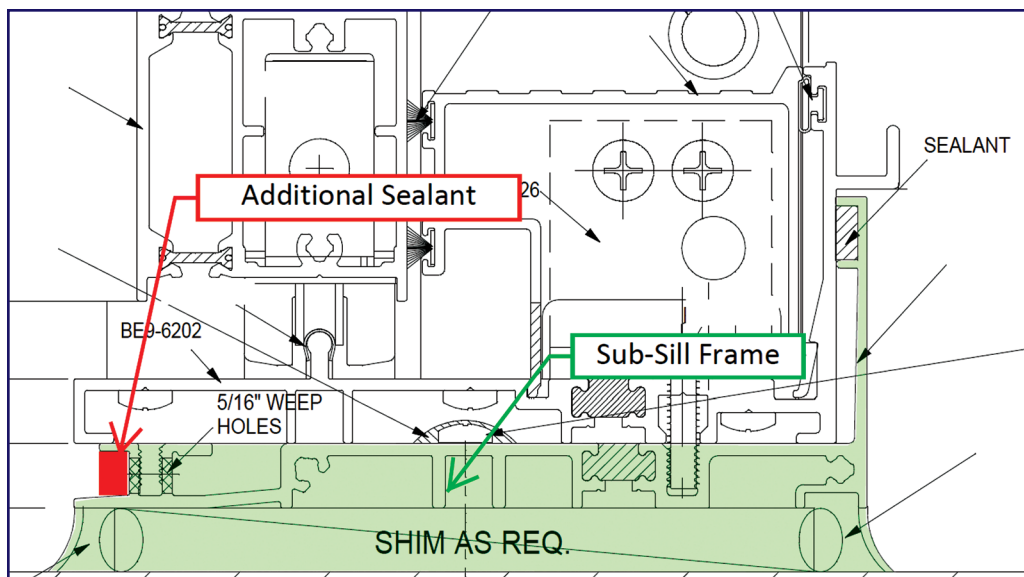
During a water penetration testing session, evidence of water leakage was observed at the intersection of the sub-sill end dam and fenestration jamb of one of the sliding glass doors (Figure 4). Closer examination of these intersections did not exhibit any open gaps or

Figure 4. View of location of sealant.

holes in the sealant following the water penetration testing. The manufacturer's design of the sub-sill included the installation of weepholes to allow for any incidental water to exit.

Following extensive discussions with the manufacturer and contractor, it was concluded that the weepholes located within the sub-sill needed to be closed with a bond breaker and sealant. Though the sub-sill was designed with weepholes, the incidental water drawn into the sub-sill during water testing was not being purged, thereby creating a head of water within the sub-sill and subsequently overtopping the back dam. The installation of the new sealant over the weepholes of the sub-sill would create a barrier-type system as an alternative to the originally designed drainage system. This supplemental bond breaker and sealant system was installed at all previously installed and newly installed sliding glass door locations. Subsequent water penetration testing was not able to recreate this specific type of water leakage. It should be clearly noted that this type of change could be considered an undesirable consequence and a potentially problematic maintenance issue for the owner. However, by working with the manufacturer, specific design changes could be implemented on future fenestration systems.

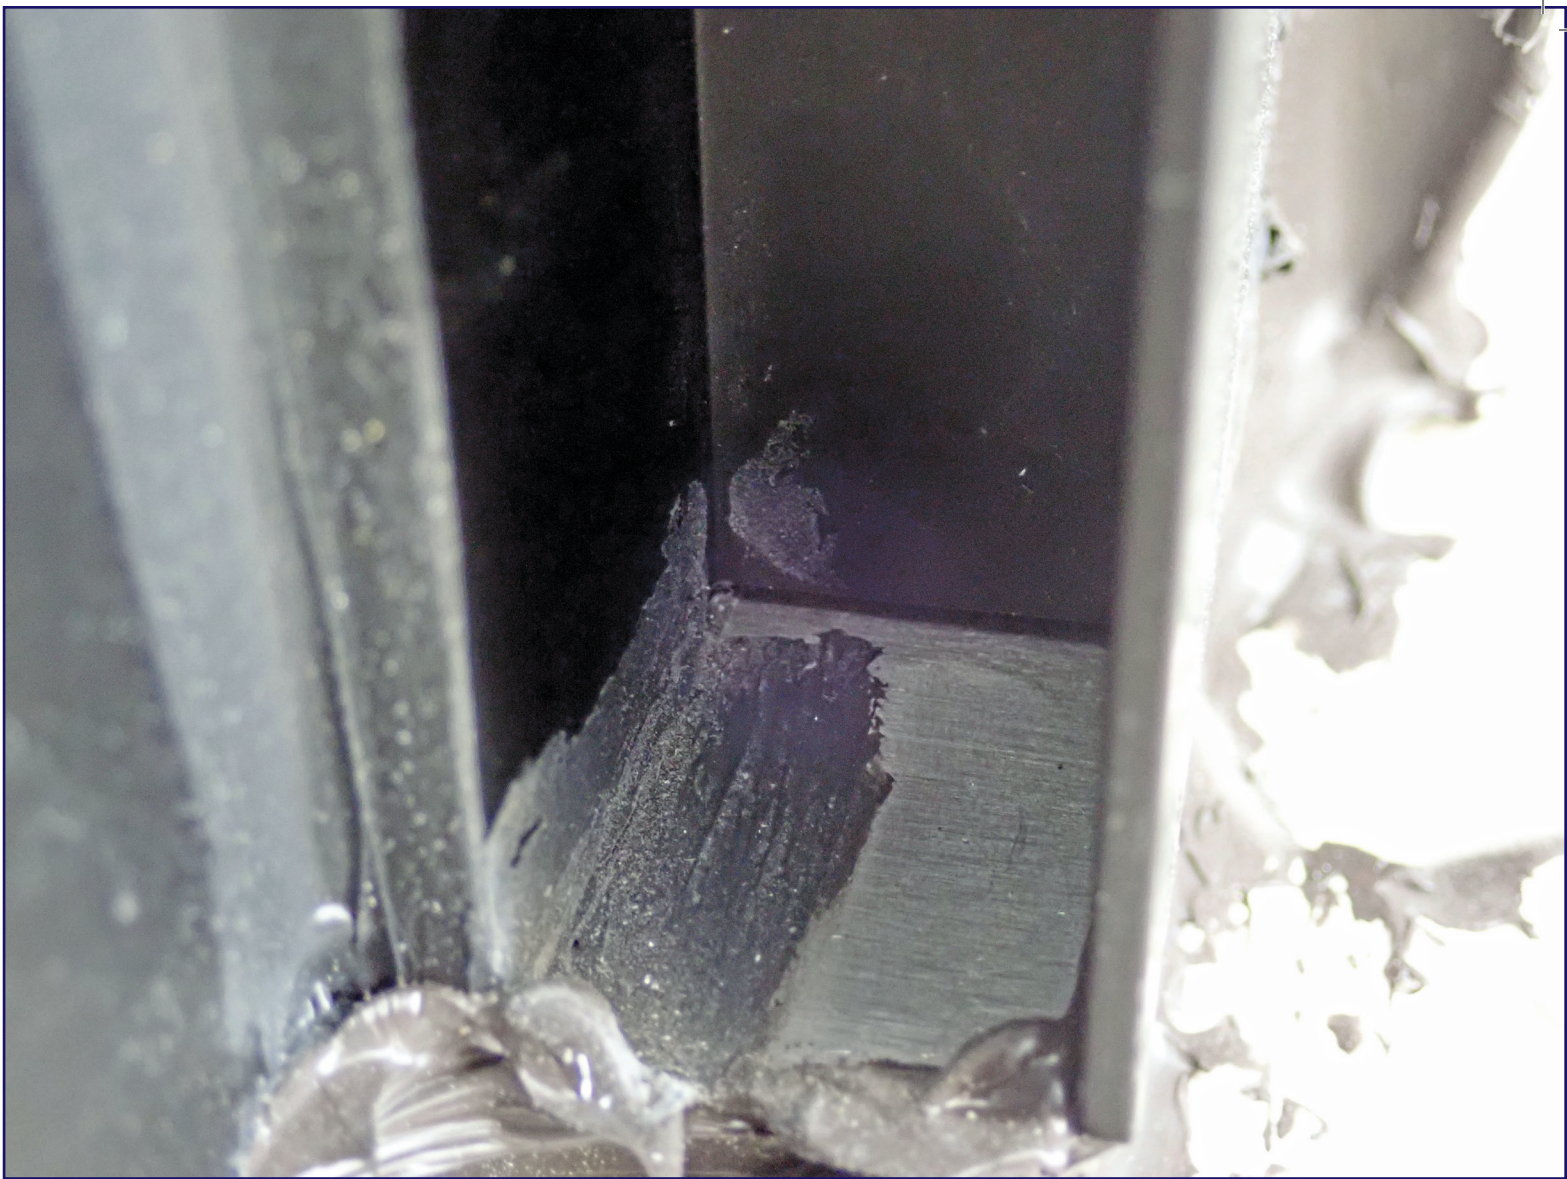
During a water penetration testing session, the water level was observed to be increasing along the back dam of the newly installed sliding glass door. Inspection of the sealant with the use of a smoke pen following the water penetration testing concluded that a small hole in the exterior sealant joint allowed water to fill and overtop the sill pan due to the pressure differential across the sliding glass door (Figure 5). These types of small voids and/or pinholes can be caused by the thinning out of the sealant, improper tooling, or adhesion failure.

Figure 5. View of thinned-out sealant and void.

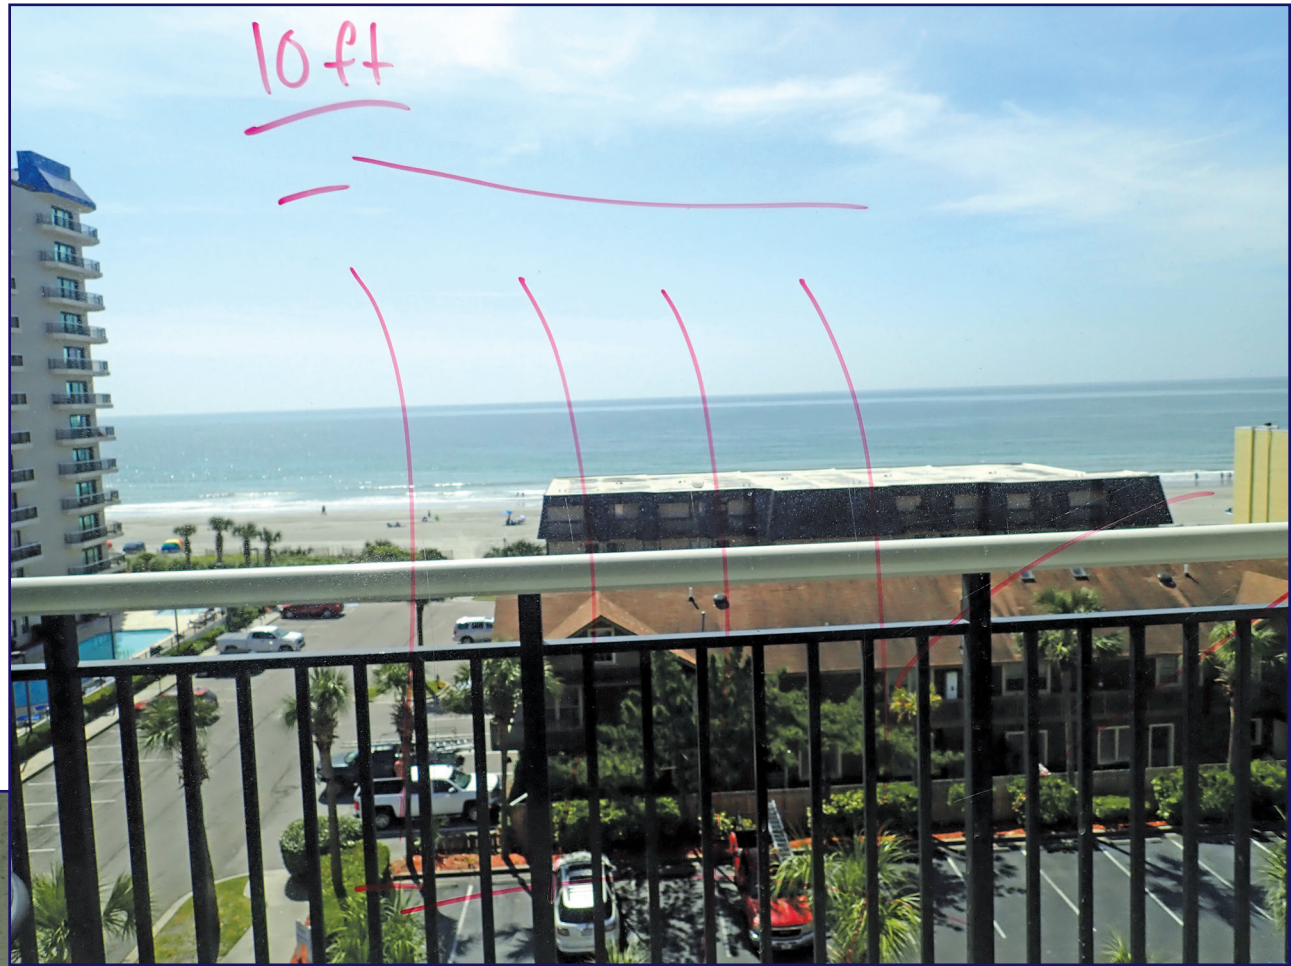
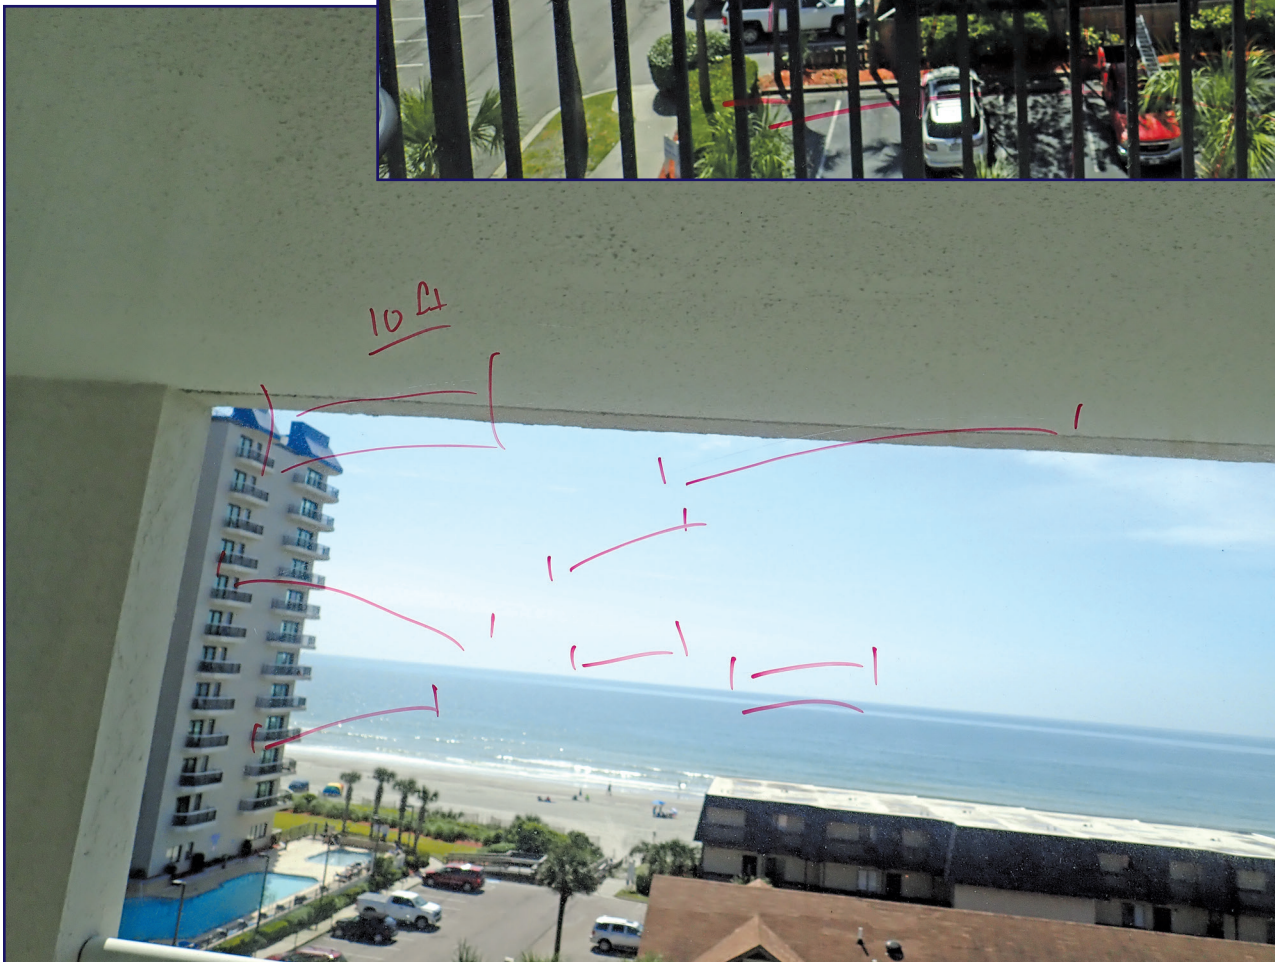
During the visual inspection, a combination of medium and heavy blemishes were identified on the top surface of the individual IG unit panels for the windows and sliding glass doors (Figure 9). Several of the glass panels were observed to have one linear blemish, while several of the glass panels were observed to have a series or grouping of closely spaced linear blemishes. Of the 300 individual IG unit panels observed within all of the windows and sliding glass doors, 29 glass panels required removal and replacement with new IG units.

Figure 9. Views of glass surface blemishes (highlighted with red).

As part of the original recommended outline scope of repair following the inspection of the windows and sliding glass doors, any identified medium-surfaced glass blemish that was considered to be allowed by ASTM C1036 could be polished. Based on preliminary research, the design professional understood that the polishing technique was proven to be an effective repair for light- to medium-surfaced glass blemishes. However, supplemental research and discussions with regard to this repair technique resulted in an issued addendum that revised the scope of repair to include all IG units with a medium-surfaced glass blemish to be removed and replaced. This revision was determined on the premise that there is a likelihood that a reduction in the cross-sectional thickness of the glass could result in failure or breakage due to the significant wind pressures produced during a high-wind event.
