The Reroofing of an Iconic Structure in Memphis

Employing Technology to Develop a Suitable Solution

By Charles Sietmann, RRO, REWO, CCCA, CIT, and Kami Farahmandpour, F-IIBEC, REWC, RRC, RWC, RBEC, PE, CCS, CCCA

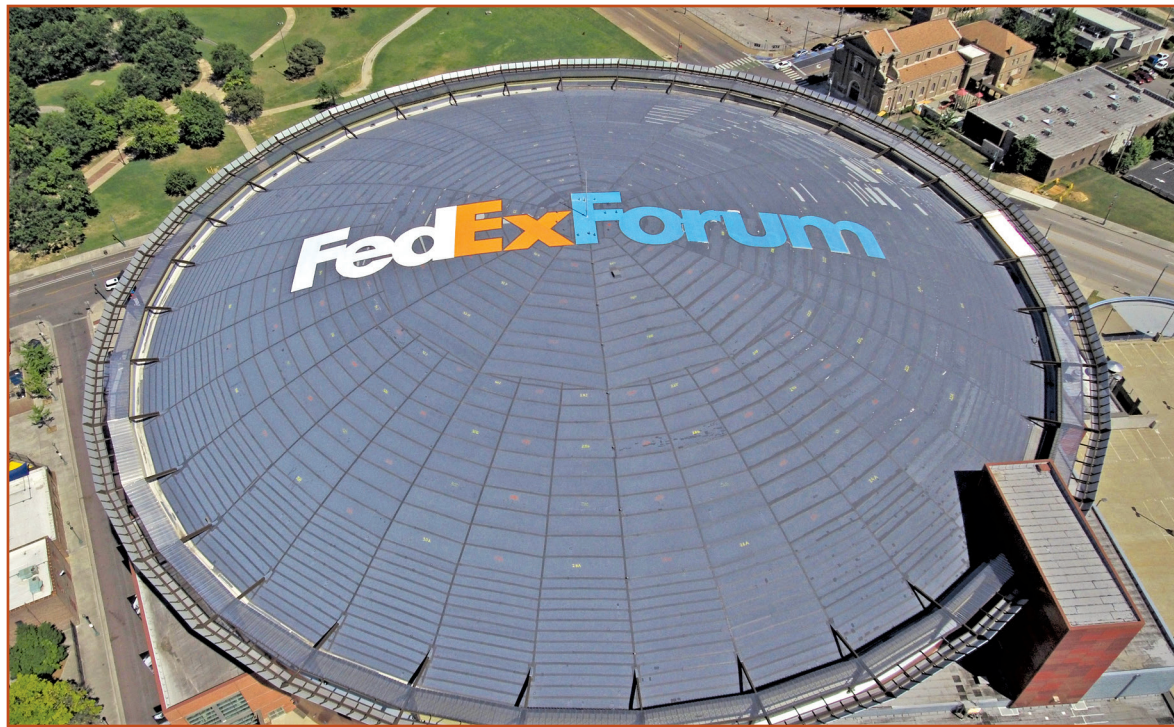
The dome structure consists of a steel frame with 36 perimeter columns and trusses, each forming a 10-degree sector of the dome (Fig. 2). The original roofing assembly of the dome consisted of a 20-gauge steel deck supported by the steel framing, two layers of rigid insulation panels, and a single-ply 45-mil-thick TPO roof membrane. A building wrap, apparently serving as an air barrier, had also been incorporated into the roofing system between the upper and lower layers of rigid insulation.

Figure 2. Overall aerial image of existing dome roof showing the roof sections.

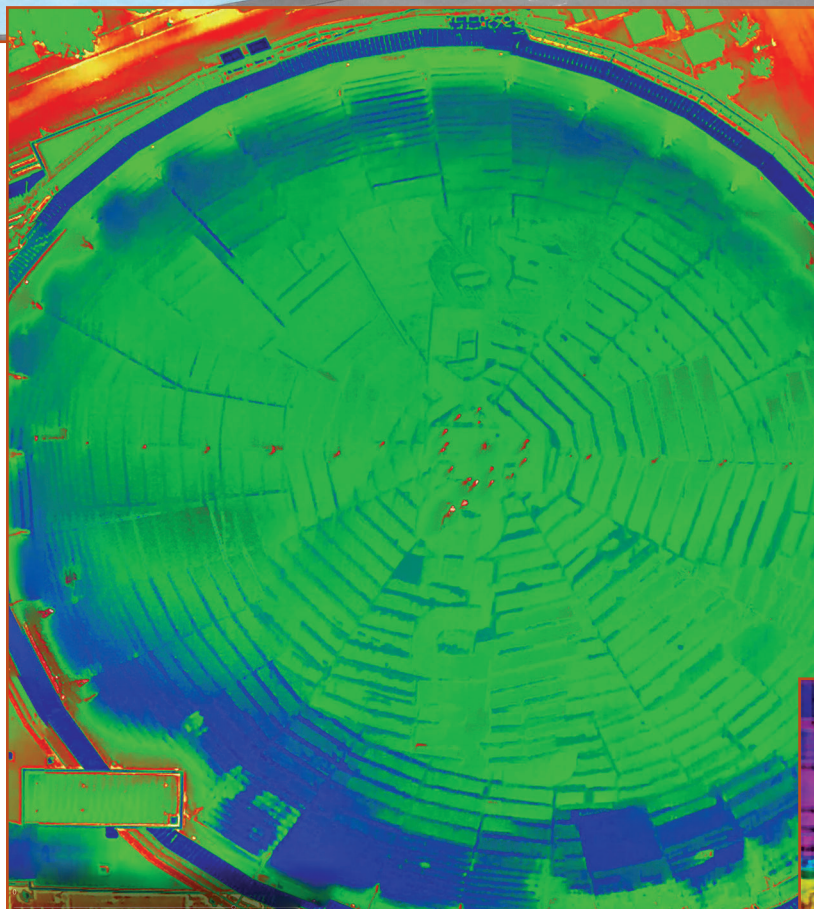
The visual review was supplemented with an aerial review and infrared thermographic survey performed using a UAS equipped with a gimbal-mounted remote thermal imager (Fig. 3). Several areas of the dome roof along the perimeter exhibited thermal anomalies (Fig. 4 and 5). Some of the thermal anomaly locations coincided with areas that had been previously repaired. Other thermographic anomalies correlated with the extent of craze cracking of the roof membrane. These observations of thermal anomalies indicated that moisture intrusion through craze cracking, and through the resulting tears, had saturated the lower areas of the roof. Similar craze

Figure 4. Stitched overall thermal image. Colors between blue and red typically indicate varying degrees of moisture within the substrate, with blue being colder areas, and red being warmer areas. Note the brighter green areas along the lower perimeter of the dome; these represent lower surface temperatures and were primarily areas of suspected saturated insulation.

cracking was also observed at the upper areas of the dome. However, our infrared thermographic survey did not indicate presence of moisture accumulation on the upper dome areas. This finding was attributed to two factors: (1) as water runs down the dome, the lower areas are exposed to more water, causing more water penetration through the roof membrane deficiencies; and (2) water that penetrated through the roof membrane also runs down the dome through the insulation joints, accumulating in the lower areas. Based on these observations, it was concluded that areas where water penetrated the roof membrane on the upper dome evaporated through the moisture-permeable air barrier. However, the rate of wetting and moisture accumulation at the lower dome areas exceeded the evaporation rate.

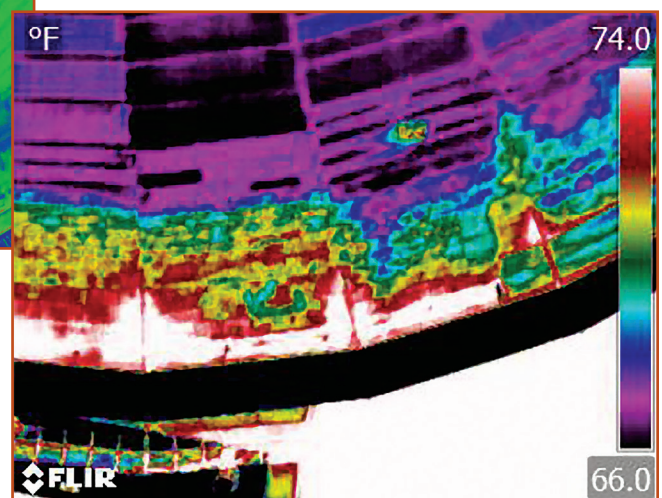
Figure 5. Close-up thermal image at the lower roof. Note thermal anomalies along the lower perimeter of the dome.

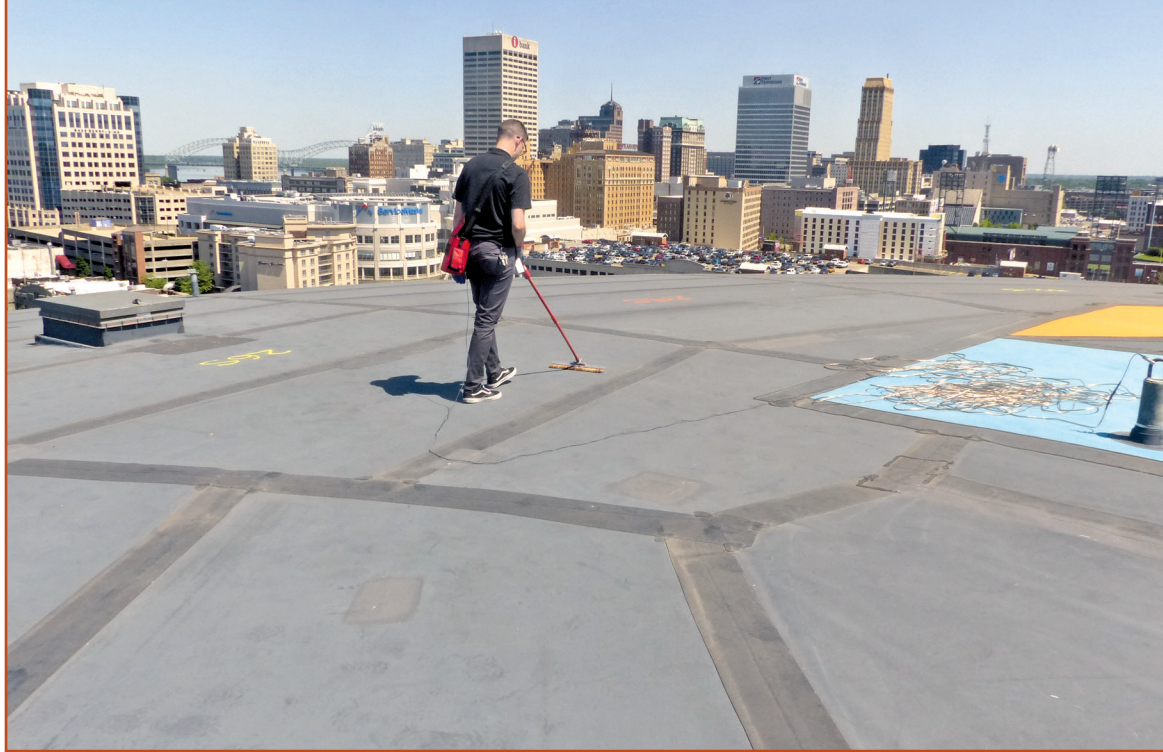
Figure 6. High-voltage electronic leak detection testing being performed.

age leak detection testing identified numerous membrane breaches in the test areas. The breaches were recorded and roughly correlated with the extent of thermal anomalies detected through the infrared thermographic survey.

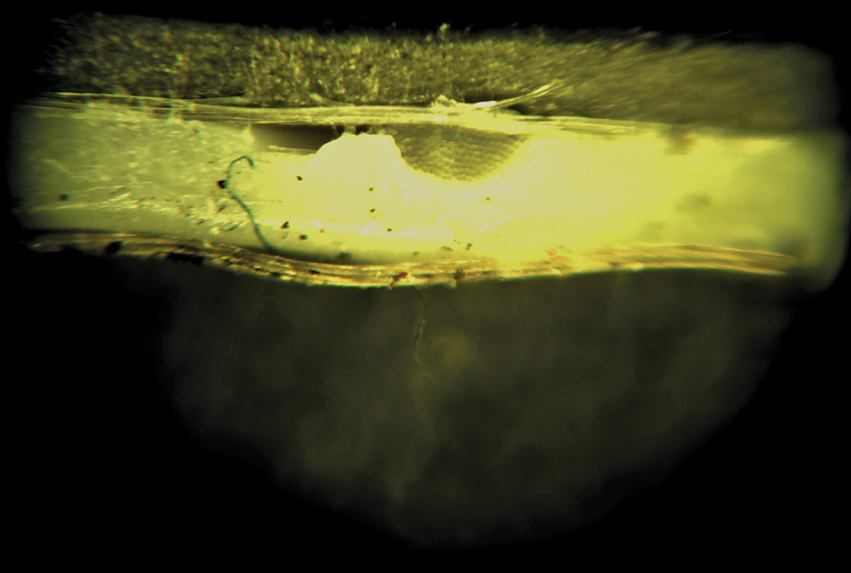
Figure 7. Microscopic examination of existing membrane. Note the void adjacent to reinforcement.

sample, three cross sections of the roof membrane were cut and examined under a variable magnification digital microscope. The investigators used their in-house equipment to evaluate the depth and potential cause(s) of the observed membrane crazing. Sections cut away from the apparent tears and crazing in the membrane indicated that the craze cracking had extended to the reinforcing scrim, and that there was a thinner TPO top coating than TPO bottom coating (Fig. 7). In one section, nearly the entire top TPO coating had been diminished. This condition was likely due to exposure to elements over the years that reduced the top coating thickness. In addition, in several examined sections, voids were observed near the reinforcing scrim; these were likely due to the original manufacturing process.

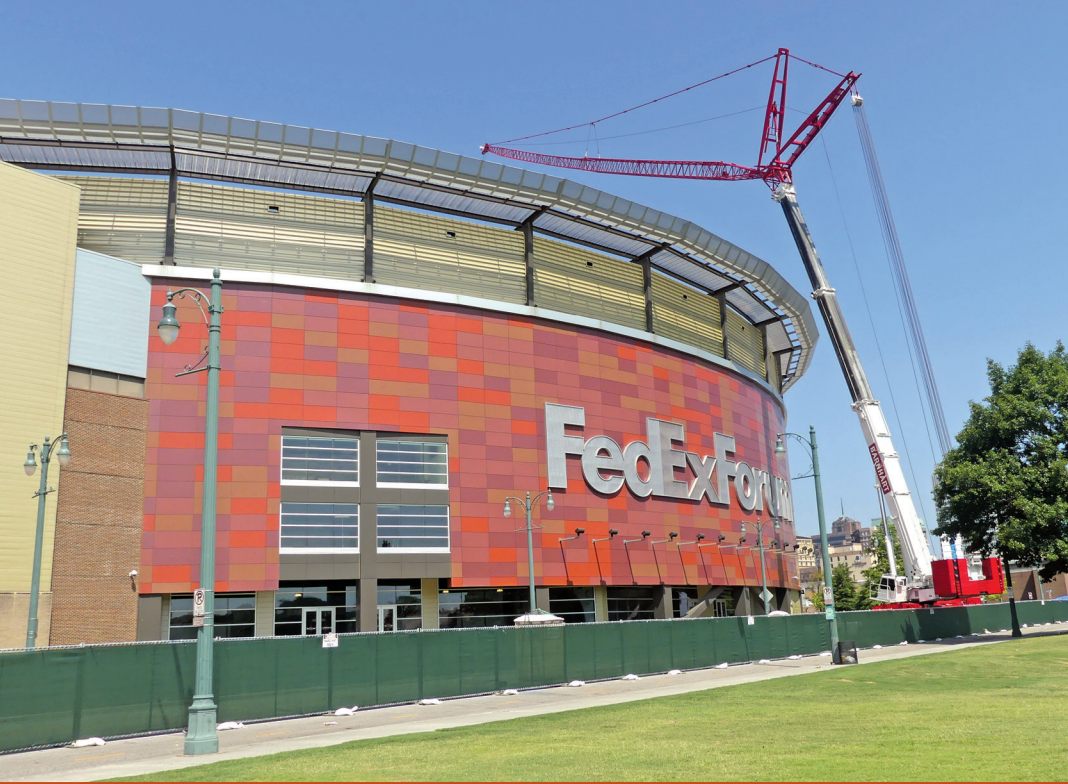
Figure 8. Staging area and crane in use.

Transportation of materials to the top of the dome roof posed the biggest logistical challenge. The use of a large crane (a mobile crane with 100-ft [30-m] tower, luffer boom, and large outriggers) was required to reach the central area near the top of the dome (Fig. 8). Use of a smaller crane with less reach and capacity was also required during tear-off of the lower dome areas.

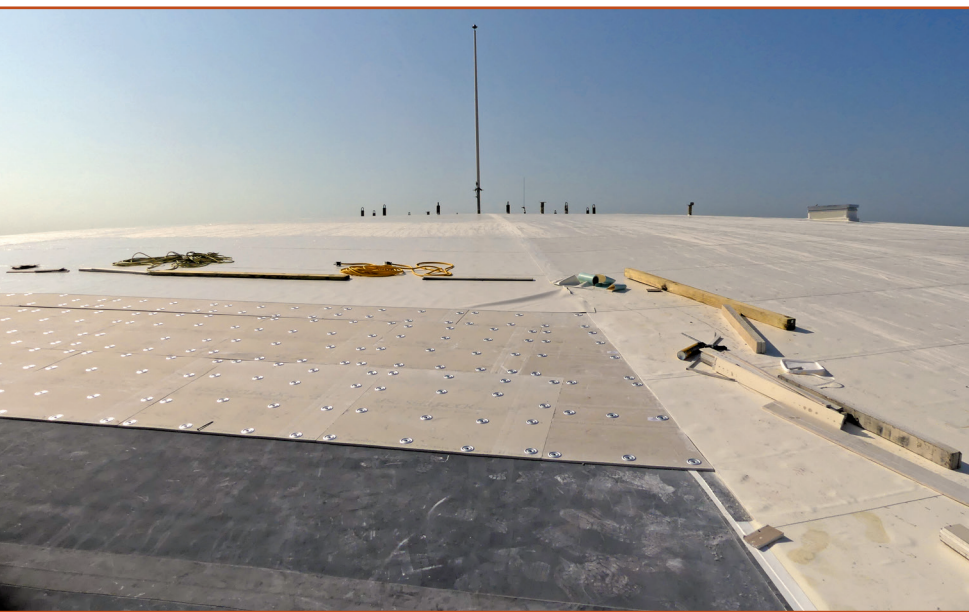
Figure 9. Roof re-cover in progress at the upper dome.

narrow gutter area around the lower dome (Fig. 9 and 10). The steel beams around the perimeter of the roof also made it difficult to navigate through the gutter area. Materials had to be strategically placed, and supported, around the dome to limit material movement issues while on the roof, and to avoid overloading of the roof structure.

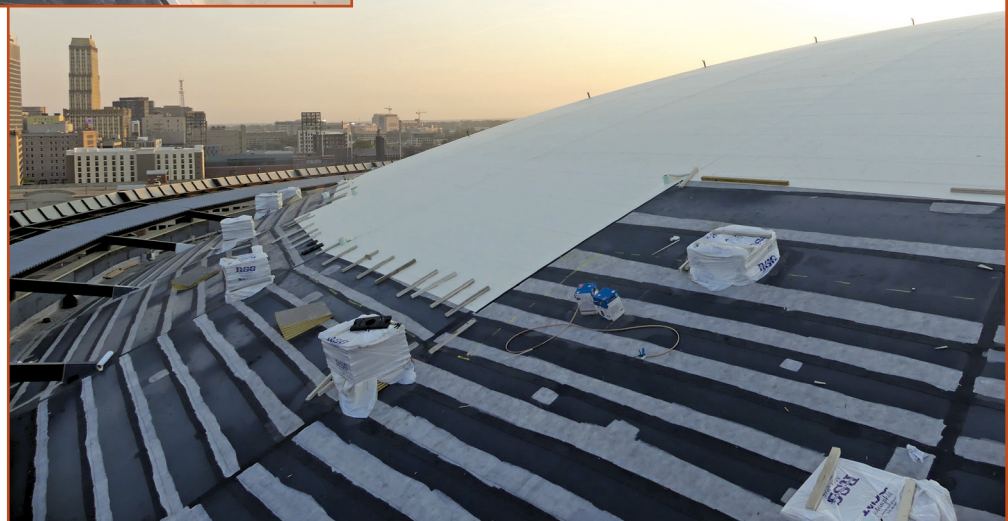
Figure 10. Roof re-cover in progress at the upper dome.

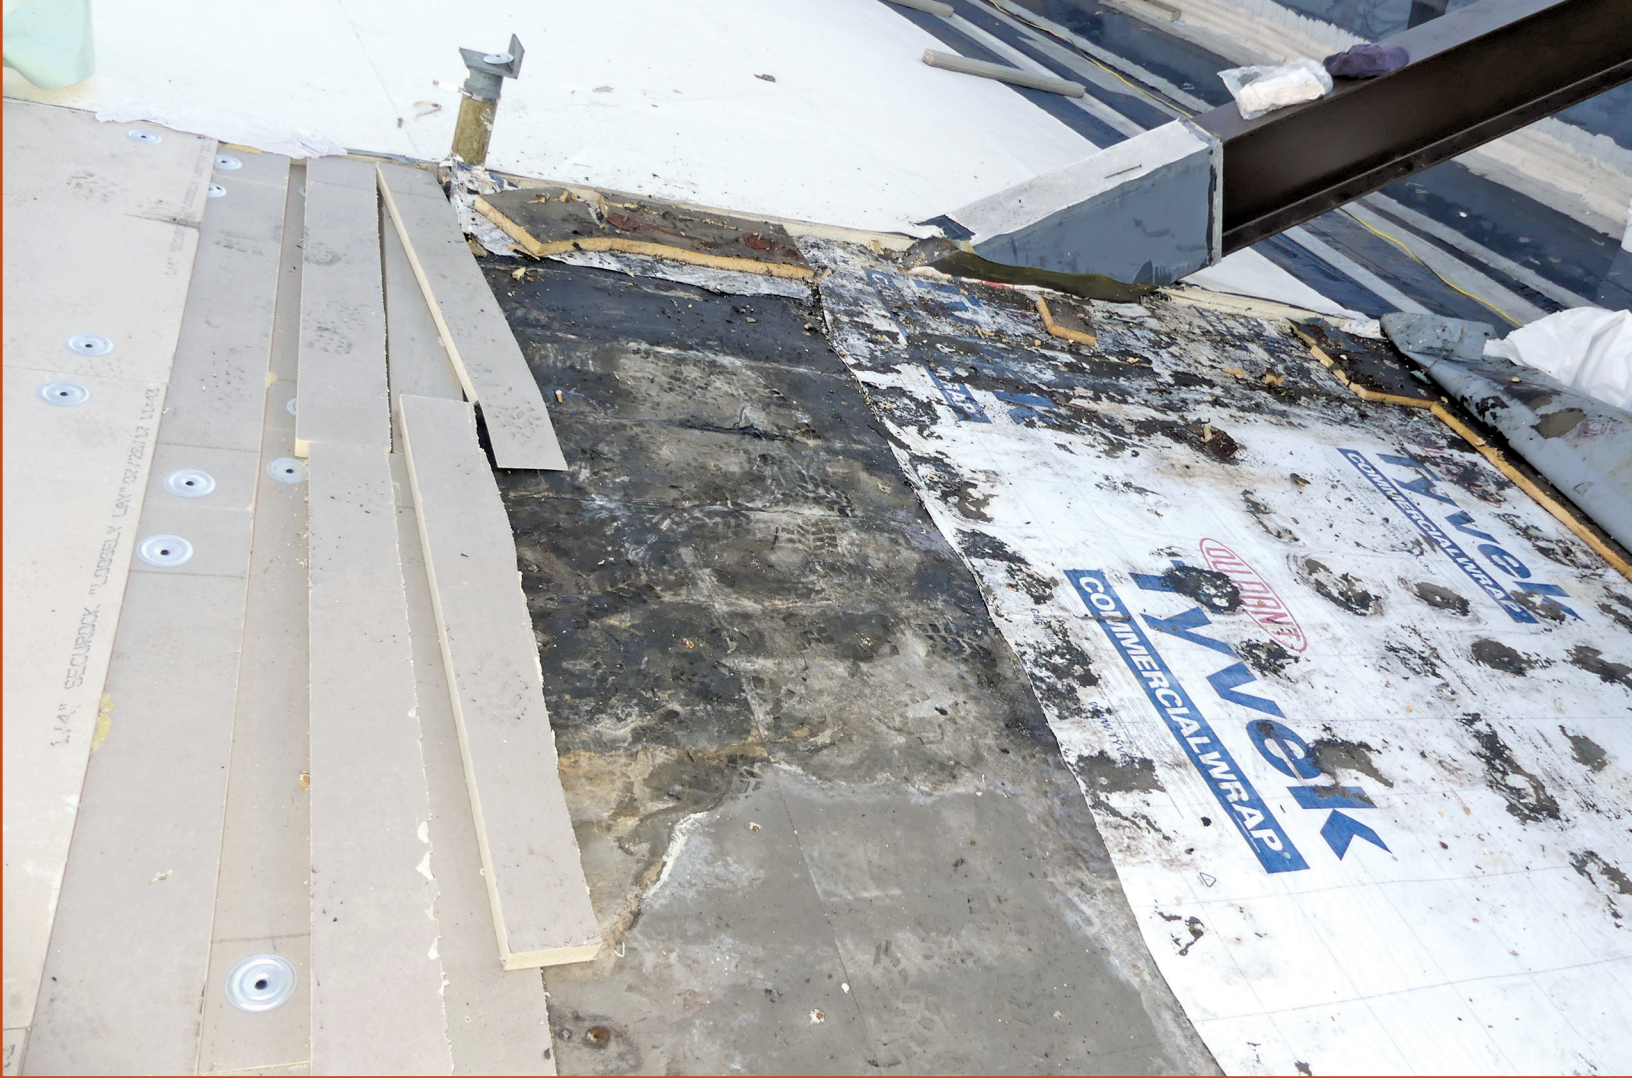
Figure 11. Tear-off in progress at lower dome. Note the signs of moisture on the existing insulation.

The areas designated for full replacement were reviewed during tear-off and appeared to correlate with the extents of the thermal anomalies observed during the evaluation phase's infrared survey (Fig. 11). No changes in the

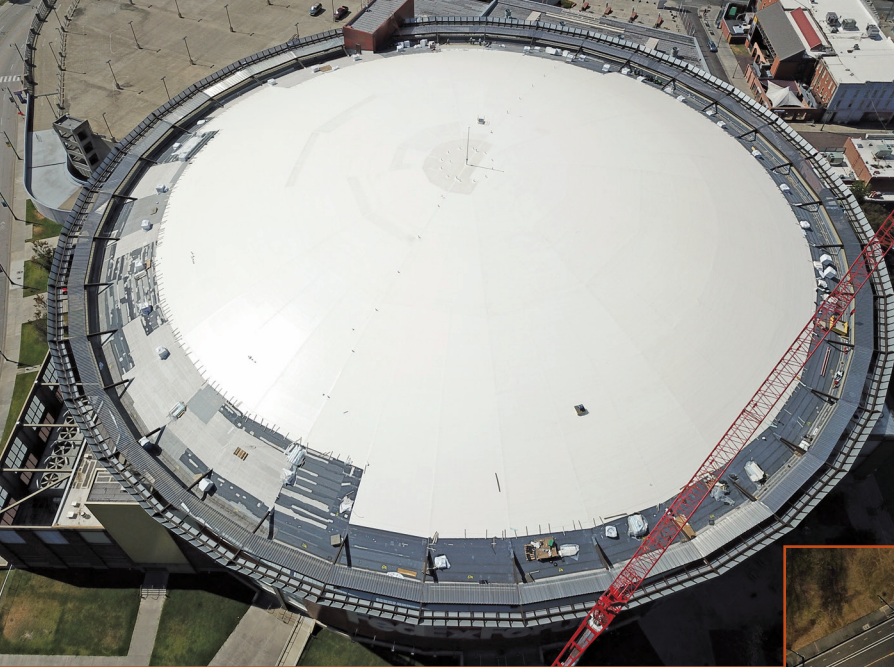
Figure 12. Work progress around the dome.

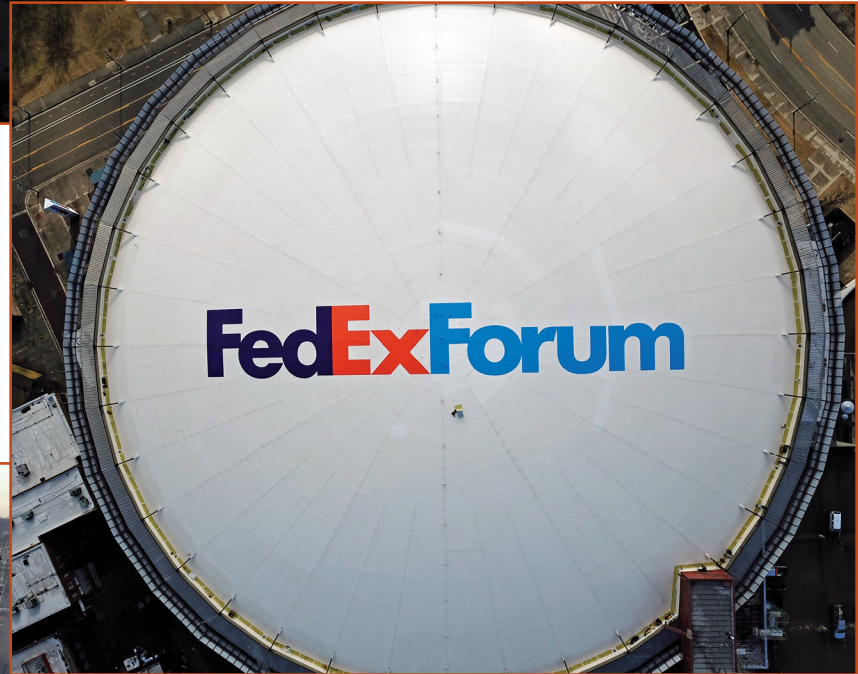
Figure 13. Completed work, including the new logo.

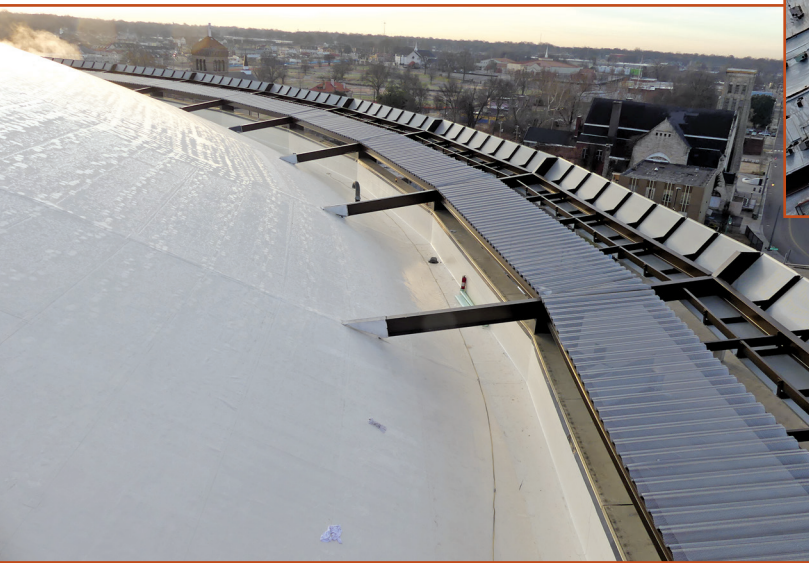
Figure 14. Work progress at the lower dome.

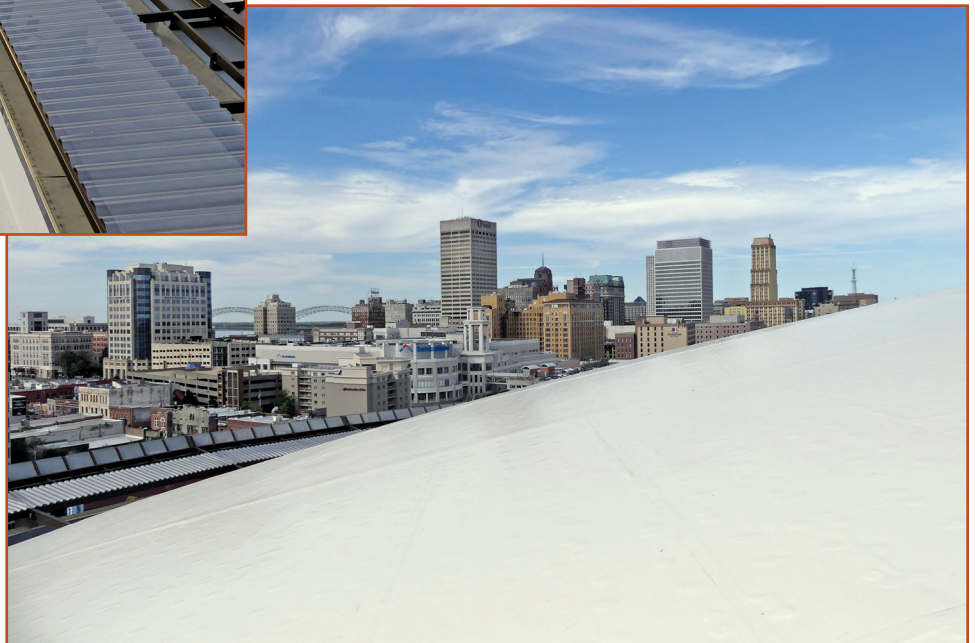
Figure 15. The completed roof overlooking downtown Memphis.
