# Tornados Versus the Building Enclosure:

## A CASE STUDY

By John C. Wylie, REWC, RRC, RRO, PE

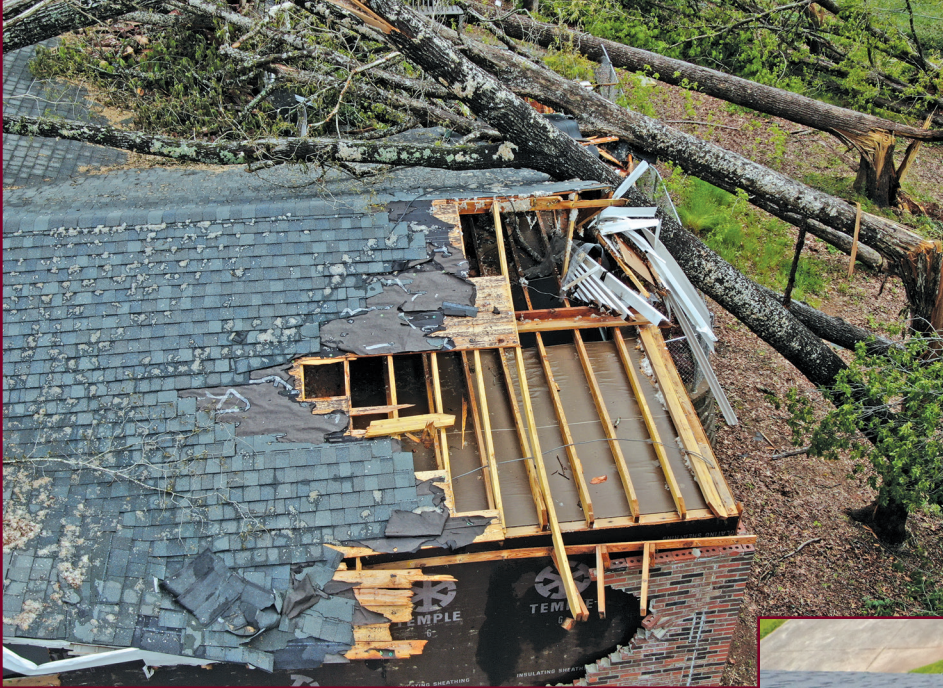
*Figure 4. View of displaced wood roof framing, roof decking, and roof covering.*

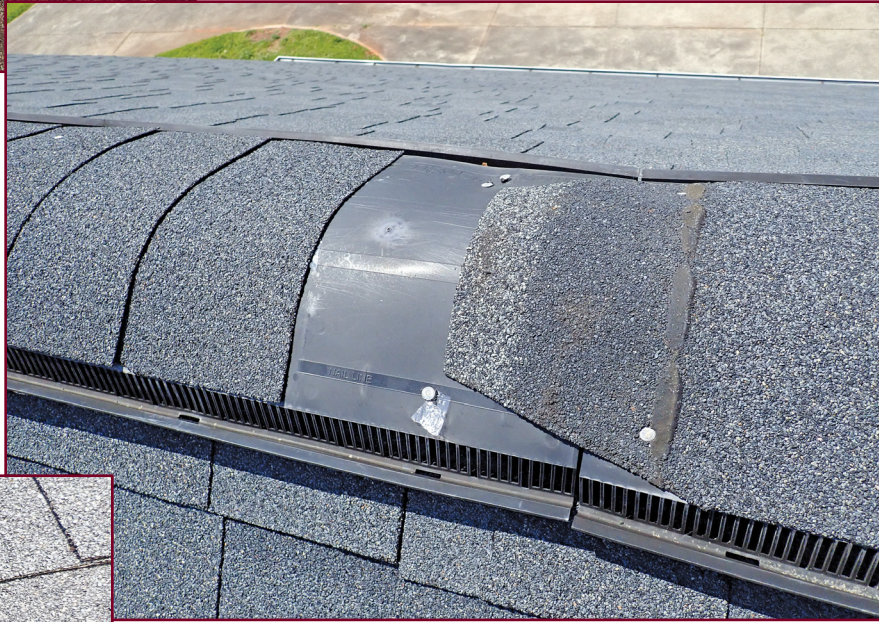
*Figure 5. View of displaced shingles at ridge.*

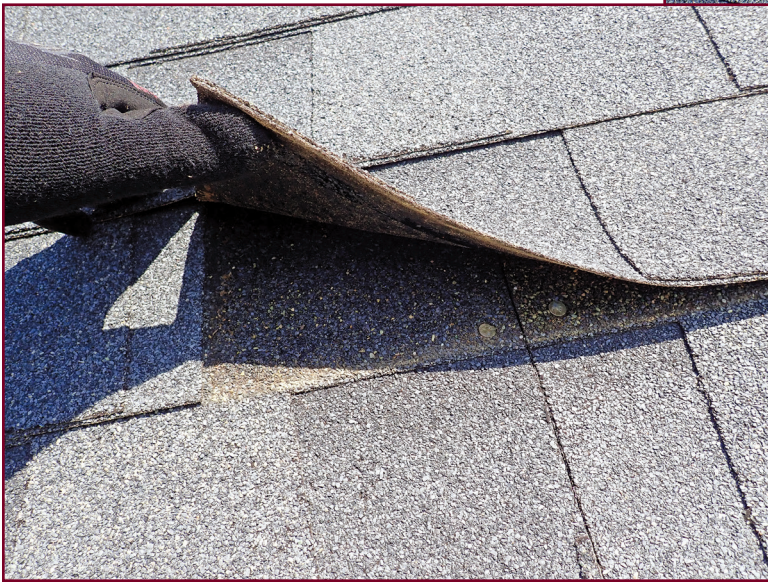
*Figure 6. View of unadhered laminated composition shingle.*

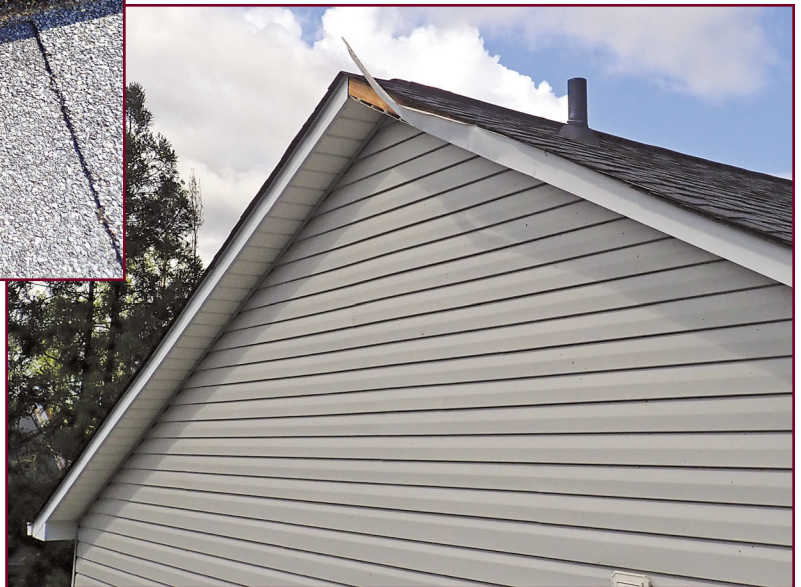
*Figure 7. View of displaced metal rake trim.*

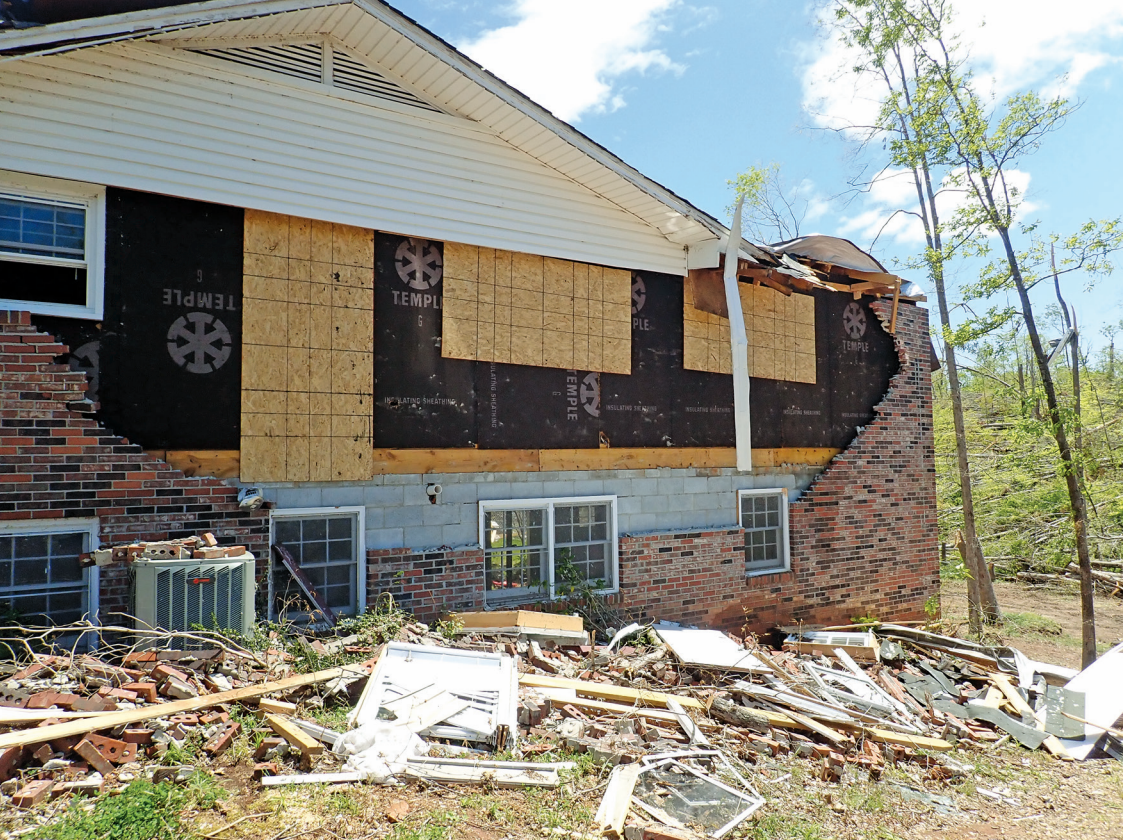
*Figure 8. Partial displacement of brick veneer cladding. OSB panels cover window and door openings.*

surrounding landscape and vegetation decreased from residence R-1 to residence R-4; however, the type of exterior cladding and the age of the roof covering also affected the degree of damage to the residences. For example, at residence R-1, the brick veneer was partially displaced due to the wind pressures developed during the tornado event. Furthermore, a localized section of the roof system was completely displaced, starting at the end of the roof eave, where wind pressures are considered to be the highest. As wind pressures penetrate an opening in the exterior wall or roof area, the interior behaves similar to an expanding balloon and adds supplemental outward pressure. This type of effect can exacerbate the displacement of the roof system or displacement of a fenestration.

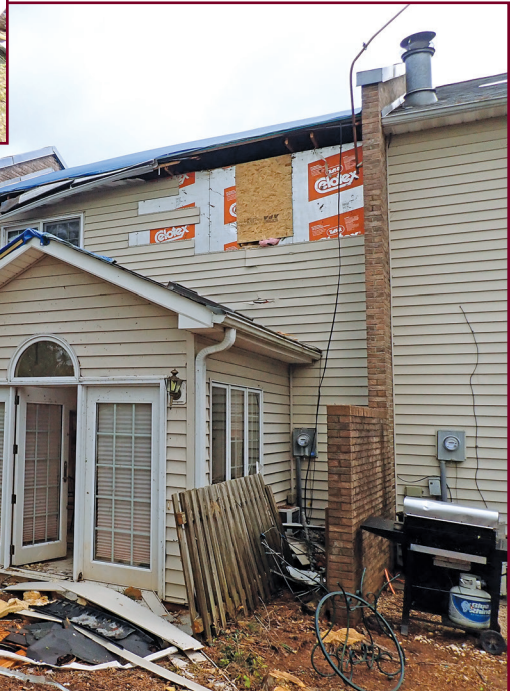
*Figure 9. View of displaced vinyl siding.*

At residence R-4, the vinyl siding was displaced, even though R-4 was subjected to lower wind pressures than residence R-1. The attachment of residence R-1 and residence R-4 exterior cladding systems are different—with brick veneer physically attached with corrugated brick ties and vinyl siding being hung on a wall

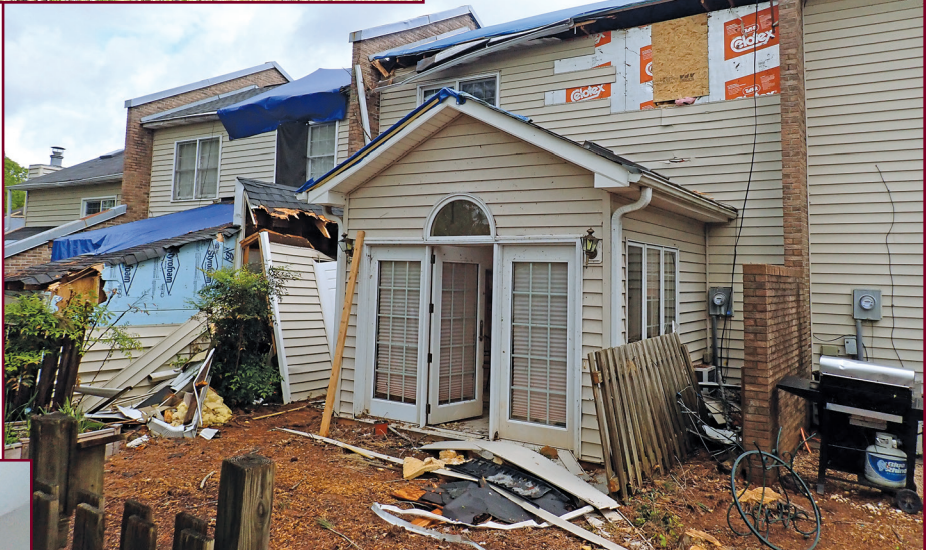
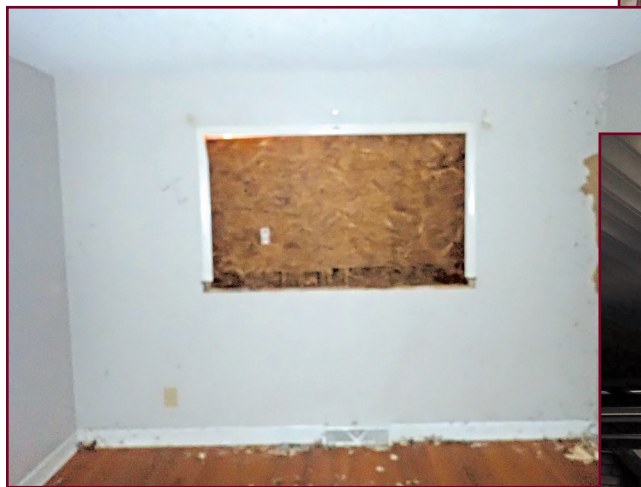
*Figure 10. View of complete displacement of window from rough opening.*

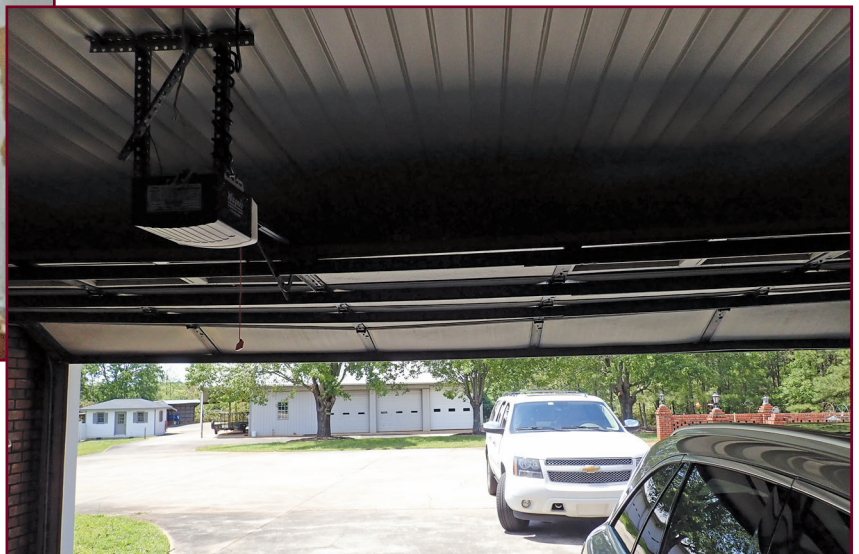
*Figure 11. View of damaged aluminum garage door framing and panels.*

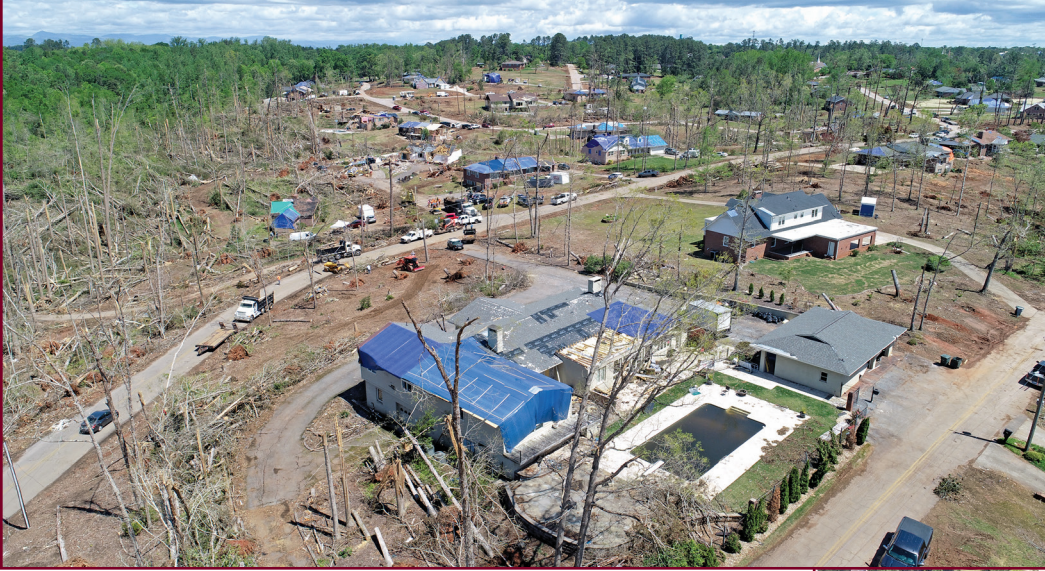
Figure 12. Damage adjacent to residence R-1.

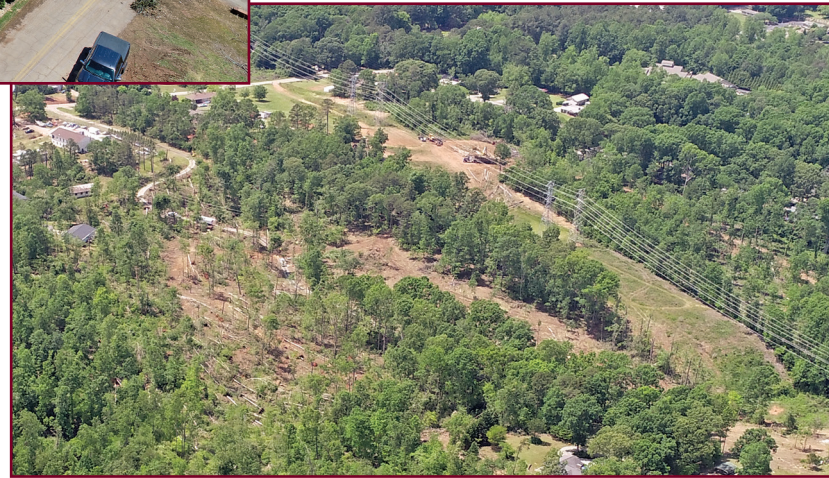
Figure 13. Damage adjacent to residence R-2.

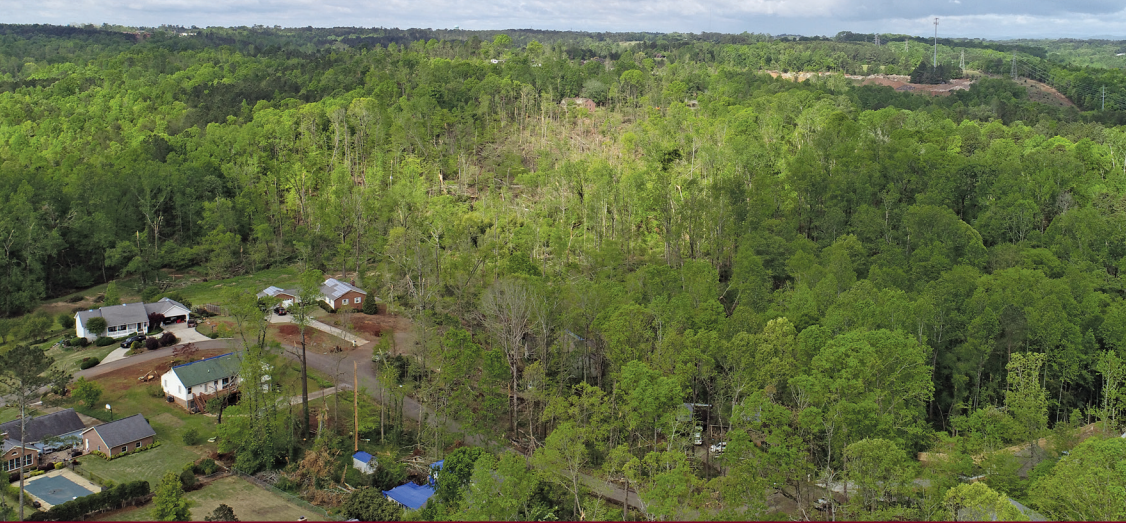
**Figure 14. Damage adjacent to residences R-3 and R-4.**
