Improper Use of Storefront Window Systems Leading to Costly Repairs:

A CASE STUDY

By Jason Popovich

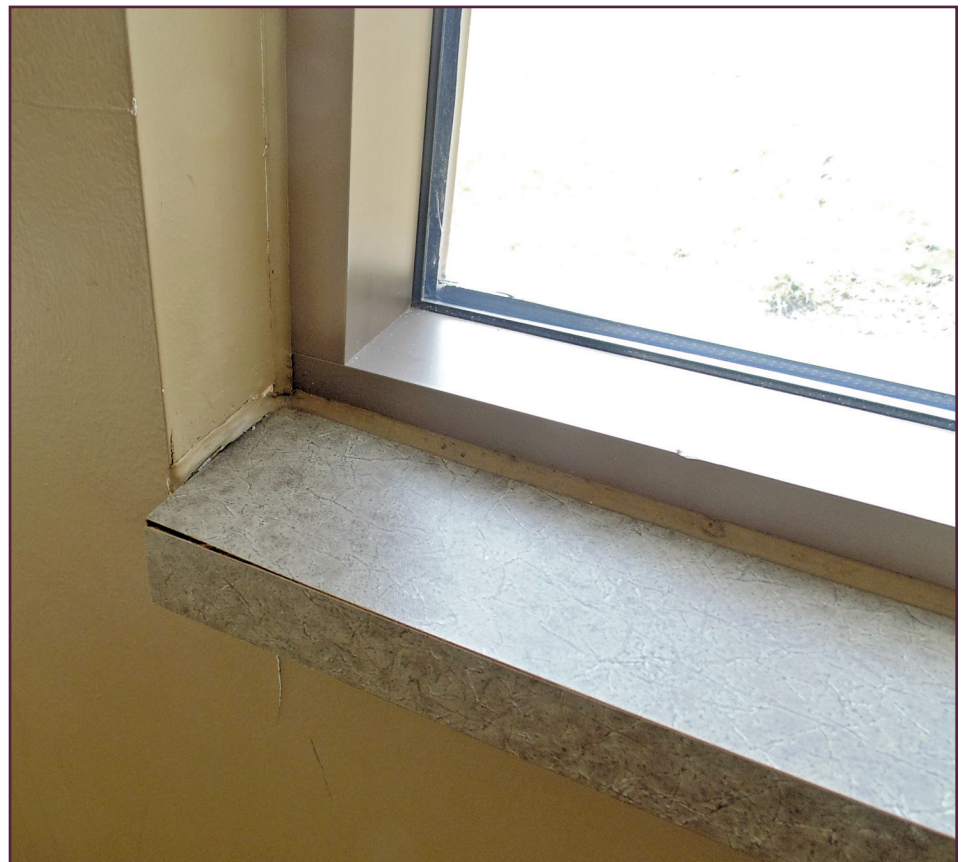
In early 2021, members of a church in Minneapolis, Minnesota, were frustrated after experiencing years of issues dealing with water infiltration below the church windows, which had caused the plastic-laminate sills to visibly swell as they took on water (Fig. 1).

Figure 1. Visible moisture damage of the plastic laminate sills. Photo courtesy of Inspec.

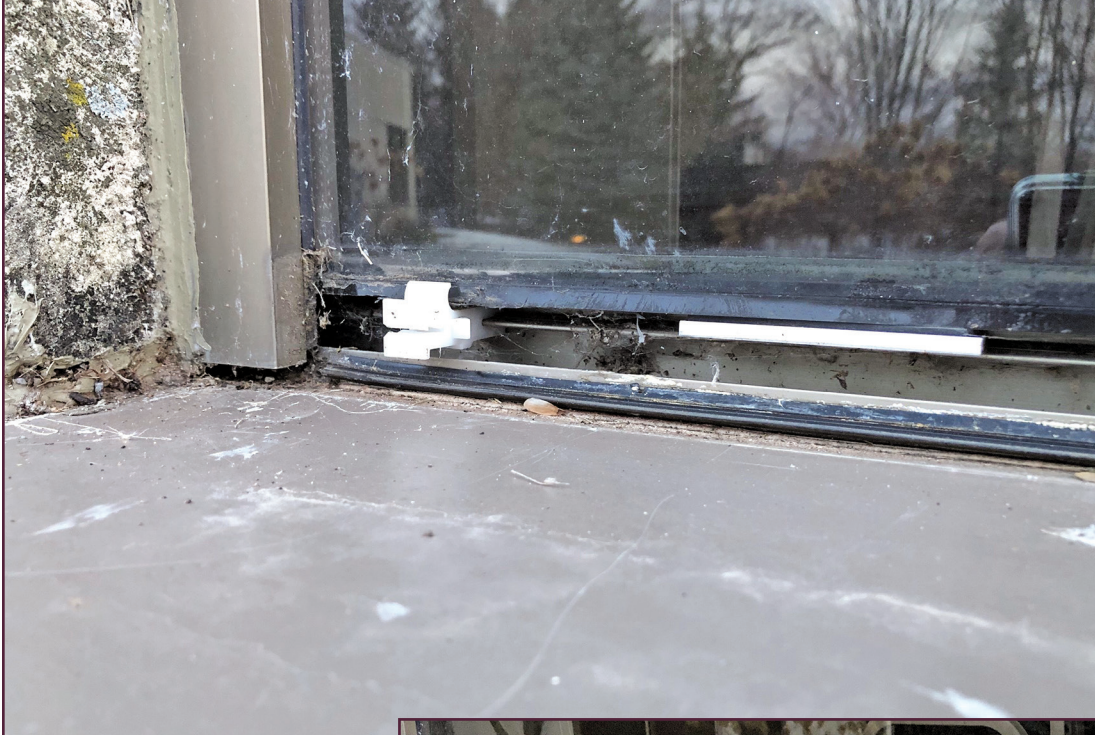
Figure 2. Plastic clips secured the aluminum to the glazing gaskets, allowing movement and water entry. Photo courtesy of Inspec.

pressures on a building will cause the glass panes to push away from the glazing gaskets, allowing water to penetrate the system. The plastic clips of the church's storefront system (Fig. 2) secured the exterior aluminum with the glazing gaskets, allowing the aluminum to move. This movement caused gaps in the gasketing, allowing water to enter the mullion system. This water then needed to be managed.

This combination of factors led the consultant to recommend replacing the existing larger openings with a curtainwall system, which would incorporate a pressure bar with gasketing that is fastened to the mullions to resist the movement that allows water in. There were two options for the windows located at the

smaller openings: they could be replaced with an alternative aluminum system that is glazed from the interior so that the exterior gasketing is fixed and less susceptible to that same type of movement, or a curtainwall system similar to that recommended for the larger openings could be used.

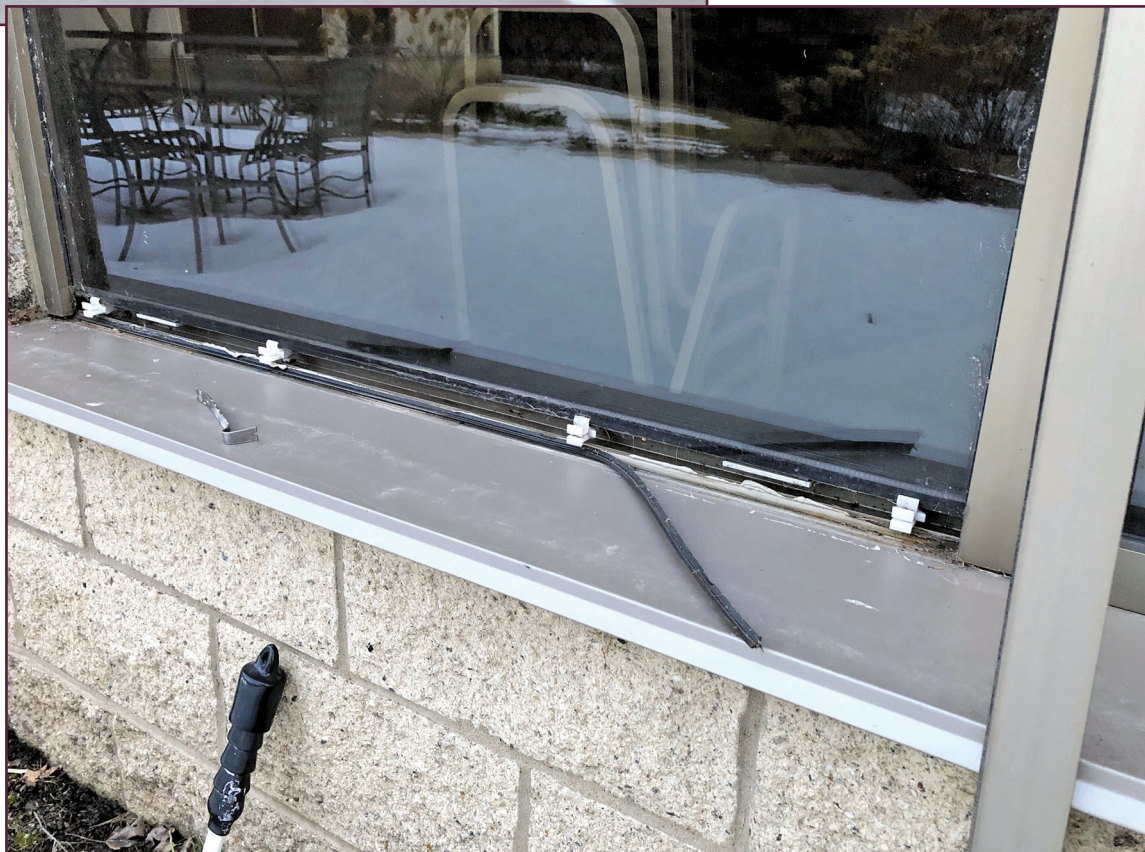
Figure 3. The window frames did not incorporate a sill pan to direct water to the exterior. The flashing shown stopped at the front of the window, where it met the gasketing and no end dams were incorporated. Note the previous attempt to seal the window system from the outside where the flashing met the gasketing. Photo courtesy of Inspec.

Upon removing the trim, the consultant determined that there was no sill pan beneath the frame to direct intruded water that would run down the vertical channels back to the exterior (Fig. 3). The flashing over the sloped block on the exterior terminated at the front of the sill where the gasketing is located. Without a sill pan and end dams, water within the system was able to enter the interior space below the sill. The previous attempts to seal the window system from the outside further prevented moisture within the system from escaping.

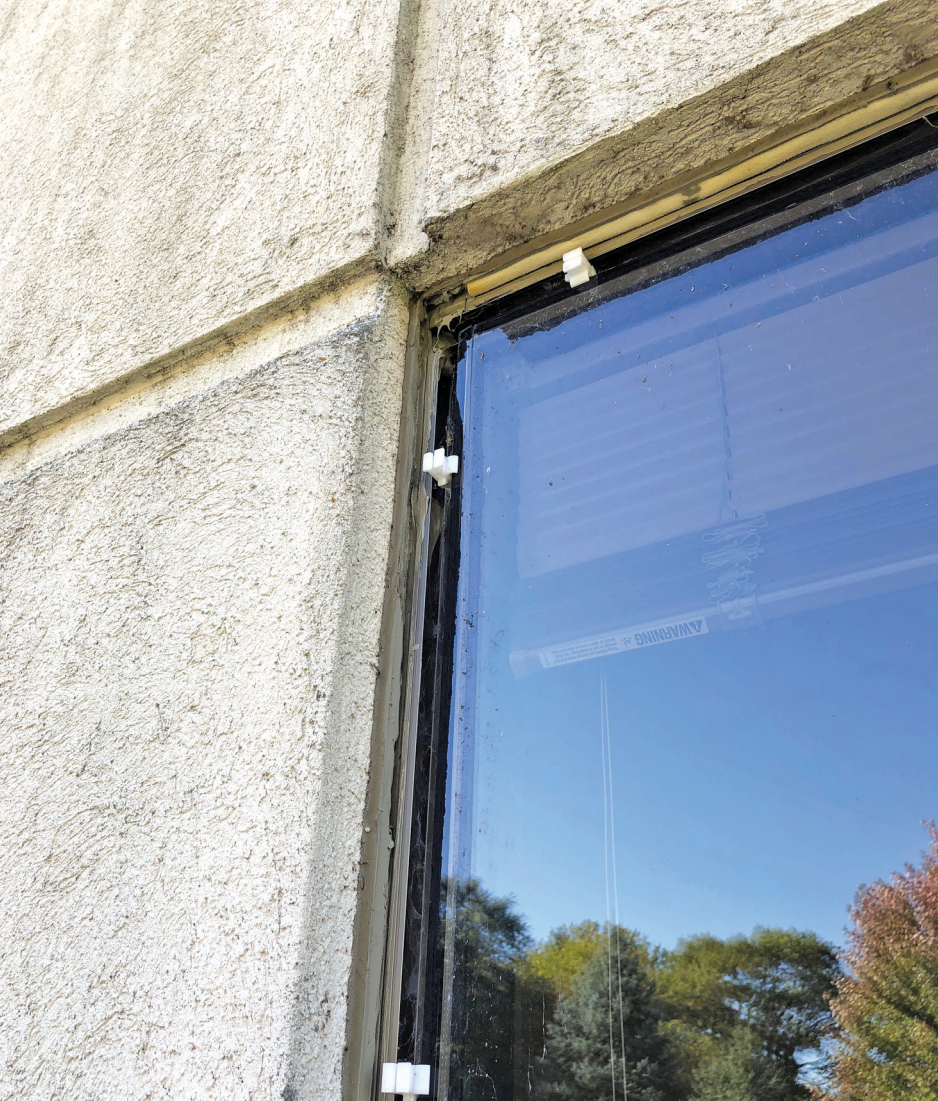
Even if water is directed to the exterior, it still needs a means to escape. Therefore, proper weeps must be incorporated. In their further review of the church windows, the consultant also found a lack of existing weep holes (Fig. 4).

The consultant determined that the lack of a proper collection and drainage system was the cause of the initial water infiltration. The addition of sealant to the exterior further inhibited the drainage of water. These combined factors resulted in an abundance of water that collected below the sill, leading to the damage to the sills and the framing beneath.

Figure 4. There was no evidence of existing weep holes, which would have provided drainage of water to the exterior. Photo courtesy of Inspec.

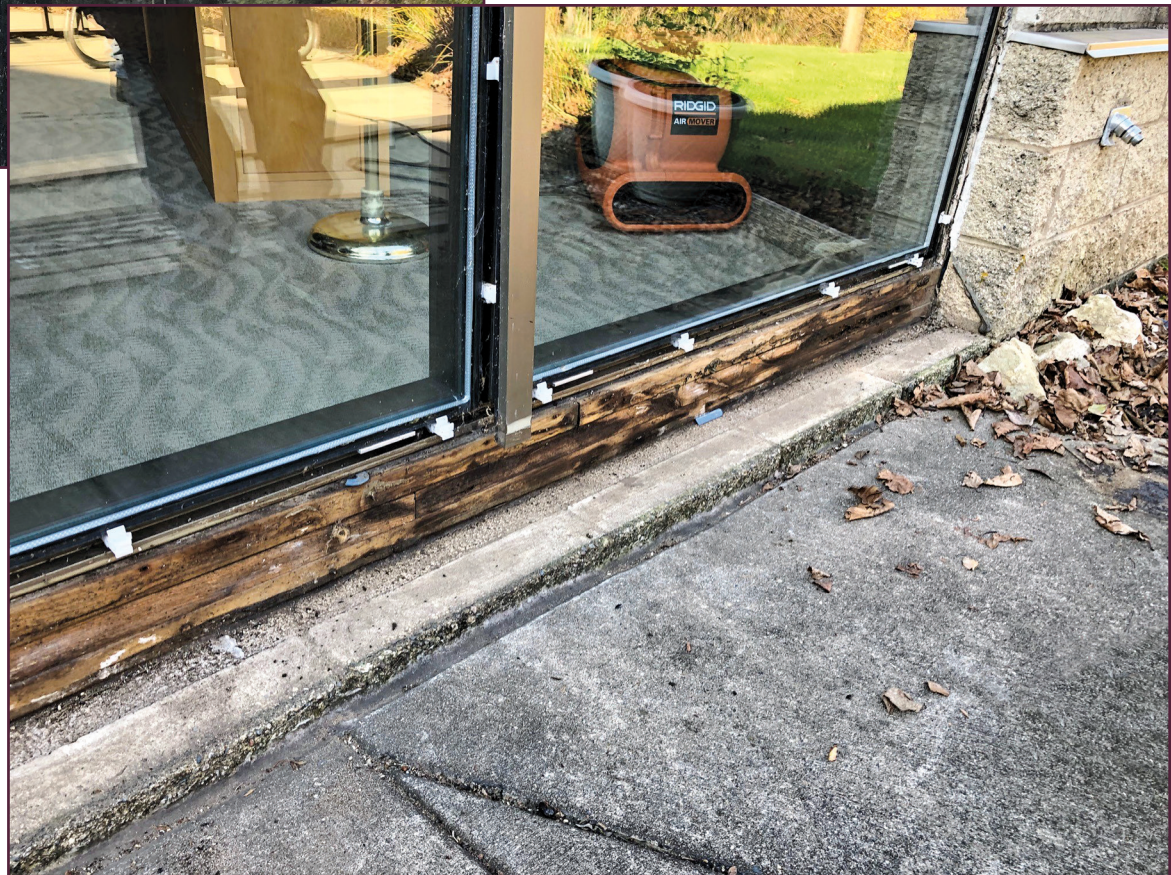
Figure 5. Because the storefront window system lacked proper sill pans and end dams, water could escape into the wall below the sill, causing damage to stacked wood framing. Photo courtesy of Inspec.

they were susceptible to additional moisture from surface runoff. The lack of any protective membrane or other means of waterproofing resulted in even more extensive damage to the stacked wood frames, as is evident in Fig. 5.
