Testing Built-up and Modified Bitumen Roofs for Hail Damage

By Stephen L. Patterson, RRC, PE

This paper was originally presented at the 2022 IIBEC International Convention and Trade Show.

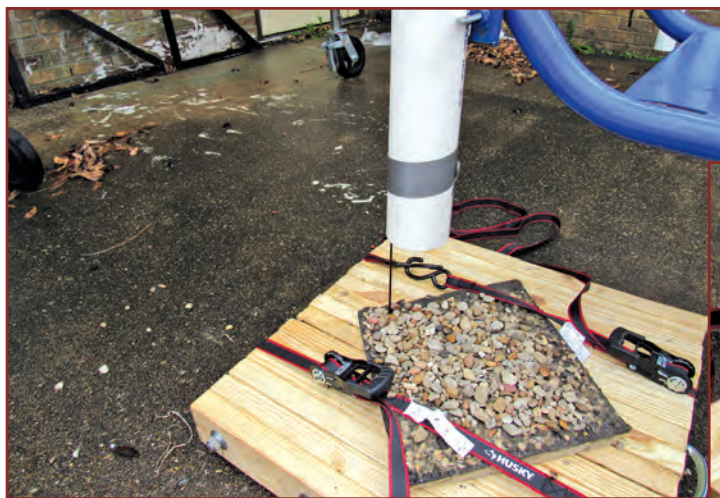
Figure 1. A test sample positioned on the platform.

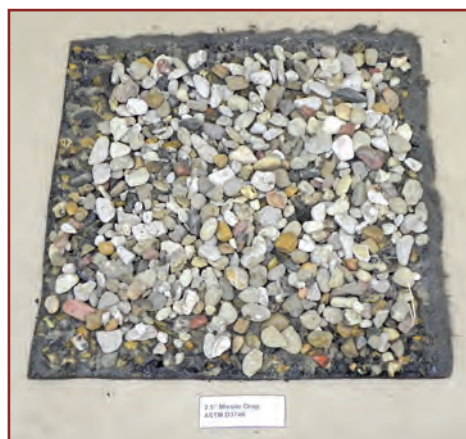
Figure 3. The test sample before the missile drop.

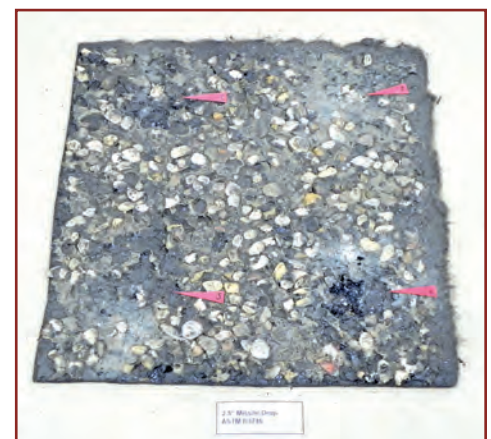
The test results related to surface damage were consistent. The impact from a 2.5 in. (64 mm) missile resulted in surface damage to the samples on both the insulated and noninsulated substrates. The results of the laboratory impact damage to the surface were compared with test samples of roofs that had been damaged by hail as well as examples included in Haag Engineering's *Built-up Roofing: A Pictorial Guide*.⁸ The test sample before the missile drop is shown in **Fig. 3**. The test sample after the missile drop and after the loose gravel was removed is shown in **Fig. 4**. The red arrows identify the area of impact in **Fig. 4**.

Figure 4. The test sample after the missile drop and after the loose gravel was removed.

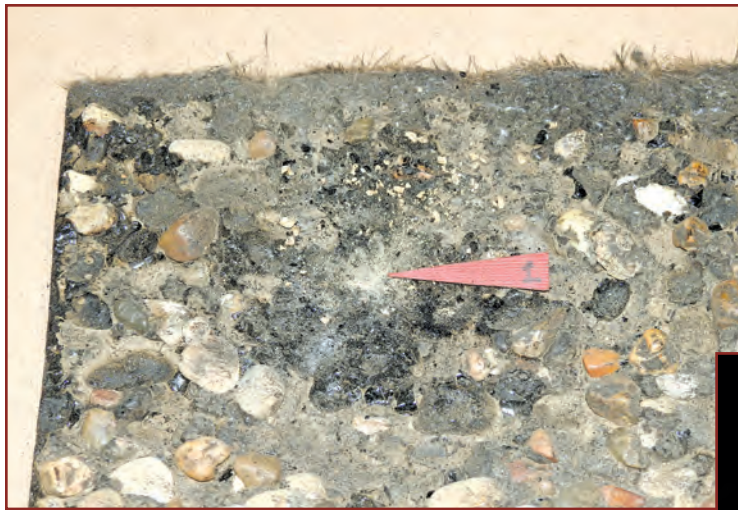
The areas of impact were very similar on all tests. There was a general displacement of the imbedded aggregate and exposure of the asphalt flood coat. The aggregate at the point of impact was crushed at some of the impacts (**Fig. 5**). In no case did the impact result in aggregate being driven into the sample, affecting the felts below. The crushed aggregate was likely the result of using a steel missile rather than an ice ball for testing, as hail typically shatters on impact and steel does not.

Figure 5. The test sample after the missile drop showing crushed gravel at point of impact.

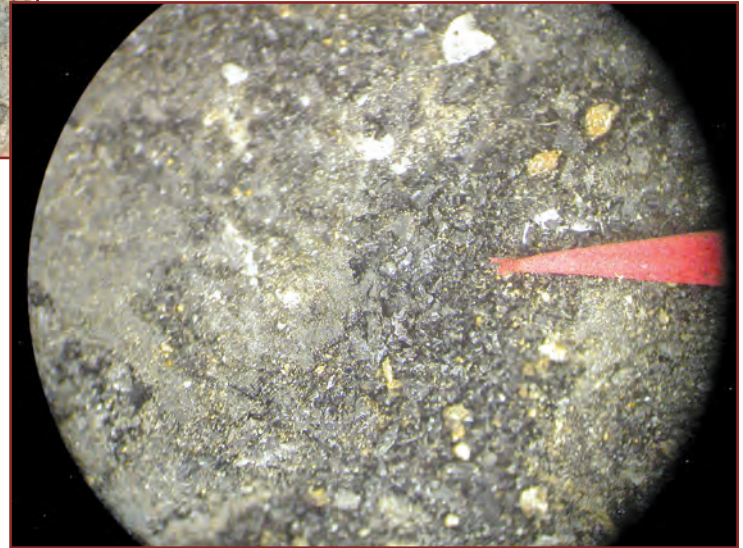
There was localized crushing of the asphalt flood coat at the point of impact, as shown in **Fig. 6**.

Figure 6. Localized crushing of the asphalt flood coating at the point of impact is shown in this 10-power photograph.

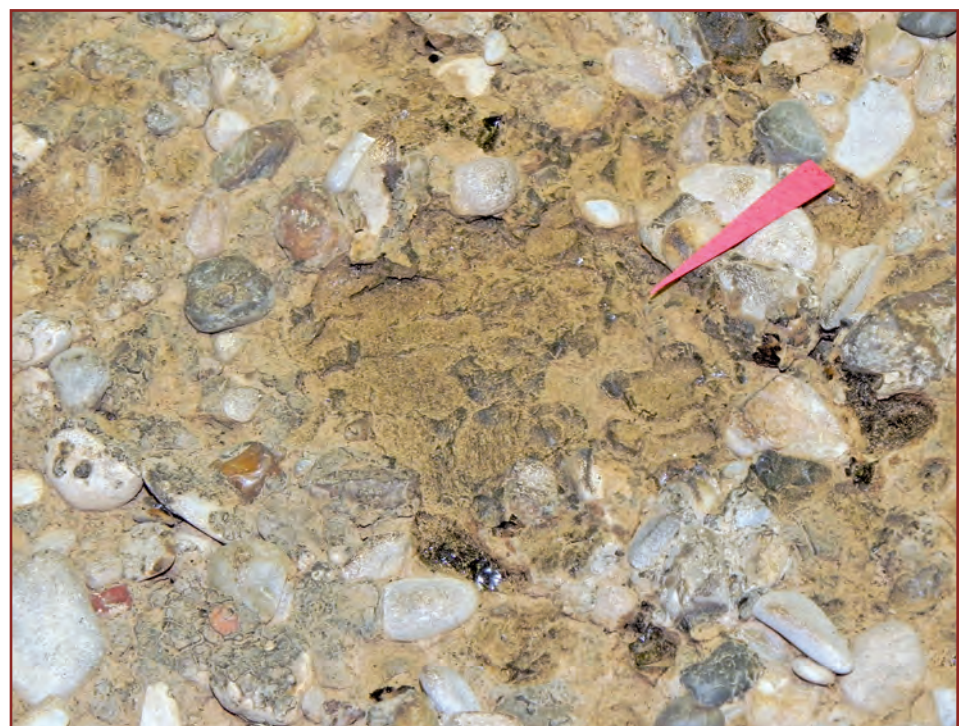
The area of impact in our simulated testing is also consistent with roof samples that we have tested from roofs damaged by hail. **Figure 7** shows a test sample taken from a roof that was damaged by hail. The meteorological and physical evidence indicated that the hail was in the 2.5 in. (64 mm) and larger range.

Figure 7. A test sample taken from a roof that was damaged by hail.

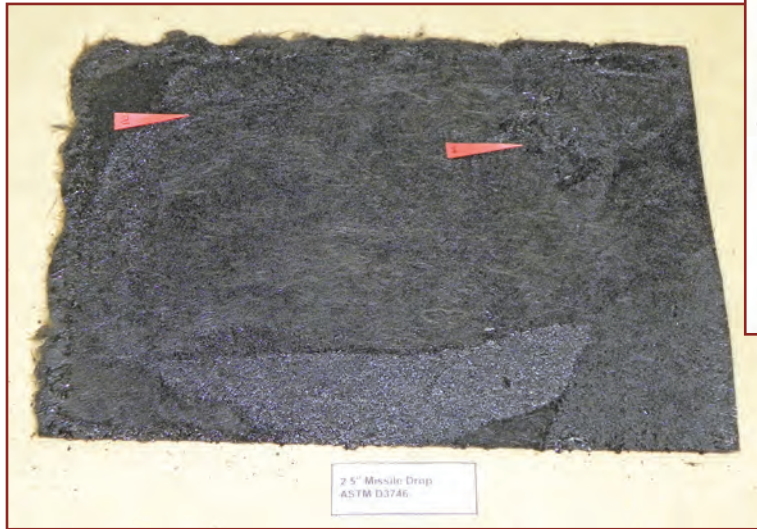
Figure 8. The back side of the top ply of felt, which was partial lap-ply.

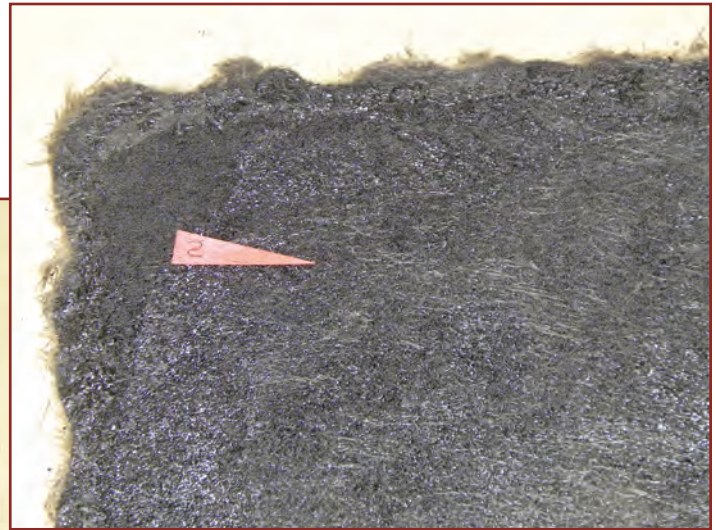
Figure 9. Close-up of impact 2 with no evidence of crushed or disturbed interply.

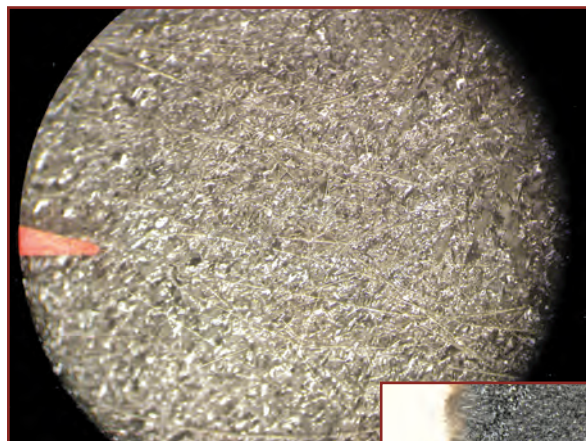
Figure 10. Impact area at 10-power with no evidence of crushed asphalt.

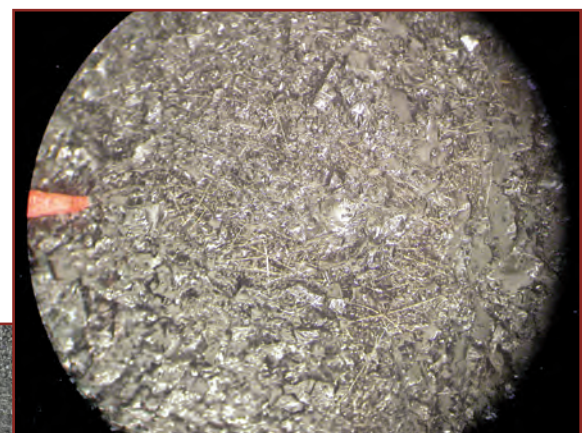
Figure 12. Impact area 4 at 10-power and the crushed interply asphalt at the point of impact.

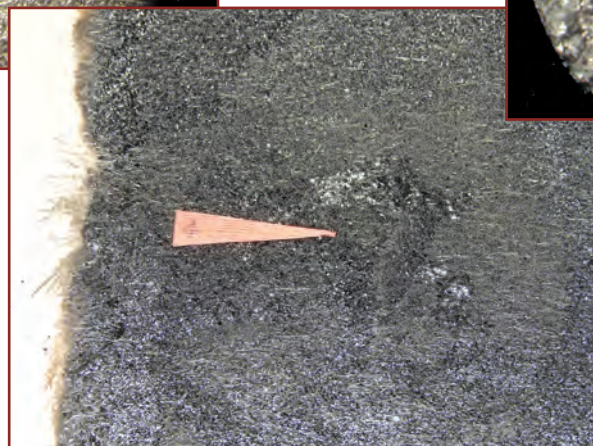
Figure 11. Impact area 4 on the back of the first full ply.

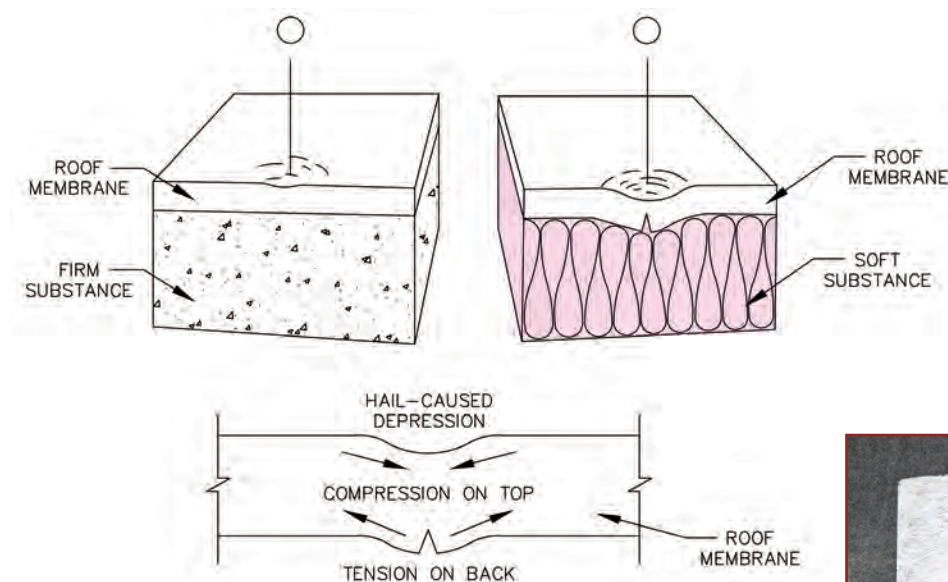
Figure 13. The softer substrate allows for more deflection in the membrane, resulting in tension in the bottom layers of the felts. Figure: Adapted from Haag Engineering's *Built-up Roofing: A Pictorial Guide*.

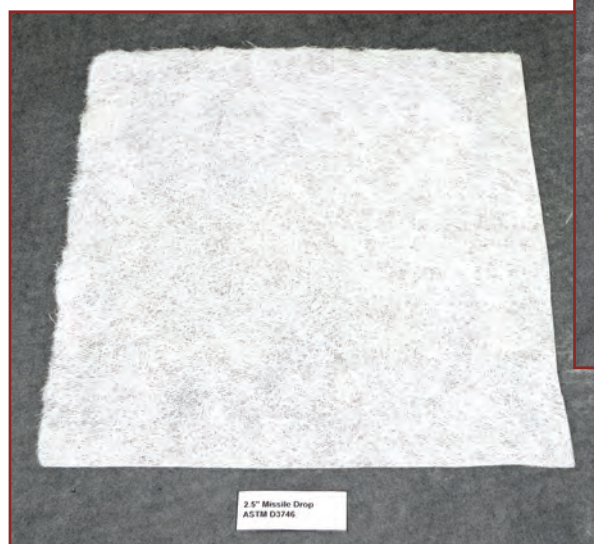
Figure 14. Desaturated bottom ply of felt in the noninsulated (firm substrate) sample.

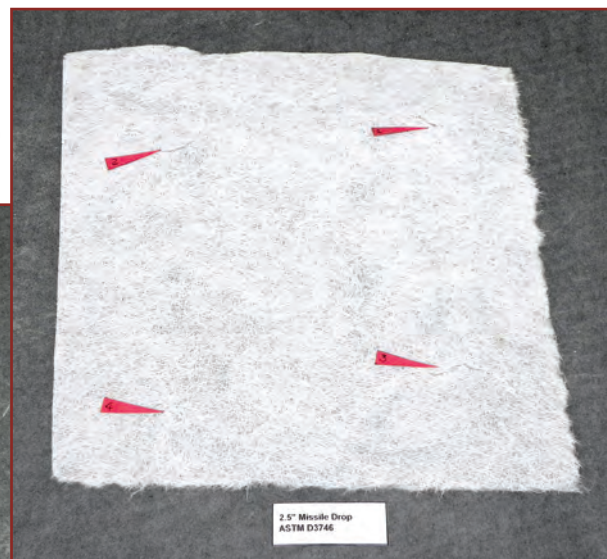
There were fractures at all impact areas in the insulated sample. Figure 15 shows the bottom full ply with impact fractures identified with the red arrows. Figure 16 shows a magnified view of the fracture in the felt at impact area 3.

Figure 15. Bottom full ply with impact fractures identified by red arrows.

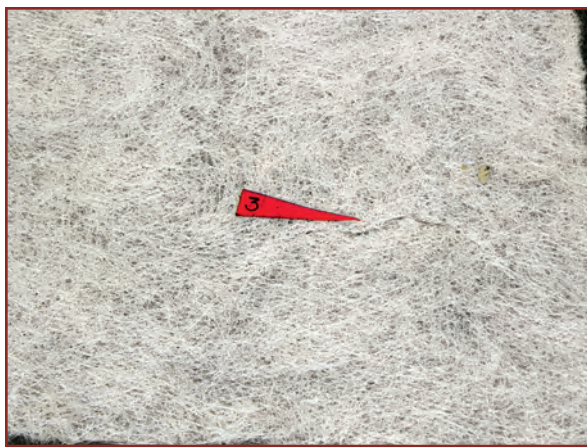
Figure 16. Magnified view of the fracture in the felt at impact area 3.

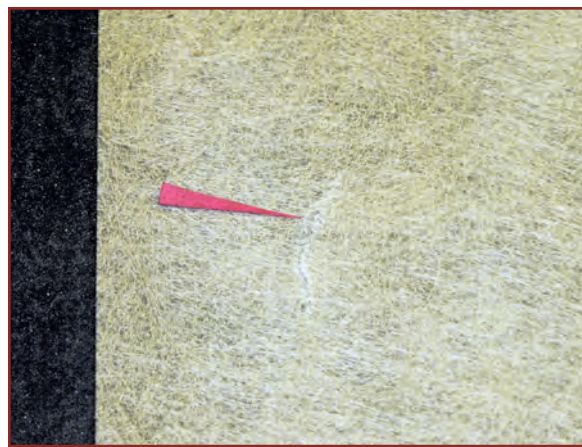
Figure 17. Fractured felts in a test sample from a roof that was damaged by hail.

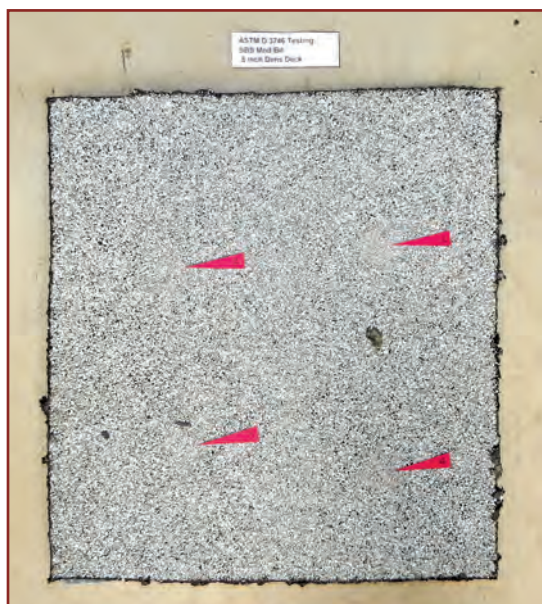
Figure 18. The new modified bitumen sample on noninsulated substrate after the sample was impacted by the four missile drops.

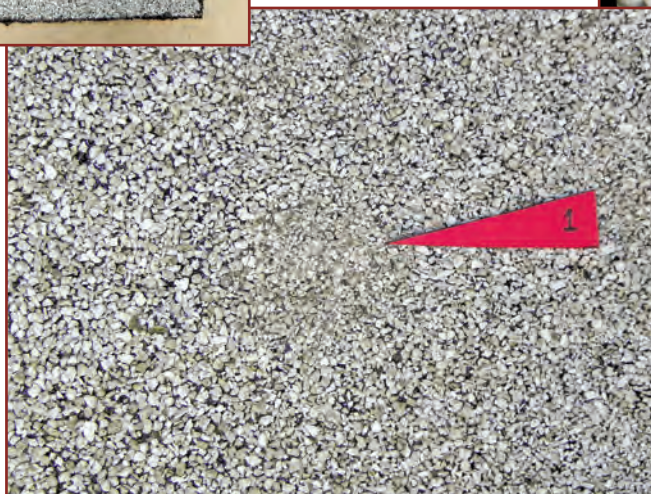
Figure 19. A closer view of impact area 1. There is a slight difference in the color of the granules.

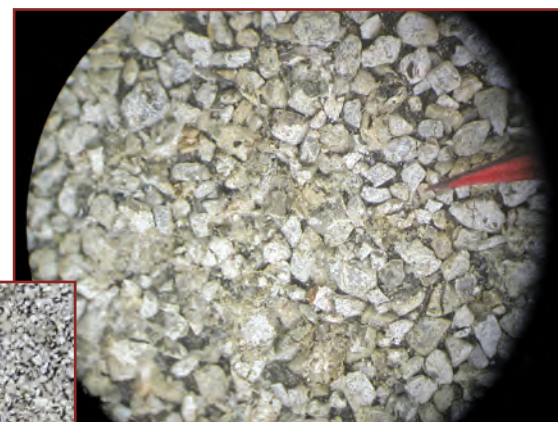
Figure 20. A 10-power view of impact area 1. There are no discernible displaced granules. The change in color is the result of localized crushing of the granules at the point of impact.

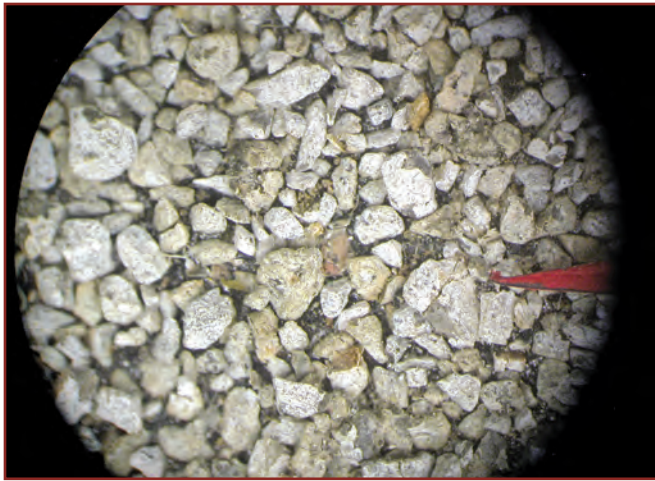
Figure 21 shows a 10-power view of a typical impact area on the insulated sample. There are no discernible displaced granules. There is no evidence of localized crushed granules on the insulated samples.

Figure 21. A 10-power view of a typical impact area on the insulated sample. There are no discernible displaced granules. There is also no evidence of localized crushed granules.

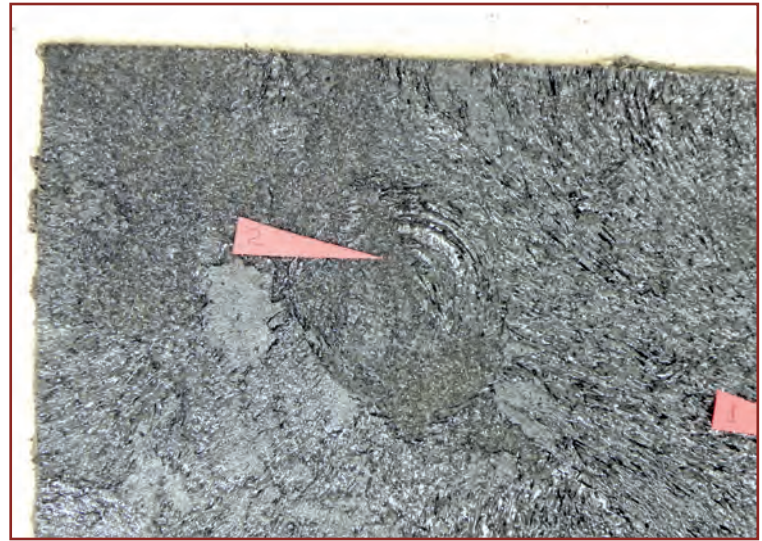
Figure 22. Example of crushed interply on the insulated sample.

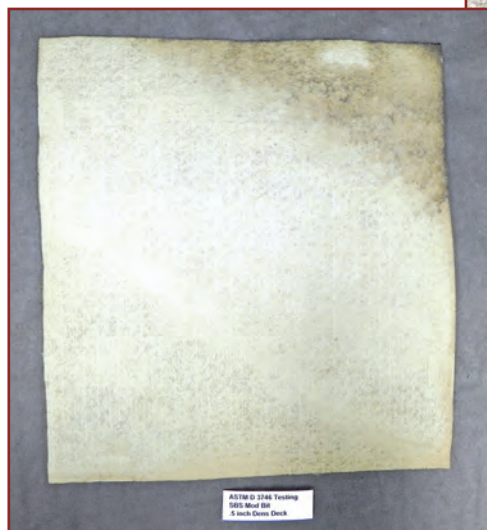
Figure 23. Dual-carrier mat with no fractures or denting.

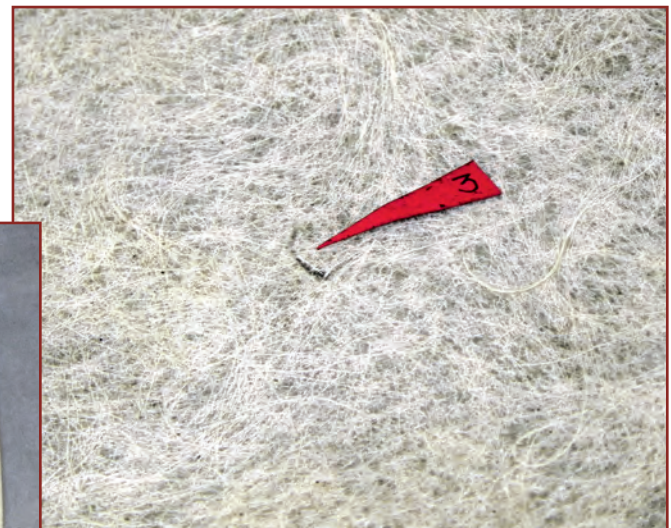
Figure 24. Fracture in the bottom ply (fiberglass felt) on the noninsulated sample.

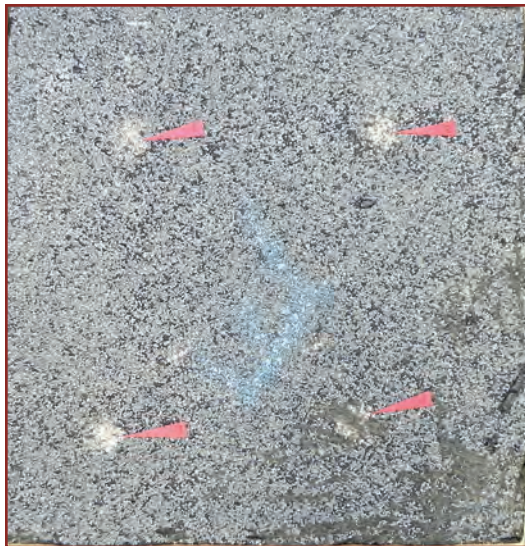
Figure 25. Aged modified bitumen roof on the noninsulated substrate after the sample was impacted by the four missile drops.

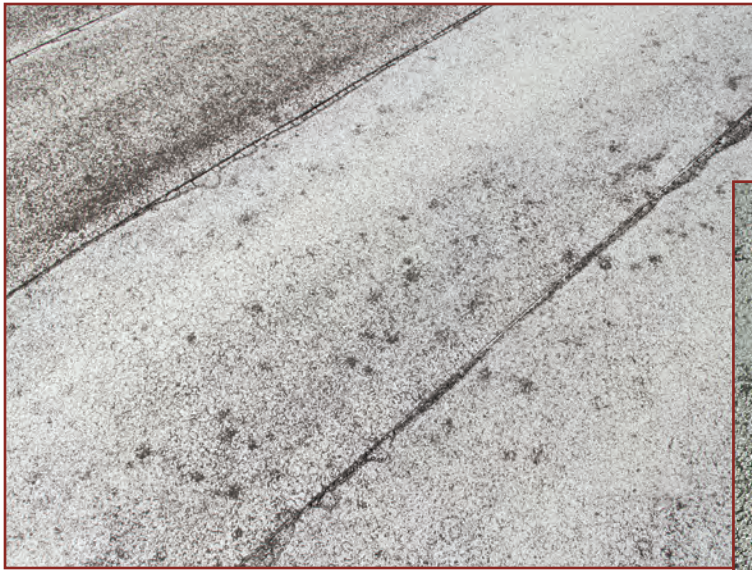
We have observed localized granule loss at impacts from actual hail on aged modified bitumen roofs. **Figure 30** shows an example of localized granule loss on an aged modified bitumen roof. The pattern of granule loss was consistent with the random distribution of the large hail that fell and matched the pattern of the larger hail-caused impacts on the air-conditioning units and larger spatter marks.

Figure 30. An example of localized granule loss on an aged modified bitumen roof.

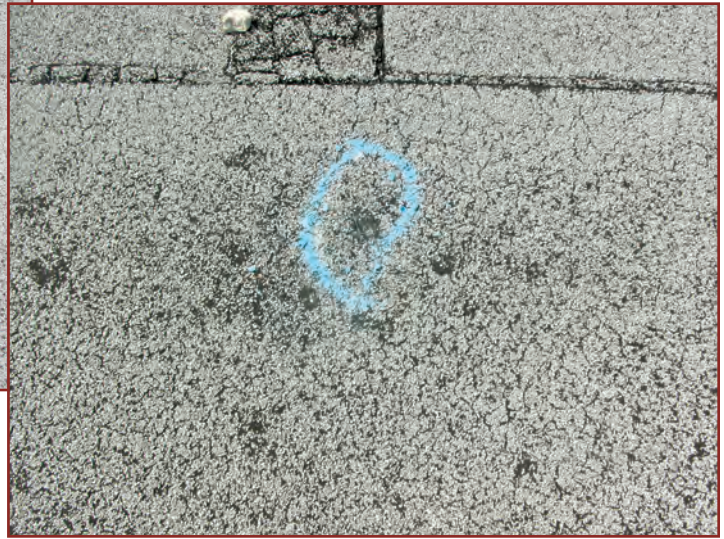
Figure 31 shows a closer view of the hail-caused granule loss on the same project.

Figure 31. A closer view of the hail-caused granule loss on the same project as Fig. 30.

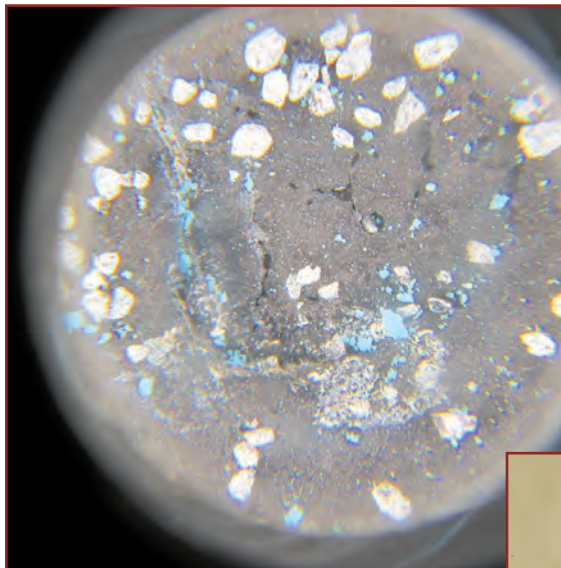
Figure 32 shows the impact at 10-power. There are visible fractures in the surface at the point of impact. Also, note that the surface of the exposed modified bitumen is relatively smooth. There is no evidence of shrinkage cracking or oxidized bitumen typically seen on older modified bitumen roofs.

Figure 32. Impact at 10-power.

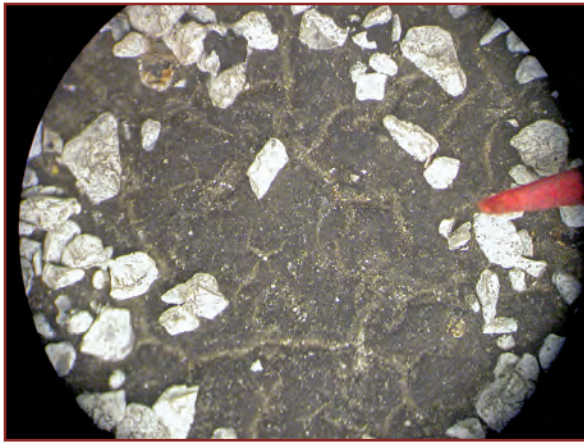
Figure 35. Point of interest at 10-power.

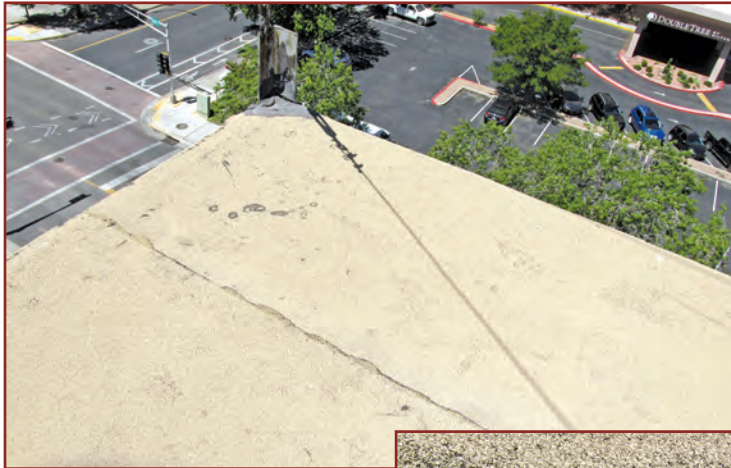
Figure 36. Localized areas of granule loss tend to be in specific areas where birds congregate.

This type of localized area of granule loss tends to be in specific areas where birds congregate, as shown in **Fig. 36**. This type of localized granule loss is often confused with granule loss from hail-caused impact. **Figure 37** shows a closer view of localized granule loss occurring as a result of contaminants from bird droppings. **Figure 38** shows the progression of granule loss occurring as a result of the bird droppings. Remnants of the bird droppings are visible. The granules typically continue to come off over time. **Figure 39** shows the progression of granule loss from small semicircular areas of granule loss to complete circular granule loss.

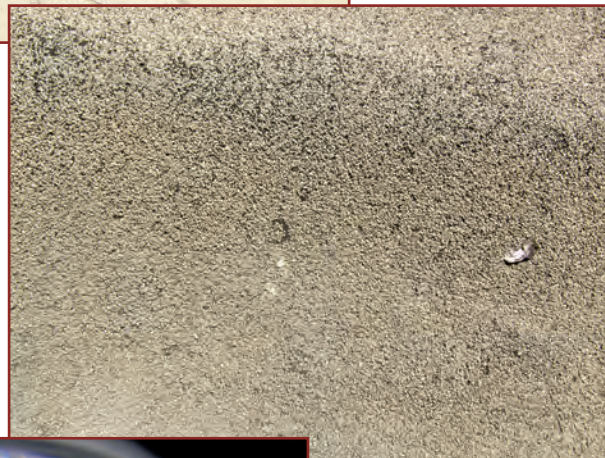
Figure 37. A closer view of localized granule loss occurring as a result of contaminants from bird droppings.

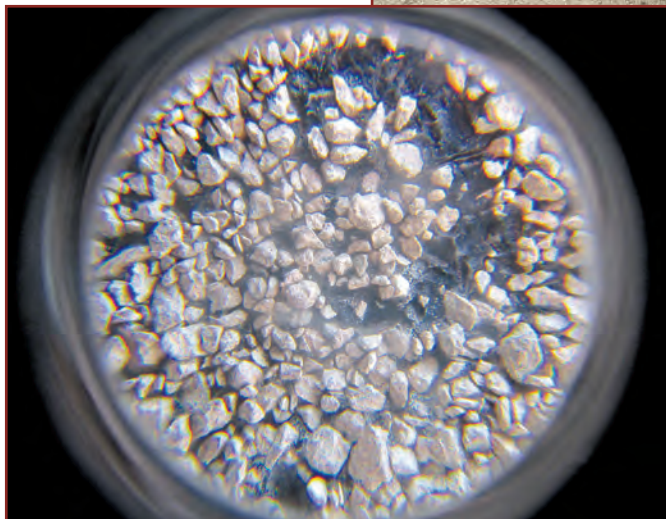
Figure 38. Progression of granule loss occurring as a result of the bird droppings.

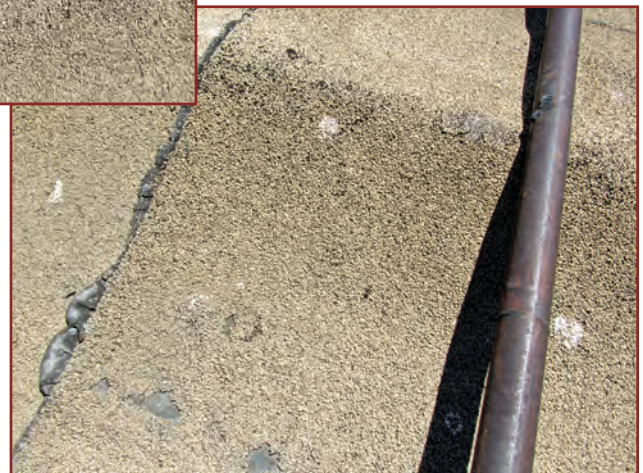
Figure 39. Progression of granule loss from small semicircular areas of granule loss to complete circular granule loss.

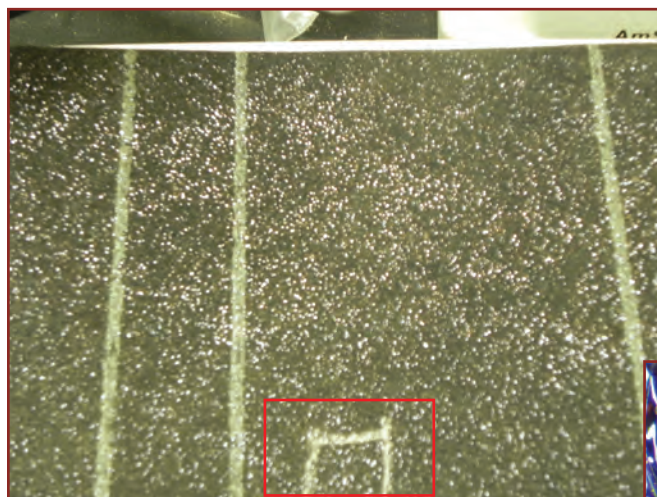
Figure 42. A 12 × 12 in. sample was removed and placed on a light table illustrating the normal holes in the new felt. Note: 1 in. = 25.4 mm.

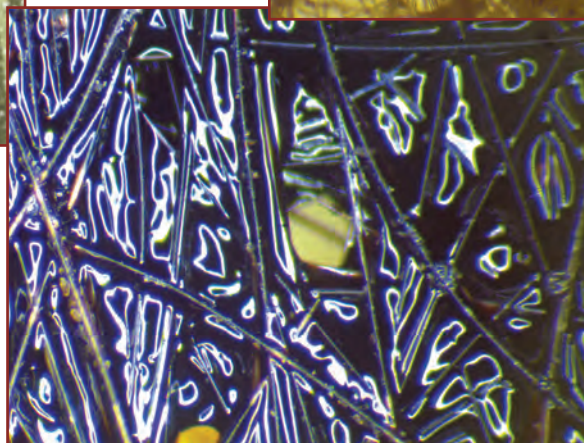
Figure 43. When magnified, the portion of the felt in the red box (test area) of Fig. 42 shows the normal holes in a typical fiberglass felt.

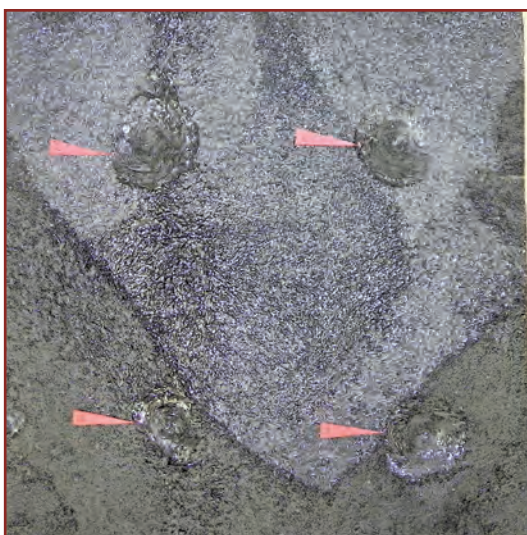
Figure 40. An example of crushed interply on the insulated sample.

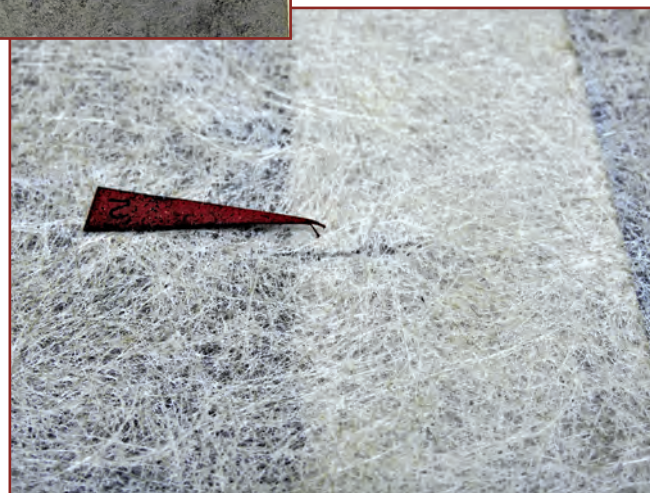
Figure 41. Fractured bottom ply of the membrane.

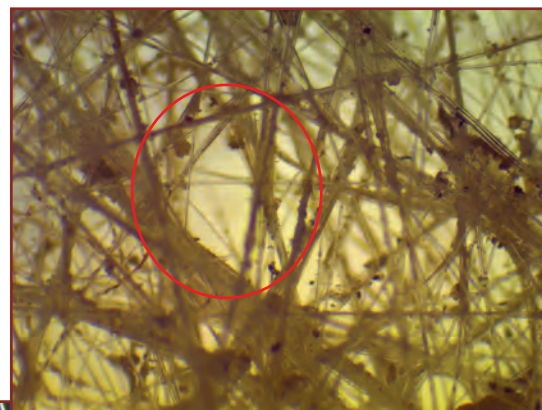
Figure 44. Desaturated test area.
