# The Perils of Undue Structural Reliance on “Lag Screws”: A Case Study

By Lonnie Haughton, MCP, LEED AP

## INVESTIGATION – BALCONY COLLAPSE DUE TO SUDDEN LAG SCREW WITHDRAWAL

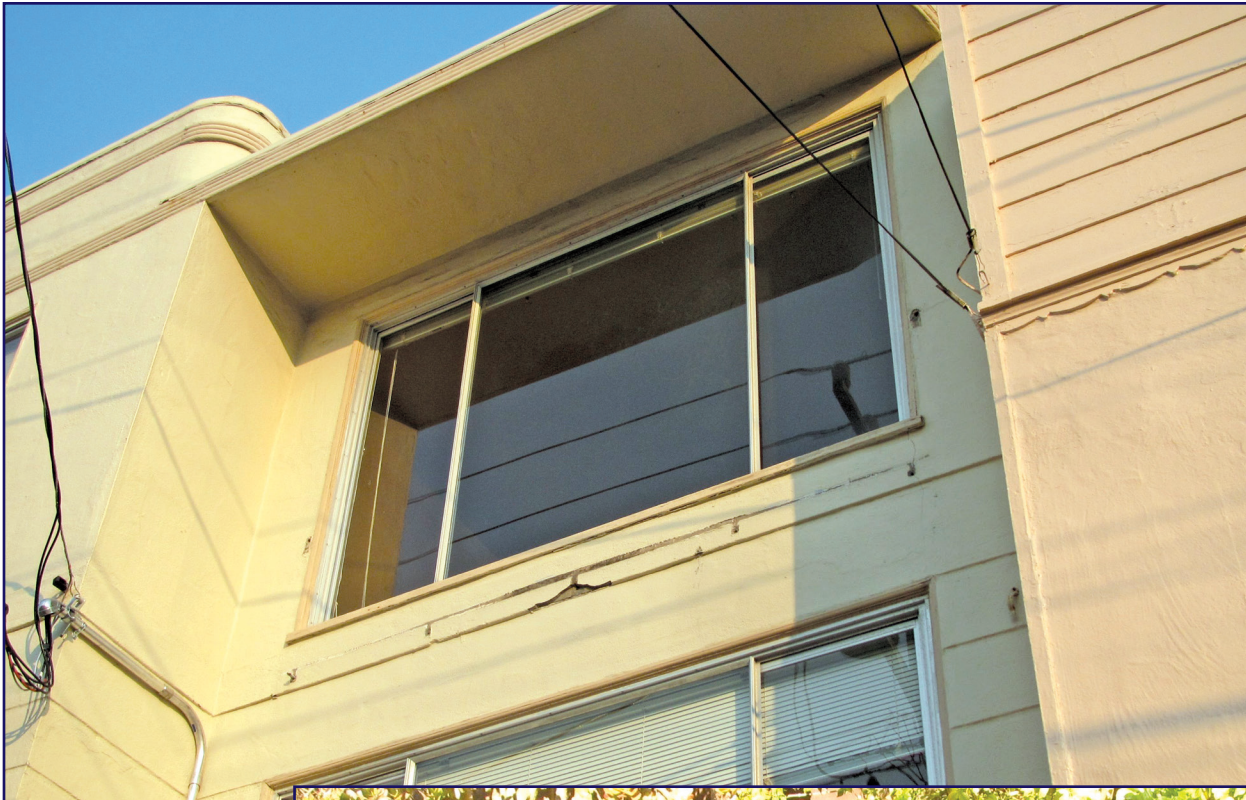
*Figure 2. Window at the upper apartment after the wrought iron balcony collapsed. The collapsed balcony was identical to the one shown in Fig. 1.*

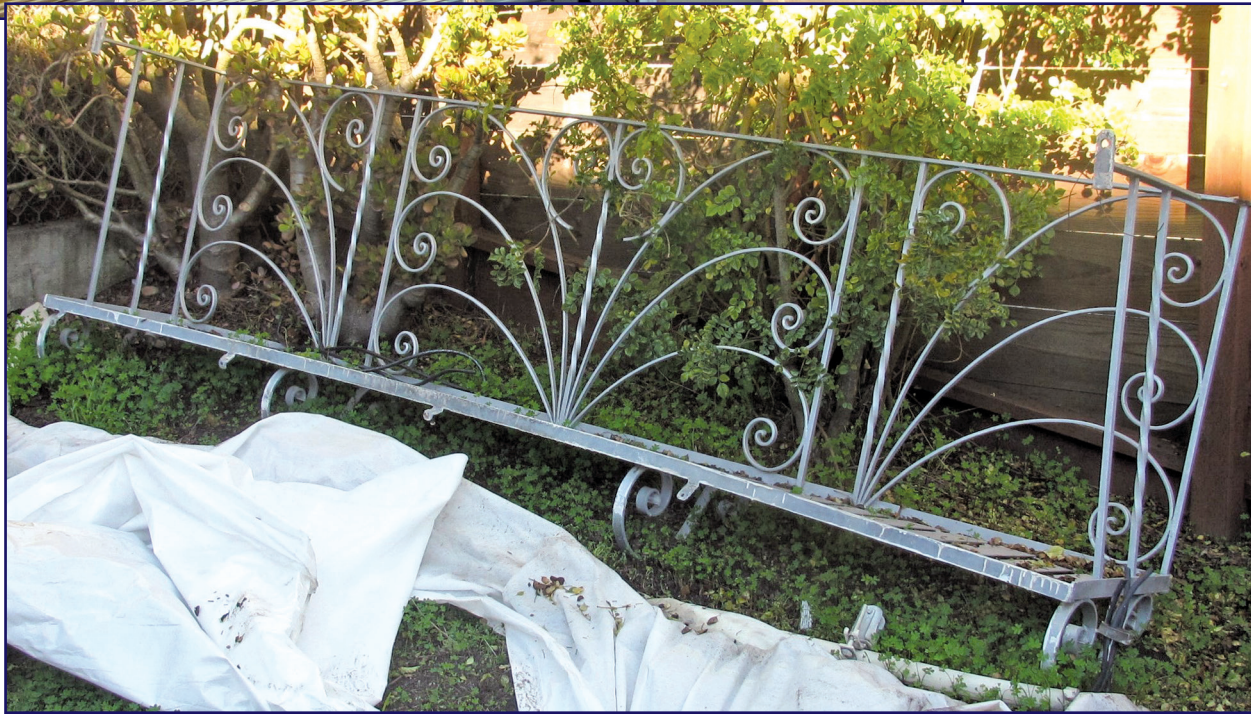
Figure 2 shows where the upper balcony was located, and Fig. 3 provides a view of that balcony’s remnants after it collapsed. Four partygoers were occupying the upper balcony when it suddenly failed at midnight. While two guests managed to safely leap back through the openings, two others were seriously injured during the fall. As would be expected, the ensuing personal injury litigation process encom-

*Figure 3. After its sudden collapse, the failed balcony was stored in the backyard for expert inspection.*

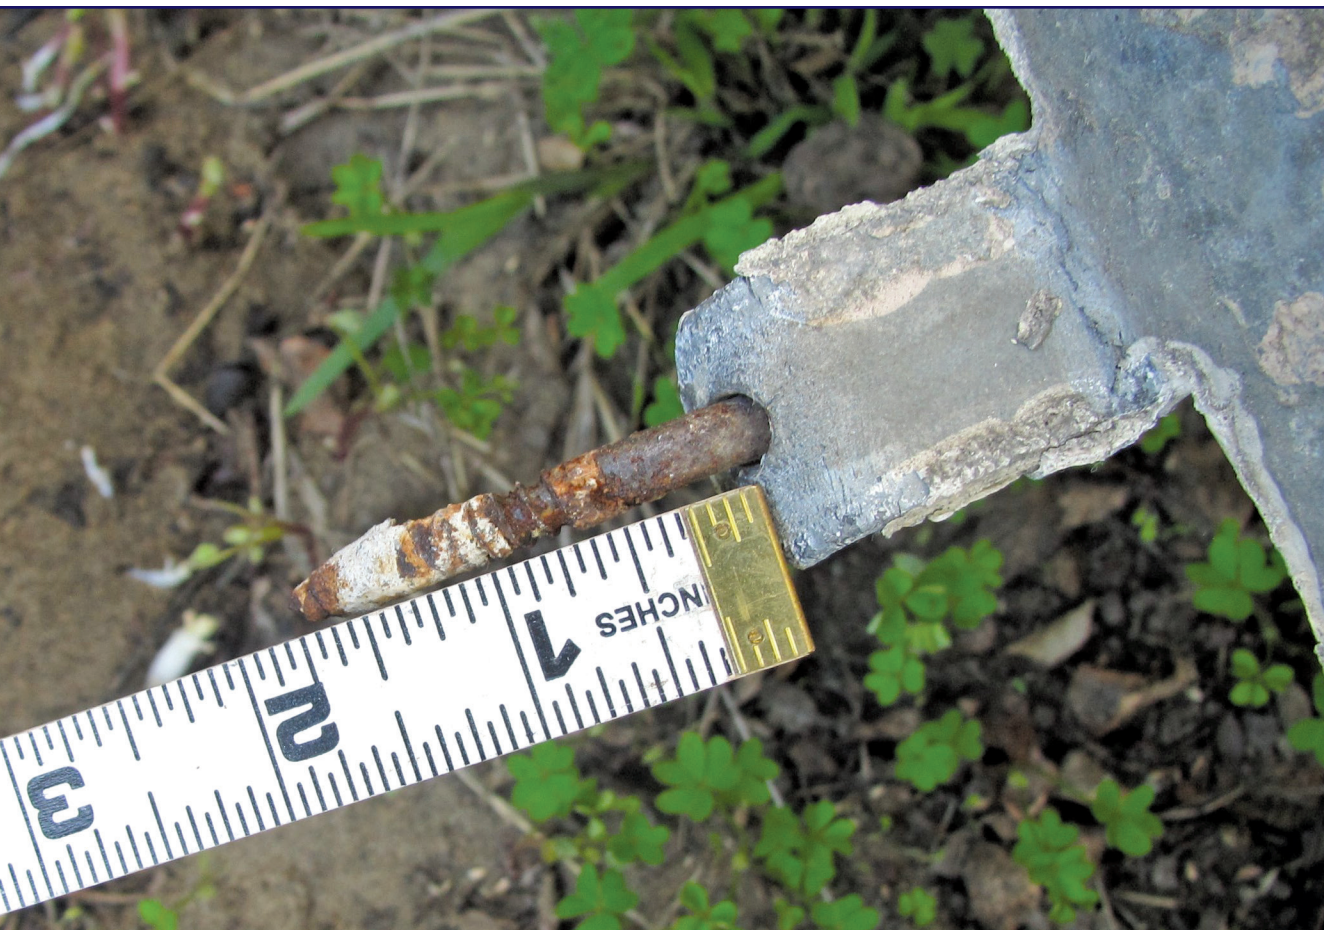
**Figure 4.** The bottom edge of the failed balcony was secured to the stucco-clad wall with five wood screws. Note: 1 in. = 25.4 mm.

Our inspection found that these wrought iron balconies had been attached to the stucco-clad wall with (a) five wood screws (Fig. 4) at the bottom with overall lengths of 2 in. (50 mm), and (b) two ½-in.-diameter, 4-in.-long (13-mm-diameter, 100-mm-long) (overall length) hanger screws at each upper corner (Fig. 5 and 6). Note that even though the nominal dimensions of a 4-in.-long lag screw and 4-in.-long hanger screw are the same, the hanger screw (see Fig. 5 and 7) provides significantly shorter net penetration into a structural member because of the positioning of the machine-threaded nuts.

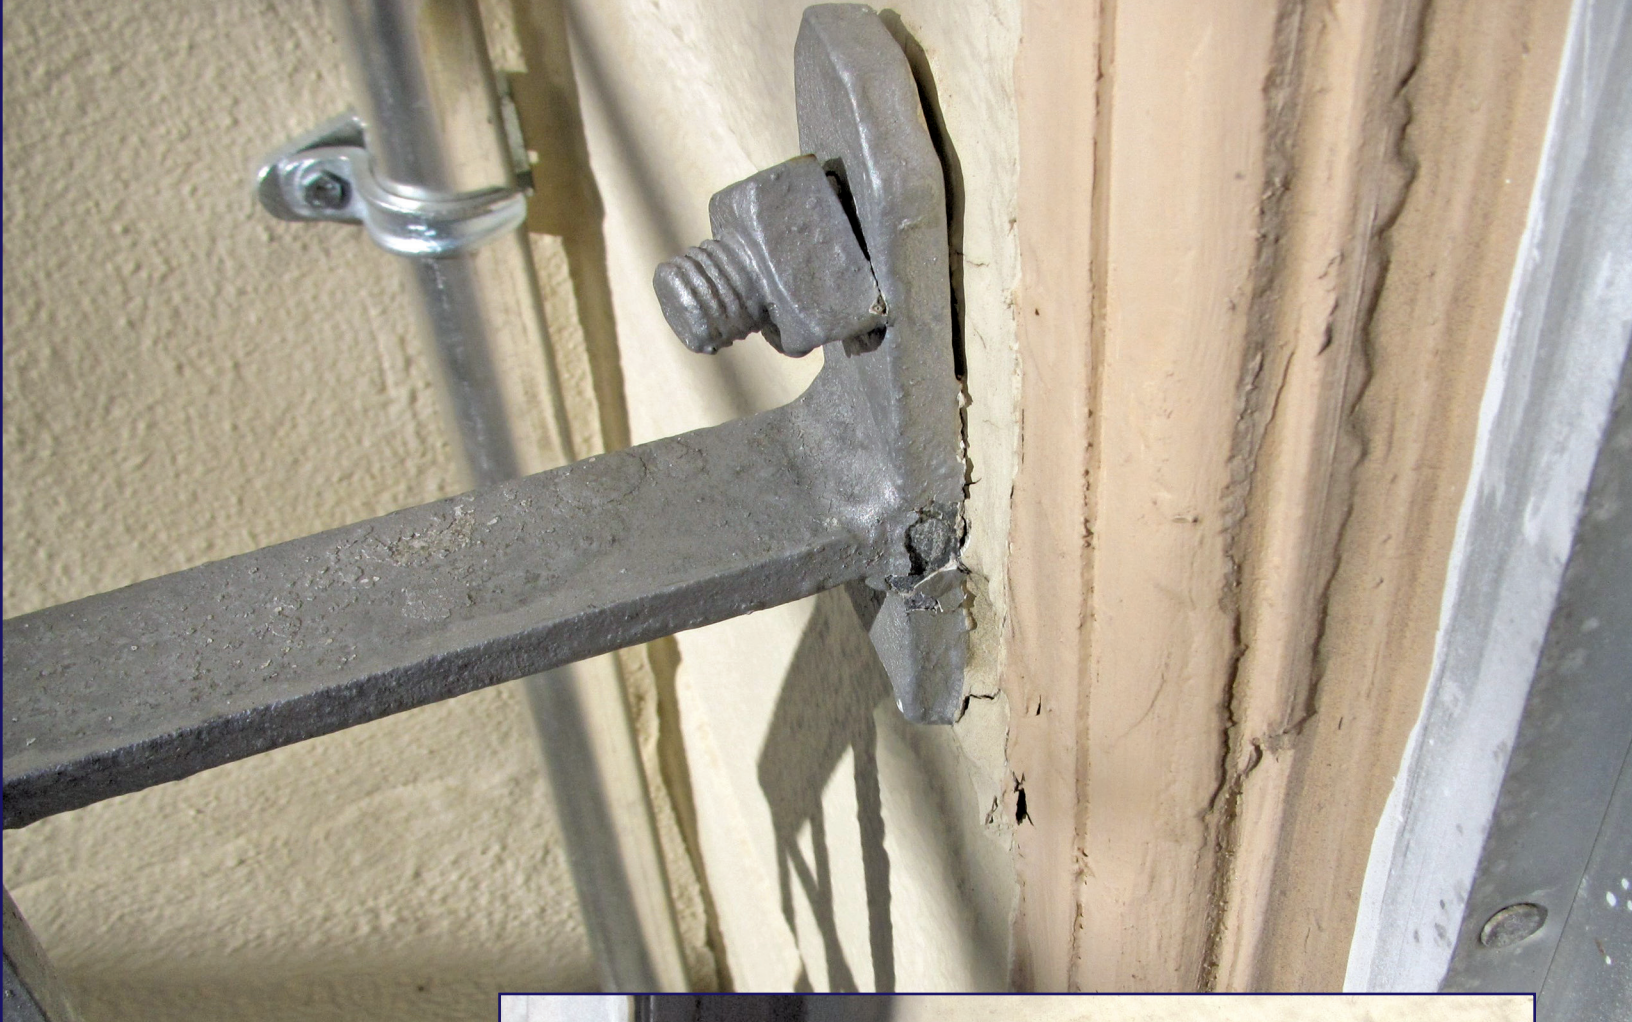
1.5 in. (38 mm) of the 4-in.-long hanger screws was exposed (see Fig. 5), which indicates that approximately 1 in. (25 mm) of the tapering ends of the hanger screws penetrated into the wood framing.

still-attached lower balcony exhibited clear evidence of axial (overturning) overloading and withdrawal (Fig. 5).

*Figure 5. The lower balcony was attached at the upper corners with 4-in.-long, ½-in.-diameter hanger screws. This fastener exhibits evidence of an axial prying action and withdrawal, as compared with the opposite hanger screw shown in Fig. 6. Note: 1 in. = 25.4 mm.*

tension to the steel threads of the hanger screws for multiple decades, with the ensuing rust oxidation slowly degrading the screws' axial load-bearing capabilities. This worsening degradation made these downward-sloping fasteners even more susceptible (particularly when wetted) to the pull-out forces of human loading of these Juliet balconies.

Finally, we noted that even though the helical threading at the partially failing hanger screw (see Fig. 5 and 7) at the lower balcony was more severely deteriorated than the failed screw (Fig. 8) from the upper balcony, it was this top balcony that, due to human loading related to this party, suddenly collapsed. This indicates that the lower Juliet balcony was also at high risk for sudden collapse if subjected to human loading.

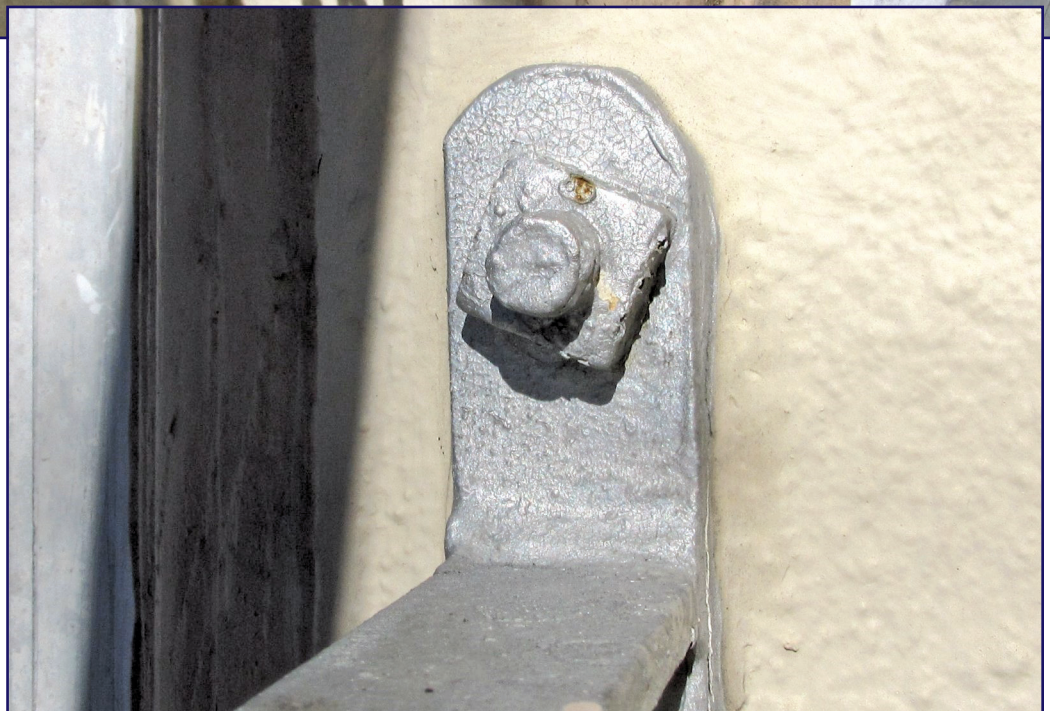
*Figure 6. This hanger screw at the opposite end of the lower balcony from the screw in Fig. 5 did not exhibit evidence of axial (overturning) overloading and withdrawal comparable to that shown in Fig. 5.*

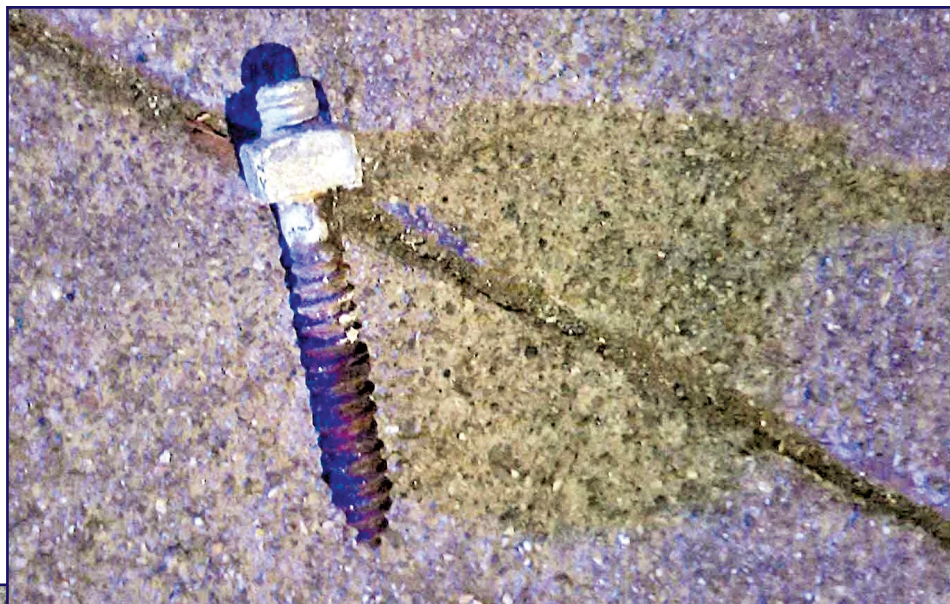
Figure 7. San Francisco Police Department photograph of a failed hanger screw from the night of the balcony collapse.

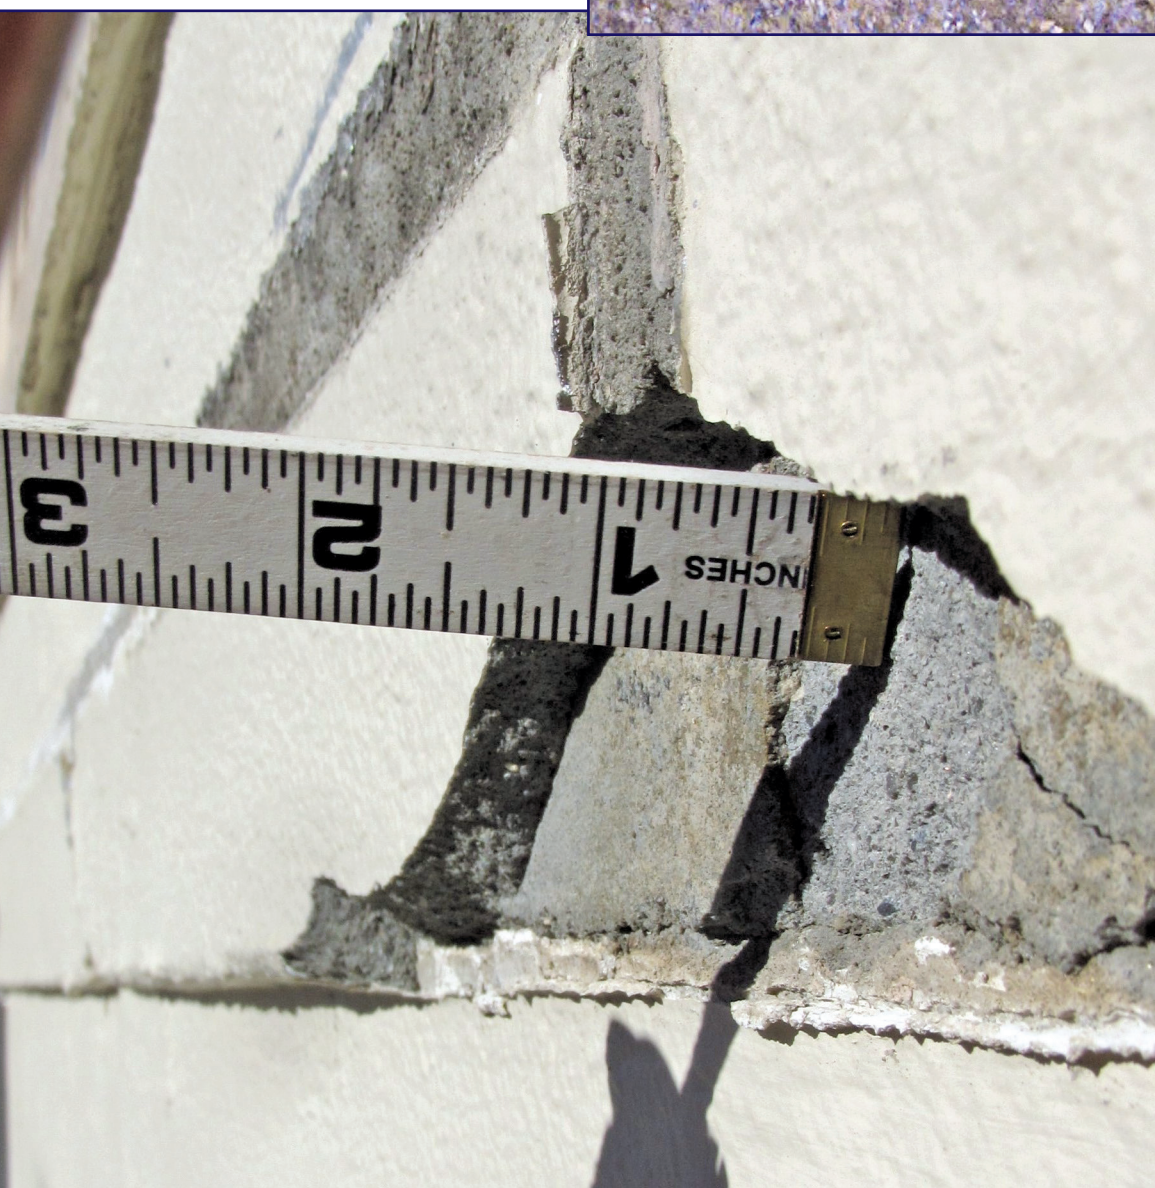
The combined thickness of the stucco cladding assembly—including the ¼-in. (6-mm) decorative layer of plaster cement seen in Figure 8, and its underlying diagonal wood board sheathing—was approximately 1.75 in. (44 mm). As a result, only the two hanger screws were structurally engaged with the wood (Douglas fir) framing. Approximately

Figure 8. Damage from the failed wood screw shown in Fig. 4 to the 1/4-in.-thick layer of decorative plaster cement applied for aesthetic relief atop an underlying 3/4-in.-thick stucco cladding assembly. Note: 1 in. = 25.4 mm.

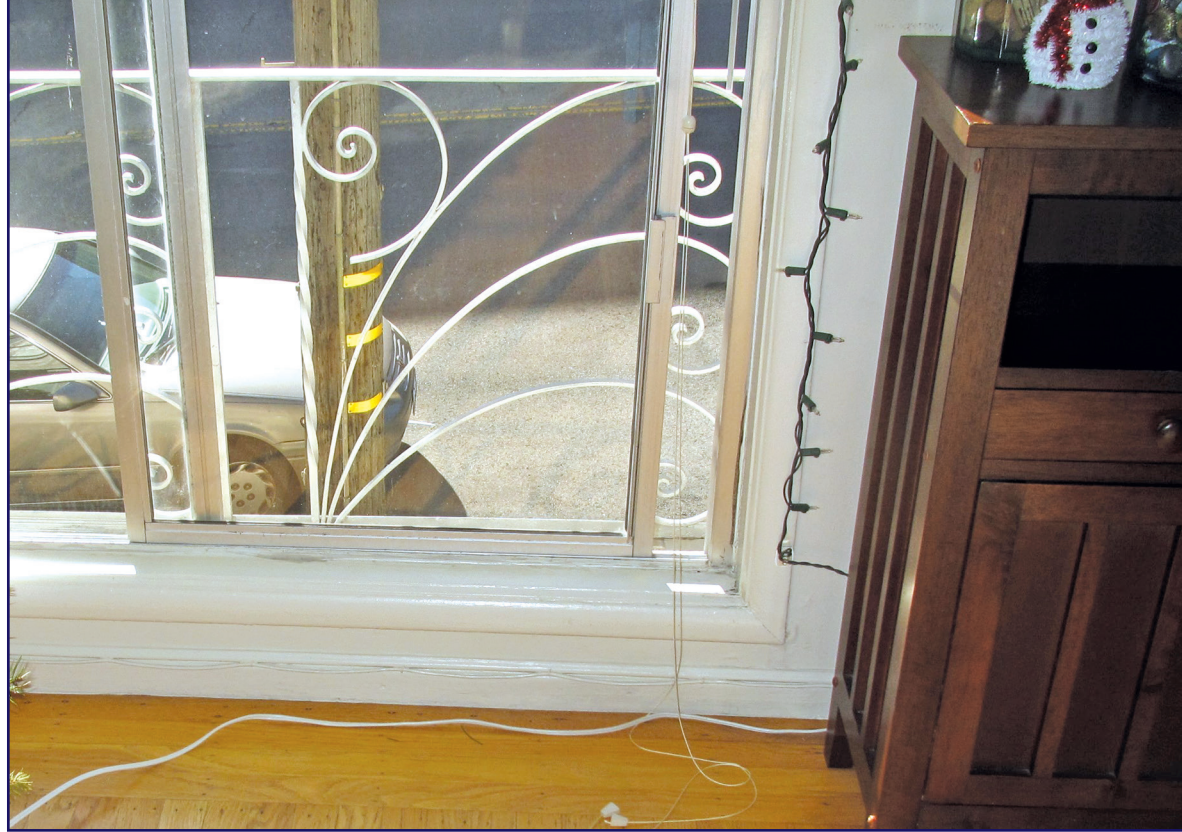
**Figure 9.** The invitingly low (7 in.) interior threshold height for the operable sashes at these circa-1972 horizontal sliding aluminum windows encouraged tenant access to the two balconies. Note: 1 in. = 25.4 mm.

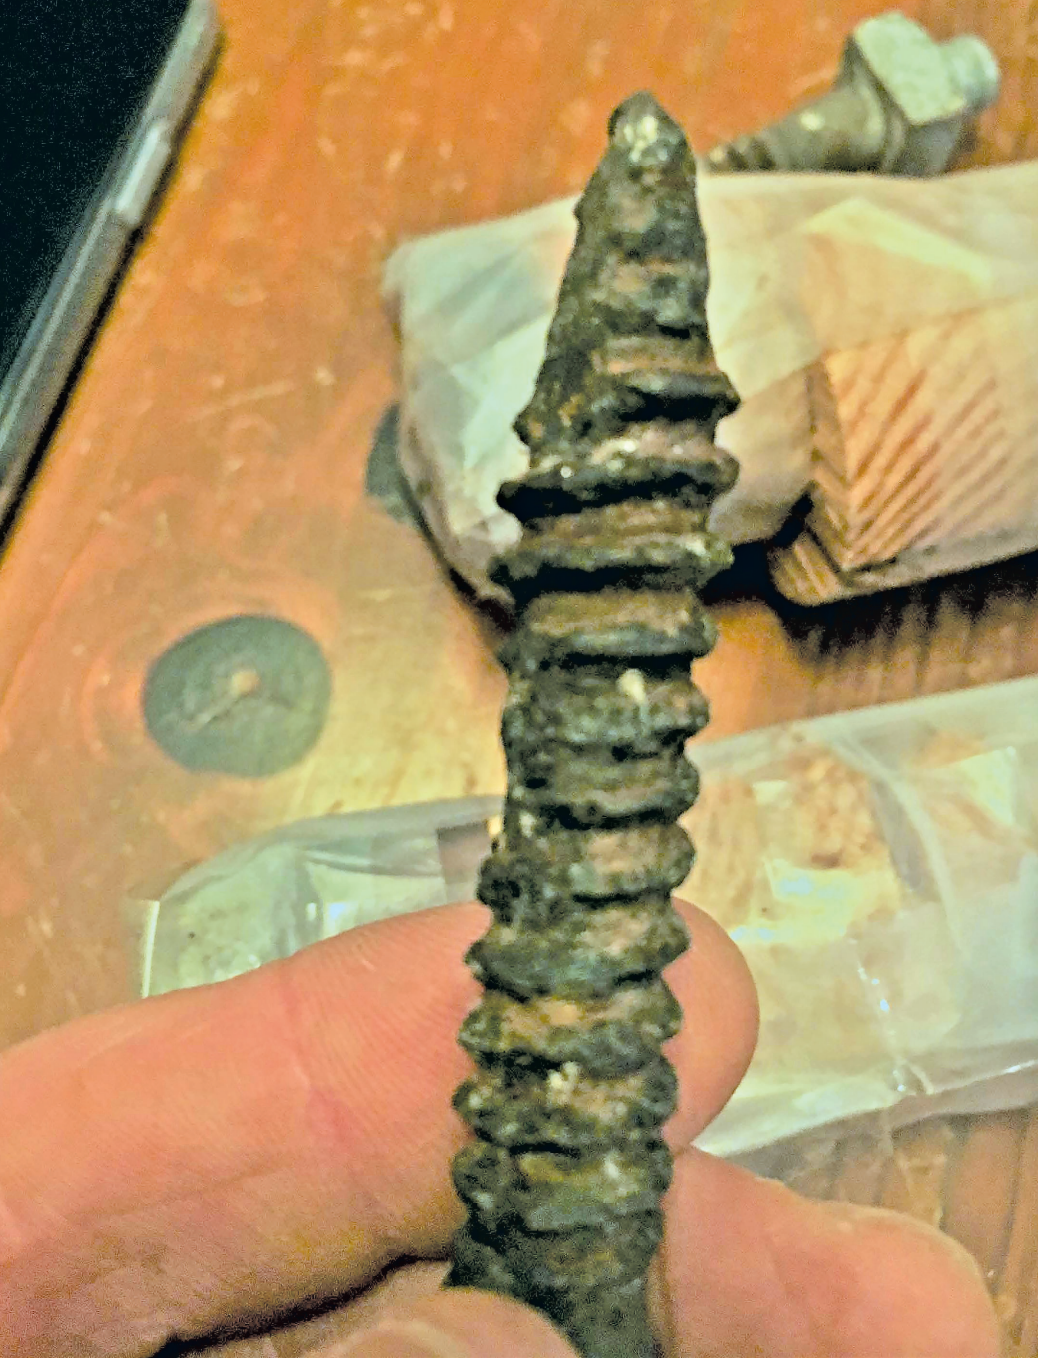
**Figure 10.** The hanger screw removed from upper left corner (see Fig. 5) of the lower balcony had severely corroded threads. Photo: Thomas H. Lutge, SE (<http://www.quakestructural.com>).
