# The Roofs of Chichester Cathedral, England

By Keith Roberts, BSc, CEng,  
MICE, MStructE

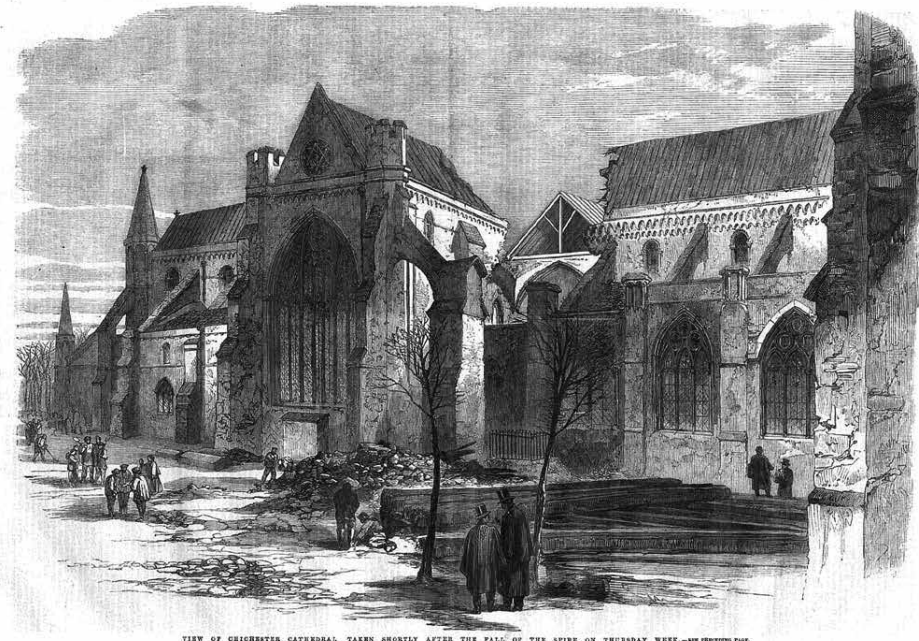
**Figure 2.** View prepared shortly after the fall of the spire in February 1861.

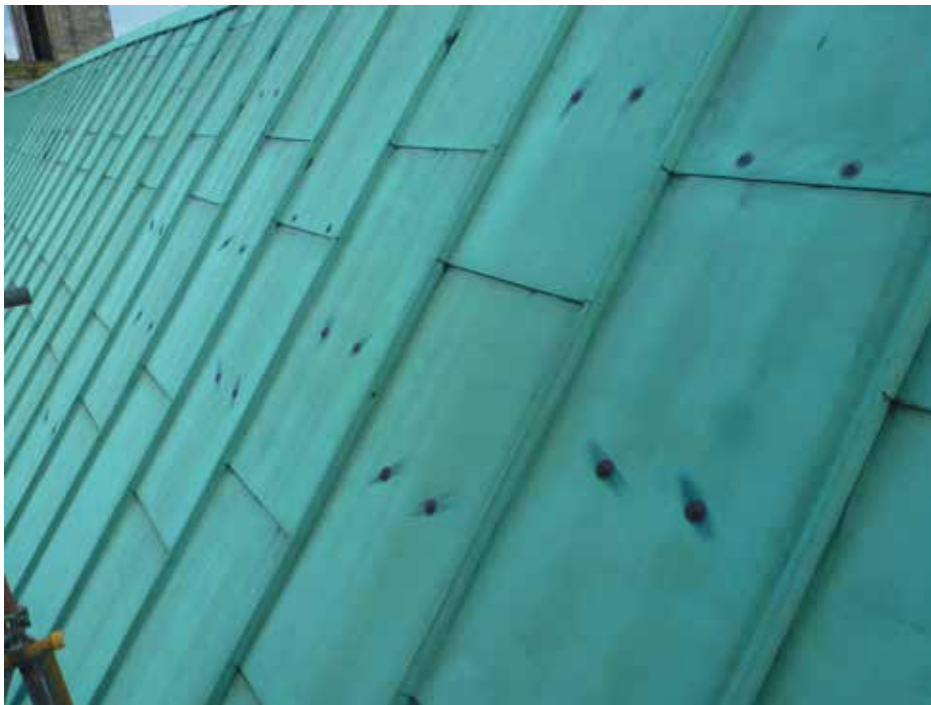
**Figure 3.** The 1949 copper roofing with additional fasteners to reduce uplift and splitting.

Unfortunately, the copper roofs have had a number of shortcomings. The cathedral is less than 10 km (6 mi) from the sea, such that the pitched roofs more than 20 m (65 ft) above ground level regularly experience high-wind-suction loading. With the exposed nature of the roof and the open form of the roof attic, the wider bays have not been fully able to withstand the wind forces lifting the pans of the sheets away from the roof slope. The movement in the copper has led to work hardening, fatigue, and splits developing along the centerline of the sheets and cross welts where two panels are joined with an interlocking single fold. This damage has, in turn, resulted in rainwater ingress and the need for local patch repairs.

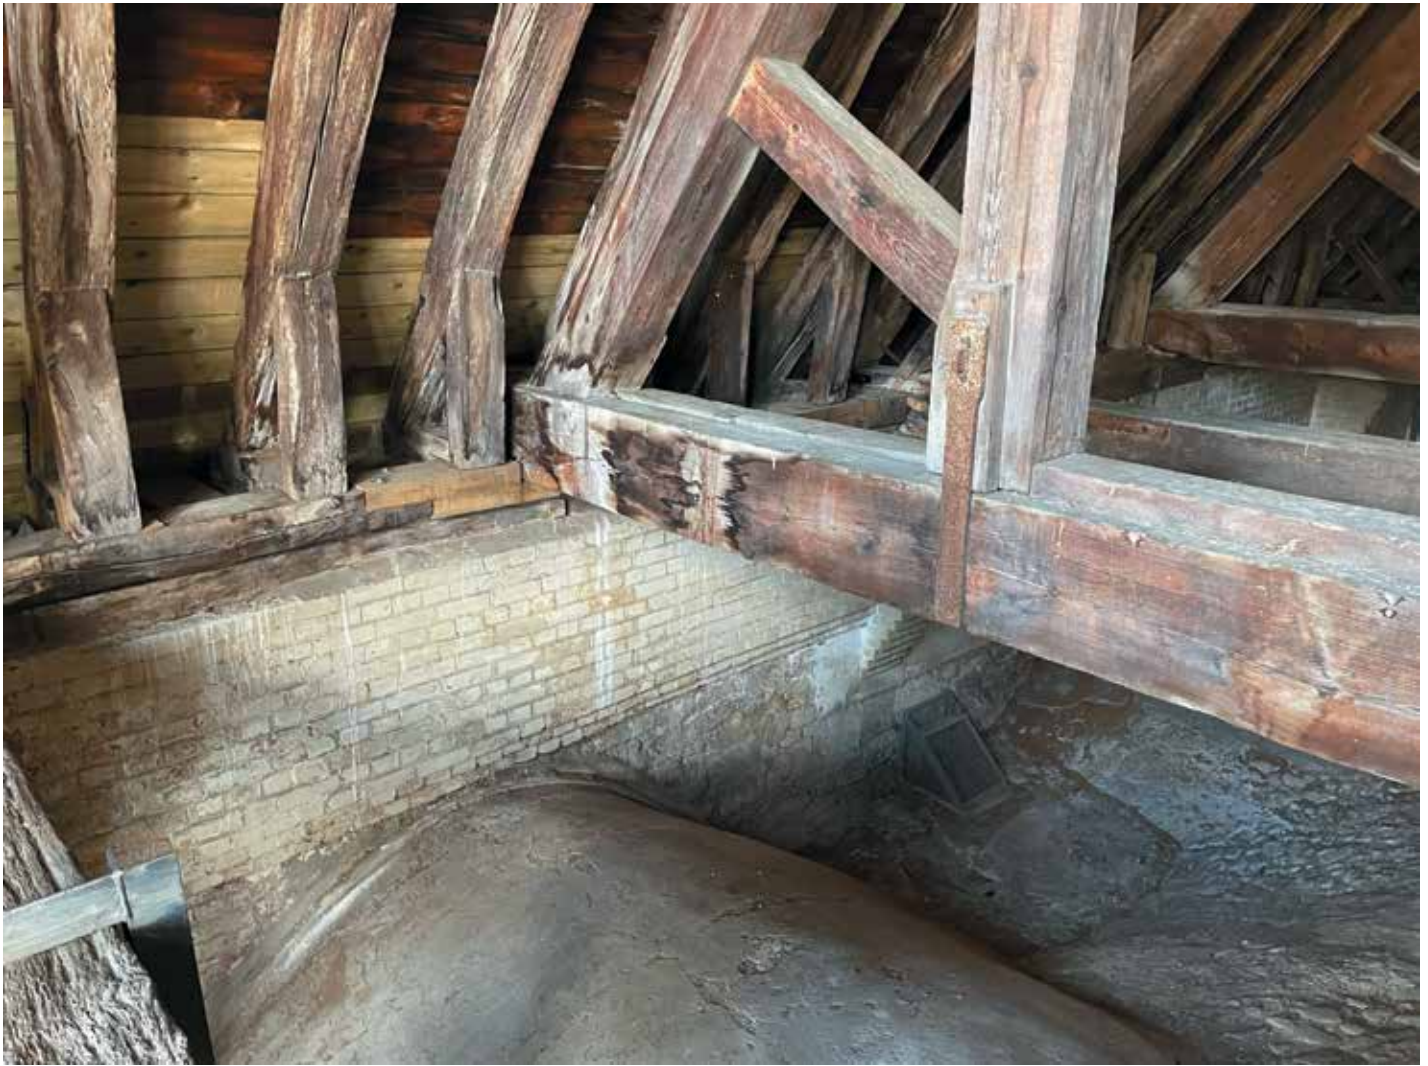
**Figure 4.** Rainwater staining of timber structure, including a replaced wall plate.

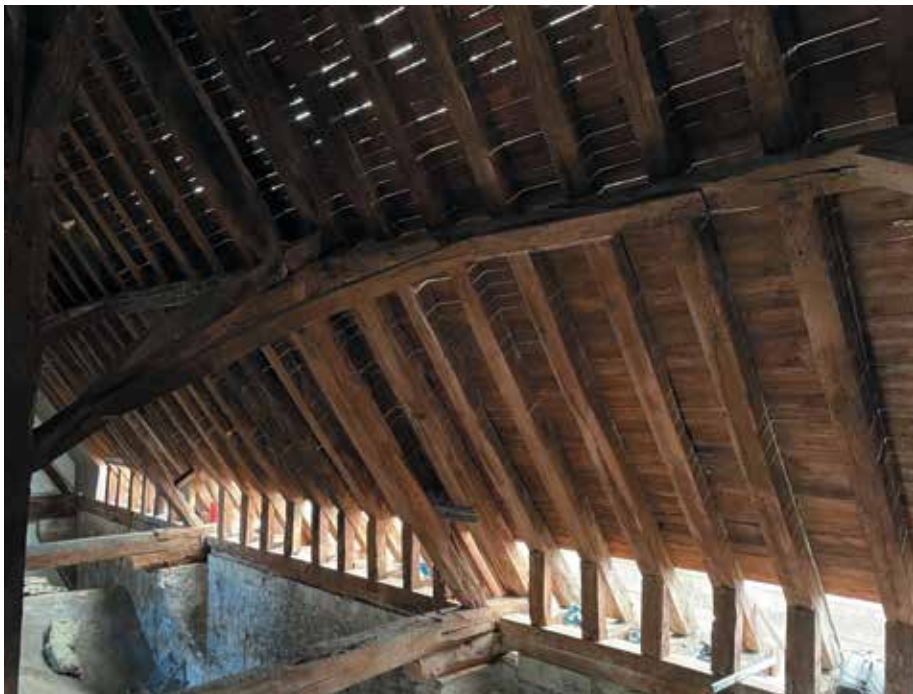
**Figure 5.** Medieval timber supporting the nave roof; with the external copper removed, daylight shines through penny gaps between sheathing boards.

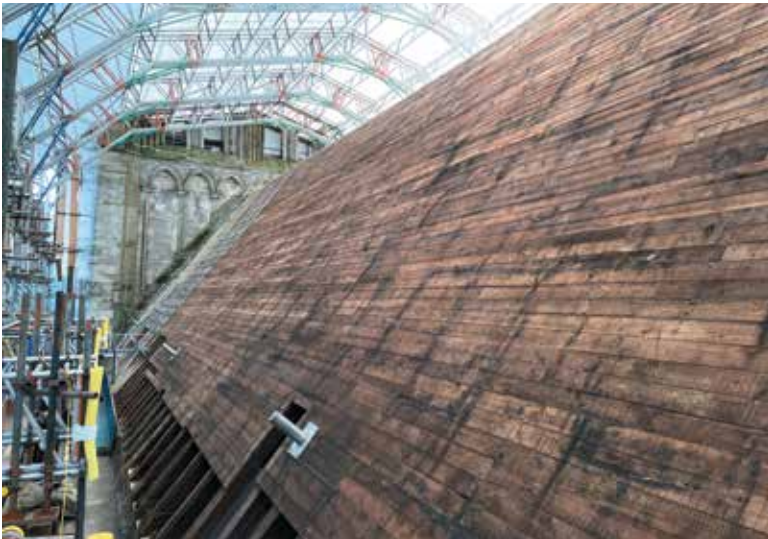
**Figure 6.** Copper removed, 1949 sheathing boards retained.

a major cost element, currently running at more than £70,000 (\$90,000) per week in hire charges. The aged and split copper roofing has been removed and sent for salvage. The earlier softwood sheathing boards are being retained with penny gaps, typically 3 mm (0.118 in.) wide, to provide good ventilation to the reverse side of the new lead roofing. The lead to the pitched roofs is code 8 (3.5 mm [0.138 in.] thick) and in the parapet gutters the even heavier code 10 (4.23 mm [0.167 in.] thick).

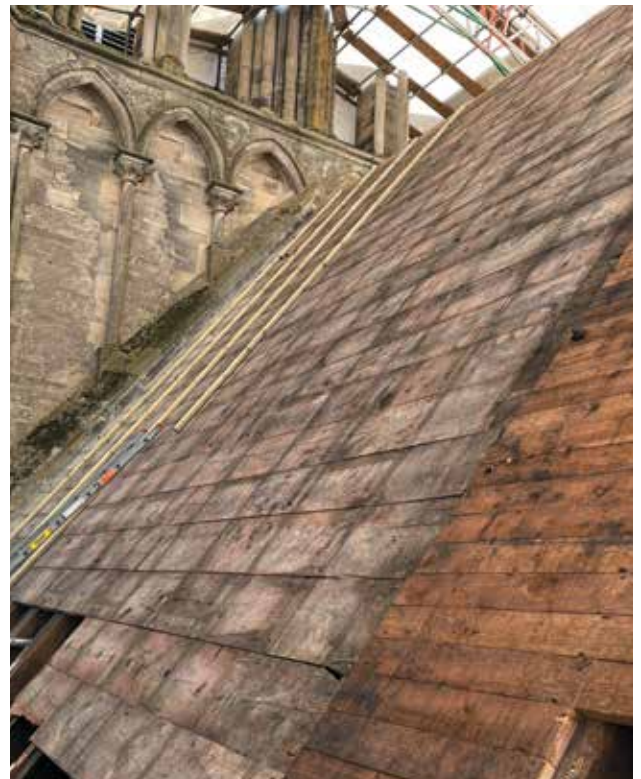
**Figure 7.** Batten roll wood battens fixed to sheathing, no underlay.

The lead is laid directly onto the softwood and dressed over the batten roll—shaped timber battens. A breathable underlayment is not being used because it has been found to retain water and prevent adequate air movement to the underside of the lead, increasing the risk of reverse-side corrosion. This is a lesson learned from other roofing works on churches in England, which is being shared for the benefit of the future generations who will maintain our ancient buildings.

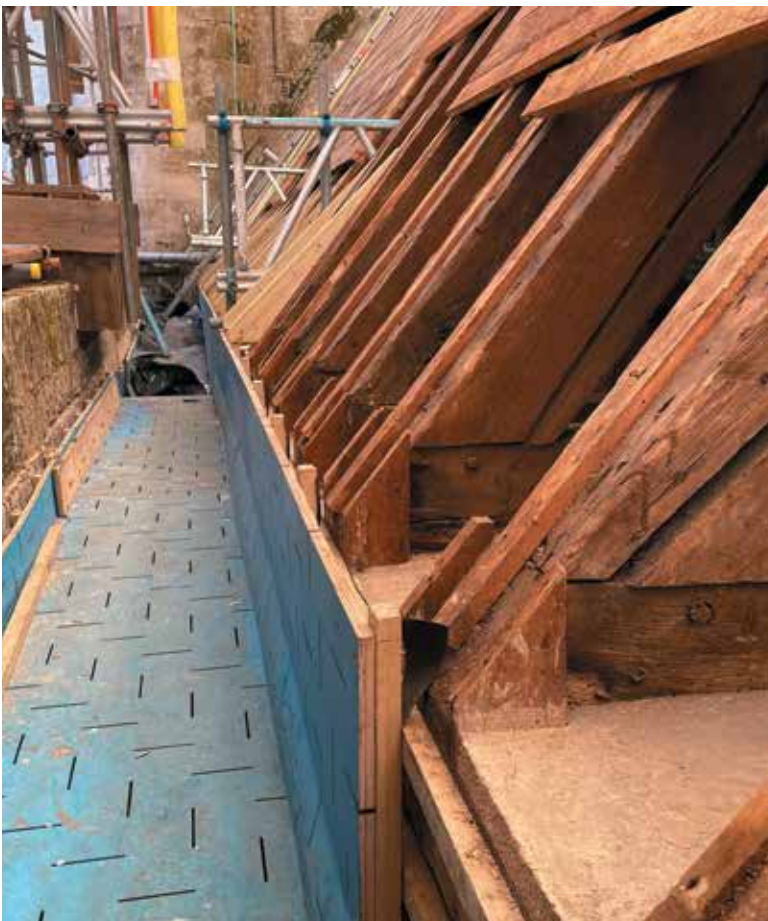
**Figure 8.** Plywood to support new gutter with ventilation slots.

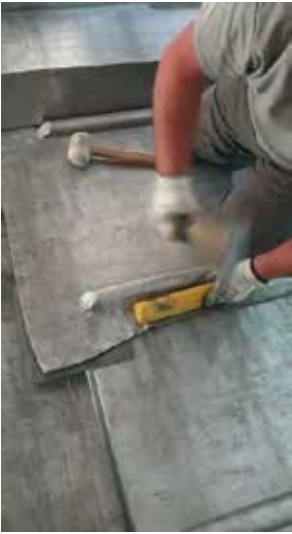
**Figure 11.** Lead dressed over timber batten rolls.
