Wind Tunnel Testing of Edge Metal

By James R. Kirby, AIA; Erica Sherman, PhD; Ameyu Tolera; and Johnny Estephan

This paper was originally presented at the 2023 IIBEC International Convention and Trade Show.

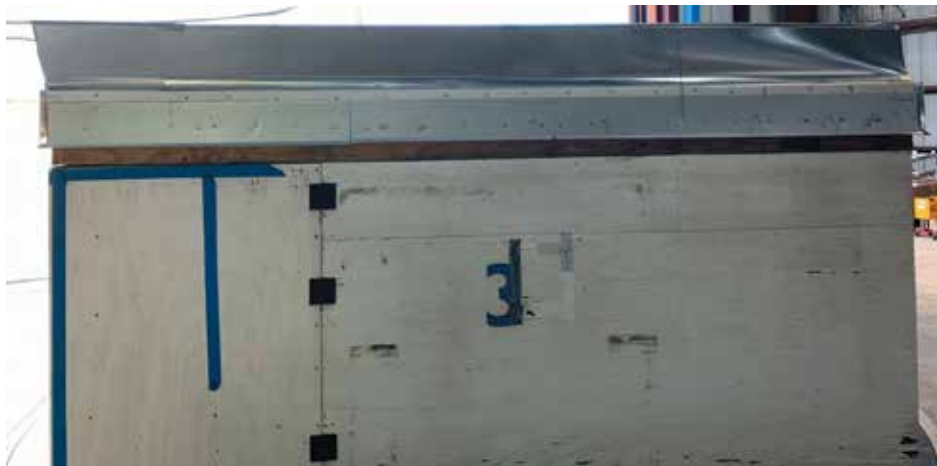
Figure 10. Failure mode of configuration 1.

Configuration 1 used cleat 1, the 6 in. (150 mm) cleat. The cleat fastener was located 1¾ in. (44 mm) above the break line for the drip edge. Configuration 1 was the only configuration to have a failure before reaching the wind tunnel's maximum wind speed. During the "low-speed" aerodynamic testing, the fascia released from the cleat nearly the entire length of the test deck, but it did not flip up and onto the roof. It was observed that the cleat was likely set too high, and therefore, the engagement of the cleat and the fascia was greatly reduced. The failure assessment testing was initiated without adjustment of the fascia or cleat. During the next wind-speed level, the fascia completely folded back onto the roof its entire length. At that point, the system was considered to have failed. Observations made of the failure found the cleat was indeed set too high (approximately ¼ in. [6 mm]) relative to the location of the drip edge portion of the fascia. This reduced the amount of engagement between the cleat and the drip edge (**Fig. 10**).

assumption. During this testing, however, this configuration failed at the lowest wind speed due to the misalignment of the cleat fastener. This emphasizes the importance of a well-engaged cleat–drip edge interface.

- During the failure where the cleat was set too high, a small (approximately 1/4 in. [6 mm]) misalignment reduced the amount of engagement between the cleat and the drip edge and significantly reduced the wind speed at failure of the edge-metal system.

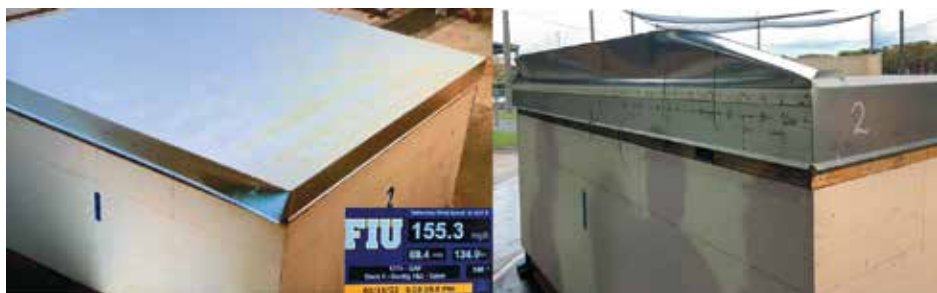
Figure 11. Failure mode of configuration 2.

Configuration 2 used cleat 1, the 6 in. (150 mm) cleat. The cleat fastener was located 4½ in. (110 mm) above the break line for the drip edge. A small amount of cleat/drip edge separation with some minimal fluttering of the fascia was seen in the higher wind-speed levels. The small amount of fluttering was located adjacent to the corner where the drip edge receiver was disengaged from the cleat (approx. 6 to 10 in. [150 to 250 mm] in length). There was little outward permanent deformation of the fascia and cleat system; the edge-metal system appeared to remain able to perform until the point it failed. The failure occurred at approximately 134 mph (215 km/h). The failure was immediate; there was a small amount of flutter at the corner, then it was folded up and on top of the roof (Fig. 11).

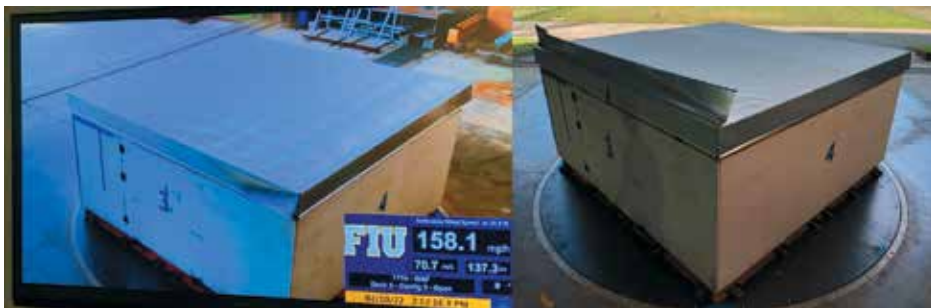
Figure 12. Failure mode of configuration 3.

At approximately 134 mph (215 km/h), the fascia folded up and over the horizontal surface (Fig. 12). The drip edge separated from the cleat. The cleat did not have any permanent deformation and remained in place (Fig. 13).

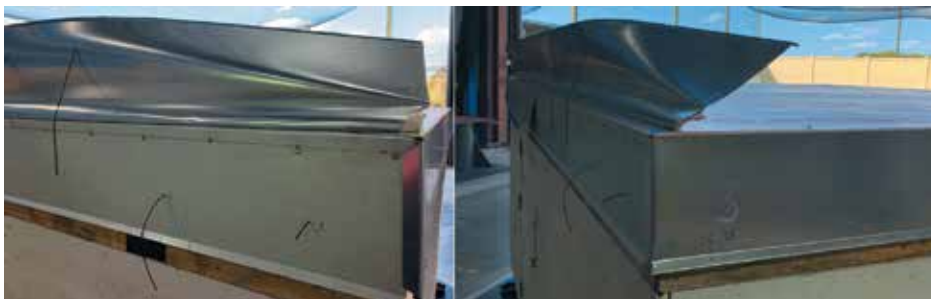
Figure 13. Failure mode of configuration 3 up close.

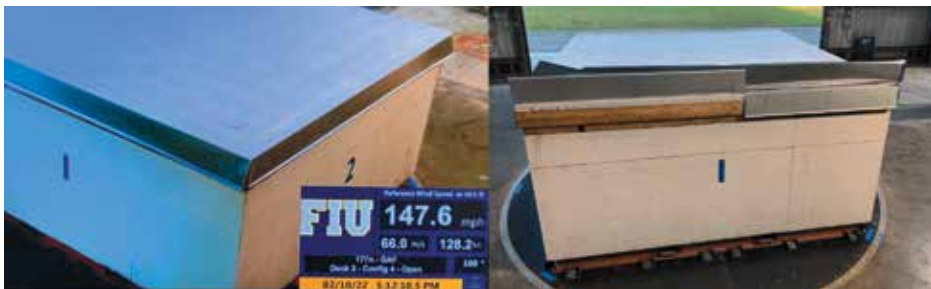
Figure 14. Failure mode of configuration 4.

The portion of the cleat closest to the corner stayed in place while the portion of the cleat farthest from the corner folded upward (Fig. 14). Some of the nails pulled out at the far end of the fascia. This seemed to imply that there was a greater pressure at the far end of the “left side” of configuration 4 relative to the other configurations.

- For configuration 4, the cleat did not entirely disengage from the fascia. Both pieces of metal failed—the metal folded up and over along the length—while still engaged at the drip edge. Failure occurred because the metal yielded; only a few nails pulled out, and only at the far corner.

- Only configuration 4 had nails pull out of the substrate. A small number of nails fastening the fascia on the horizontal at the furthest end from the corner pulled completely out of the 2x6 wood nailer. No specific reason was determined.
