# ROOF DECKS A TO Z

## PART 18: When the Deck . . . Isn't

By Lyle D. Hogan

*This is the 18th article in a series examining various deck types. This installment features five examples where a functional roof deck is not present. Potential risks associated with these types of examples and mistakes in judgment that may occur during the course of decision-making are discussed.*

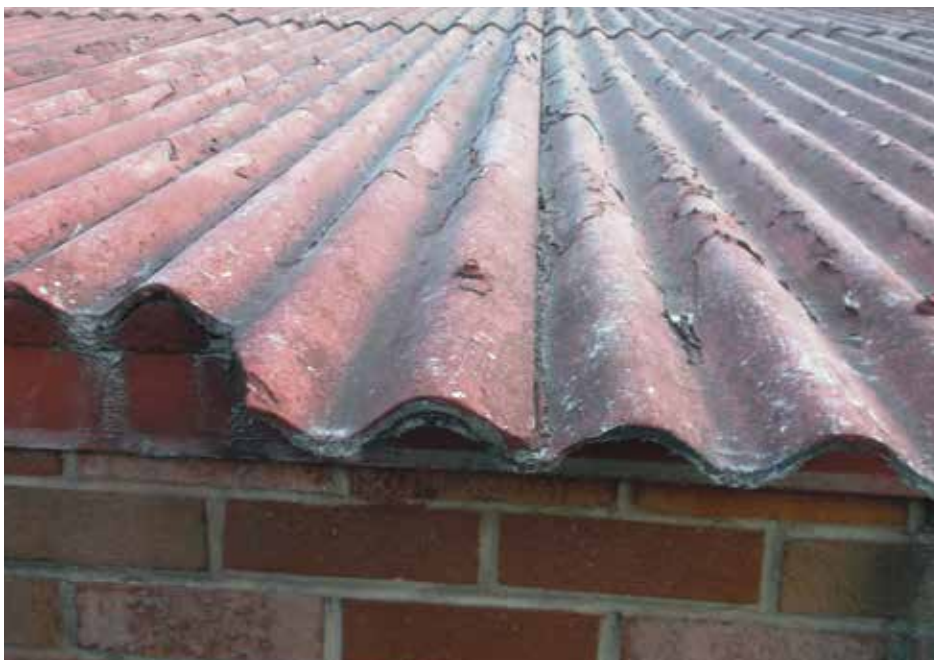
Corrugated asbestos panels are vintage products that were widely used as siding or roofing materials (**Fig. 1**). Leaks manifesting on a pitched roof constructed from this type of material may often be related to a flashing or penetration, and appropriate repairs may well extend the service life. **Figure 2** depicts a steeply pitched asbestos-panel roof that has served for decades, owing heavily to its generous slope. When the time comes for complete reroofing, corrugated asbestos panels should be removed by a professional qualified to handle asbestos and disposed of in a regulated landfill. Consideration can then be given to the new system selection.

*Figure 1. Corrugated asbestos panels are a vintage product that were widely used as siding and roofing materials alike. They are inappropriate for use as the substrate for over-roof assemblies.*

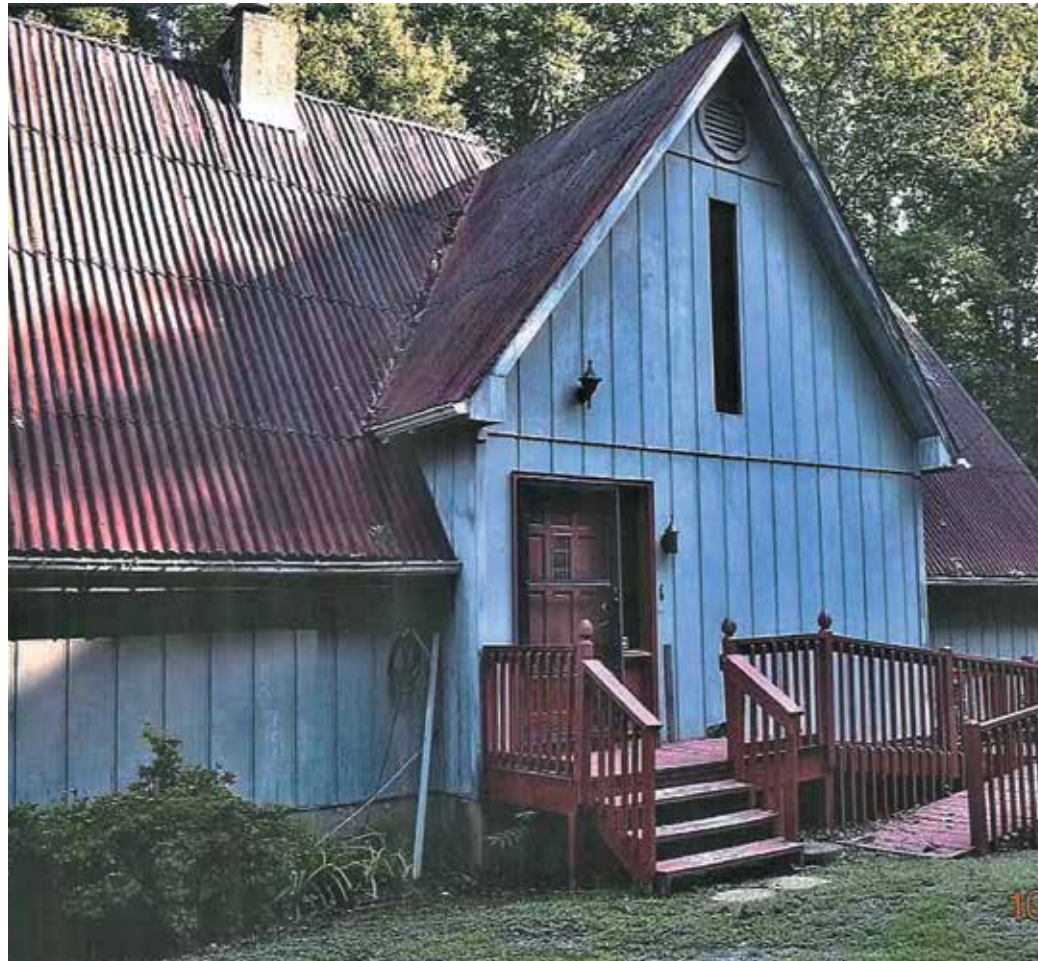
*Figure 2. This steeply pitched asbestos-panel roof has served for decades.*

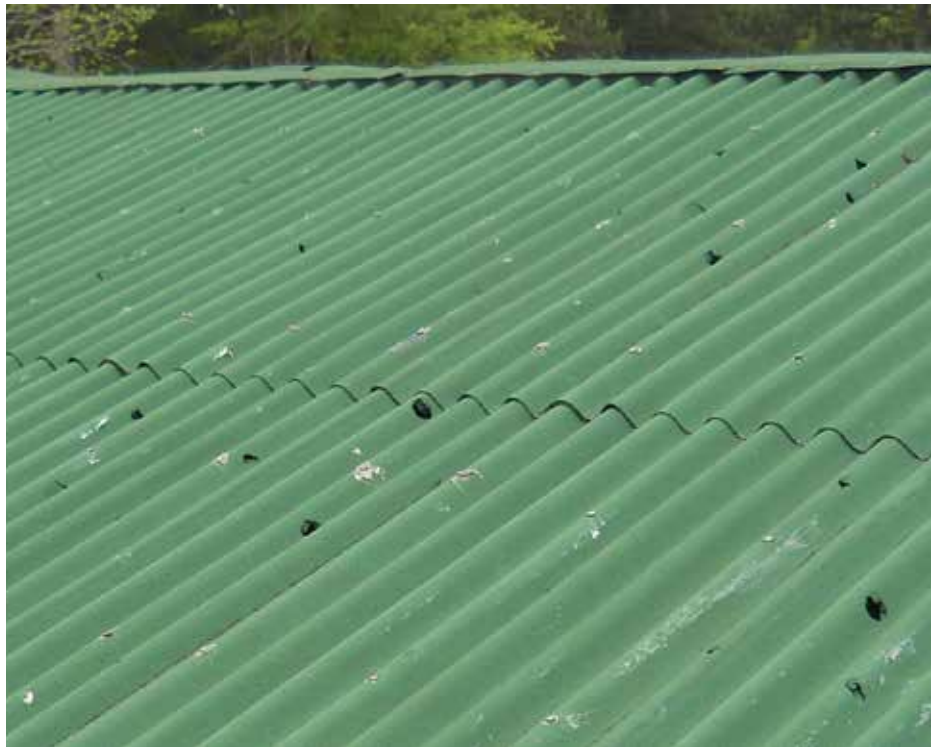
The corrugated fiber-reinforced polymer (FRP) roof shown in **Fig. 3** sustained impact damage during a hailstorm. This product has a different profile when compared with legitimate FRP decking (a topic to be explored in a later installment). The temptation to apply materials over corrugated FRP should be

quickly dismissed, as its load-carrying capacity is dubious, and fastening difficulties are sure to arise. It is inappropriate to place additional materials on top of corrugated asbestos or FRP panels.

*Figure 3. This corrugated fiber-reinforced polymer roof sustained impact damage from hail exposure. Materials should not be applied on top of this roofing product.*

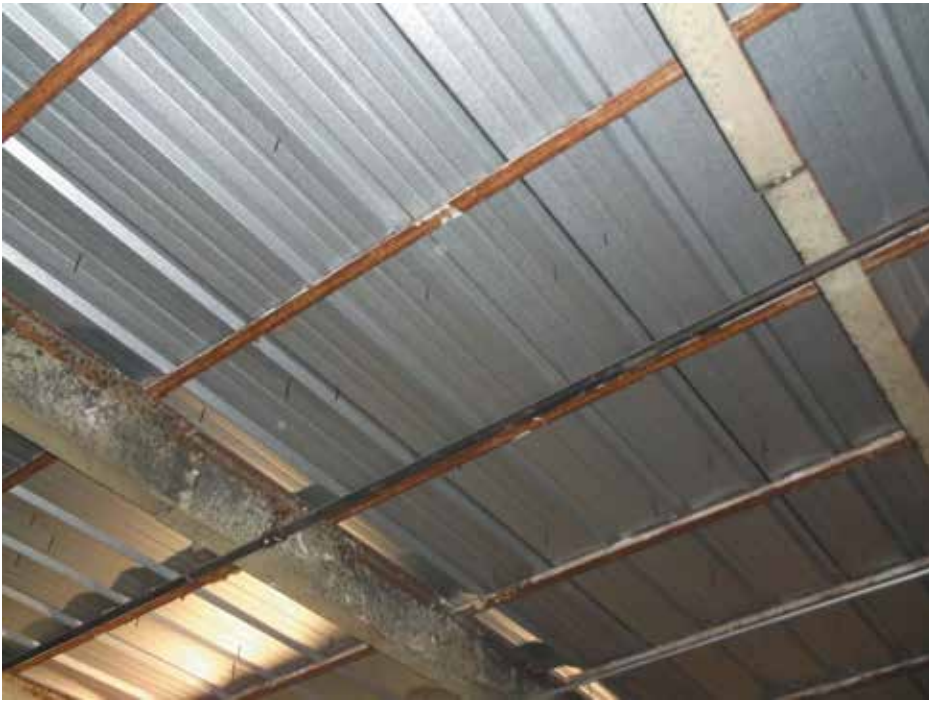
**Figure 4** depicts ordinary ribbed metal panels situated over iron bulb-tee rails that were left in place following removal of the old poured-gypsum deck and formboards. The mechanically attached ethylene propylene diene terpolymer (EPDM) roof above was quite loose underfoot

for reasons that were not fully recognized at first. Underside examination revealed that metal panels had merely been "loosely laid" over the iron rails, which clearly created a fastening problem. This type of construction was a completely irresponsible choice on the part of the installer and the consumer; hopefully, no consultant or "designer of record" was involved.

Figure 4. Ordinary ribbed metal panels are situated over iron bulb-tee rails left in place following removal of the old gypsum deck.

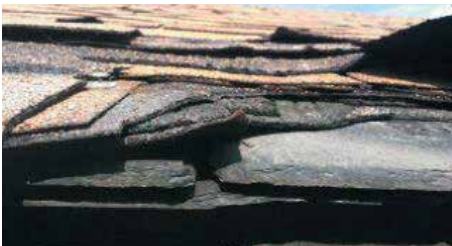
**Figure 5** depicts two layers of asphalt shingles applied over an original slate roof. It is perplexing to consider what the installer was thinking as nails were being driven through these materials. The shingle installers evidently assumed that the overall stack of materials was bulky enough to hold the nails. However, this structure had spaced wood sheathing (skip-sheathing). While a spaced substrate is fine for slate, it is not intended as a deck for shingles—especially two layers of shingles over old slates;

Figure 5. Two layers of asphalt shingles over a slate roof. It is perplexing to consider what the installer was thinking as nails were being driven.

predictably, this installation failed. Slates have even been found wired to iron framing (Fig. 6), but they would still not be suitable for receiving any kind of additional material placed atop.

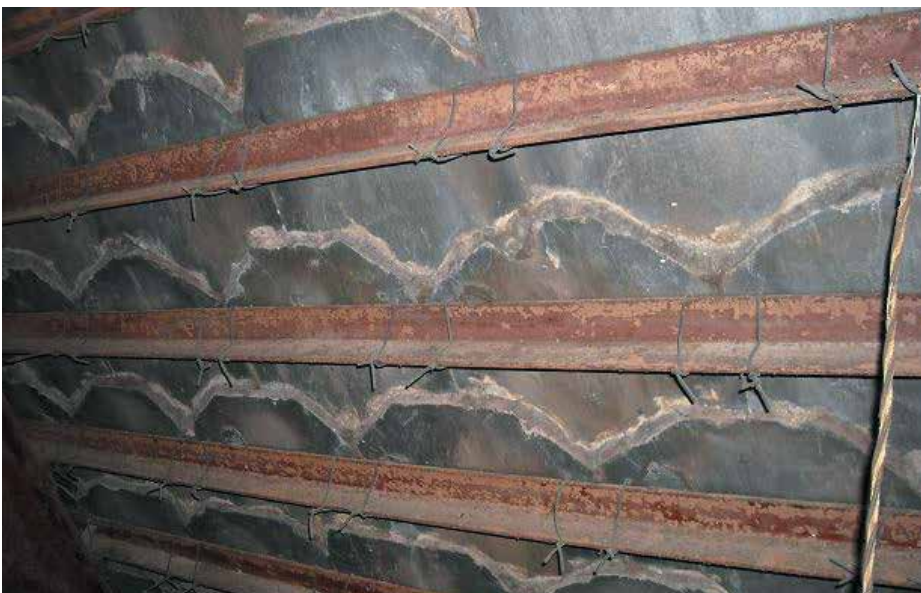
Figure 6. Slate roofs can sometimes be found wired down to iron framing. Slates are not suitable for receiving any kind of additional material.

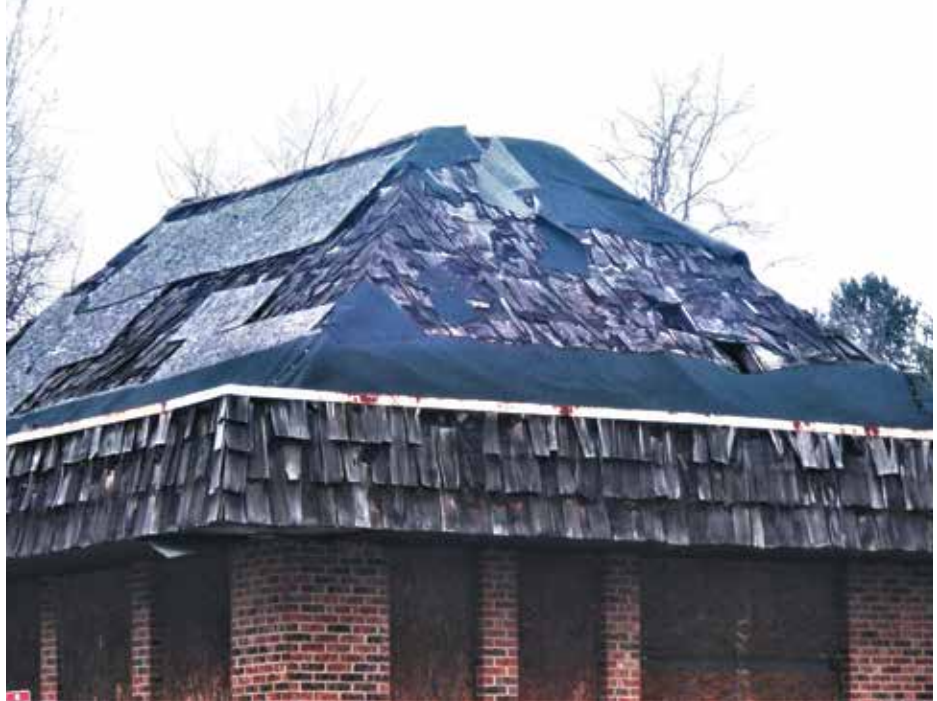
More unsettling is the building featured in Fig. 7, where roll-roofing had been placed across an old wood-shake roof. This kind of work is a departure from rational thinking, as the building would have been better served with a blue tarp. Although this arrangement was undoubtedly driven by financial concerns, one still struggles to understand the logic

Figure 7. Roll-roofing placed across an old wood-shake roof.

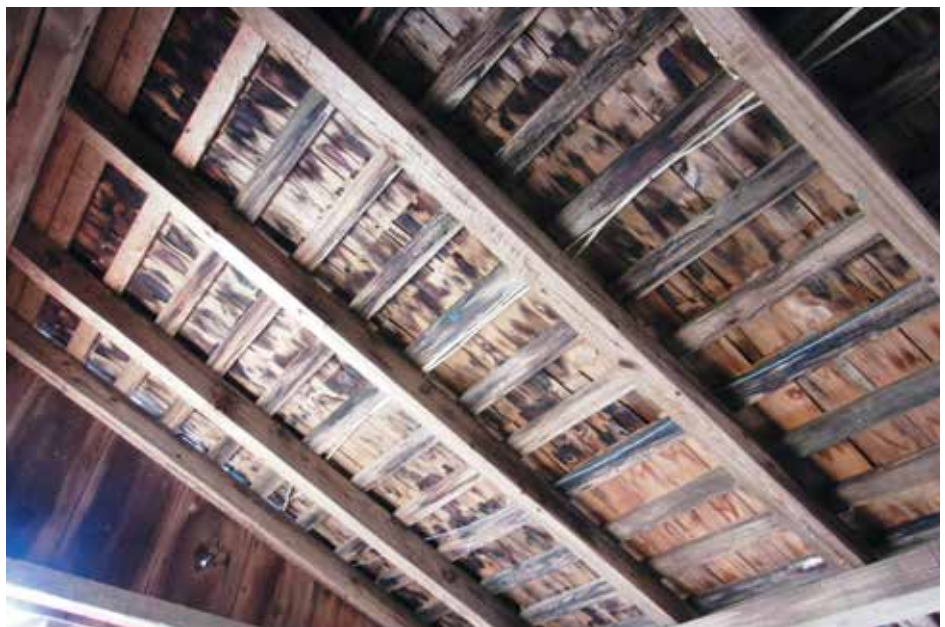
behind it. As discussed in Part 12 of this series, wood shakes can perform very well over skip sheathing (Fig. 8); however, this form of roofing is not a suitable substrate for any additional layers. As Benjamin Franklin is credited with saying, “The bitterness of poor quality remains long after the sweetness of low price is forgotten.”

Figure 8. Wood shakes can perform very well over skip sheathing. However, this form of roofing is not a suitable substrate for any additional layers.

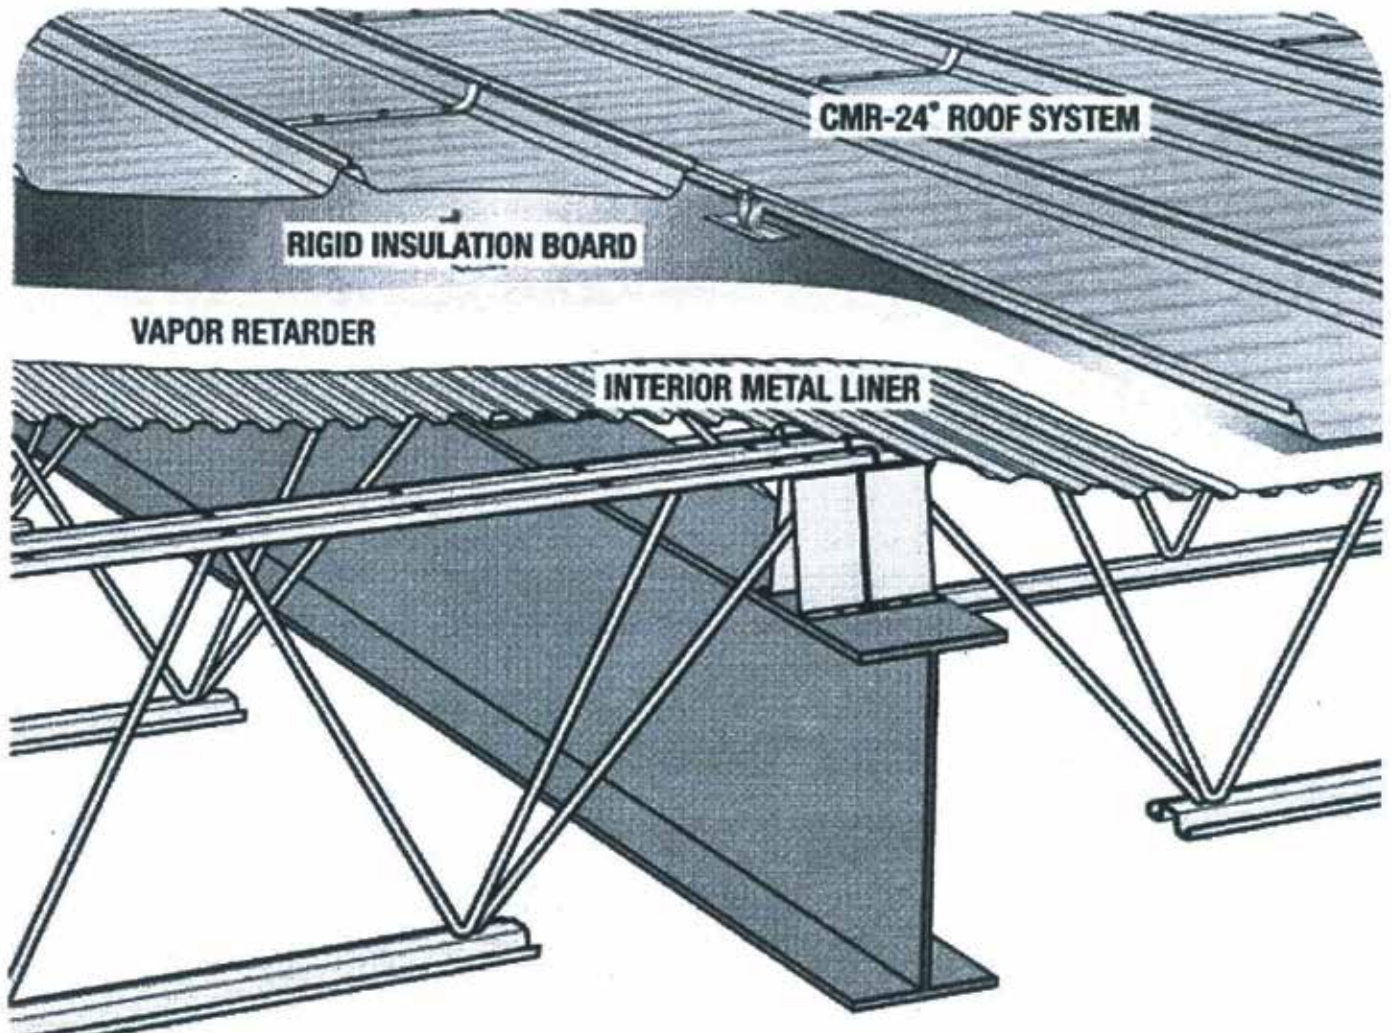
The focus of this discussion is one distinctive feature of the truss purlin: the light-gauge metal liner that supports board insulation below a premium standing-seam metal roof covering (Fig. 9). It resembles a “formboard” of the type used for some poured decks, but its sole function here is to support the board insulation. It has no sidelap stitching, and it isn’t even attached to the framing girts—and it doesn’t need to be. Micrometer measurement (Fig. 10) can confirm that this 26-gauge metal liner is incapable of serving as horizontal shear diaphragm; that function is gained by rod bracing, as it is in other buildings with structural metal roofs. The liner can be cut with household scissors (Fig. 11) and is incapable of holding threaded deck screws.

Most standing-seam metal roofs have a fiberglass insulation blanket merely draped across the sub-purlins, although wire or mesh netting can also be used. In any event, this metal liner is *not* a roof deck. Remember that a structural standing seam, by definition, does not require a subdeck of any kind. It would be somewhat unusual to need to over-roof a premium standing-seam system, but over-roofing proposals should not suppose that this liner can be engaged with threaded deck screws—or any other kind of fastening device. It simply isn’t a deck.

Figure 9. This proprietary metal assembly has a metal formboard/liner that is merely used to support the board insulation; it is not a steel roof deck. Photo used by permission of Butler Manufacturing.

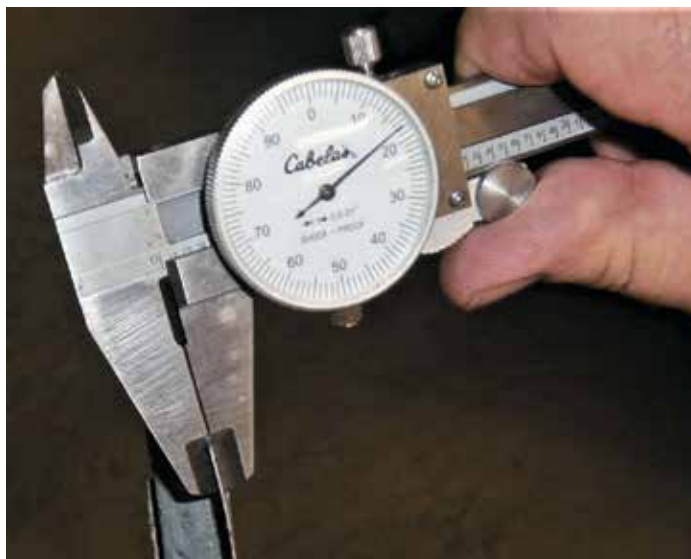
Figure 10. Micrometer measurement confirms that this 26-gauge (0.017-in.) metal liner is not intended to hold fasteners.

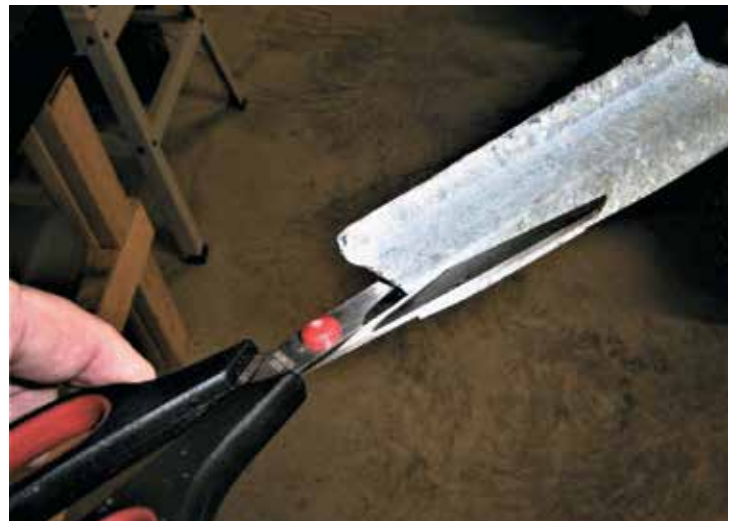
Figure 11. This light-gauge metal liner can be cut with household scissors. There is no wind rating whatsoever to be had when materials are fastening with screws to this type of liner.

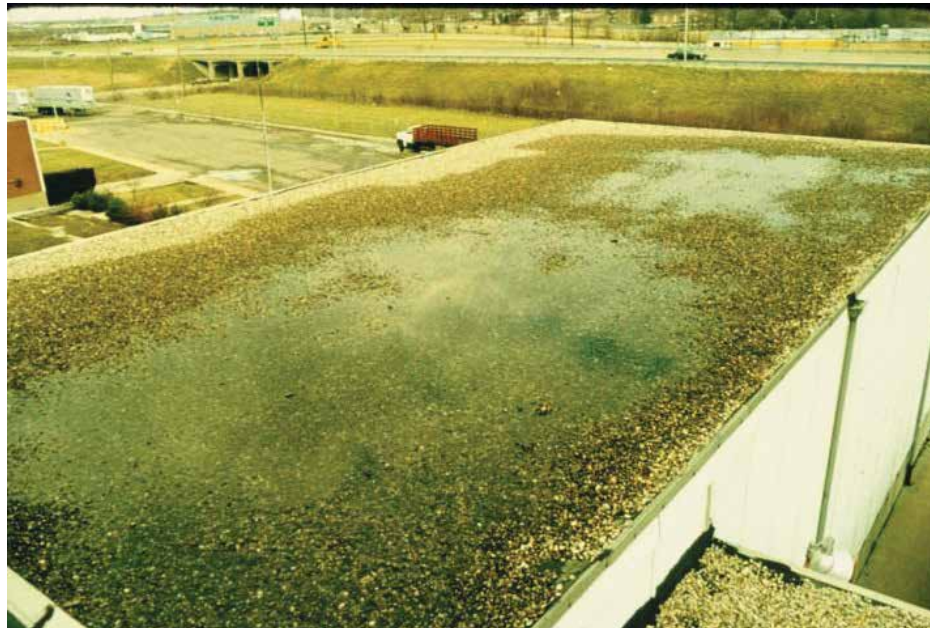
**Figure 12** depicts an unstable structure where collapse was imminent (circa 1984). Part of a large midwestern food distribution center, this low-slope assembly was experiencing creep deflection from long-term overloading. In this example, the old built-up roof was still in place, the heavy ballasted roof had been added years prior, saturated wood-fiber insulation was present, and there was a snow drift potential against the higher building wall. Surface deformation had resulted in a considerable depth of ponding water (more than 4 in. [100 mm] deep at midspan).

Collapse scenarios are almost always caused by a combination of factors. **Table 1** presents the estimated loads observed at the time of inspection. This estimate does not include contribution by periodic drifting snow, which can be very high, especially during a "rain-on-snow" episode. Moreover, the author has encountered freezer panels of this type that were completely impacted with ice from decades of slow moisture

diffusion during service life (remember that a freezer has extremely high *inward* drive for moisture vapor). This ice accumulation, of course, adds yet more to the load tally.

Not to be confused with modern structural insulated panel (SIP) systems, these vintage panels do not meet current standards for a code-compliant roof deck. They may have been satisfactory for the walls, but they are grossly

*Figure 12. Insulated freezer panels can present genuine problems when over-roofing is needed. This midwestern freezer had experienced long-term creep and was subject to periodic drifting snow loads. As a result, it was perilously close to collapse when this photo was taken (circa 1984).*

inadequate for carrying loads of the magnitude shown in Table 1. Fortunately, the owner understood the peril, the roof was radically reworked, and collapse was averted. During reroofing on vintage freezers of this type, several lightweight options can be considered, but any negative camber should be eliminated, and more underside bracing will probably be needed near higher adjacent walls to accommodate periodic

drifting snow. Old, deformed, ice-impacted roof panels should be replaced, and modern SIP products can fill the bill.
