Case Study: Thermal Contraction of a PVC Membrane and EPS Insulated Roof Assembly in Alaska's North Slope Borough

By Grace Wong, AIA, PE, LEED AP BD+C; and Christian Gorry, RRC, RRO, PE

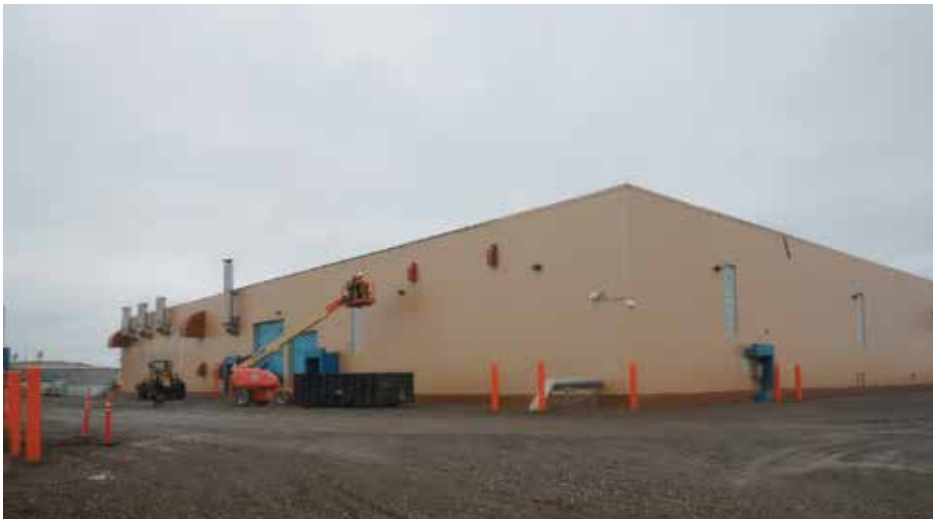
Figure 1. Overview of the building (looking northeast).

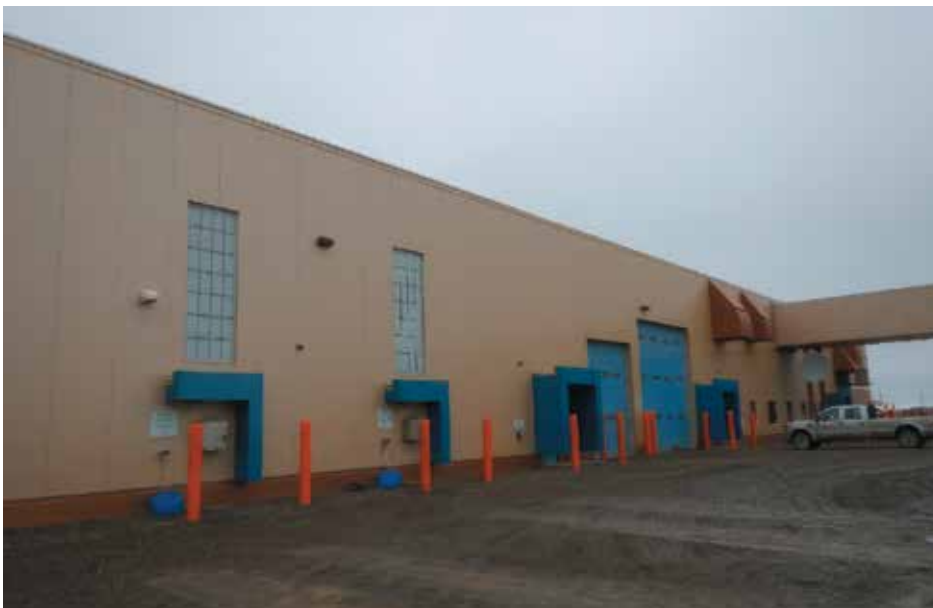
Figure 2. East elevation.

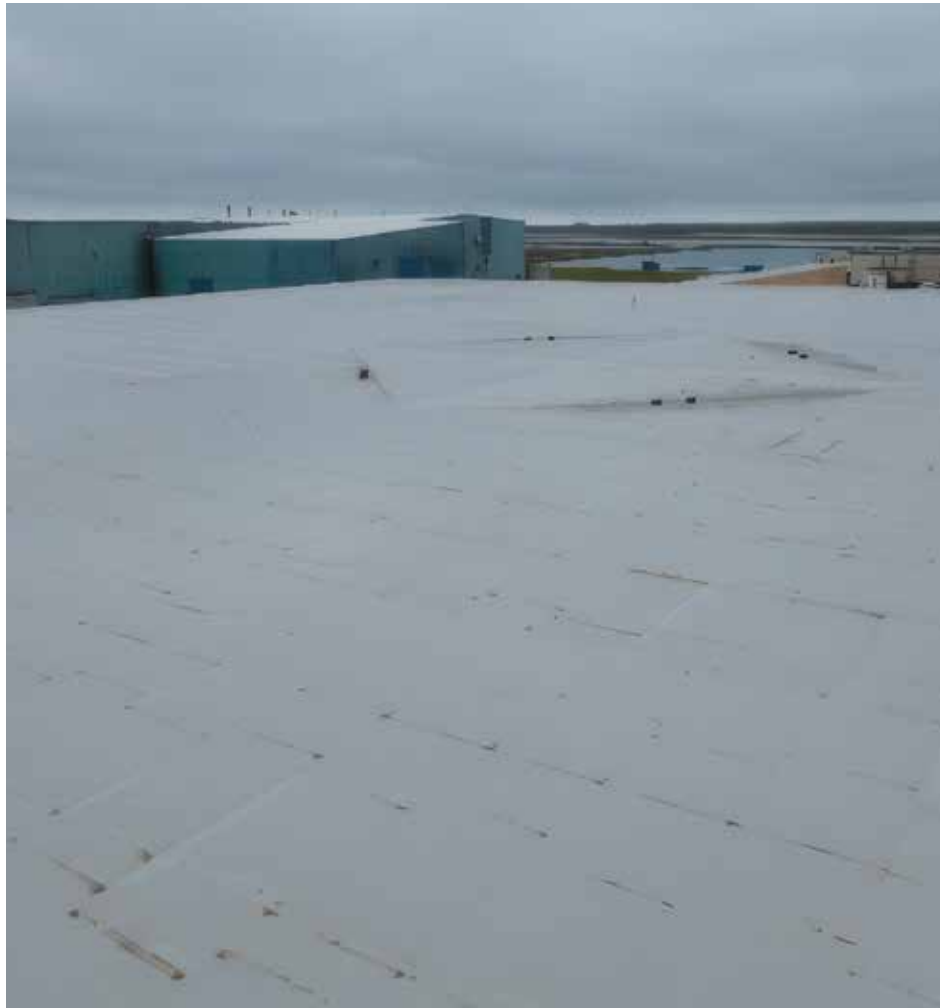
Figure 3. Overview of roof (looking northeast)

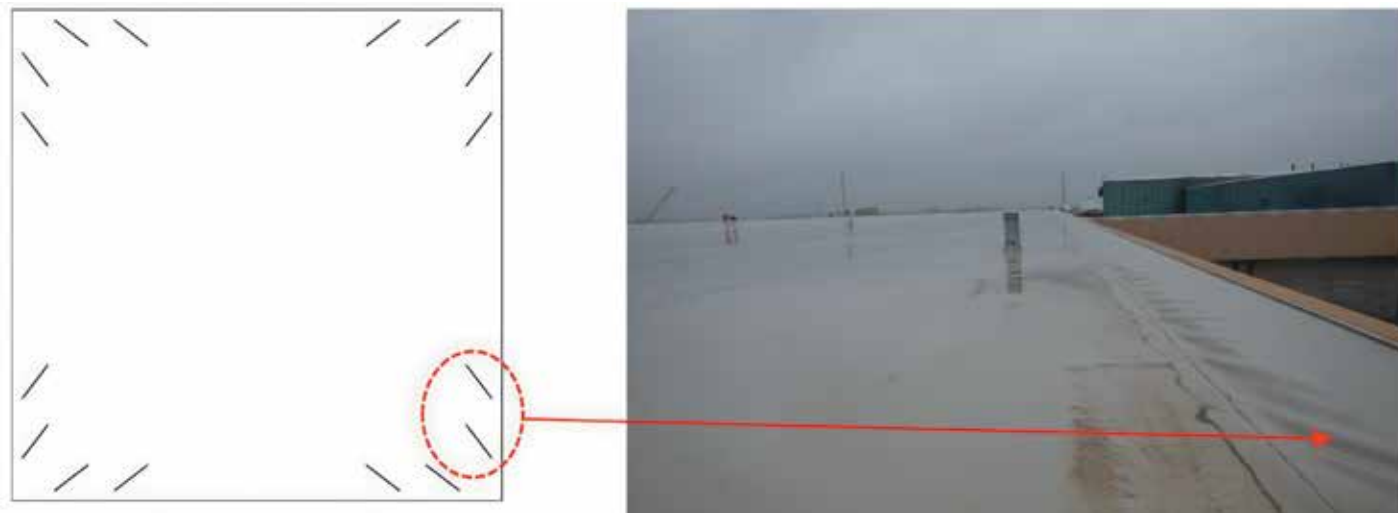
We performed a visual survey of the roof assembly from the interior and exterior and noted that the roof membrane at each corner of the building was wrinkled in a diagonal pattern that pointed toward the corners (Fig. 5). Membrane adhesion to the cover board generally appeared intact, but we noted “excess” or wrinkled membrane at several locations at the cover board joints where the membrane was not adhered (Fig. 6).

Figure 5. Roof plan and a related photo of the shear pattern observed at the roof corners.

membrane itself. We suspect this was the case because the pattern of wrinkles on the roof was strongly correlated with patterns of uniformly and concentrically applied tensile stress on the roof membrane on a square-shaped roof (Fig. 5). The membrane appeared to be pulling away from the roof edge at all elevations and toward the center of the roof. The built-up wood roof curb was attached with 0.130 in. (3.3 mm) \times 3½ in. (89 mm) nails at approximately 8 in.

Refer to Fig. 5 and note that the membrane at the perimeter is in "shear" with respect to the main field of the roof; also, the pattern of distress is consistent with membrane that is being "drawn" toward its center. Also note, ridges in the membrane at insulation panel joints indicate lack of adhesion, but there was also a significant amount of "extra" membrane at these joints, and it would not have been possible to install the membrane in this manner. These ridges occurred after the original installation, and they were most likely the result of contraction of combined PVC and EPS in the winter followed by expansion of the PVC membrane in warmer weather.

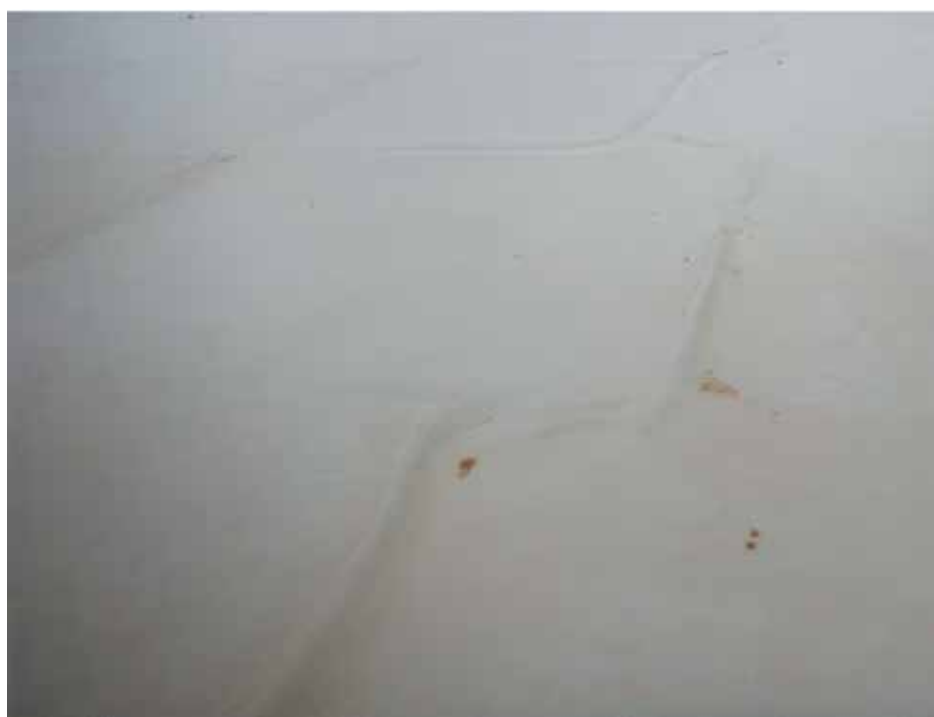
Figure 6. Ridges of unadhered membrane at panel joint.

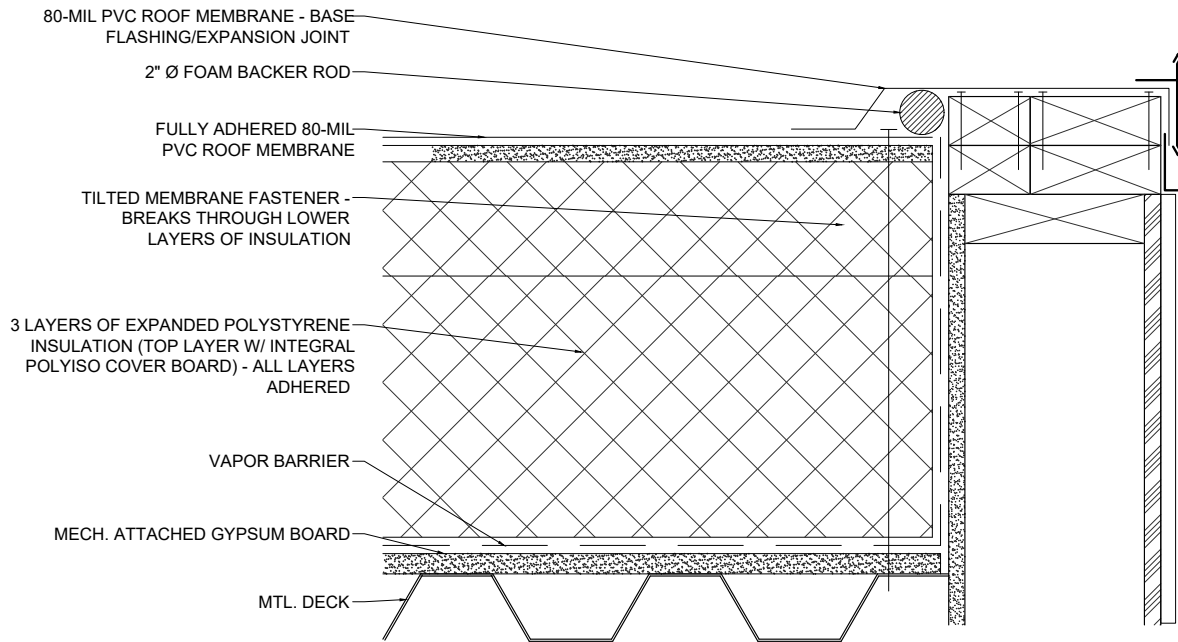
From a lift and from the roof, we observed that the top edge of the roof curb had rotated up and back toward the building and failed along the entire roof perimeter (Figs. 7 and 8). The wood-framed curb was constructed from four pieces of 2 x 6 (38 x 140 mm) and 3 x 6 (64 x 140 mm) dimensional lumber attached with 0.130 in. (3.3 mm) nails in two rows spaced alternately at approximately 8 in. (203 mm) on center (Figs. 9 and 10). The top plate of the wall appeared to be intact and had not been displaced. The failure of the roof edge at all four elevations was clearly visible and appeared to be the most severe at the center of each elevation (Figs. 11-13).

Figure 7. Roof assembly at a failed roof edge—as designed.

connecting the wood curb to the structure to at least meet the requirements of ANSI/SPRI³ would have been appropriate. A different choice of PVC membrane, one with greater dimensional stability, while not a surefire fix, seems like inexpensive insurance in retrospect.

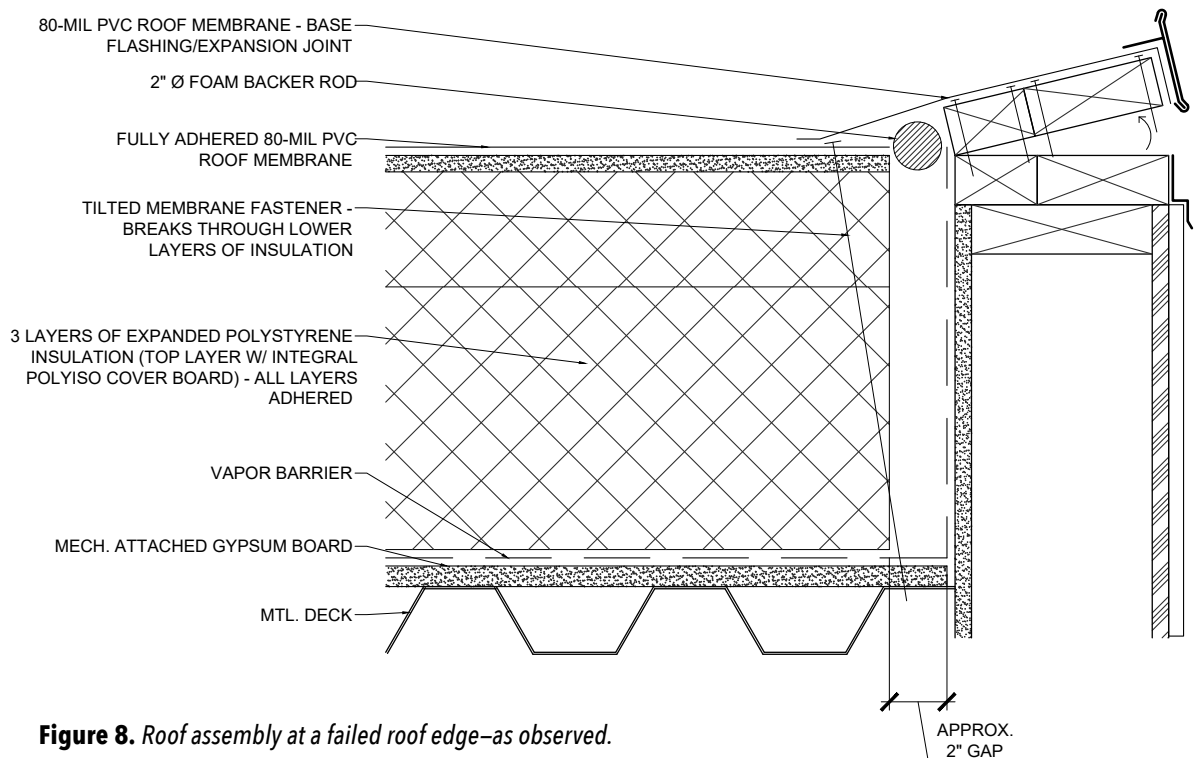
Figure 8. Roof assembly at a failed roof edge—as observed.

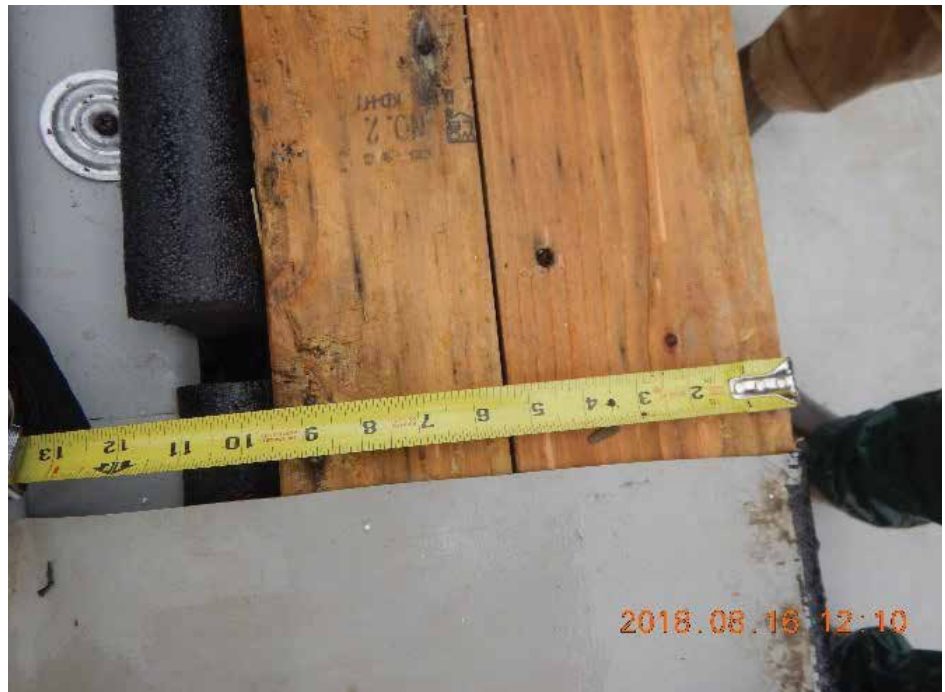
Figure 9. Top of roof curb.

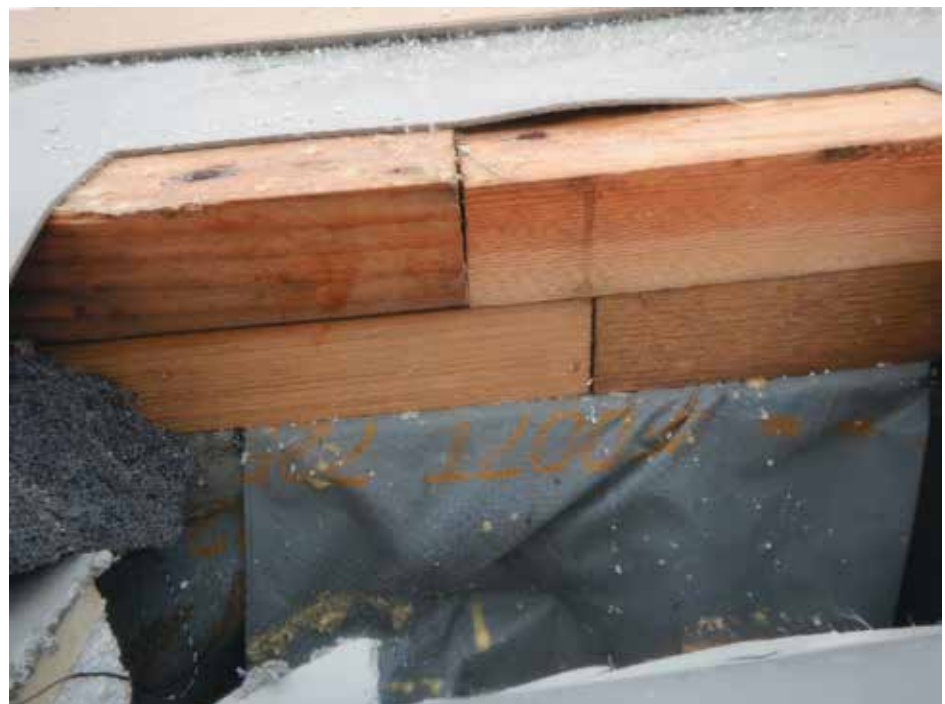
Figure 10. Built-up roof curb.

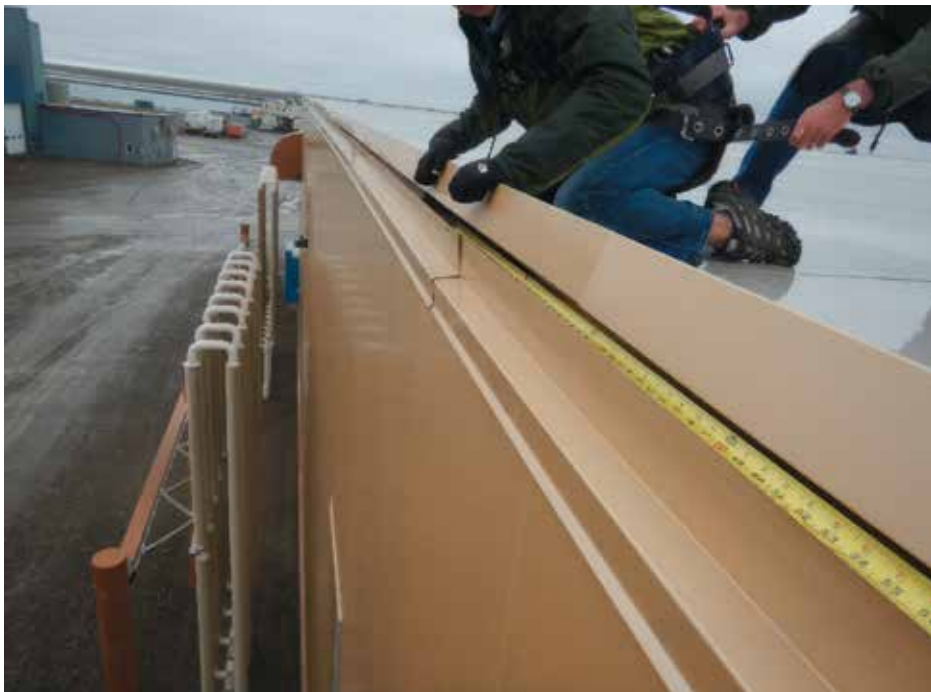
Figure 11. Failed roof edge at north elevation.

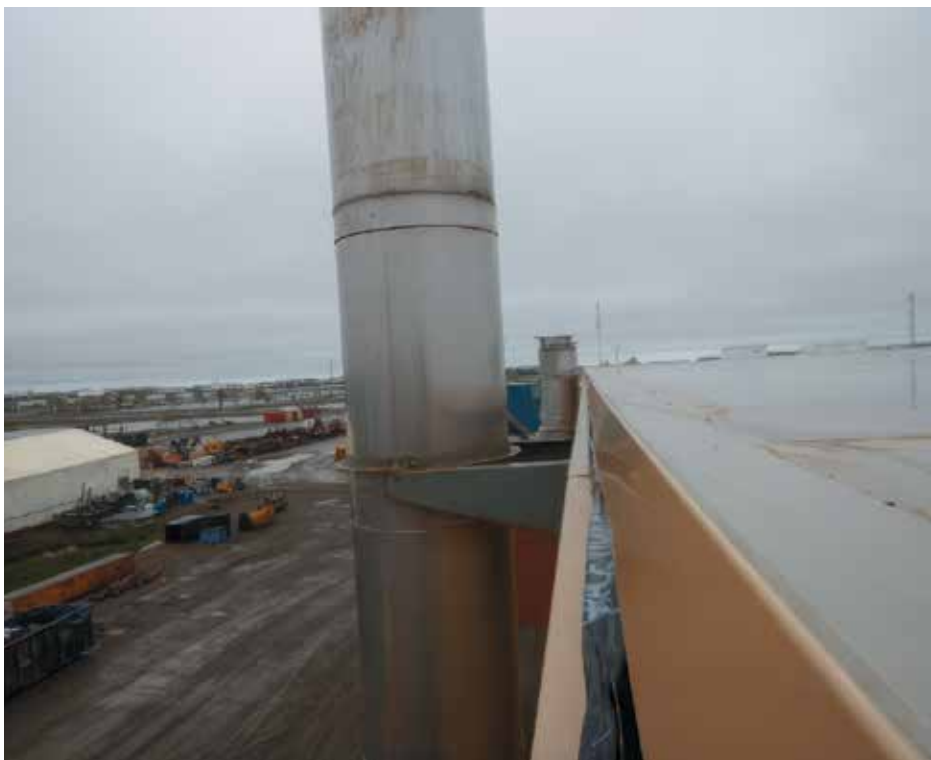
Figure 12. Failed roof edge at west elevation.

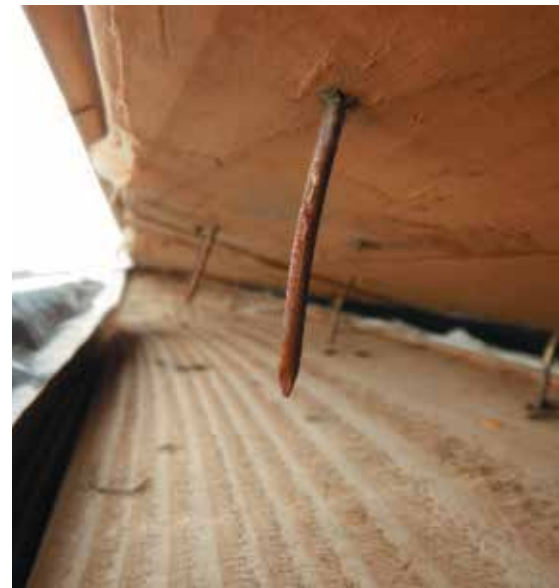
Figure 13. Failed roof edge at south elevation.

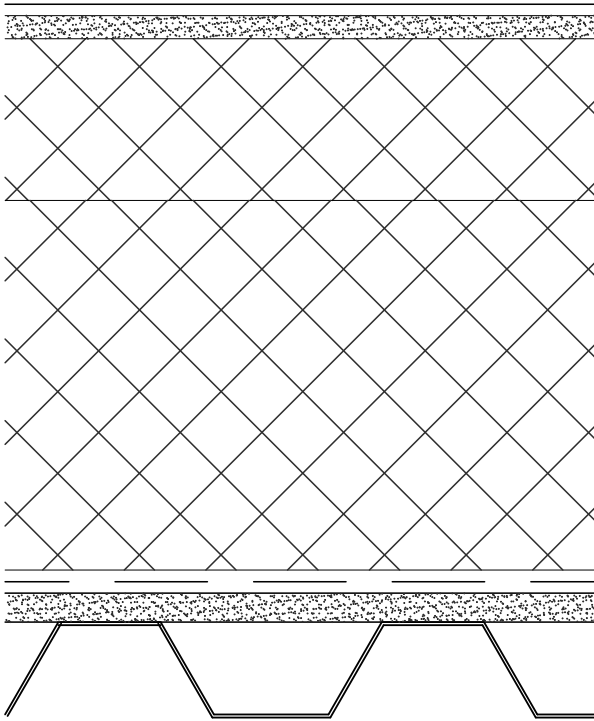
Figure 14. Typical detail for the roof assembly.

We created two openings into the roof. The first opening was made at the north elevation, approximately in the center of the building, and the second opening was made at the south elevation, toward the southwest corner. Figure 14 shows the existing roof assembly observed during our investigation, which was in general agreement with the construction documents.

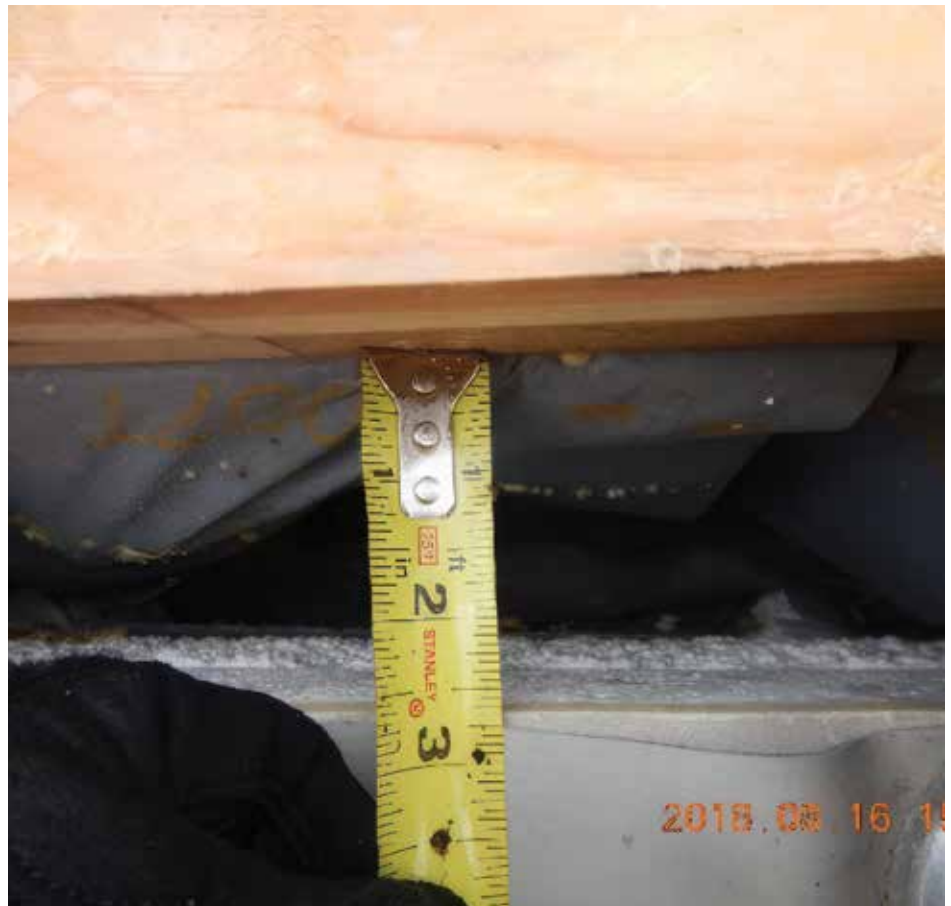
At each opening, we noted the components and attachment methods described in the roofing submittal issued during construction appeared to be present. Also, the adhesion between the roof membrane and cover board and between layers of rigid insulation appeared to be intact. At both openings, there was an approximate 2 in. (51 mm) gap between the edge of the insulation and the inside face of curb (Figs. 15 and 16).

Figure 15. An approximate 2 in. gap was observed at both openings.

Due to the limitations of the short arctic roofing season and logistics of getting multiple experts to this remote location, we were limited to one day of exploratory investigation and two openings. We observed an approximate 2 in. (50 mm) gap at both openings, but we suspect that this gap existed around the entire perimeter of the roof. The original contractor indicated that the insulation was installed tight to the curb, i.e., the insulation gap was not present initially and therefore developed over time, which is consistent with our field observations. Out-of-plumb membrane fasteners tore through the insulation in a manner suggesting all components were in place prior to failure, with small particles of EPS insulation balanced delicately on one side of the fastener only. This result would have been difficult to achieve during installation of a rotating screw.

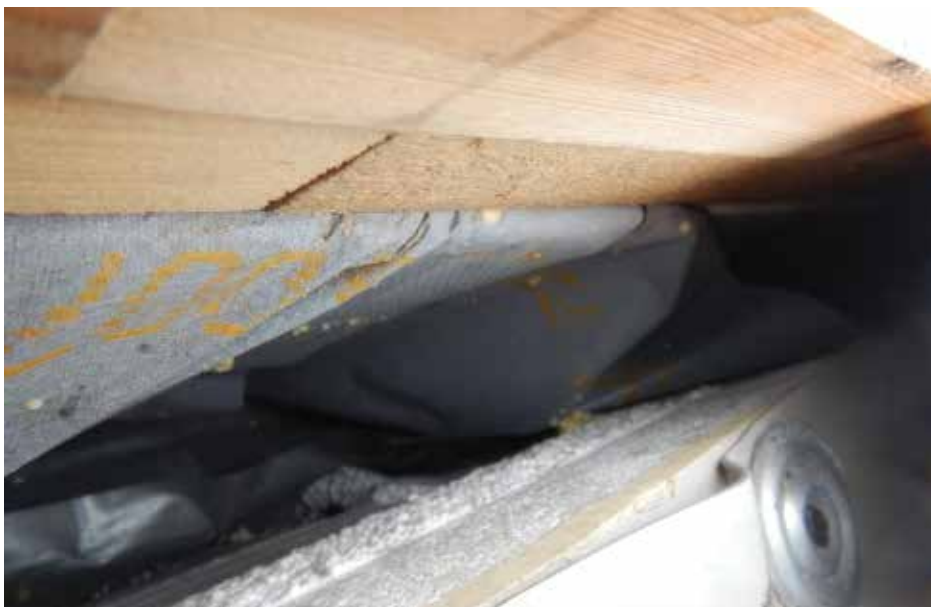
at both openings, roofing screws appeared to have been displaced (Figs. 17 and 18); they were not plumb and had begun to tear through the insulation. In addition, the roof membrane appeared deformed around the head of one of the screws (Fig. 16).

Figure 16. *Membrane under tension at fastening plate.*

Figure 16 shows the roof membrane displaced locally around the washer, indicating tension between the membrane and fastener/washer and that anchorage of the membrane at this location had failed. The screw orientation, membrane displacement, and the characteristics of torn insulation indicate that the 2 in. (50 mm) gap observed at both roof openings was not present at the time of installation and that roof assembly had in fact shrunk.

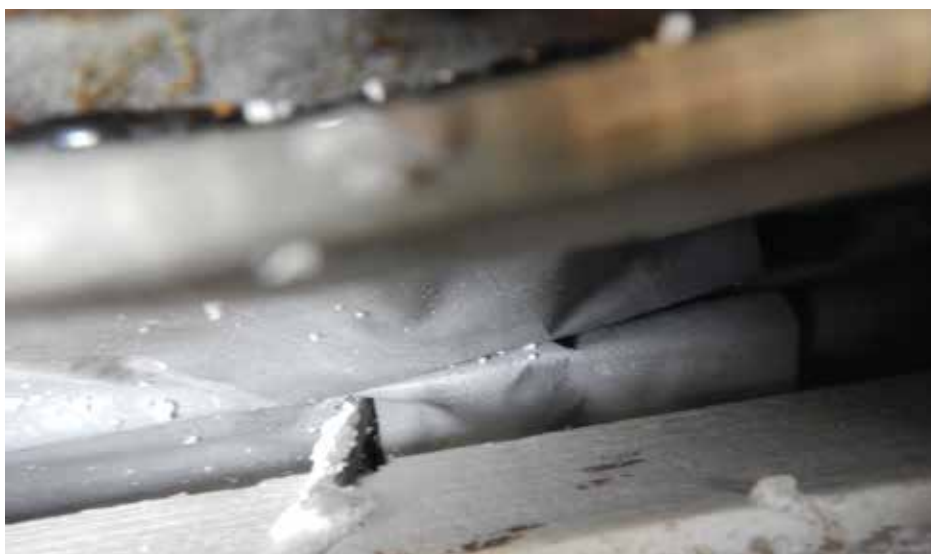
Figure 17. *Downward view of rotated membrane screw tears through insulation.*

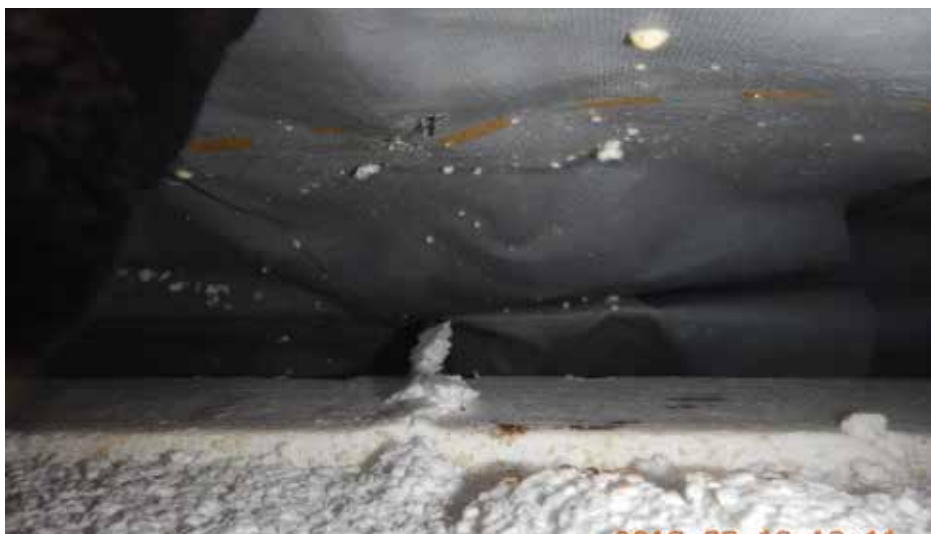
Figure 18. *Close up look at the bottom of the insulation, showing more damage on the bottom layer of insulation.*
